**REPORT ON THE SITE VISIT OF THE TEAM OF THE ASSISTANT DIRECTOR  
OF MINES & GEOLOGY ,NELLORE DIRECT BY THE HON'BLE NGT IN O.A.  
No. 168 /2021(SZ)**

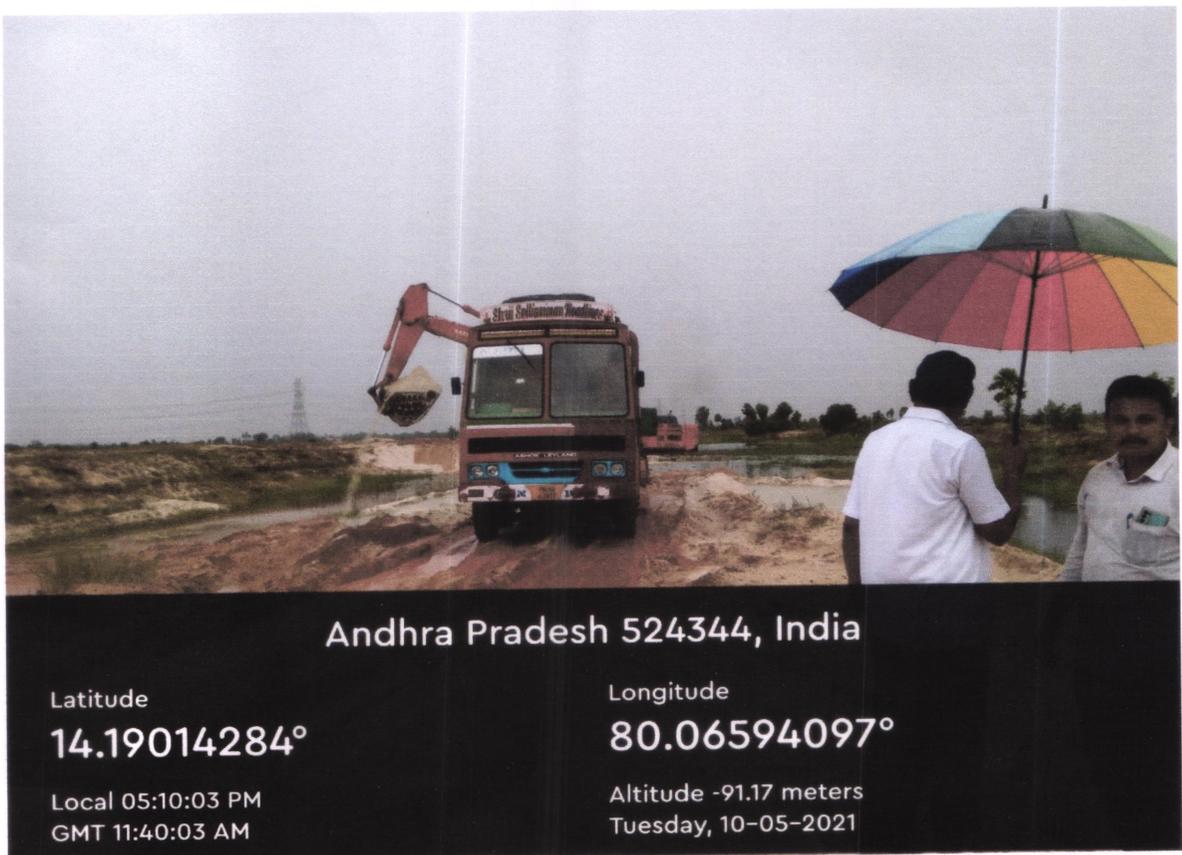
- At the time of inspection, rain is falling and noticed that the excavation of Silica Sand is going on with the help of one excavator and four labours and loading of Silica Sand to the vehicles for transportation is going on. The method of mining is open cast mechanized without drilling and blasting and the excavation will be manual, occasionally using excavators.

1. Photograph showing the loading of the Silica Sand

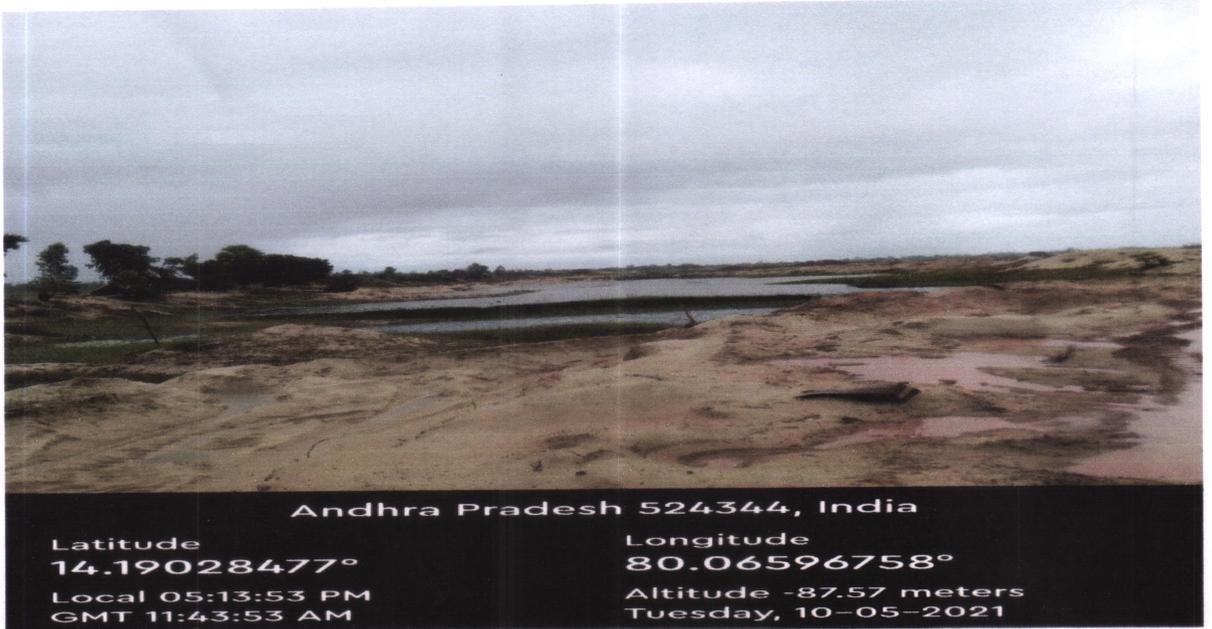
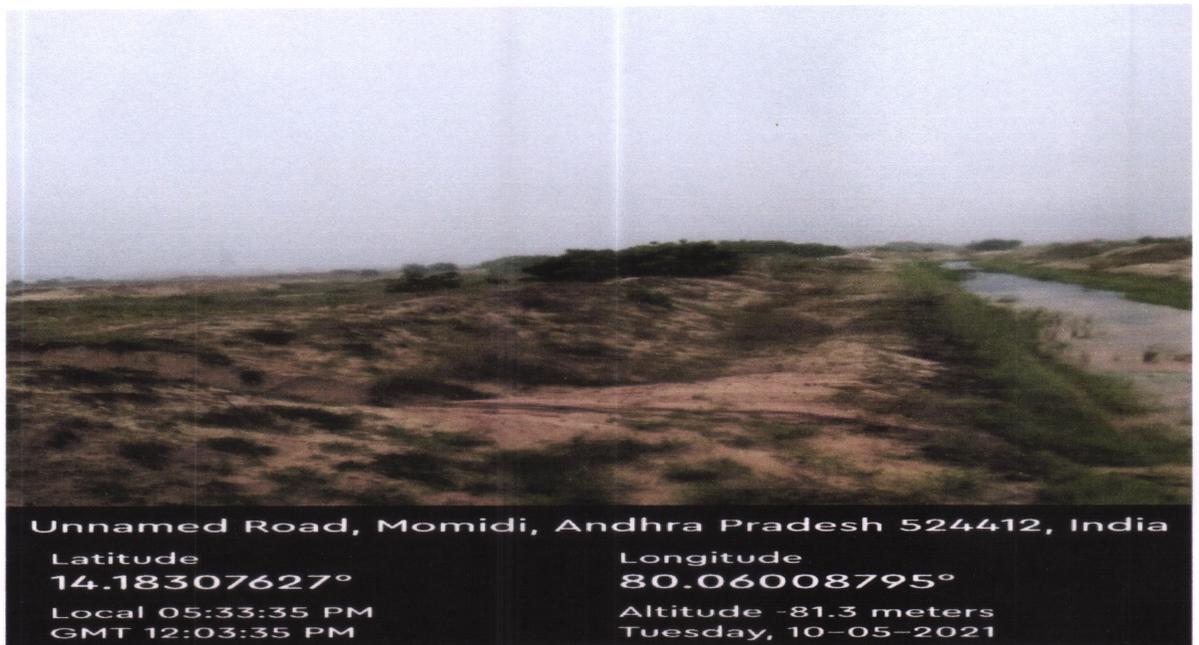
- It is observed that, no fresh Silica Sand excavation pits / workings are done within 50 mts distance from the Sona Canal present in the leased area. Further the lease holder erected the fencing on either side of the safe margin distance of 50 mts from the Sona Canal. Moreover, the growth of grass and other bushing plants are observed in the safe margin of Sona Canal indicates that, there are no fresh excavation of Silica Sand was made by M/s Kumaraswamy Silica Mines.

2. Photographs showing the erection of fencing around the Sona Canal and no fresh workings.
