**BEFORE THE NATIONAL GREEN TRIBUNAL
SOUTHERN ZONE, CHENNAI
Original Application No.119 of 2021 (SZ)**

Thadagam Valley Brick Kilns, Coimbatore

Inspection Committee Report

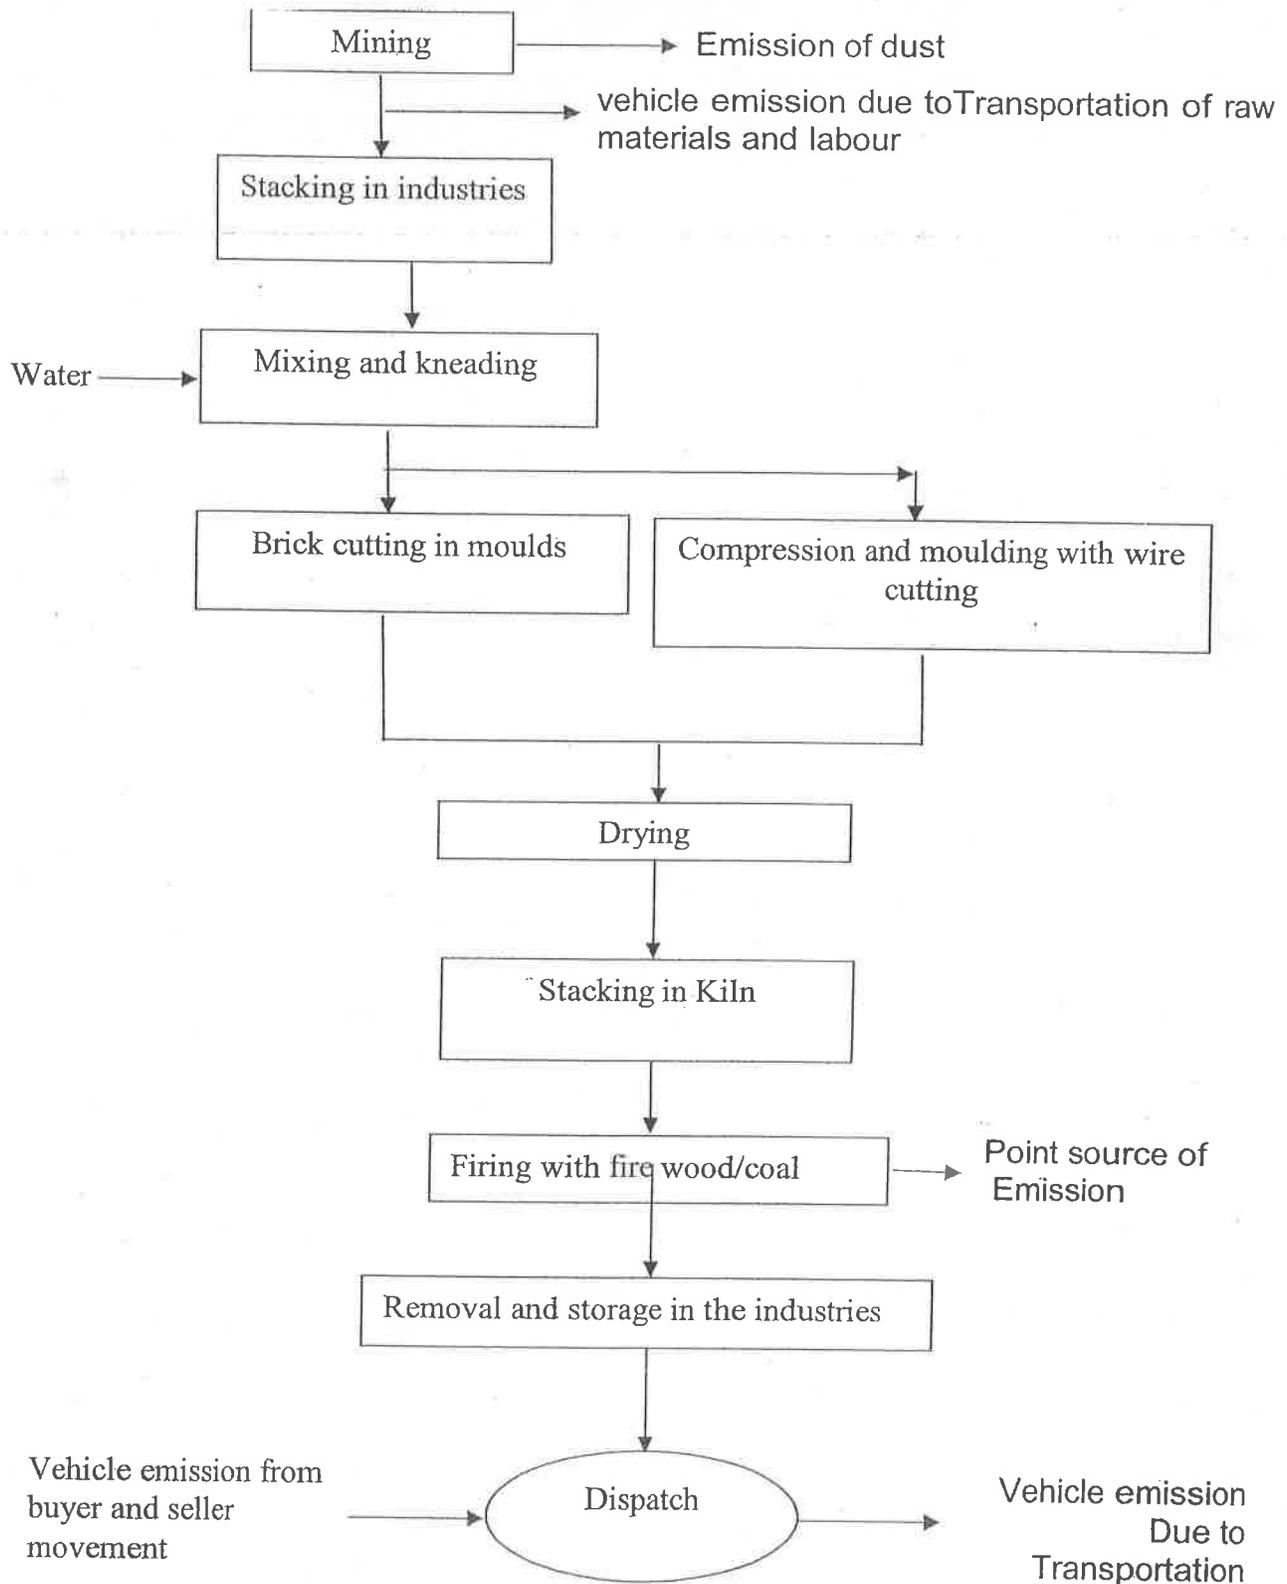
FLOW CHART OF BRICK MAKING WITH SOURCES OF EMISSION

The process of manufacture of bricks is illustrated I the flow chart given below

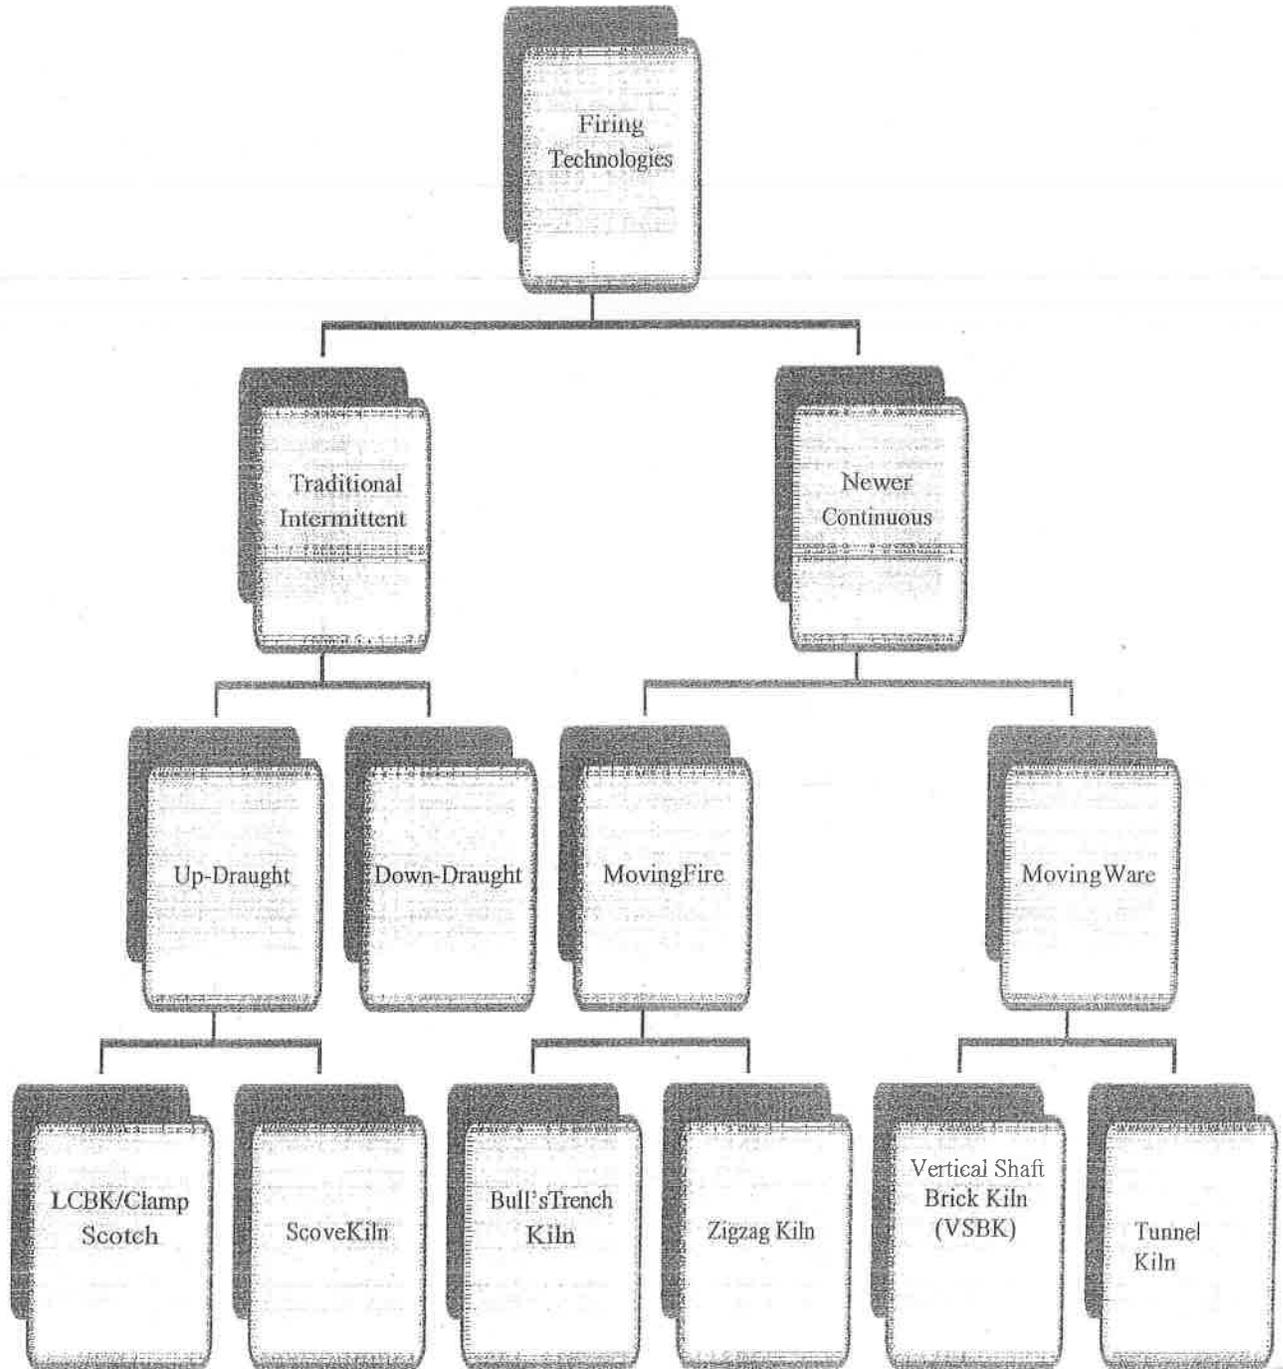
Various technologies are available to manufacture brick. Type of kilns is illustrated below. Basically the process is either intermittent or continuous.

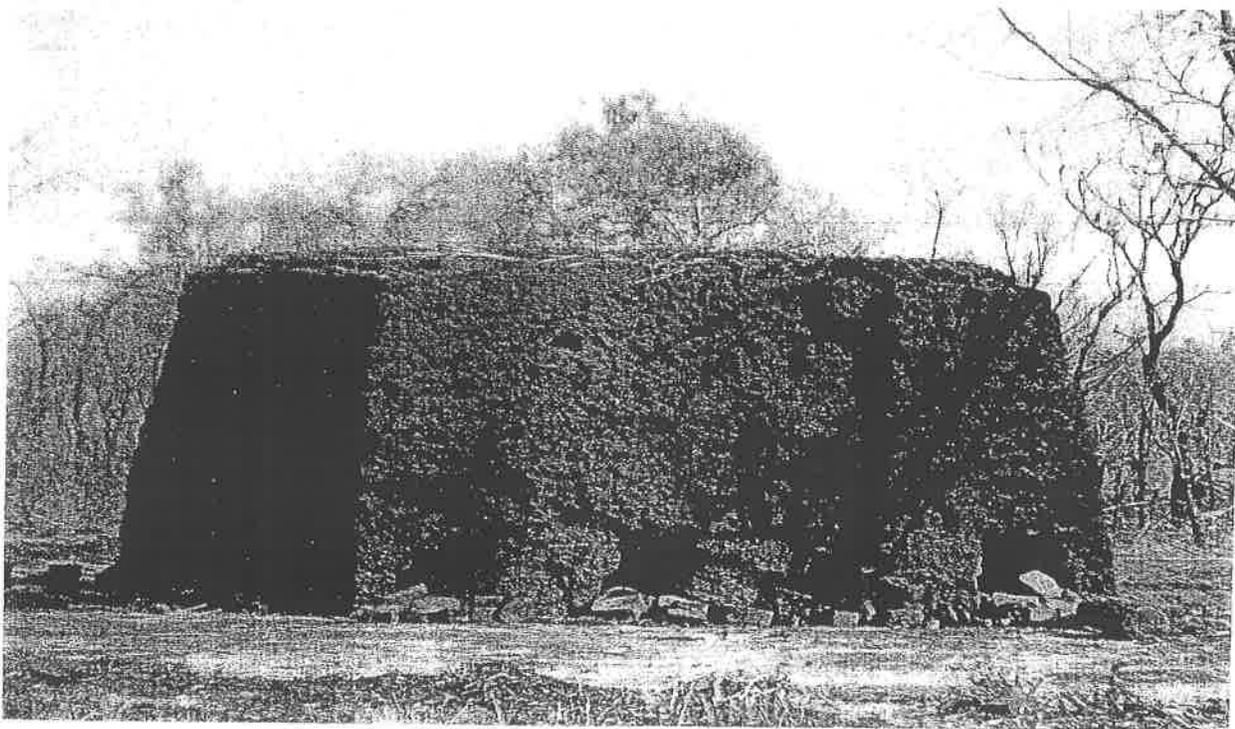
Country Kilns:

Clay, red sand or sand are mixed in required proportion, kneaded and cut as bricks in moulds. The green bricks are sun dried and stacked and fired. These bricks will be either over burnt or under burnt as there is not a uniform heating of the brick occurs in the kilns. This type of kiln is a batch process i.e. bricks will be stacked, fired and removed for despatch. These kilns will have no chimney and spread lot of fugitive emission in the surrounding area and cause nuisance and health hazard due to combustible gases

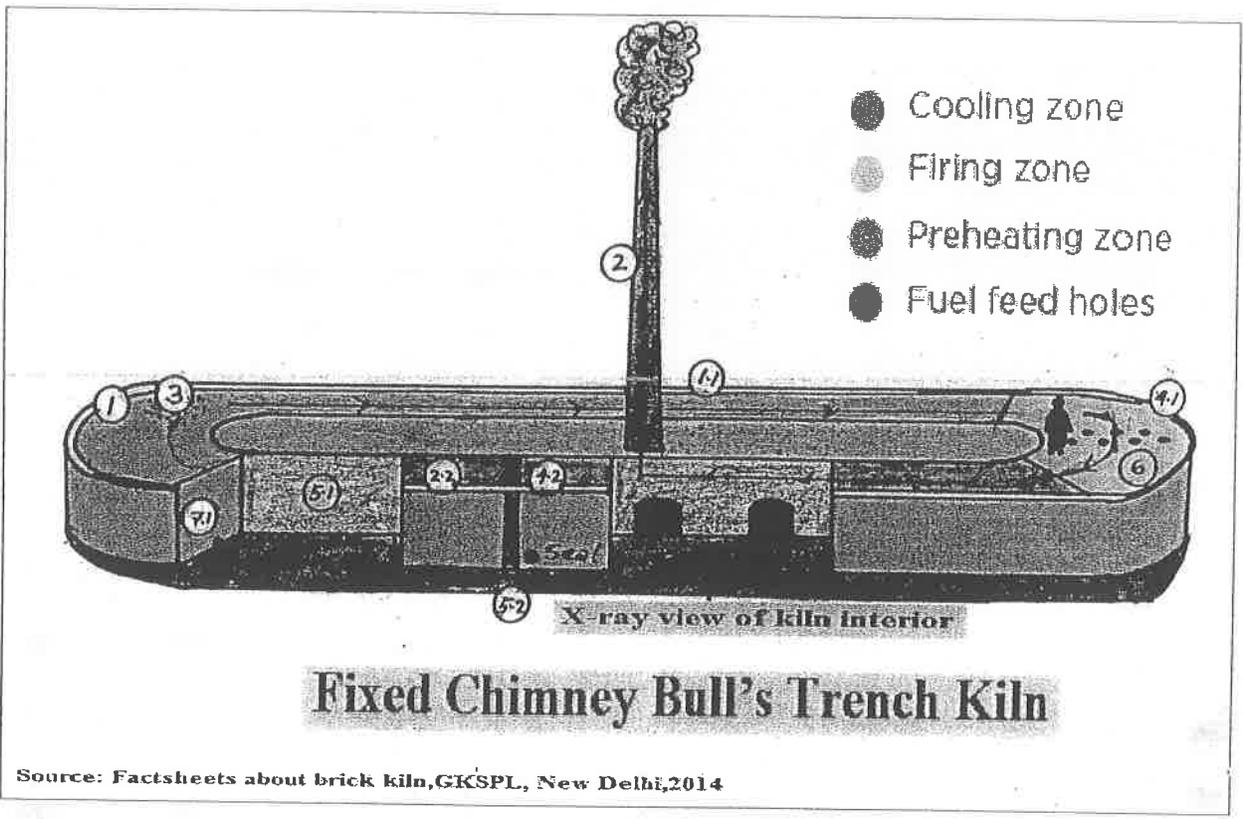
Due to the Governments initiatives to go in for fixed chimney, the Bull trench kilns have installed a fixed masonry or steel chimney instead of the mobile chimney installed in the kiln earlier. The flue gas chamber will also have dampers to reduce the velocity of flow of flue gas so that the dust will drop in the flue gas path way and less dust ladden air will flow as flue from the chimney.

To add strength of brick, the brick moulding process is also improved. The clay is mechanically compressed to make brick a with wire cutting machine. Bricks made by this process will have high density and sharp edged.

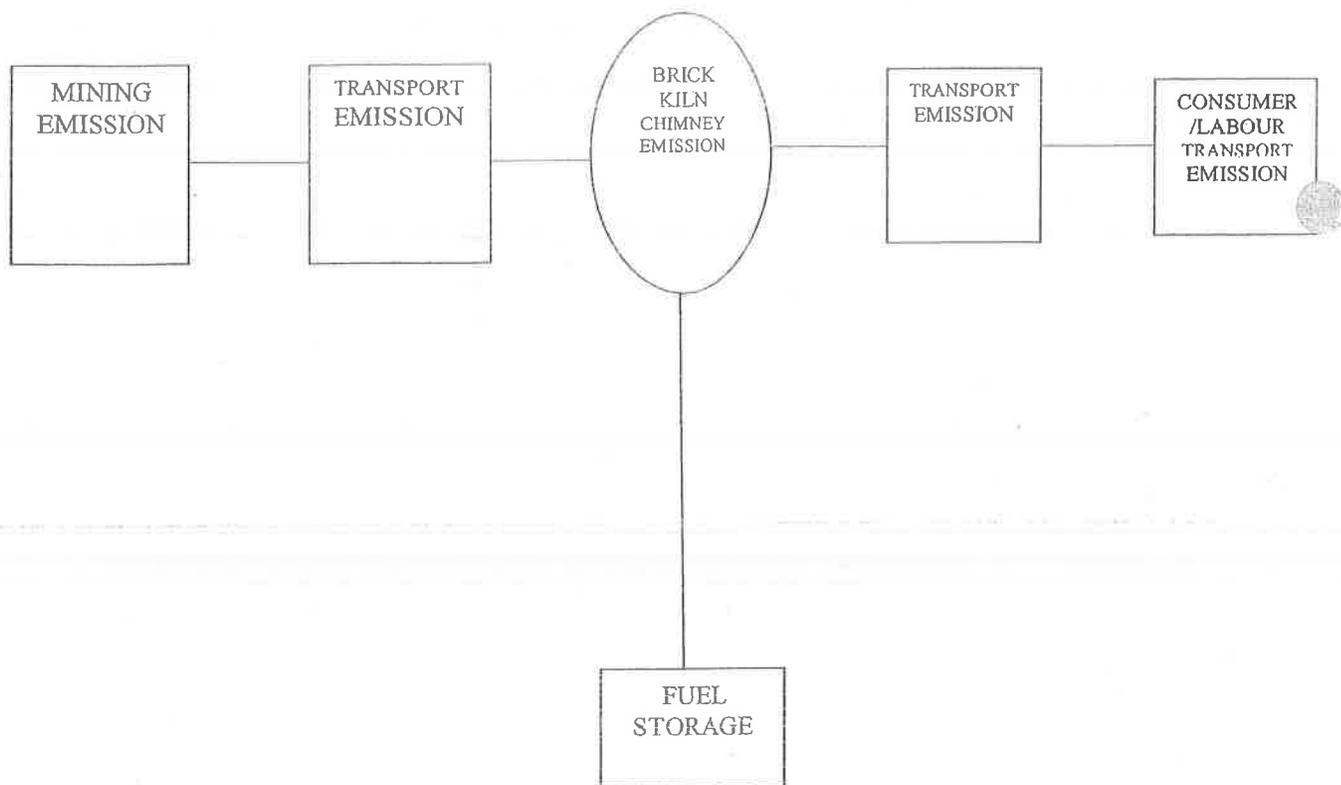
SOURCES OF EMISSION FROM BRICK KILNS:

- (1) Dust emission while mining
- (2) Loading activities
- (3) Vehicular emission due to transportation
- (4) Unloading mined materials in the industry
- (5) Firing of moulded green bricks
- (6) Removal and dispatch leads vehicular emission by dispatch
- (7) Indirect emission from employees, owners and buyers movement through automobiles.

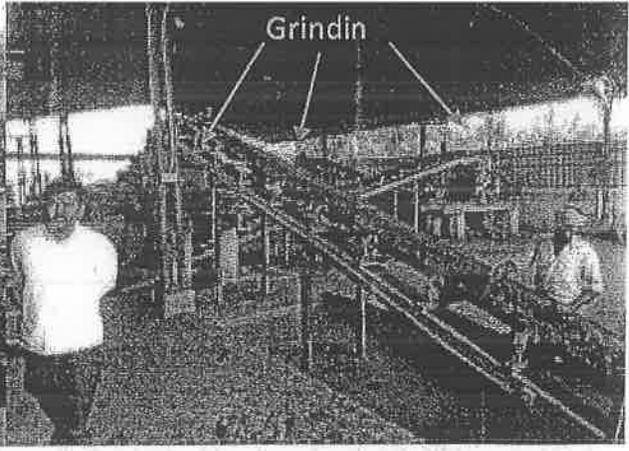
Preparation & Molding: In this cluster, the soil preparation and molding is done manually and also mechanically. Manually the soil is mixed and molded using wooden or plastic mold in table top. Large and small size of mechanical molding is also being carried out by few units. Large units have box feeder, double roller (3 nos.) for various size grinding and finally fed to pug mill to make block. This block is cutted by using wire, known as wire cutting brick. Small units has only one double roller grinder.

It was informed that due to mechanized preparation of mixing, grinding and moulding process, gives proper homogenization of clay, proper size and shape and production of better quality bricks with more strength.

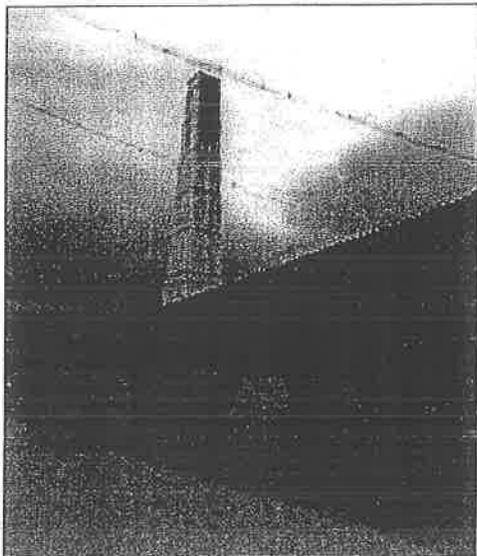
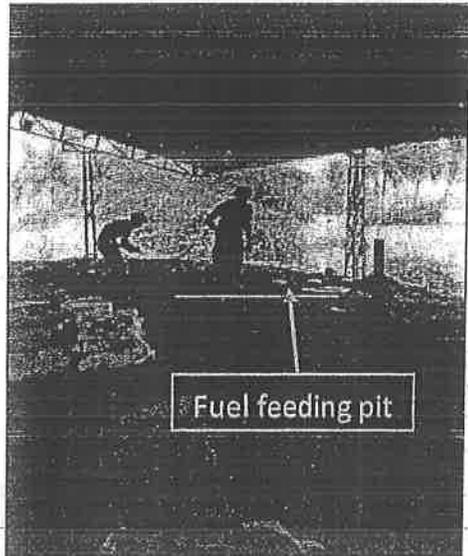
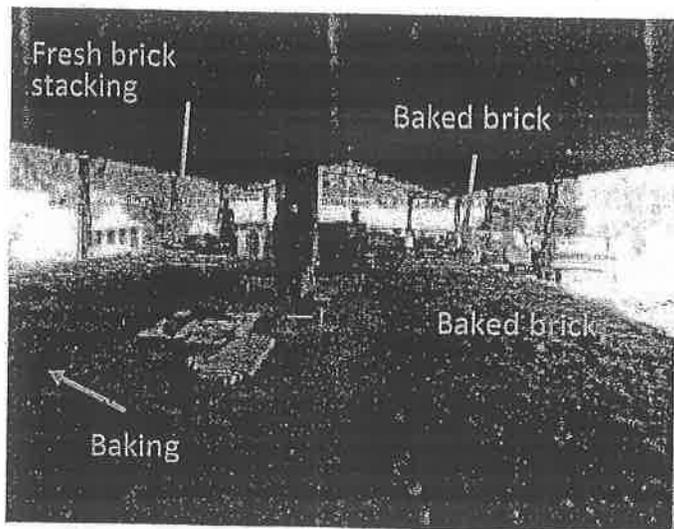
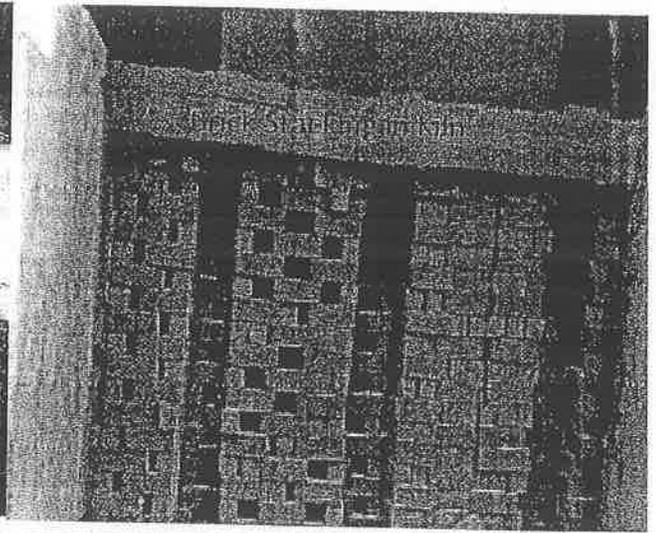
Brick drying: The molded bricks are first sun dried to remove the moisture present in bricks. Bricks are stacked under top closed hut and also in open field.

Brick firing: Sun dried bricks are stacked in zig-zag manually inside the kiln. The cluster uses natural draft Fixed Chimney Bull's Trench Kilns (BTK) and brick chamber is of same design. The fired bricks, after cooling are taken out, burning is confirmed through visual inspection and stacked for dispatch. The fuel used is either wood or coal.

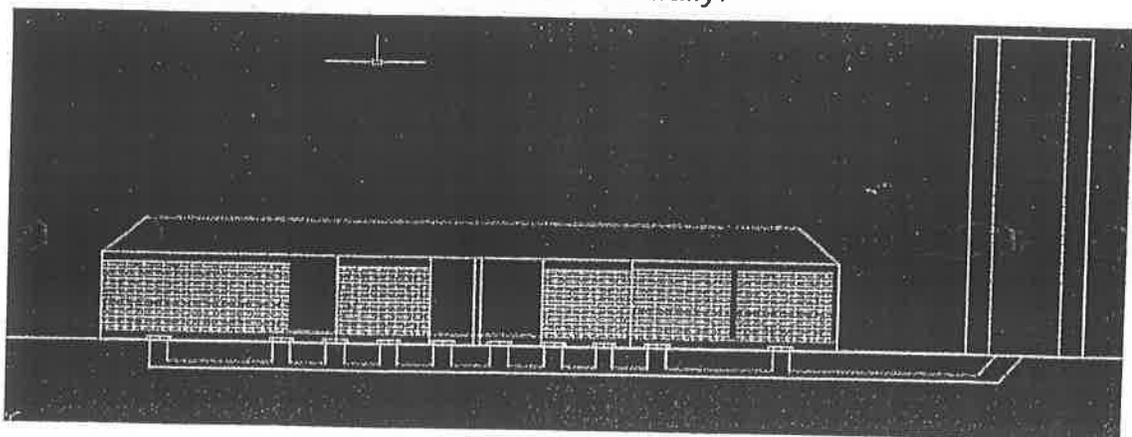
The below picture shows the operation of kiln chamber, the first zone (brown color) shows the fired (baked) bricks followed by cooling zone. Second zone in red colour represents the firing zone. Third zone in orange colour is preheating zone and fourth zone in green colour is fresh unburnt bricks. The emission from the kiln passes Fuel feeding pit Baked brick removing Baked brick cooling Baking (firing) Fresh brick stacking for baking Kiln Chamber Brick Stacking in Kiln Chamber 7 through vent hole provided at chamber bottom. This vent hole is provided with the lid system. When firing happens, the lid will be opened at the end of the preheating zone. Then the emission from the chamber is routed through the underground duct (depth 3-4 ft) and connected to the bottom of stack. It was informed that 6 ft depth is provided in bottom of stack. During non-operational time the ash settled in the duct and stack bottom is removed manually.

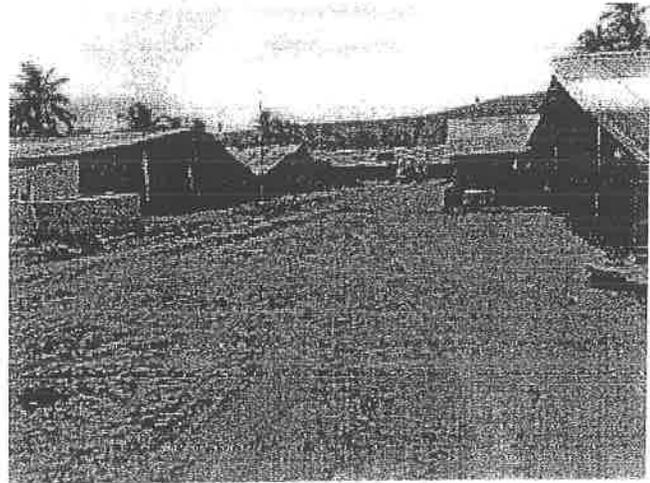
Fugitive emission: More fugitive emission is observed due to unpaved roads and fine dust accumulated around chamber.

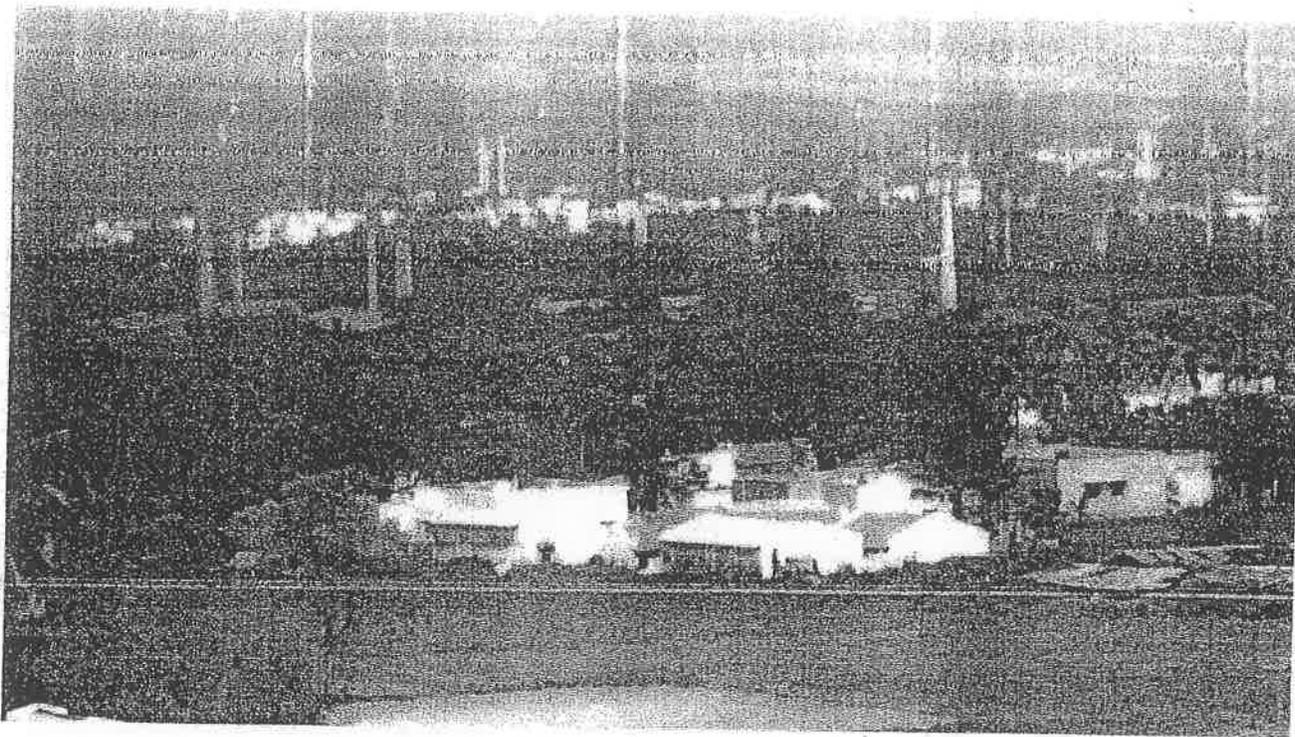
A view of cluster of Brick kilns at Thadagam Valley – 1

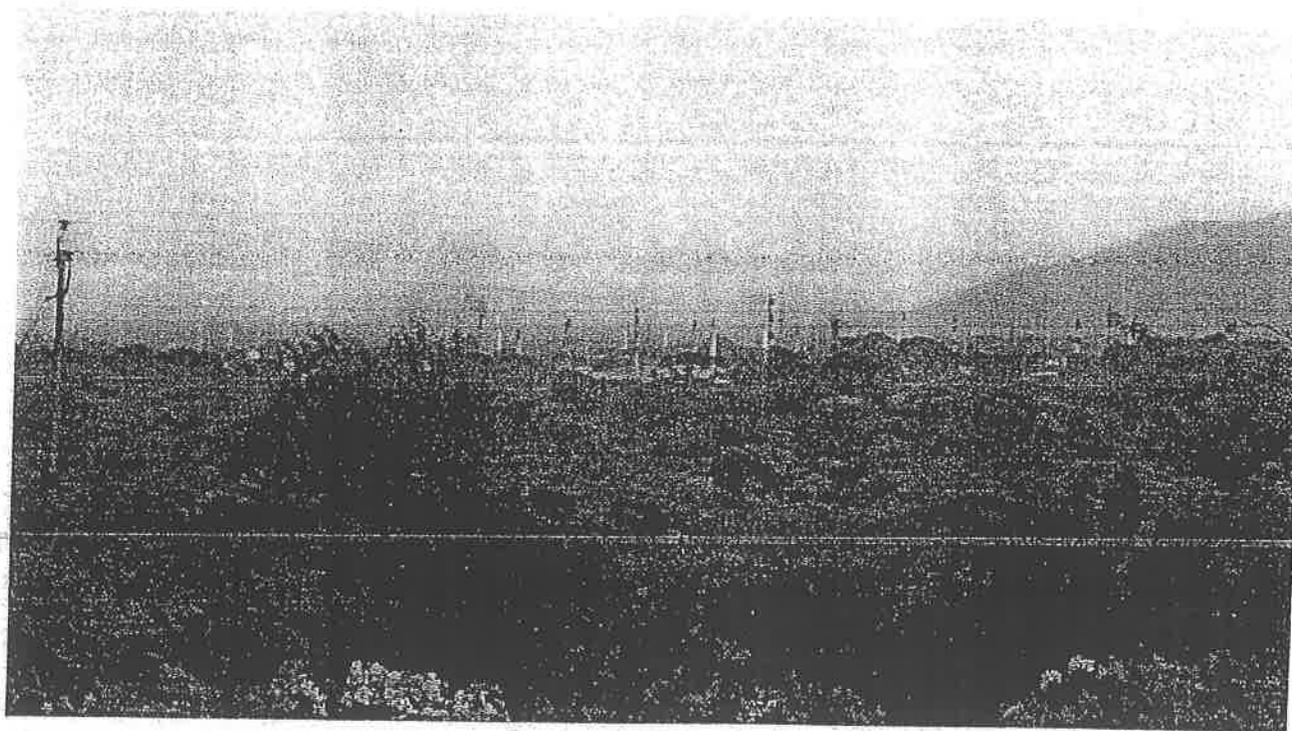
A view of cluster of Brick kilns at Thadagam Valley - 2

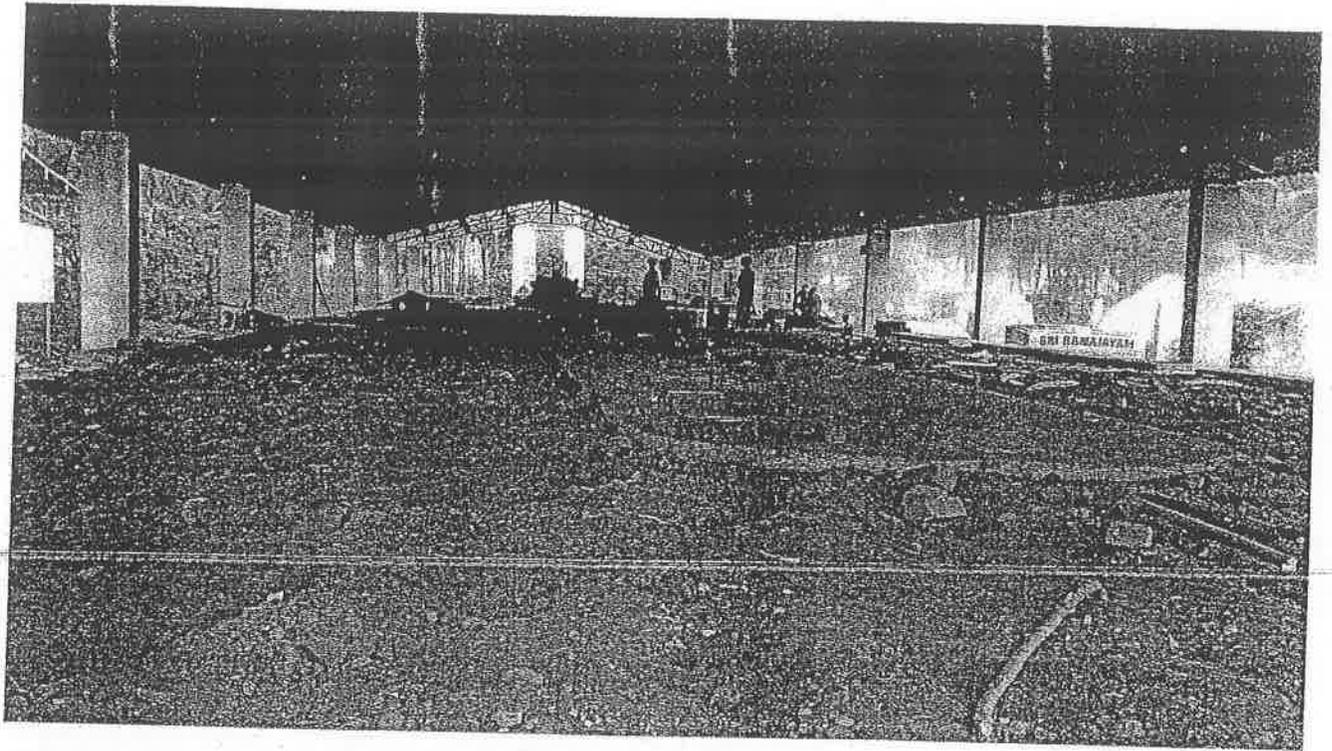
Brick kiln Chamber

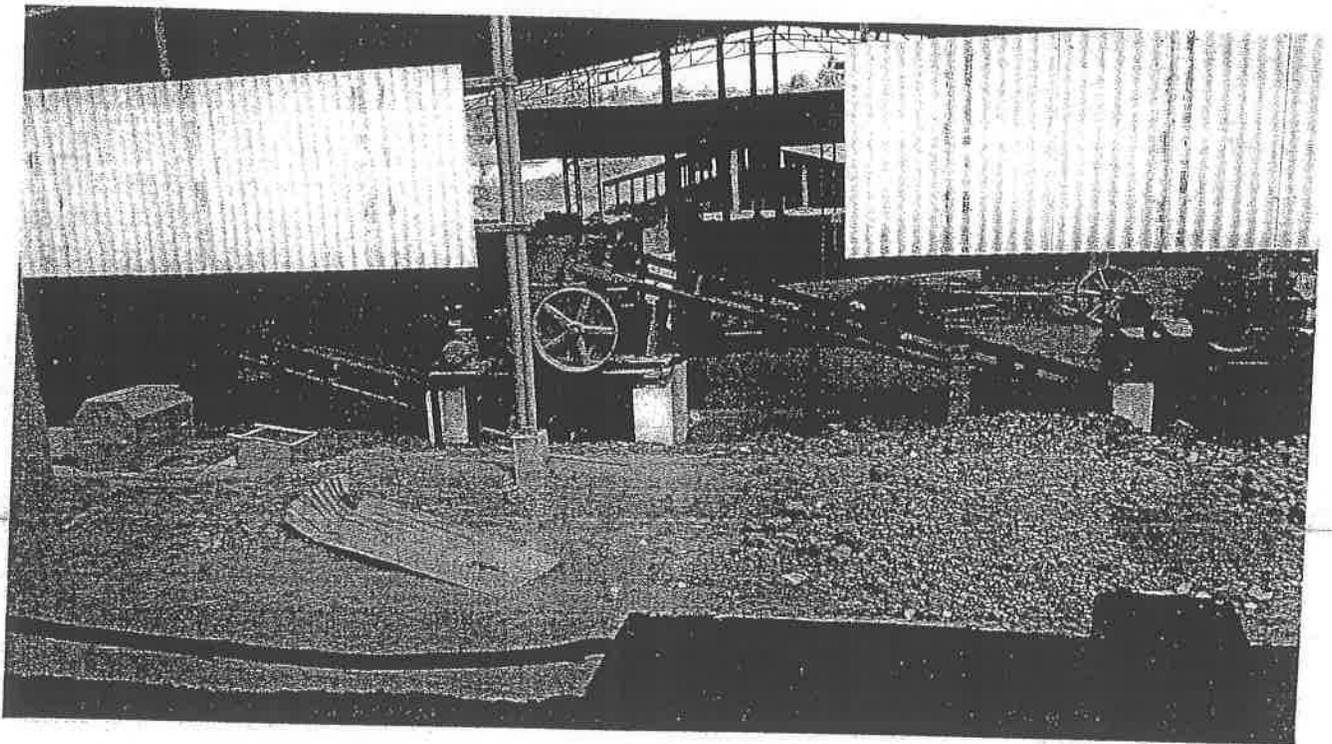
Wire cut brick manufacturing machine

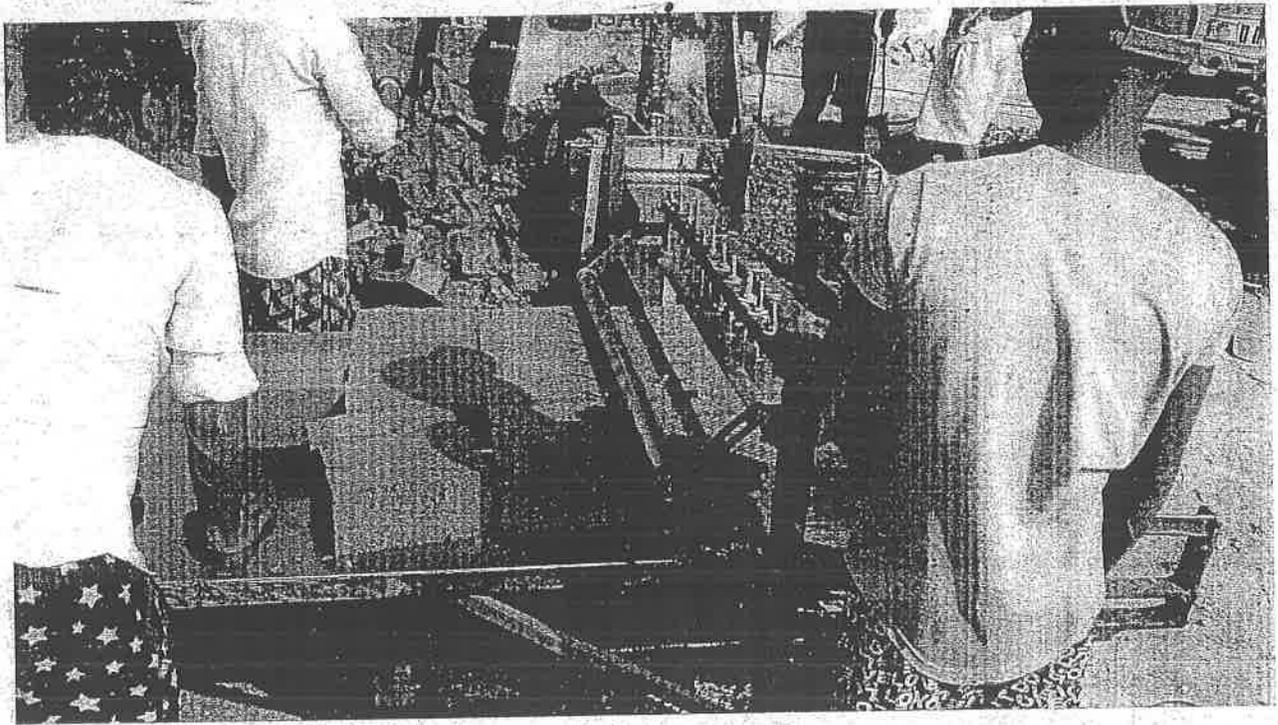
Wire cut brick making

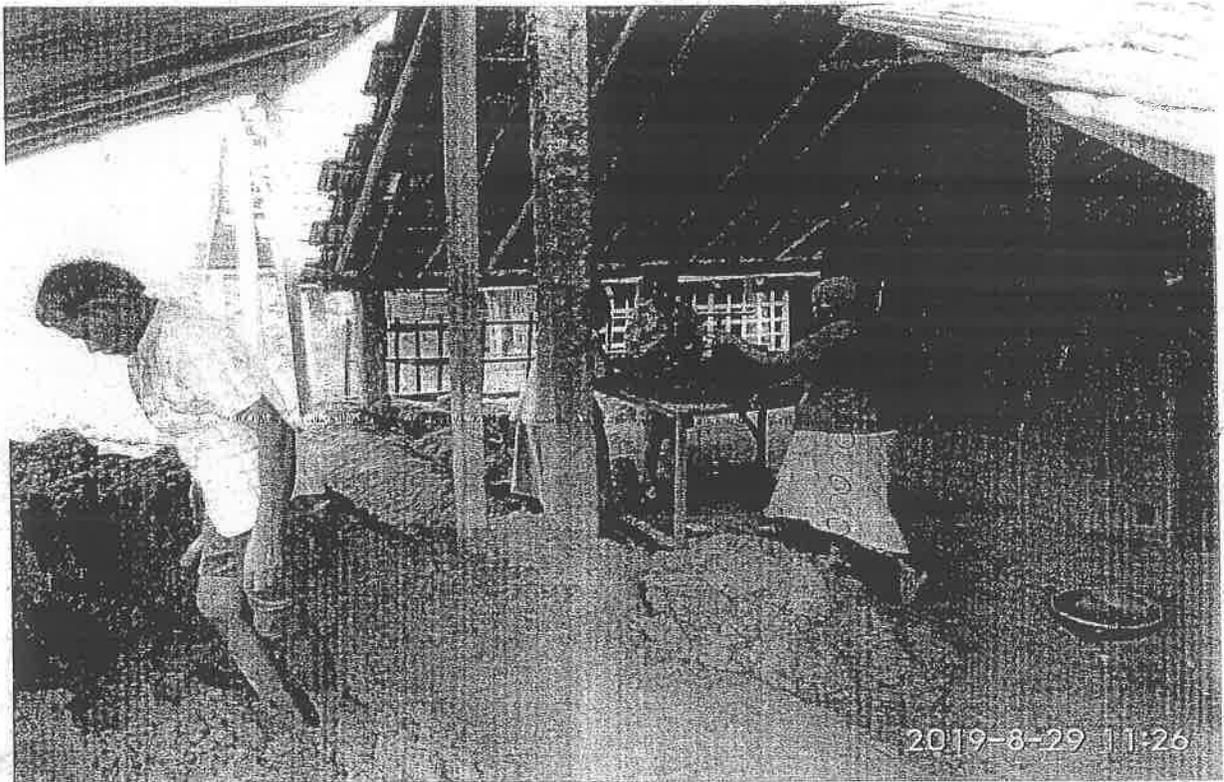
Conventional type Table moulded Brick manufacturing

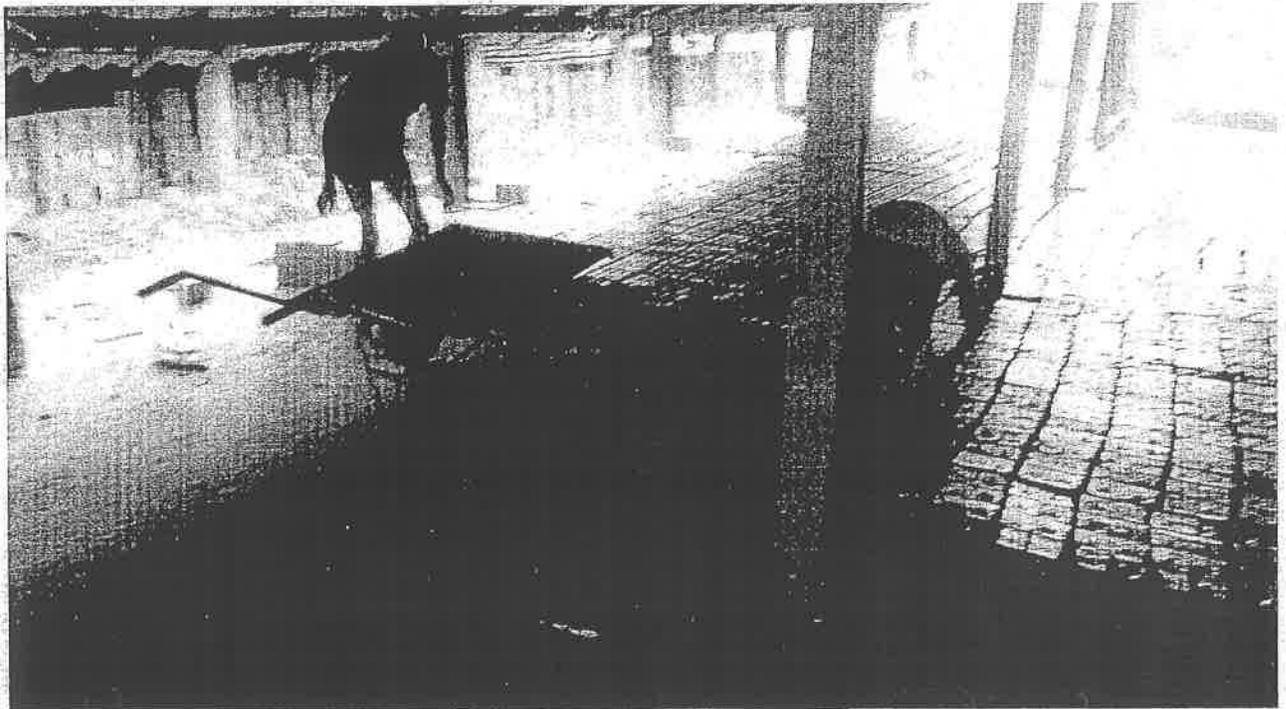
Bricks drying yard

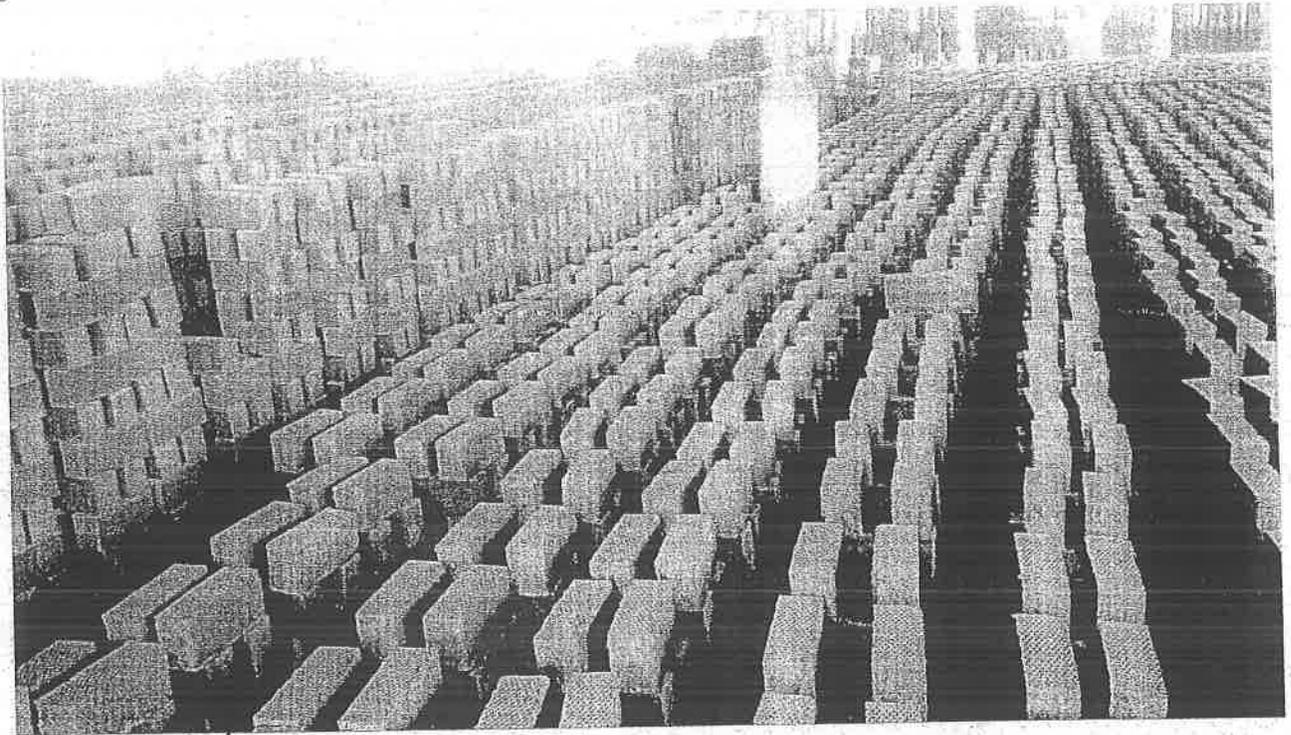
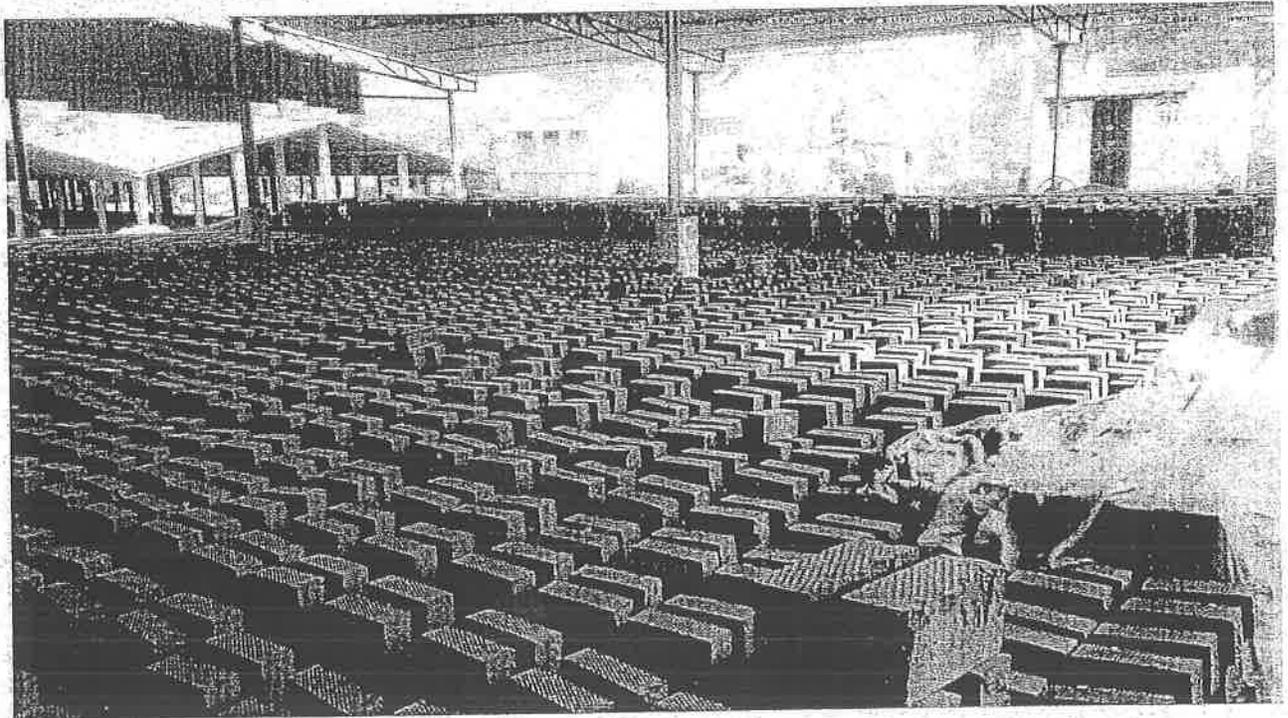
Wire cut bricks drying yard

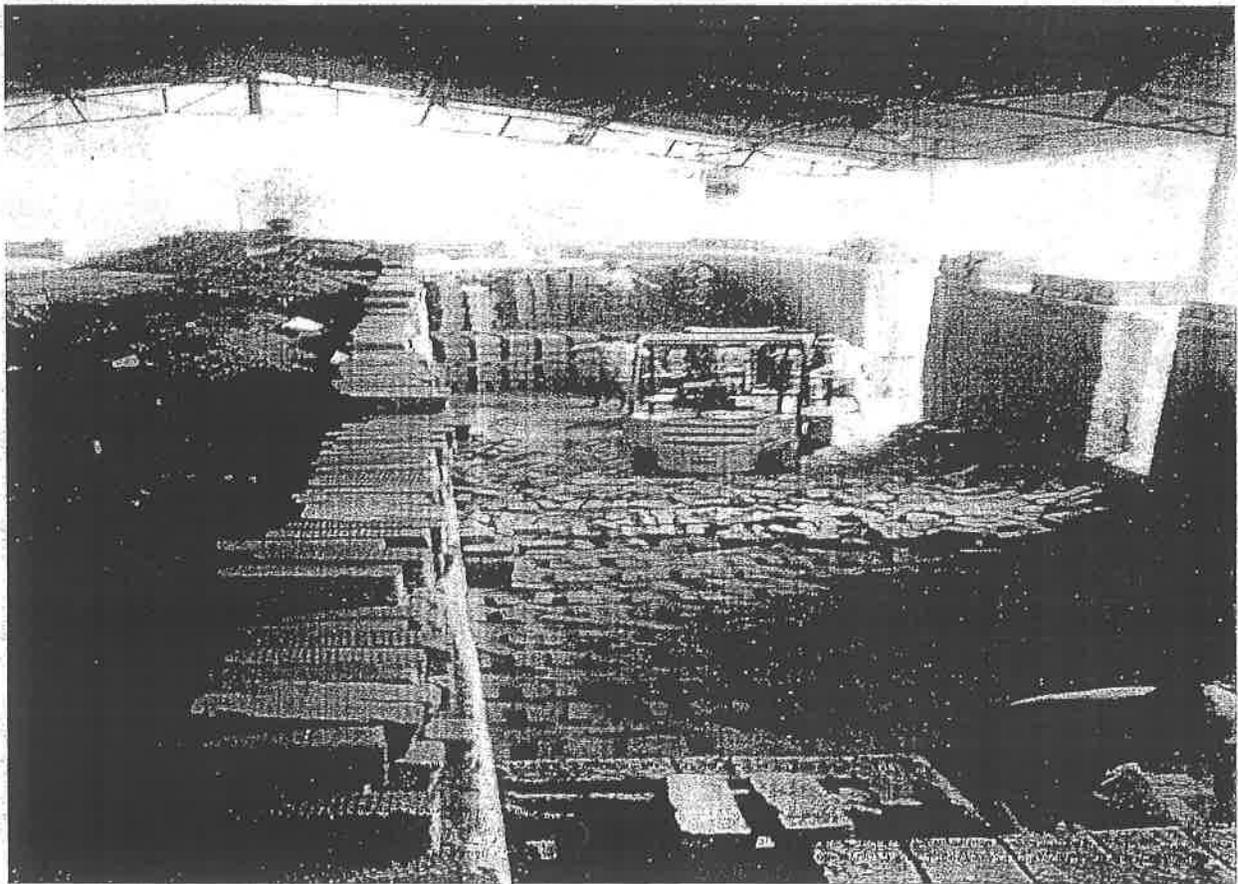
Loading and Unloading in the Brick Kiln

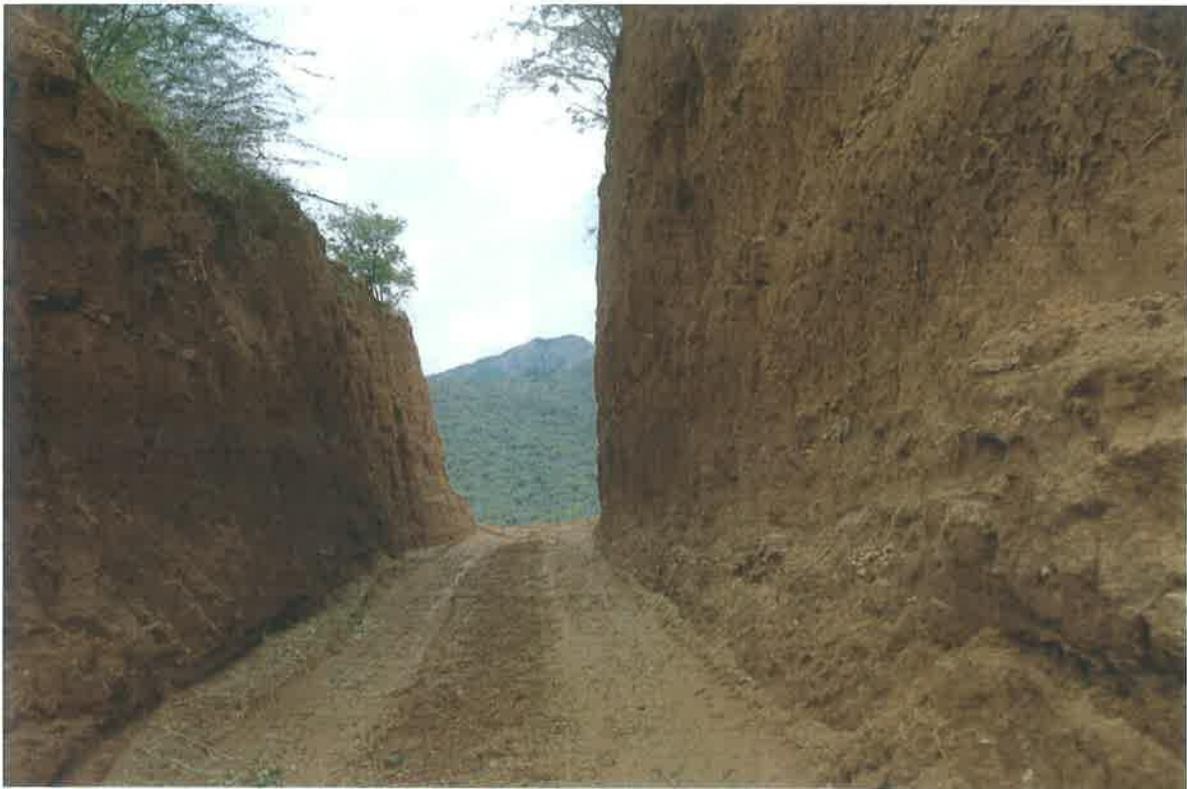
Streambeds converted into Quarry Roads

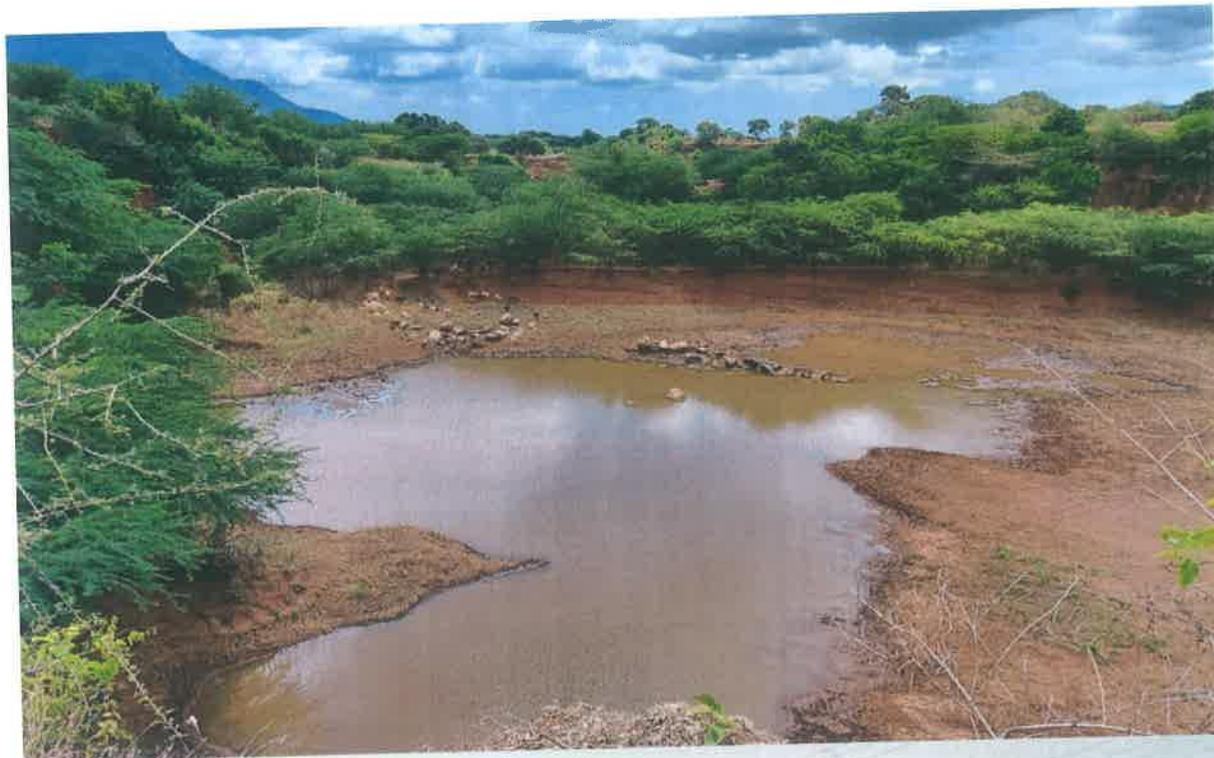
Waterlogging in Quarries and Brick Factories
