**BEFORE THE NATIONAL GREEN TRIBUNAL
SOUTHERN ZONE, CHENNAI
Original Application No.119 of 2021 (SZ)**

Thadagam Valley Brick Kilns, Coimbatore

Inspection Committee Report

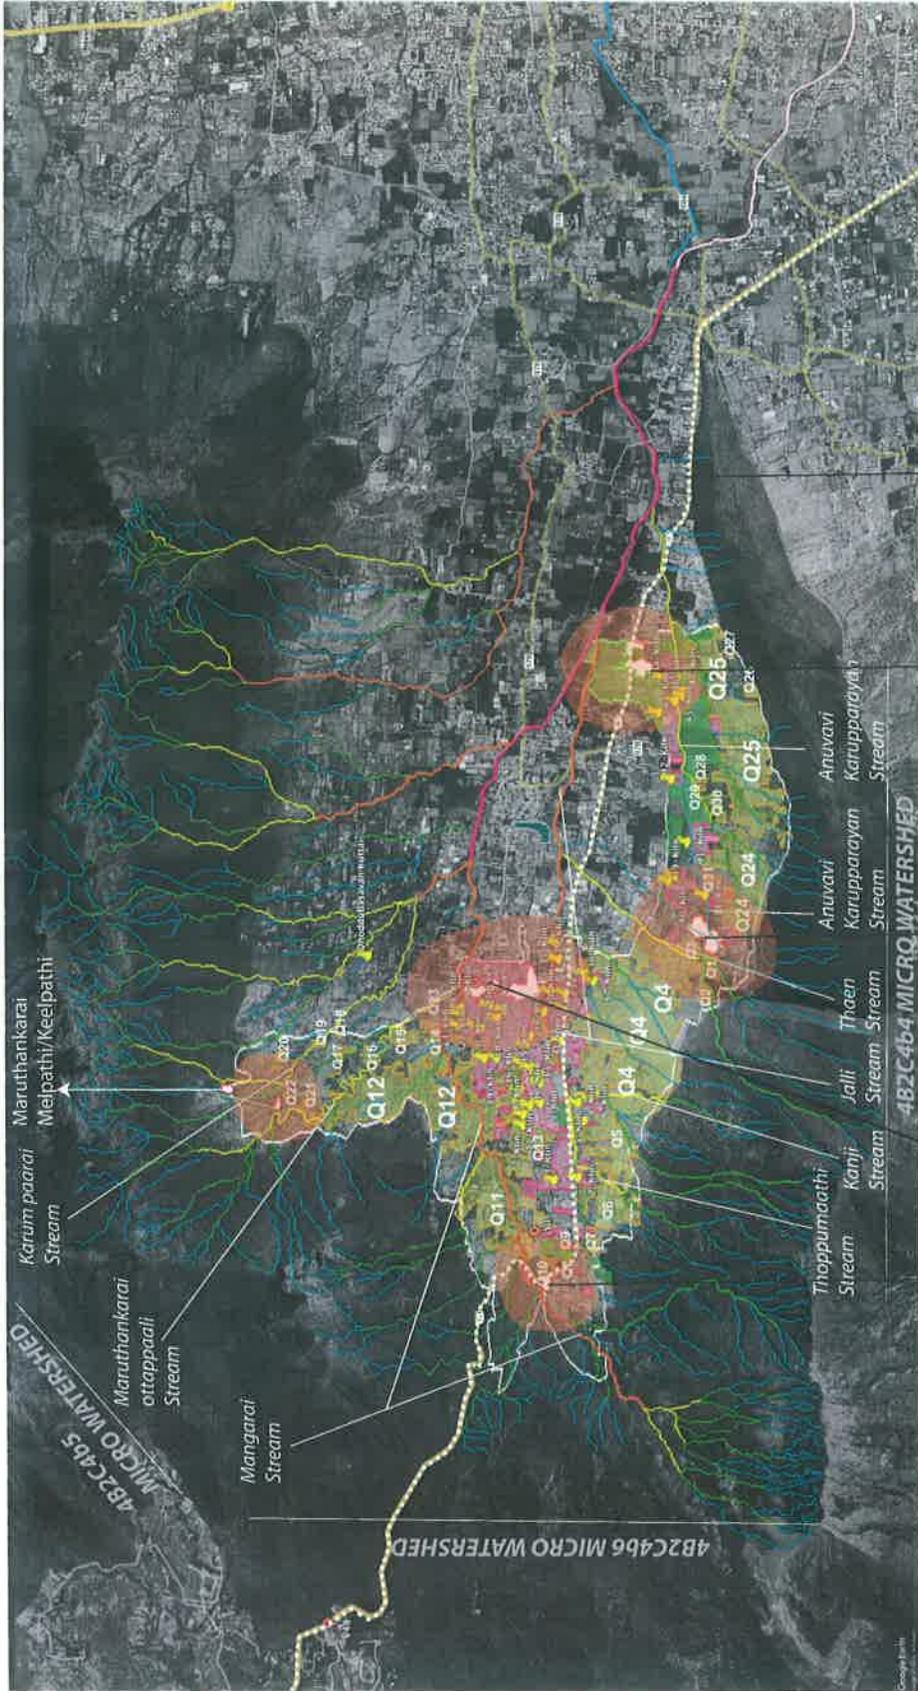
LAND USE PATTERN IN 24 VEERAPANDI (VALLEY PORTION) REVENUE VILLAGE -2022

TOTAL AREA
1511 Ha

Residential Area : 100.00 Ha - 7%

500M AROUND HABITATIONS : 100.00 Ha - 7%

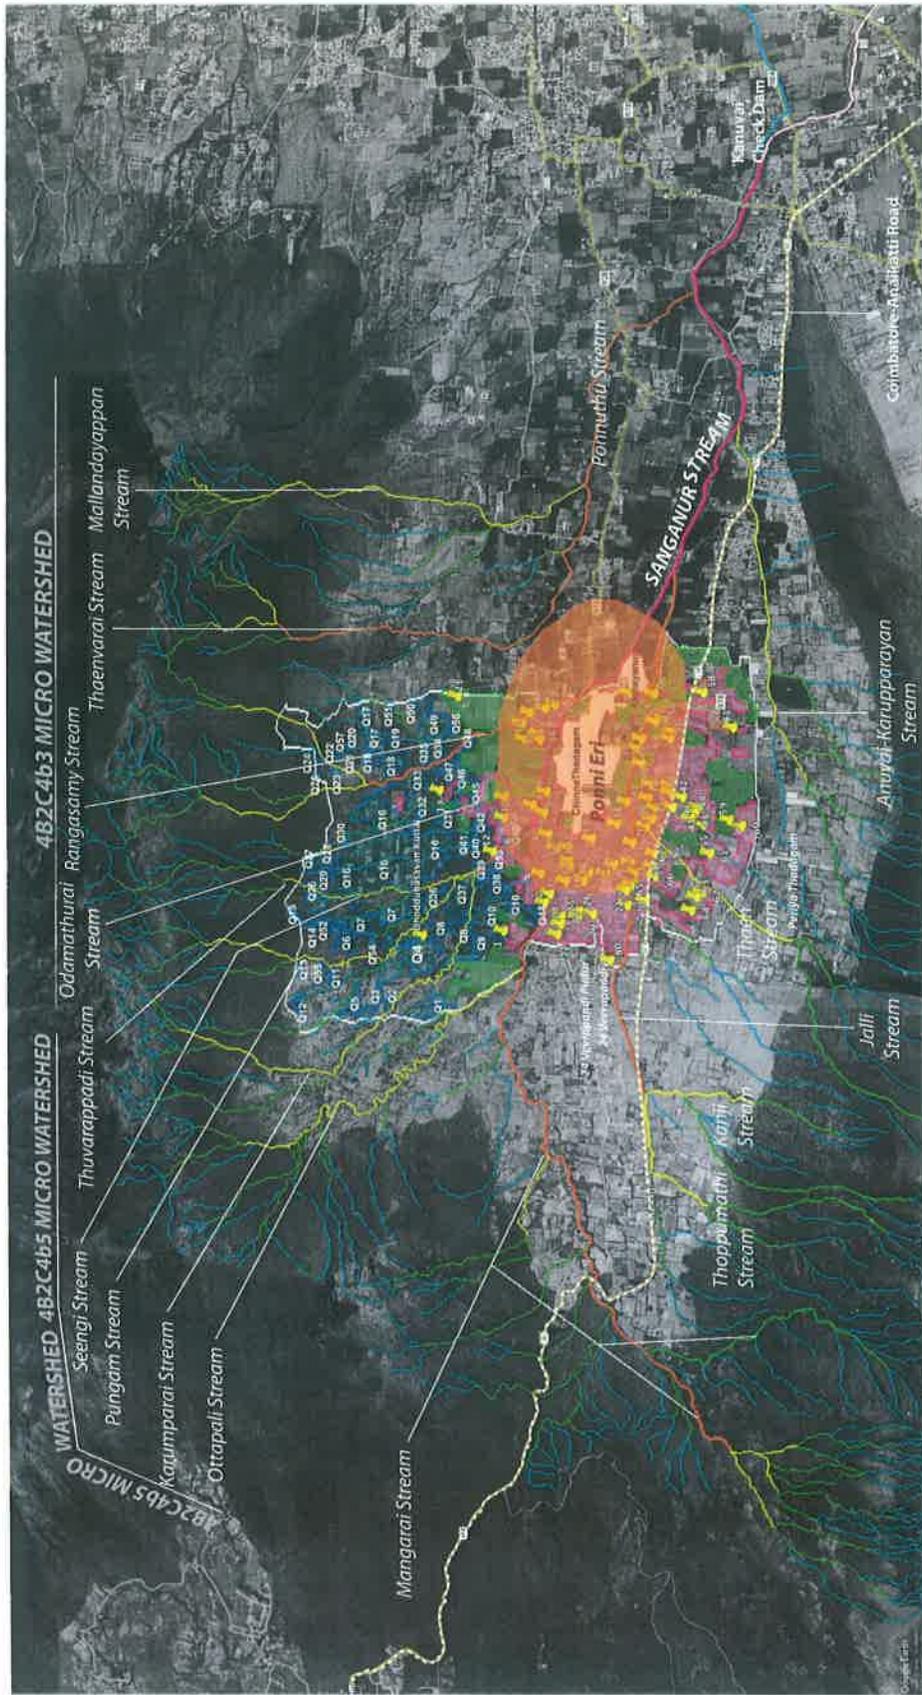
LAND USE PATTERN IN CHINNA THADAGAM REVENUE VILLAGE - 2022

TOTAL AREA 1036.4 Ha

Brick Earth Quarry : 186.16 Ha - 18% **Farm Lands** : 104.7 Ha - 10% **Barren & Other Lands** : 474.94 Ha - 46%

Brick Kilns & sheds : 242.3 Ha - 23% **Residential Area** : 28.3 Ha - 3%

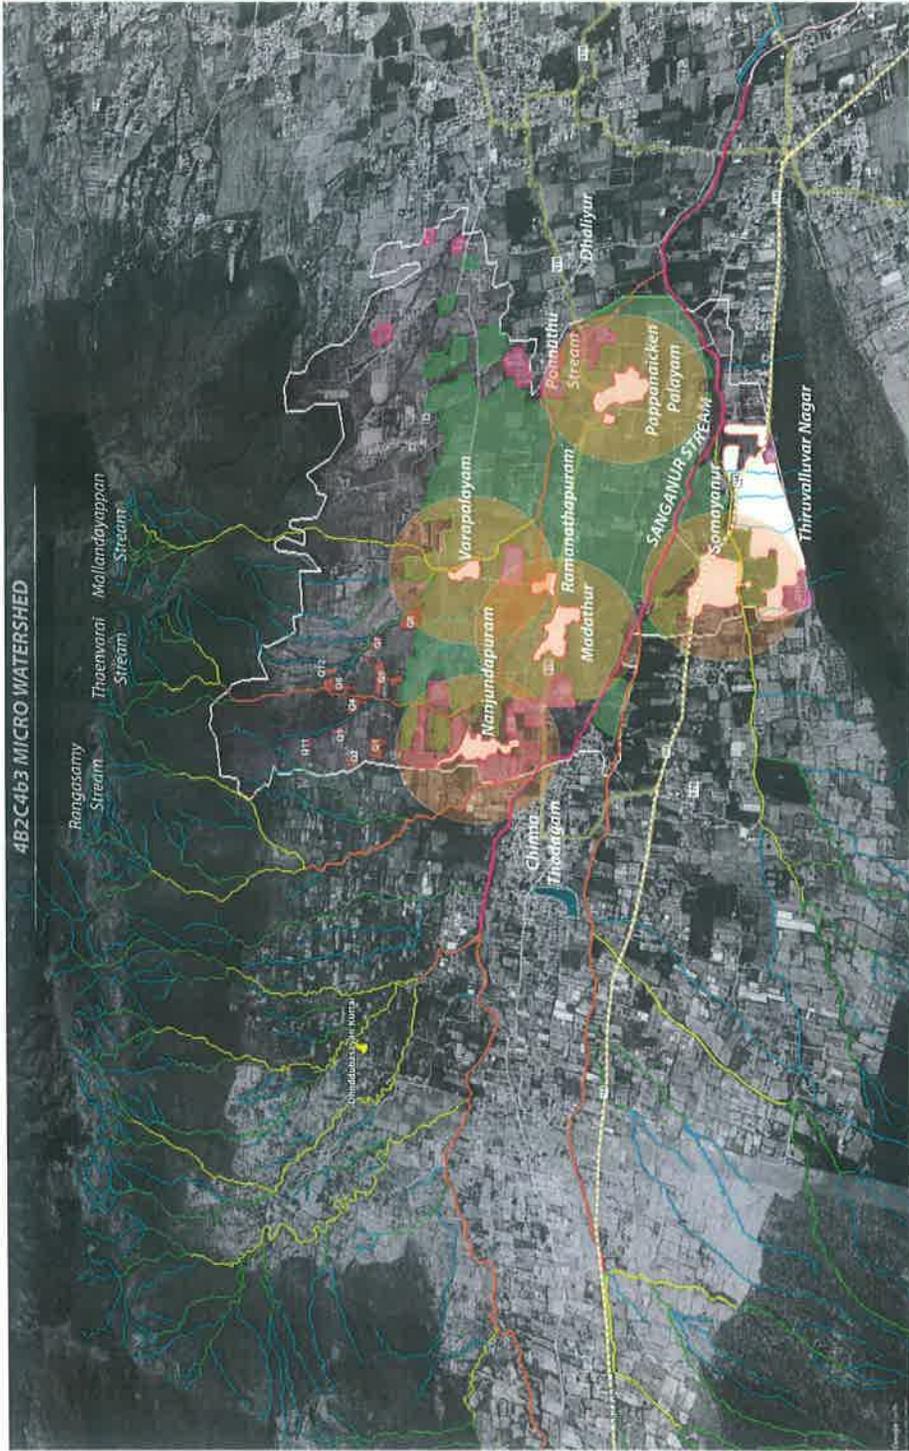
LAND USE PATTERN IN 22 NANJUNDAPURAM REVENUE VILLAGE - 2022

TOTAL AREA 1204 Ha
 Brick Earth Quarry : 13.77 Ha -1% Farm Lands : 504.65 Ha -42% Barren Lands : 569.6 Ha -47%
 Brick Kilns & sheds : 50.05 Ha -4% Residential Area : 65.93 Ha -5%

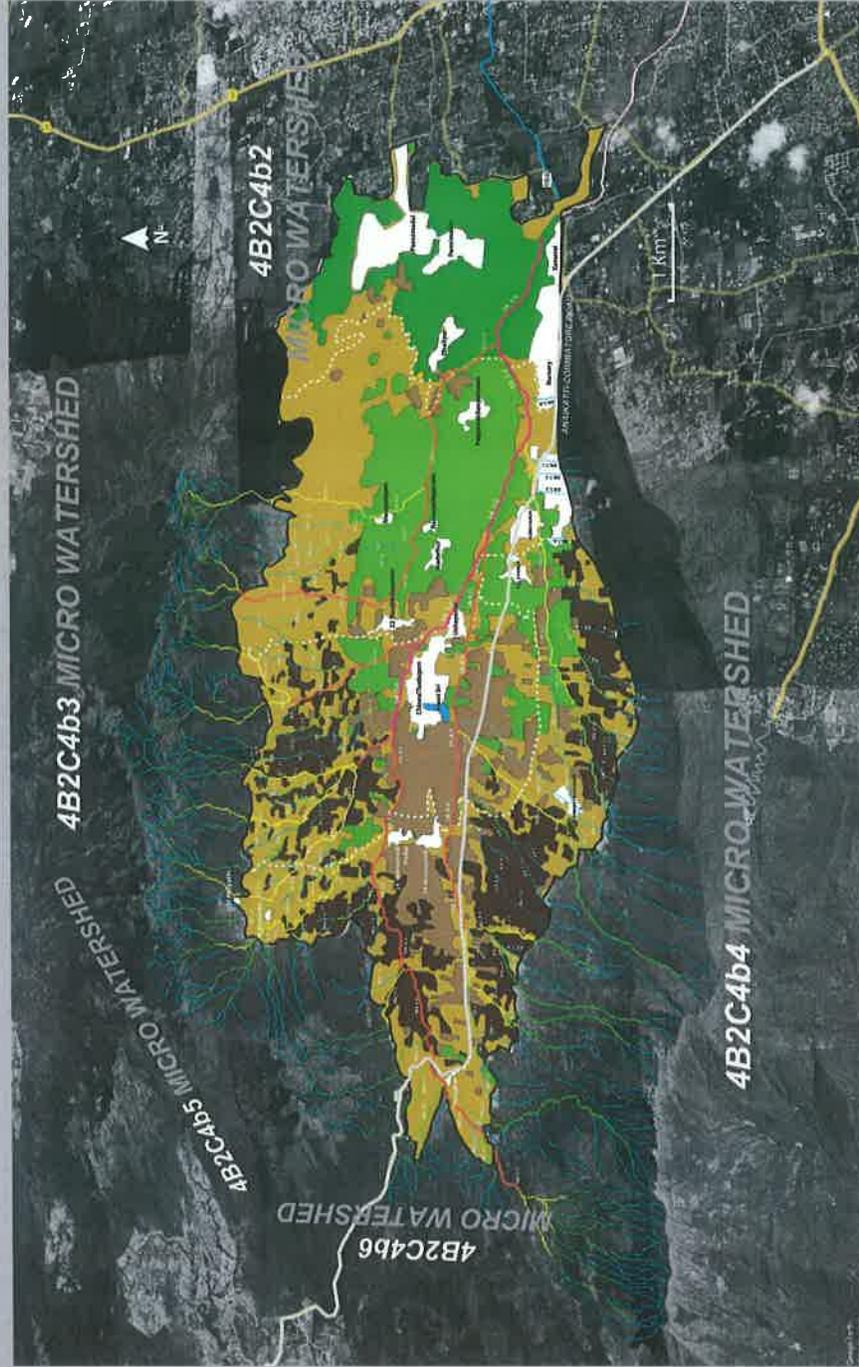
LAND USE PATTERN AND THE POSSIBLE DAMAGES TO THE STREAM NETWORK IN THADAGAM VALLEY - 2022
