**BEFORE THE NATIONAL GREEN TRIBUNAL  
SOUTHERN ZONE, CHENNAI**

**Appeal No. 3 of 2024 (SZ)**

**REPLY STATEMENT FILED BY THE THIRD RESPONDENT**

**REPORT OF COMMITTEE IN THE MATTER OF  
ORIGINAL APPLICATION NO. 20 OF 2016, SRI. SANTO P.  
L. & OTHERS Vs STATE OF KERALA AND OTHERS  
SUBMITTED BEFORE THE HON'BLE NATIONAL GREEN  
TRIBUNAL SOUTHERN ZONE, CHENNAI CIRCUIT  
BENCH, AS PER THE ORDER DATED 20.04.2022**

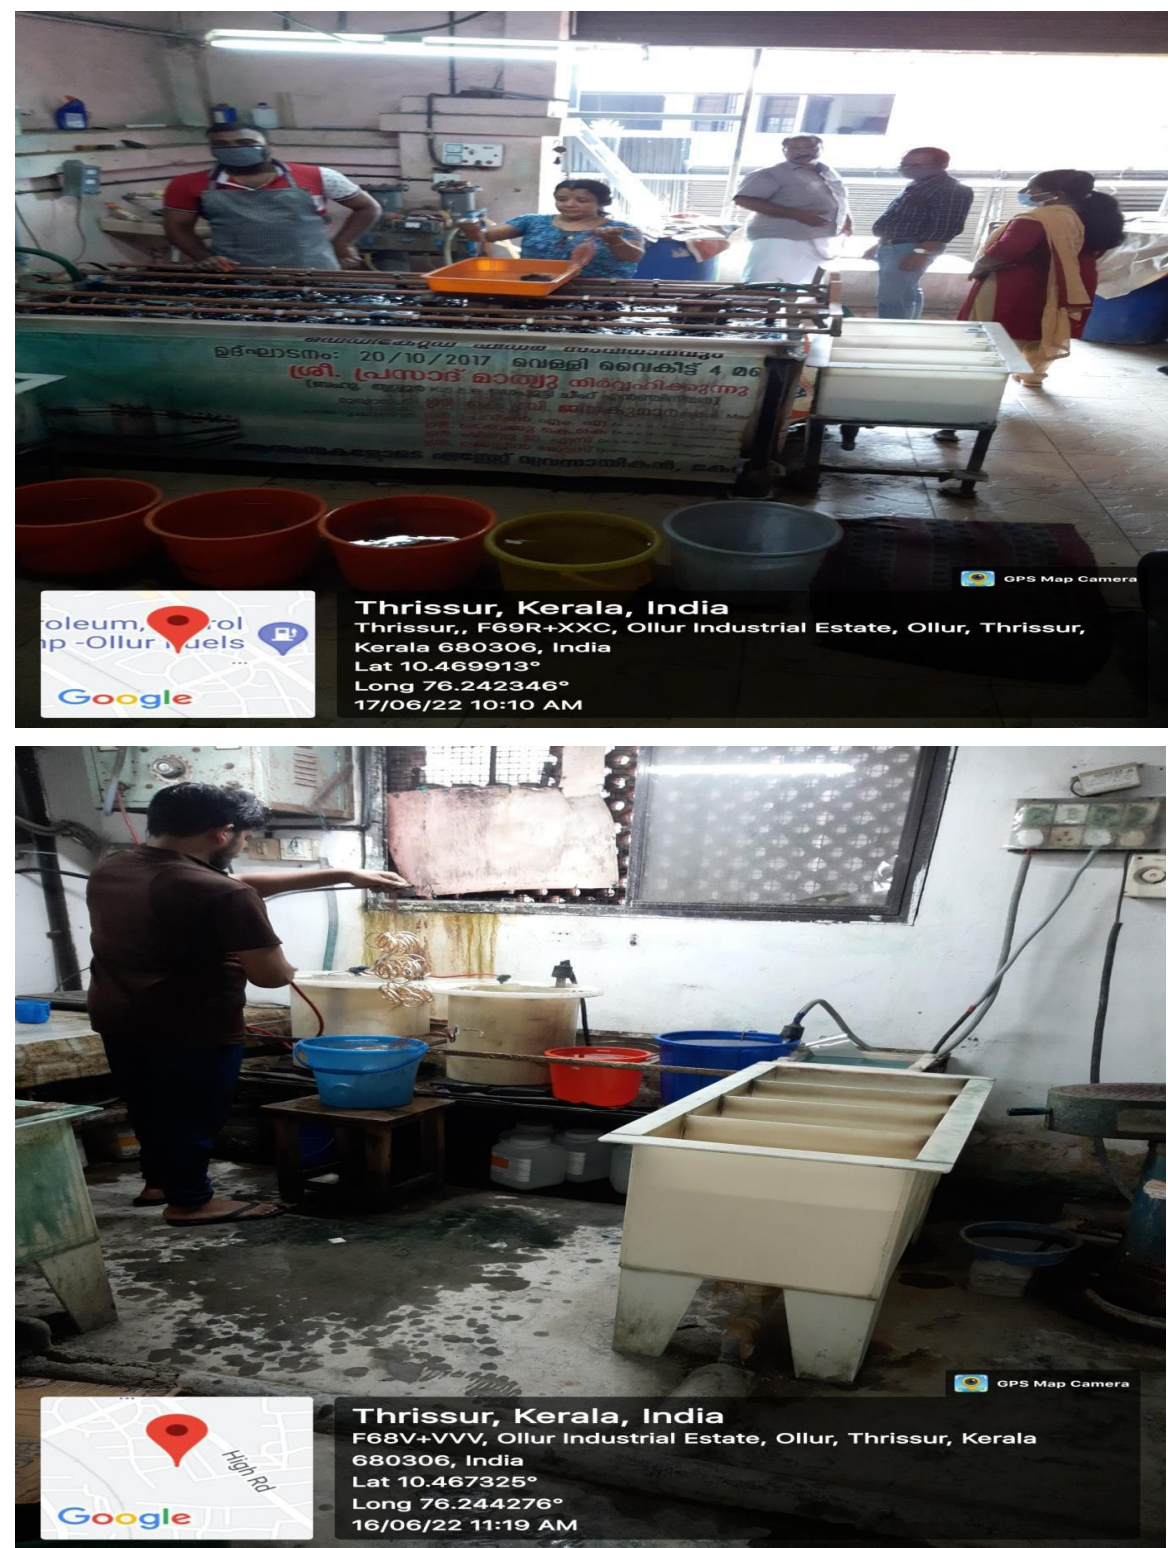
After each electroplating process, the aluminum profiles/ ornaments are dipped in the water. This water is the major source of effluent and wastewater from floor washings also form a part of the effluent. Also the occasional cleaning of electroplating baths contributes to the effluent. Hence the quantity of effluent at the end of a working day will be very less and most of the effluent treatment plants (ETP) are of batch process. Of the thirteen industries, ten are engaged in the electroplating of metallic ornaments, two in electro colouring of aluminium profiles and one is a zinc electroplating unit. Typically, these industries are small scale units functioning in two or three rooms and do not have much vacant land area. All of them have valid consent of the State Board. The ETP provided are similar in these units and consist of collection tank, settling tank, filter feed tank, pressure sand filter, activated carbon

filter, treated water collection tank. The chemicals used for the treatment are mixed in the collection tank itself.

Figure 2 - Typical electroplating units in the Industrial Estate

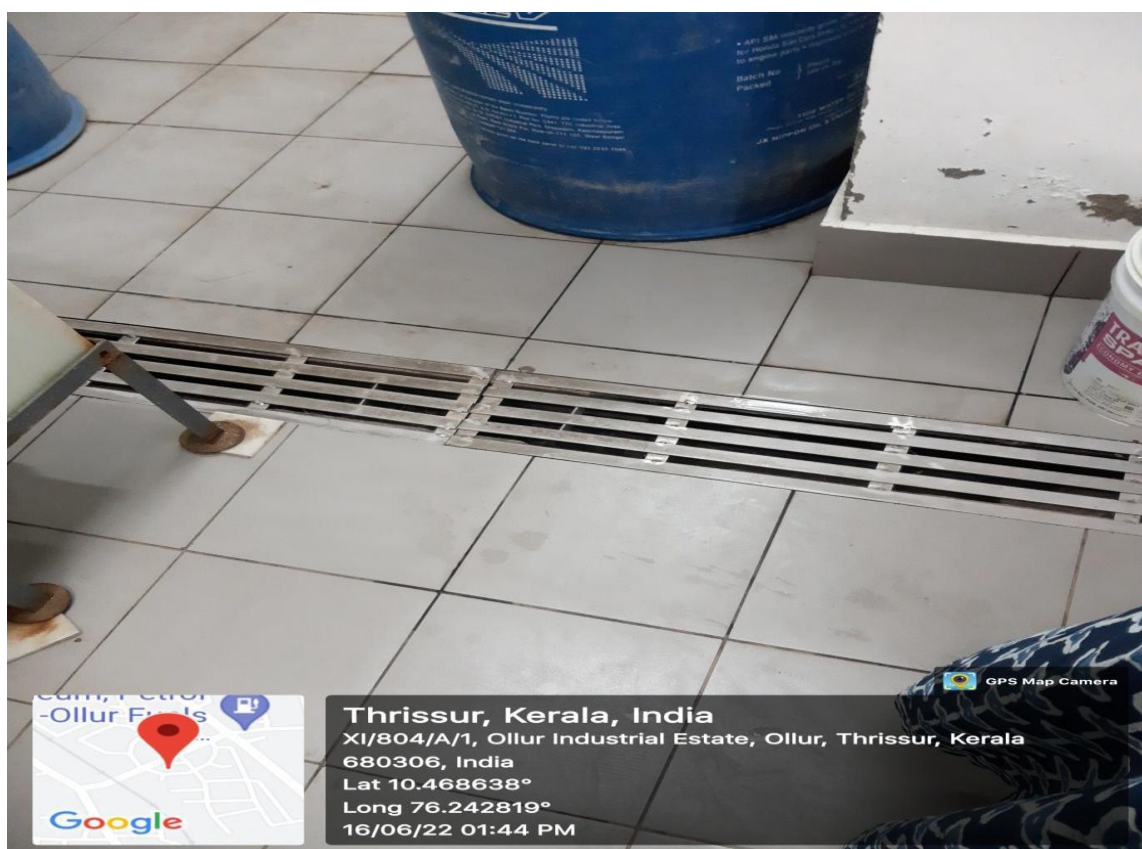
**Figure 3 - Drains for conveying spillages to the effluent treatment plant**

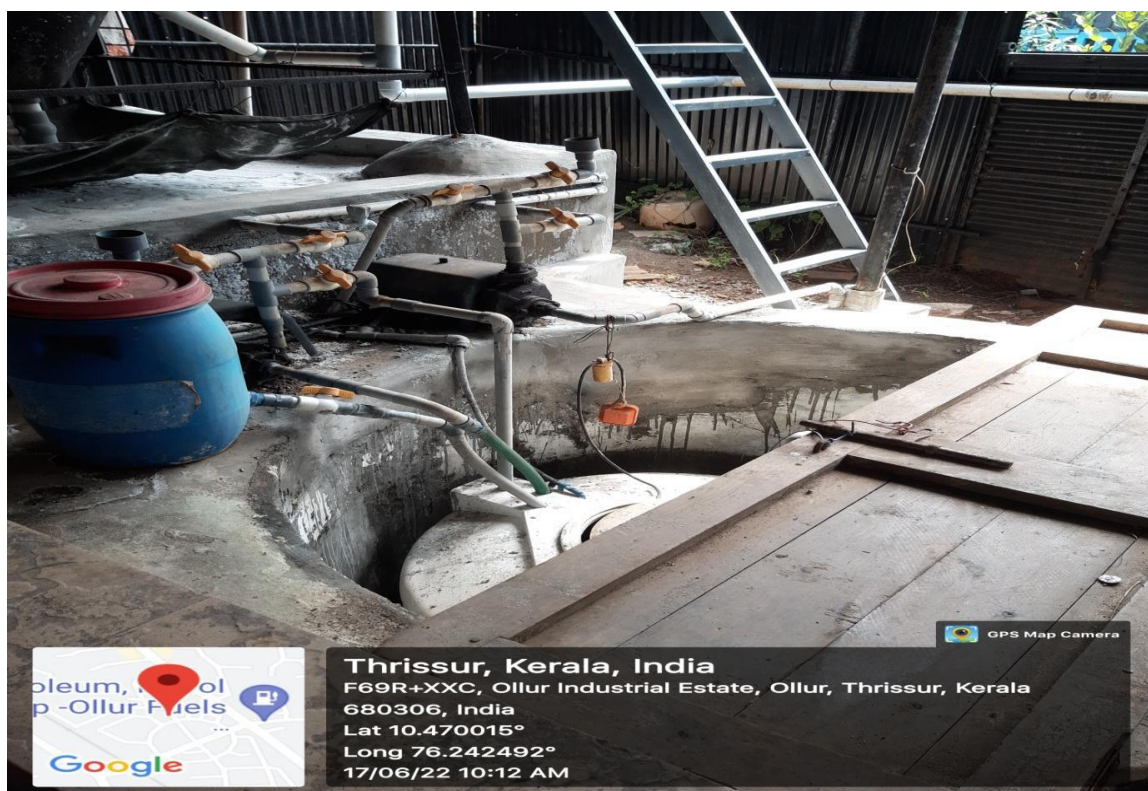
The settling tank consists of a conical shaped tank where in the sludge is drawn from the bottom and overflow goes to the filter feed tank. Below the settling tank is a sludge drying bed which consists of graded coarse and fine aggregate, and the sludge from the settling tank is allowed to dry here. The dried sludge is then transported to the common hazardous waste storage and disposal facility at Ambalamedu, Ernakulam. In all the units it is claimed that the treated water is reused.

**Figure 4 - Collection tank and chemical addition installations in ETP**

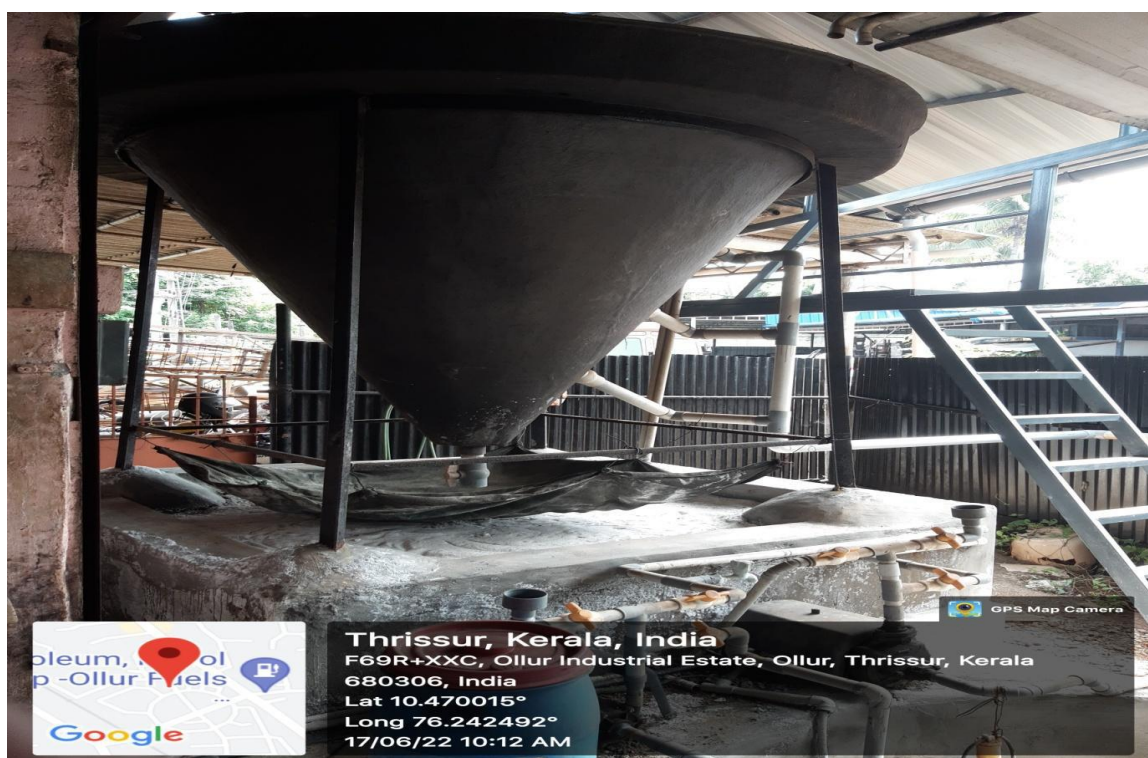
**Figure 5 - Hopper bottom settling tank and sludge drying bed**

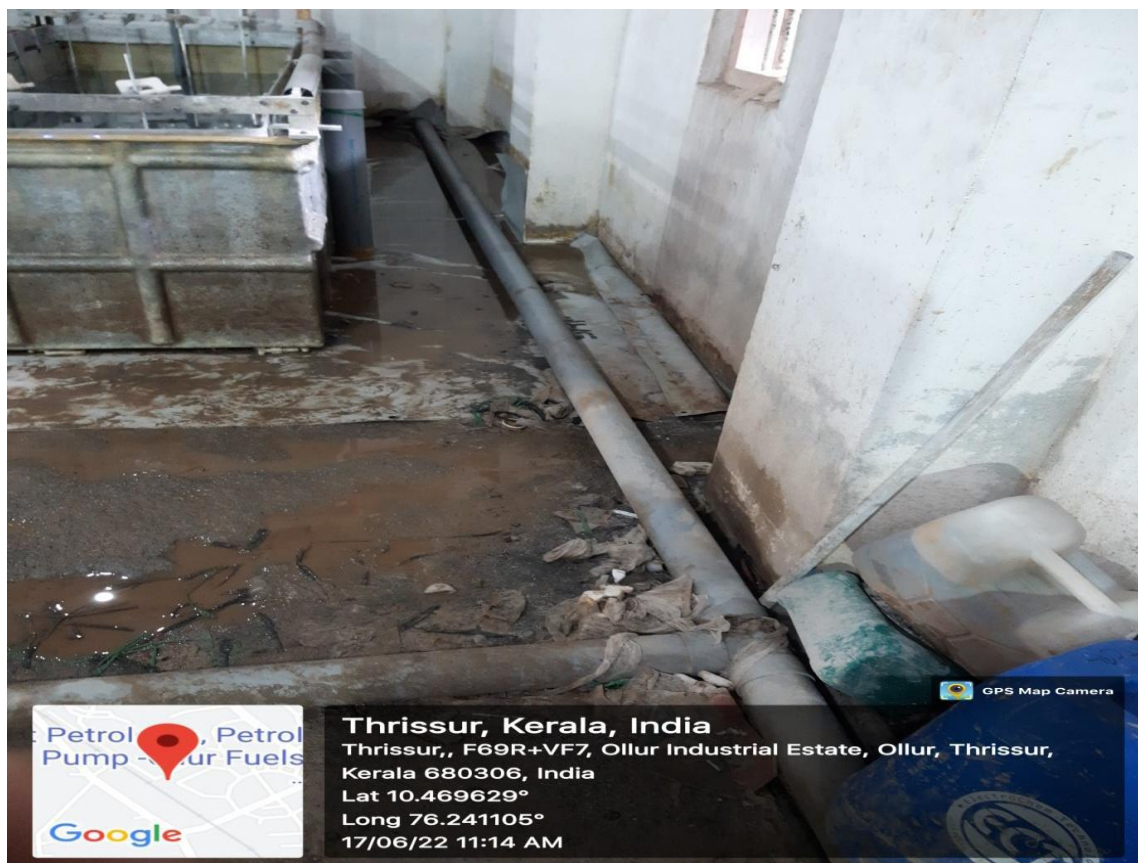
During inspection it was observed that ETP provided in the units were in operational condition (batch mode) except in the unit named Bright Precured Systems II, which is an electro colouring unit. The wastewater from the unit was discharged into the premises of the unit. The compliance of other units with regard to reuse provisions, sludge storage and manifest submission and other statutory records are being duly submitted.

**Figure 6 - Wastewater conveyed to the outside premises at Bright Precured Systems 2**

- VI. However, in Bright Precured System 2, it was observed during the visit of this committee on 17.06.2022 that wastewater was discharged outside without any treatment and ETP was not in operation. Hence the unit is liable to pay compensation for violating the conditions in Consent No. PCB/DO/TSR/R2/ICO/2871/2018 issued to the unit. Copy of the consent to operate submitted as **Annexure 14**. Also the results of open well water sample from the unit shows a pH of 4.3 as well as there are exceedances with respect to Copper, Manganese and Nickel above the limits prescribed in the drinking water standards IS 10500:2012. It was also observed from the file of the State Pollution Control Board that the unit has replied

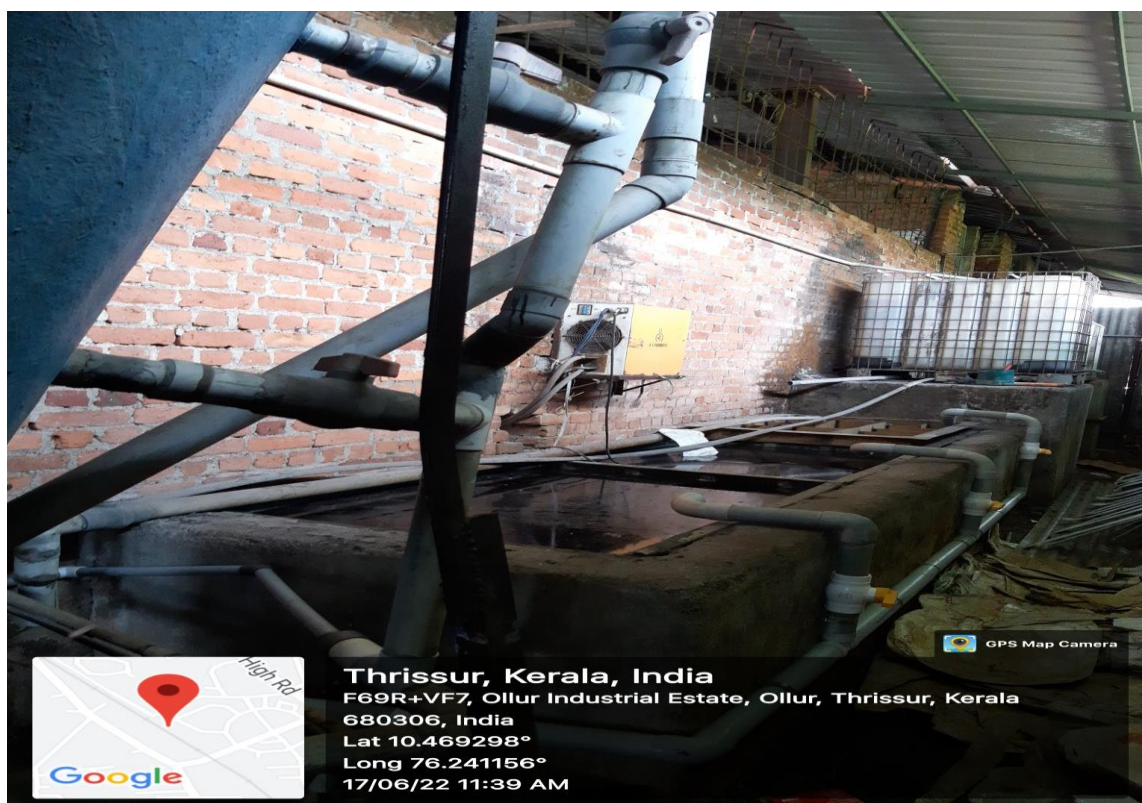
**Figure 7 - Defunct effluent treatment plant at Bright Precured Systems 2**
