INSPECTION REPORT OF THE JOINT COMMITTEE CONSTITUTED BY THE HON'BLE NATIONAL GREEN TRIBUNAL (SOUTHERN ZONE) IN RESPECT OF O.A NO. 93 OF 2020 (SZ) SUOMOTU ON THE BASIS OF THE NEWS PAPER REPORT PUBLISHED IN THE DINAMALAR TAMIL NEWSPAPER DATED 29/06/2020, "WHEN WILL KOVILAMBAKKAM LAKE BE RESTORED?"

5. JOINT INSPECTION OF THE COMMITTEE

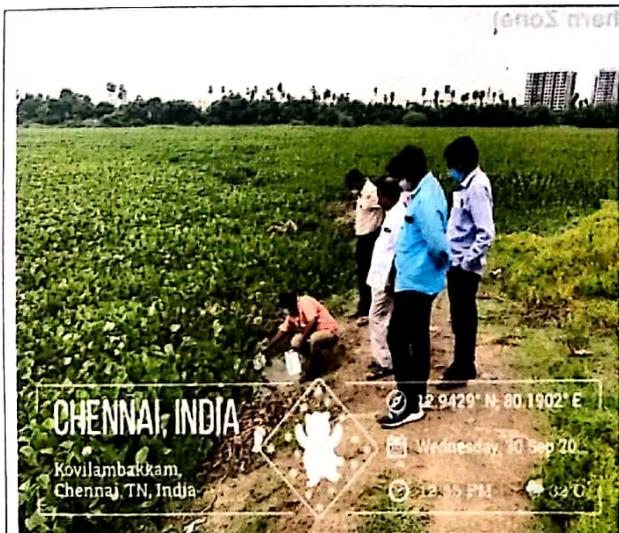
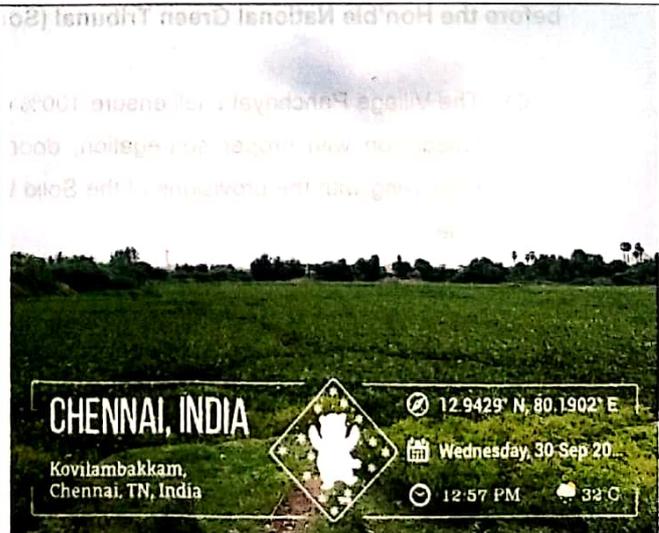
The members of the joint committee have carried out the inspection in the area in question on 30/09/2020 and 01/11/2020.

6. Hyacinth was found fully occupying the entire area of Kovilambakkam tank.
7. The households and commercial establishments in the village panchayat area have their own individual septic tank and soak pit arrangements for the treatment and disposal of the sewage. However certain households/ commercial establishments in the southern side of the tank dispose the sewage/sullage through storm water drains which reach Kovilambakkam Tank.

9. Encroachments in the form of residences were noticed along the Eastern bund of the Kovilambakkam Tank and in the Southern part of the water spread area of the tank in the form of residences and government buildings.

01. The Village Panchayat shall ensure 100% collection of solid waste being generated within its jurisdiction with proper segregation, door to door collection, processing and disposal by complying with the provisions of the Solid Waste Management Rules 2016 within six months time.

02. The Village Panchayat shall not dump solid waste under any circumstances in the said area in question i.e. at Kovilambakkam Lake of Kovilambakkam Village.

05. The Village panchayat shall identify and provide decentralized community soak pit arrangement at vulnerable locations within three months time to prevent the entry of sewage/sullage to the Kovilambakkam tank through storm water drain.
06. The Village panchayat shall provide a treatment system to intercept sewage entering the lake and to treat the same within six months.
07. The Village panchayat shall levy fine on the violators found dumping solid waste and disposing sewage into the water body under Local body Acts.
08. The Village panchayat shall create awareness among the public with the help of associations in the local body area for proper segregation of solid waste.
09. The PWD with the help of Revenue Authorities shall make fresh survey to identify the exact number of encroachment and to evict them within six months.
