Final Report

Investigations on Water Sources in 14 Villages of Tamnar Block of Raigarh District, Chhattisgarh

**CSIR- National Environmental Engineering
Research Institute (CSIR-NEERI)**
(Under Council of Scientific and Industrial Research)
Nehru Marg, Nagpur - 440020

December 2018

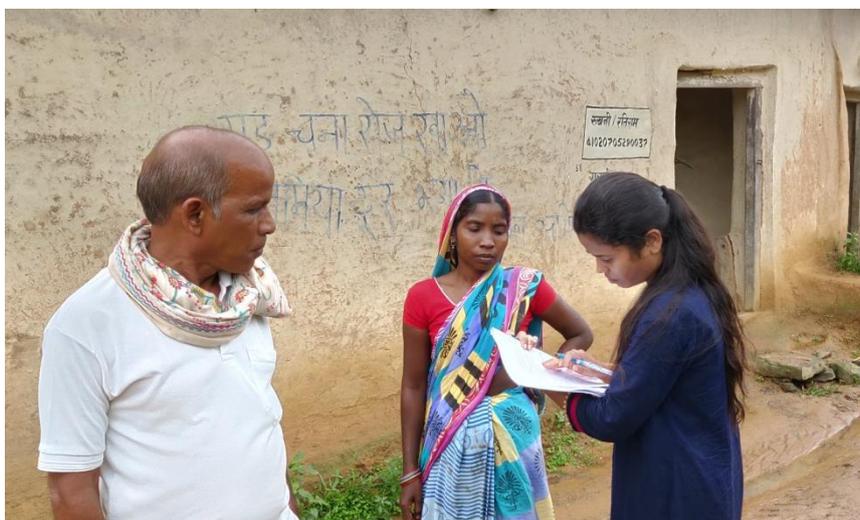
Figure 1: Socio Economic Survey at Mudgaon Village

Sampling in Mudagaon village was done at four locations from hand pumps which served as the main sources of drinking for the villagers. Water quality results are given in **Table 4**. Sample MUD-2 was observed to be slightly acidic (pH-6.3) while samples MUD-1, MUD-2 and MUD-3 were found to have high turbidity of 6 NTU, 60 NTU and 25 NTU respectively. High concentration of fluoride i.e. 2.3 mg/L was observed in MUD-4. Scaling and yellow to red tinge in teeth were also observed in some of the habitants.

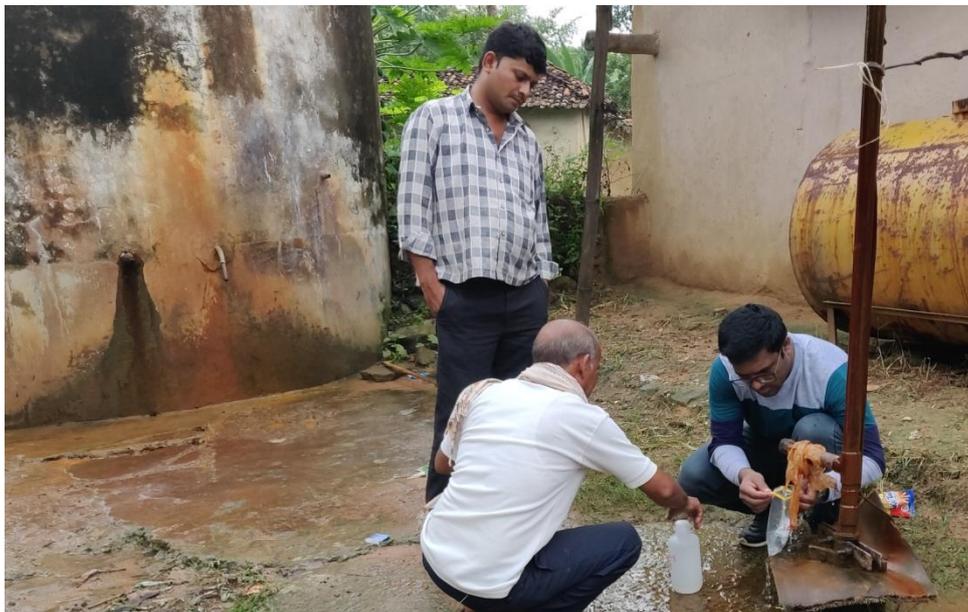
Figure 2: Sample Collection from Bore Well in Saraitola Village

Water samples were collected from four locations in Sariatola village. Hand pumps are the main sources of drinking water in this village. There was also a pond situated in the outskirts of the village, however, not used for either drinking or domestic purposes. In this village the water was pumped and stored in storage tank (through the bore well) from which it is supplied through pipes. Physico-chemical and microbial water quality of the ground water sources is depicted in **Table 5.** All the four water sources exhibit acidic pH, 5.1 to 6.1, as also high turbidity ranging from 7-380 NTU highest being in the sample SARA-2. Similarly, high concentrations of iron (Table 16), were observed, in all the four samples ranging from 7-32 ppm; the highest being in SARA-2. The high values of turbidity may certainly be attributed to the corresponding high iron content and precipitation of iron salts in all the samples. Red coloured stains were observed on the hand pump platforms indicating high levels of iron. **Figure 2** shows the sample collection from a bore well in Saraitola village. **Arsenic was found in alarming concentrations in all the four samples.** Besides iron; manganese and nickel were found be present beyond the permissible limits in samples SARA-2, SARA-3, SARA-4 and SARA-1, SARA-3 and SARA-4 respectively. Fluoride concentration were found to be high in samples SARA-2 (4.7 mg/L), SARA-3 (2.6 mg/L) and SARA-4 (2.6 mg/L) beyond the permissible limit of 1.5 mg/L for drinking water as prescribed by the BIS. Yellow scaling of teeth and turbid water were the issues reported by the villagers.

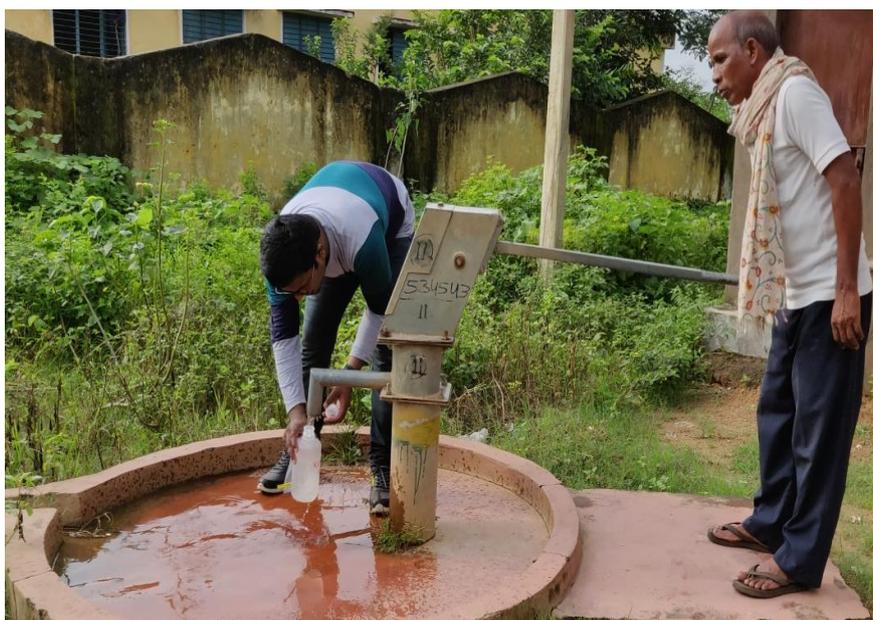
Figure 3: Red Stains around Hand Pump in Kunjemura Village

Arsenic of the order of 0.02 ppm was found in sample KUN-3. Faecal Coliforms were observed in samples KUN-11 and KUN-12 (Table 6) and KUN-2 and KUN-4 (Table 6a). **Figure 3** shows sampling activity and red staining at the hand pump platform in village Kunjemura depicting high concentration of iron in the water source. Red pigmentation and scaling of teeth were the health issues reported by the villagers.

- Hand pumps should be periodically inspected and repaired as platforms were observed to be broken, drainage channels were clogged leading to water accumulation around the hand pumps and consequently leading to microbial contamination
- Awareness campaign for safeguarding water sources against microbial contamination should be undertaken

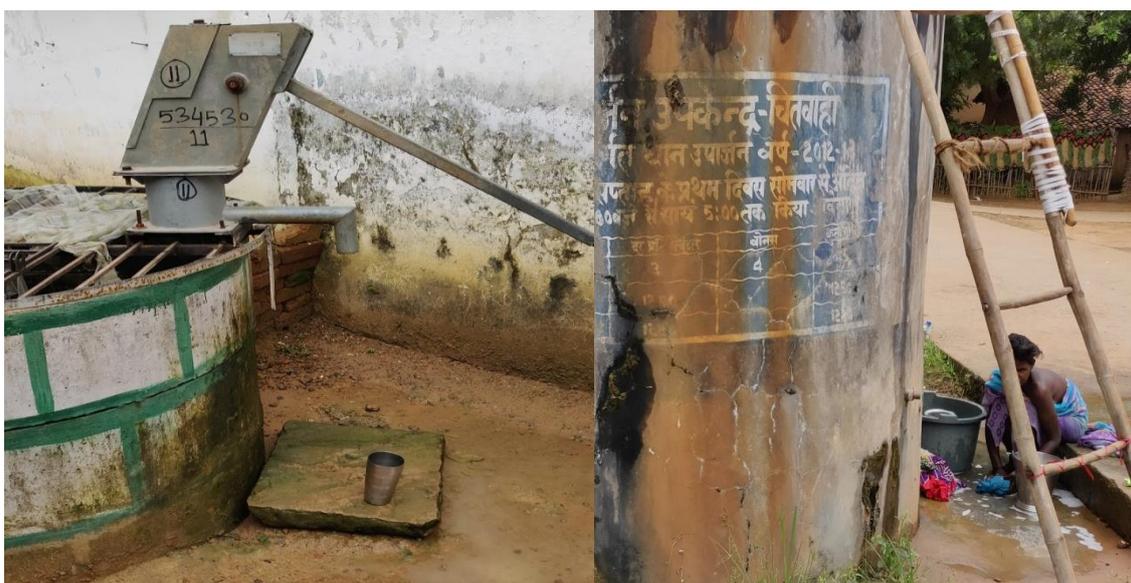
Figure 4: Dug Well and Storage Tank in Chitwahi Village

A total of six samples were collected from Chitwahi village from bore well, hand pump and lake. Bore wells and hand pumps served as the major drinking water sources in the village. It was informed that the hand pumps mostly dry up in summer season as a result of the decrease in the ground water level. Hence, deep bore wells serve as drinking water source during summer seasons. The physico-chemical and bacteriological water quality is given in the **Table 7** while metal analysis results are given in Table 16. All the physico-chemical parameters are below the acceptable limits of IS 10500: 2012 except for high turbidity in CHI-5 (20 NTU) and high concentration

of nitrate (50 mg/L) in CHI-2. Faecal contamination was found in four of the six water sources ranging from 5 to 600 CFU/100 ml; highest being in the sample No CHI-5. This could be due to the unhygienic conditions near the water source (**Figure 4**). No major health complications besides red pigmentation and scaling of teeth were reported by the villagers.

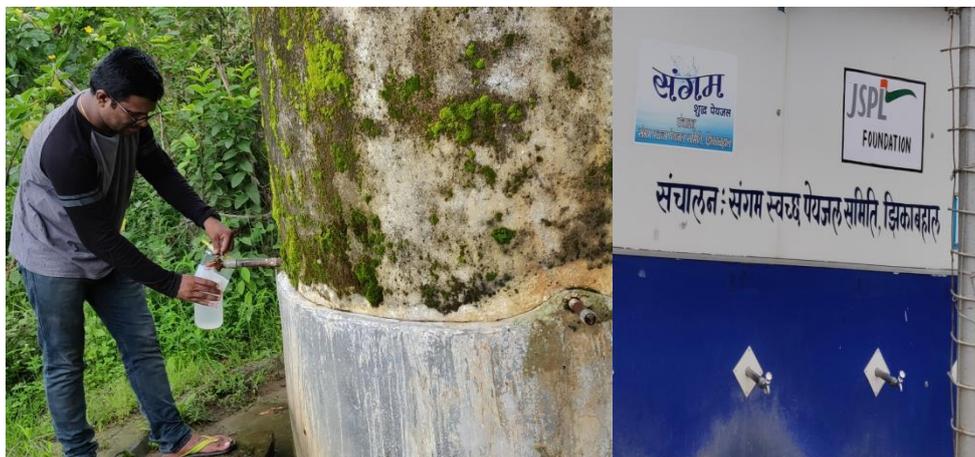
Bore wells served as the main source of drinking water even though hand pumps were present in the village. The hand pumps were reported to dry up in summer season. Storage tanks were used regularly to supply water to the villagers. It was informed that frequent power cuts sometimes forced the villagers to drink water from the hand pumps. Further it was observed that the storage tanks were not cleaned regularly as algal growth could be seen on the storage tank walls (**Figure 5**). Jindal steels have installed a treatment unit for providing safe water to the villagers. Physico-chemical and bacteriological water quality is depicted in **Table 13** while metal analysis results are given in Table 16. Moderately low pH was observed in five of the six samples ranging between 5.3 and 6.2 and observed to be quite below the acceptable limit as per the BIS. Nitrate Concentration of 79 mg/L was observed in sample JHI-4 which was beyond the BIS acceptable limit of 45mg/L. Faecal coliforms ranging from 10-193 CFU/100ml were observed in all the samples except in JHI-5. High concentrations of

Figure 5: Algal Growth on the Walls of Storage Tank (Left); Water Treatment Unit installed by Jindal steels (Right) in Jhinkabahal village

- Cleaning of the ponds, lakes, dug wells and water supply storage tanks at regular time intervals are necessary and need be made mandatory.
- The hand pumps should be well guarded and the surroundings of the water sources need be kept clean.
- Provision of safe water to the villagers only after proper disinfection

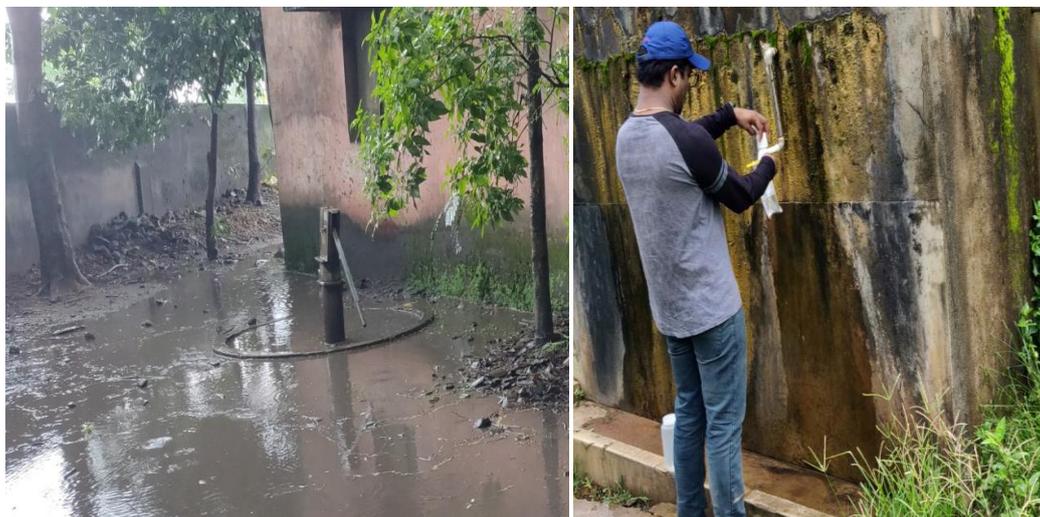
Bore wells were the major source of drinking water in the village. Storage tanks were used to store bore well water for use of the villagers. Seven samples were collected for testing from bore wells and hand pumps. Physico-chemical and bacteriological water quality is depicted in **Table 14** while metal analysis results are given in Table 16. Water from four of seven sources was observed to be marginally to moderately acidic with pH ranging from 5.5 to 6.4 which is below the acceptable pH range of 6.5-8.5 prescribed by the BIS for drinking water. Turbidity of LIB-1 (8 NTU), LIB-2 (12NTU), LIB-4 (16 NTU) and LIB-5 (15 NTU) was found to exceed the BIS limit of 1-5 NTU for drinking water. Faecal coliforms were found to be present in samples LIB-3, LIB-4, LIB-5 and LIB-6. Iron was found to be in excess concentrations in samples LIB-1 (2 ppm) and LIB-5 (6 ppm). Water collected from the hand pump (sample LIB-2) as shown in **Figure 6** was turbid and orange/red in colour. Villagers complained of

vomiting, stomach ache and severe gastric problems on consumption of the hand pump water.

Figure 6: Unhygienic Condition in the Vicinity of Hand Pump (Left), Algal Growth and Scale Formation on the Walls of the Storage Tank in Libra village (Right)

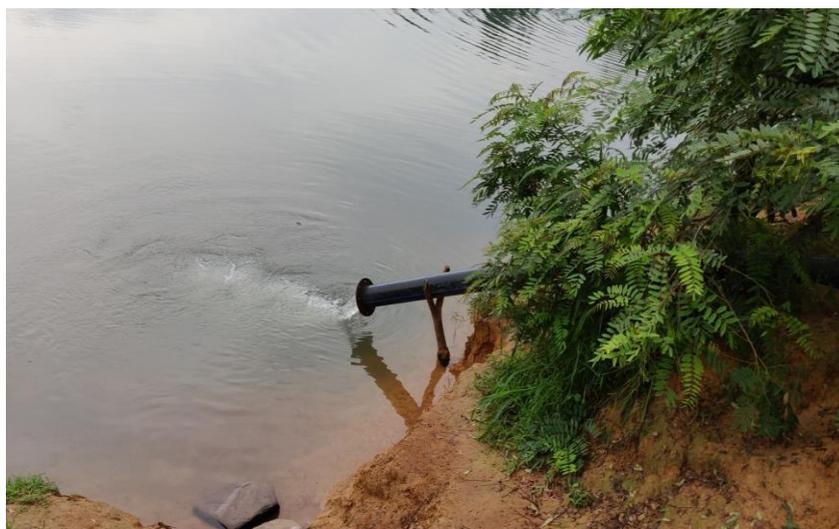
Figure 7: Pond receiving Water Pumped from the Mine in Sarasmal Village

Sarasmal (Kosampalli) village is situated around 200-300m away from the mine and comprise of two ponds. One pond was rain fed, located at the entrance of the village on roadside near mining area and used only for bathing and washing. Another pond was filled with water pumped from the mine area (**Figure 7**). **Figure 8** depicts a mine pit filled with rain water. Seven water samples were collected from bore wells, dug wells including water samples from the rain fed pond and the pond with water from the mine area. Physico-chemical and bacteriological water quality is depicted in **Table 15** while metal analysis results are given in Table 16. Except samples SARL-1 and SARL-7 all the other samples are marginally or moderately acidic with pH ranging from 5.5 to 6.4 which is below the pH range of 6.5-8.5 as prescribed by the BIS. High nitrate concentrations were found in samples SARA-2, SARA-3 and SARA-4 ranging from 82 to 133 mg/L. Turbidity was found to be 20 NTU in Sample SARL-6 beyond the BIS
