**BEFORE THE HON'BLE NATIONAL GREEN TRIBUNAL,
PRINCIPAL BENCH AT NEW DELHI
ORIGINAL APPLICATION NO. 148 OF 2020
IN
ORIGINAL APPLICATION NO.(CZ) 31 OF 2020**

AFFIDAVIT ON BEHALF OF SASAN POWER LIMITED / RESPONDENT NO. 1&2

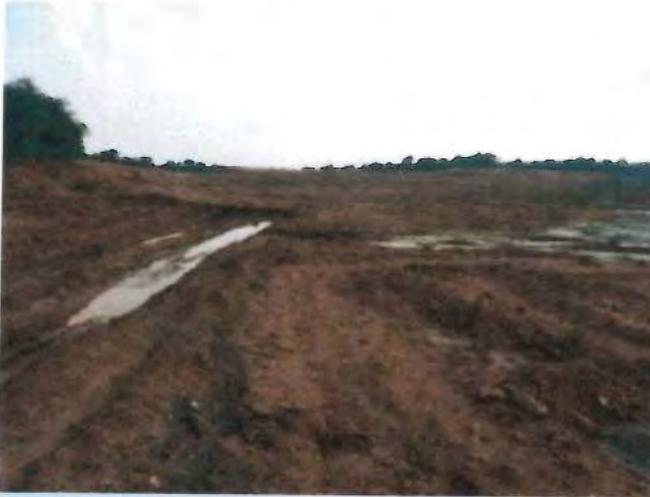
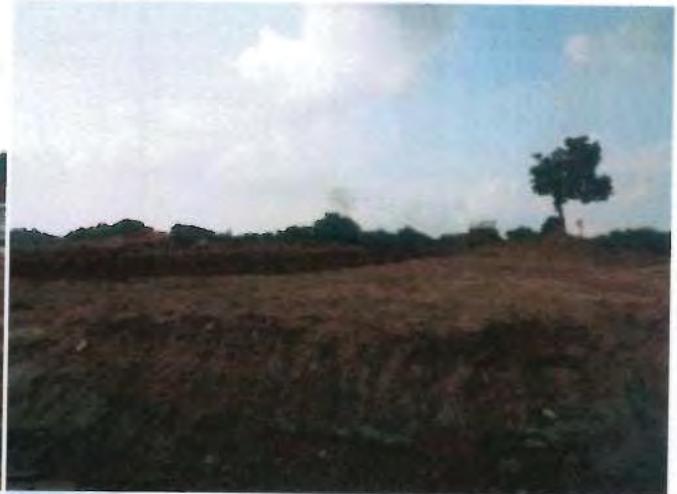
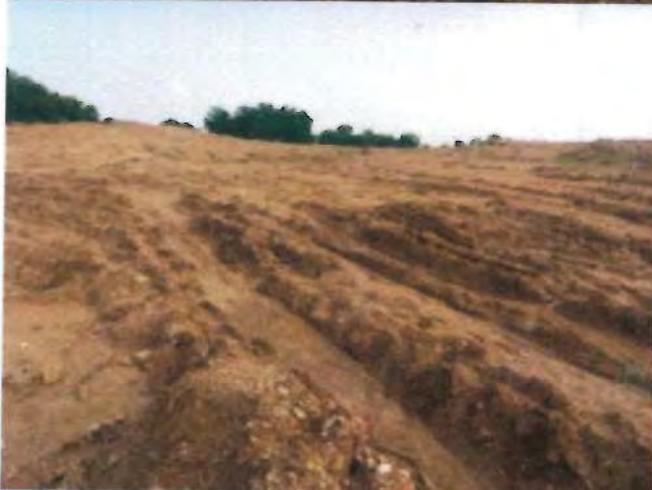
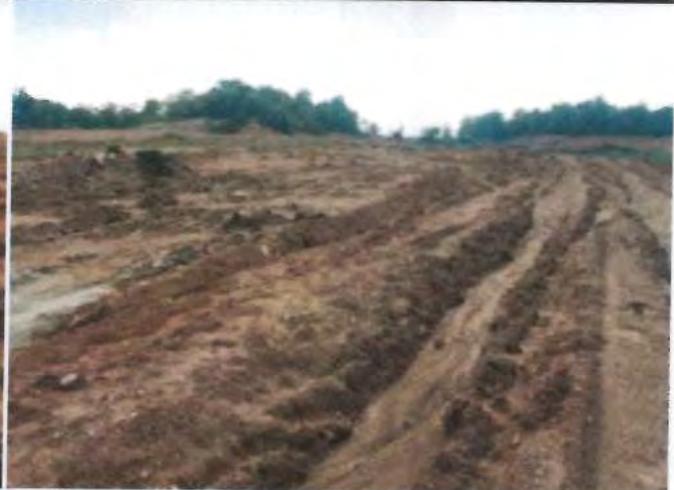
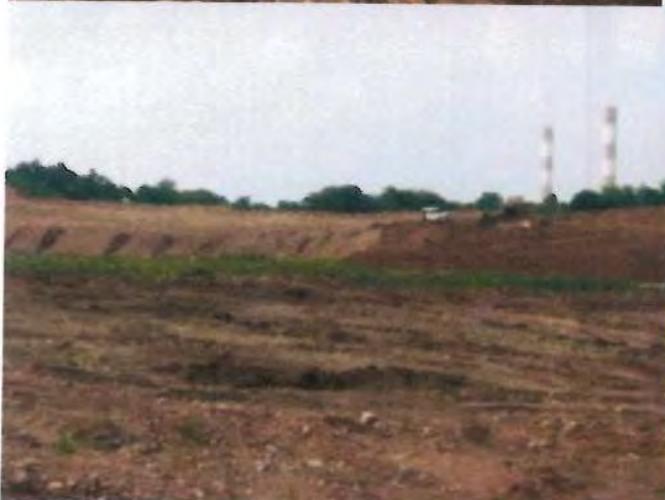
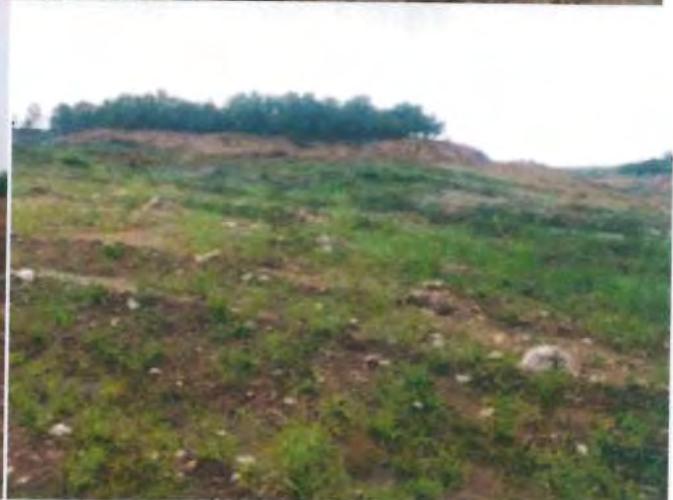
1. Low Lying Area (Island – 4): Ash removed and covered with soil leaving a channel for the safe exit of ground / rain water.

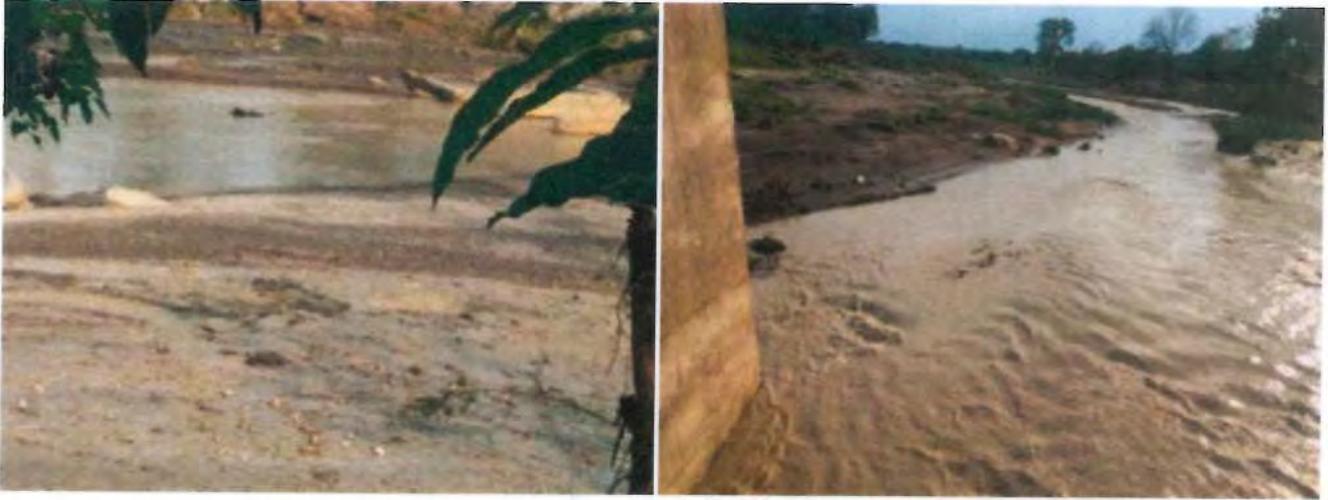
2. Island – 4 drain and Gabaiya nalla co influence up to AWRS Culvert: All area (nalla and land) cleared and paddy cultivation going on. Some part of ash lifting pending because of internal family conflict of land owners.

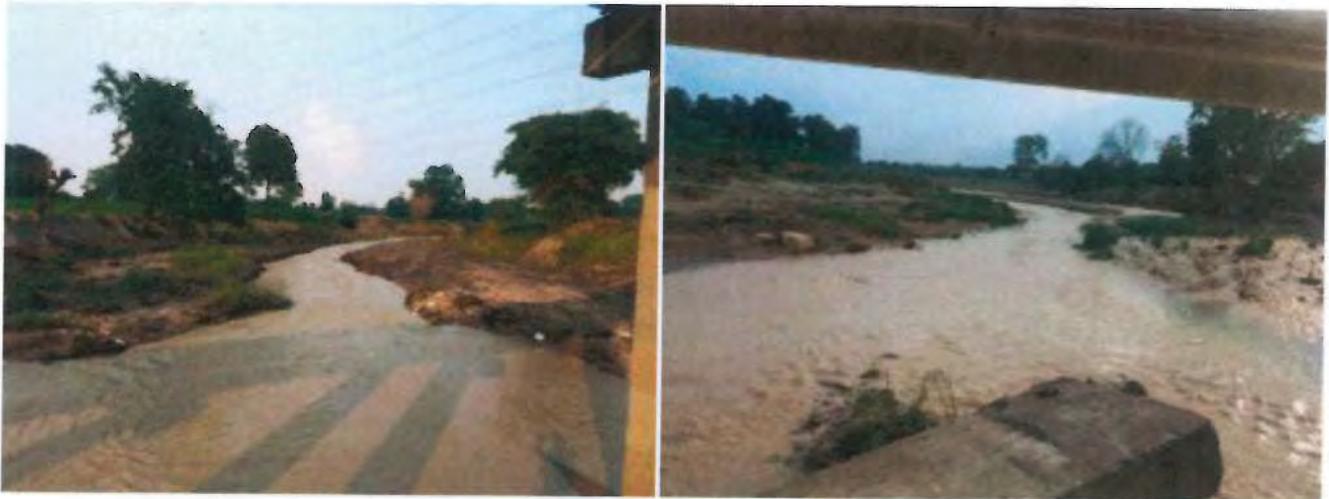
3. AWRS Culvert Area: All area (nalla and land) cleared.

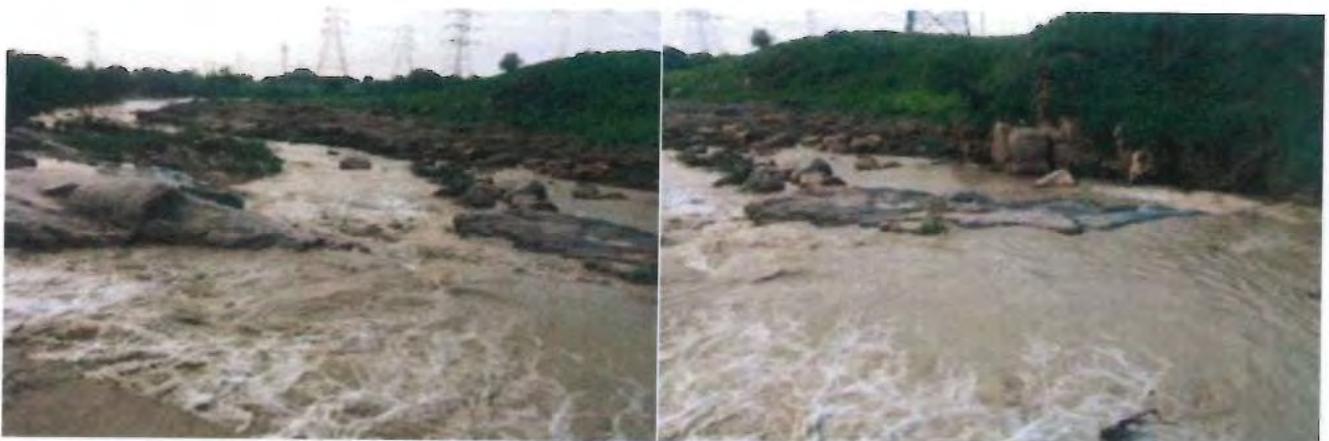
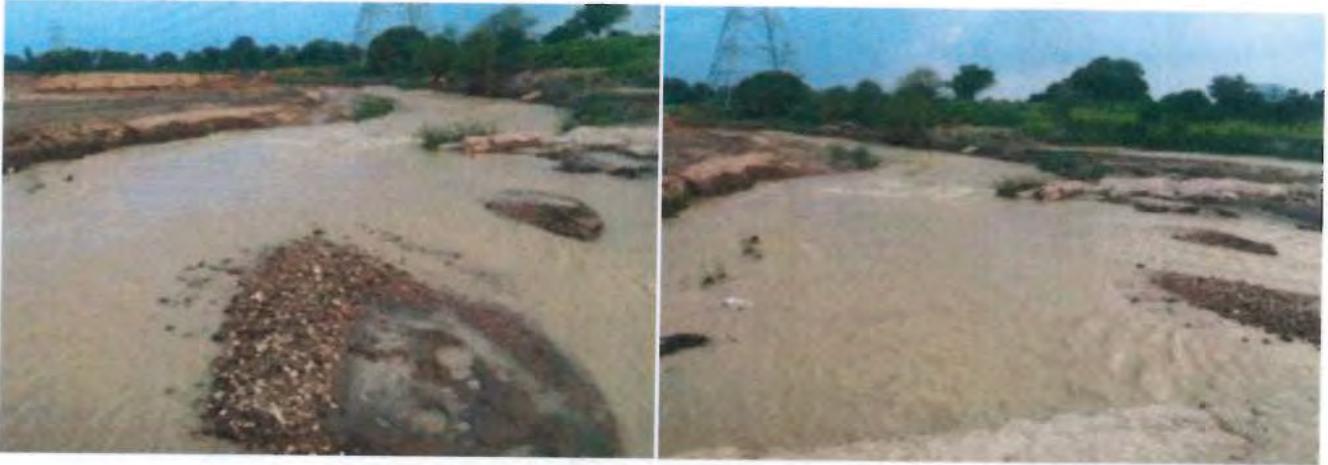
4. Gabaiya nalla main culvert area: All area (nalla and land) cleared.

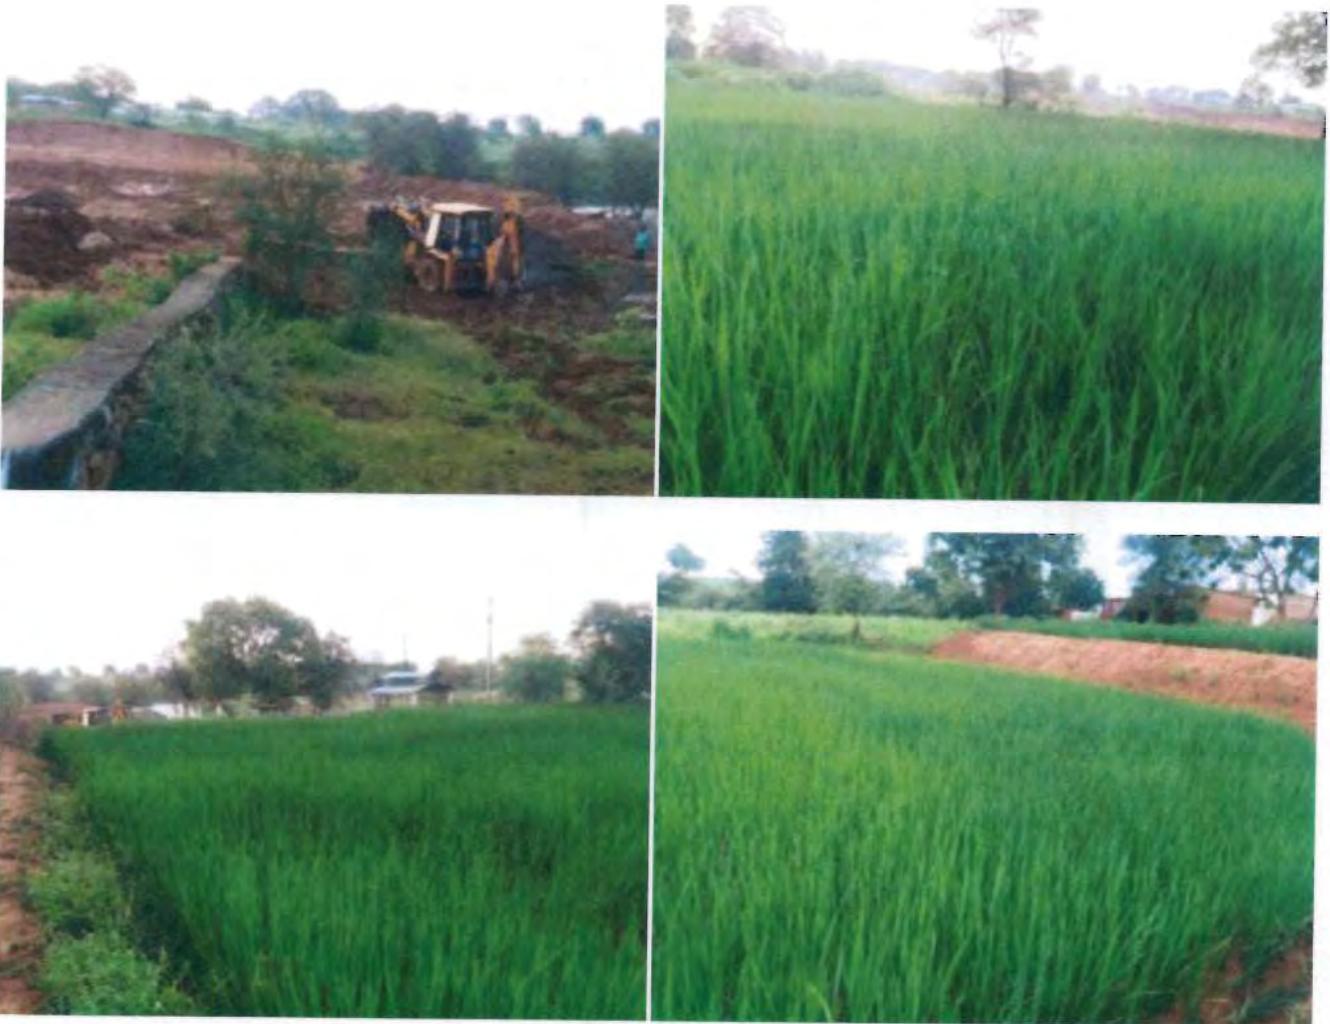
4. Gabaiya nalla main culvert downstream: All area (main nalla area and land) cleared. Cleaning of ash deposited on the side of nalla in very few patches is in progress

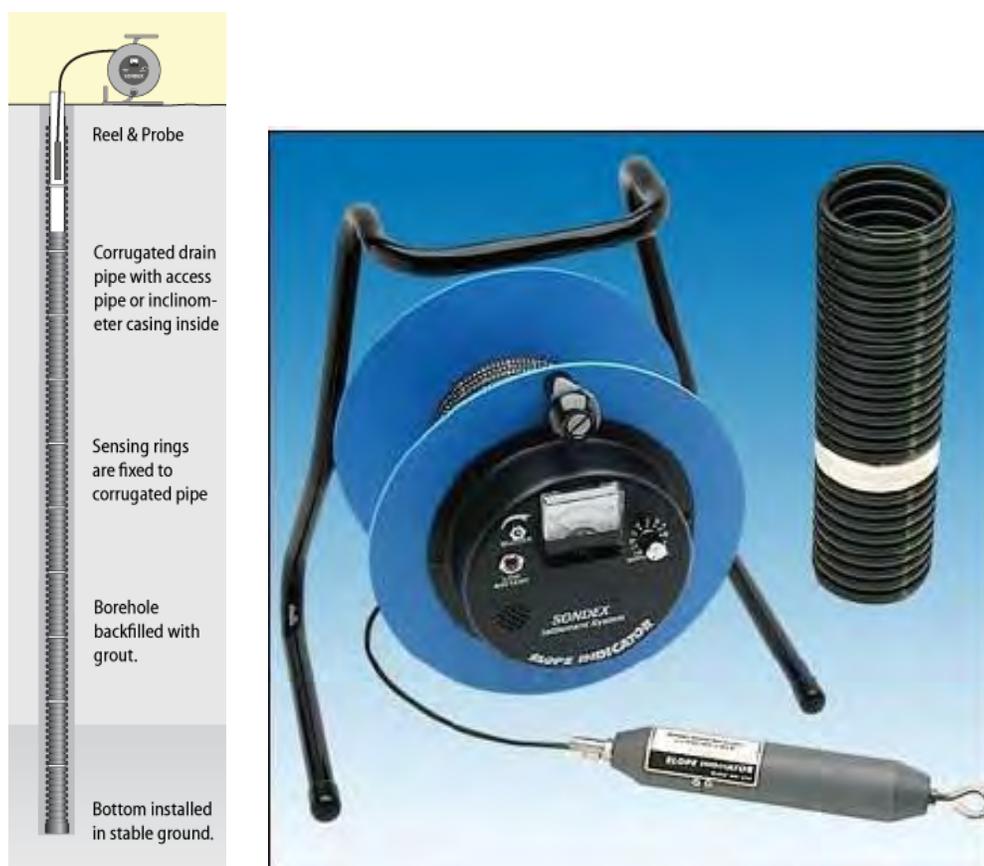
Figure 10 Sondex settlement system

Sondex settlement systems are used to monitor settlement and heave in the active waste (coal ash) stacking areas. The Sondex system consists of a probe, signal cable, and a cable reel with a built-in voltmeter, and a number of stainless steel sensing rings, as shown in Figure 10. Once installed, a baseline reading of the sensing ring depths is recorded, and then all subsequent readings collected thereafter measure the amount of settlement or heave that has occurred in that location.

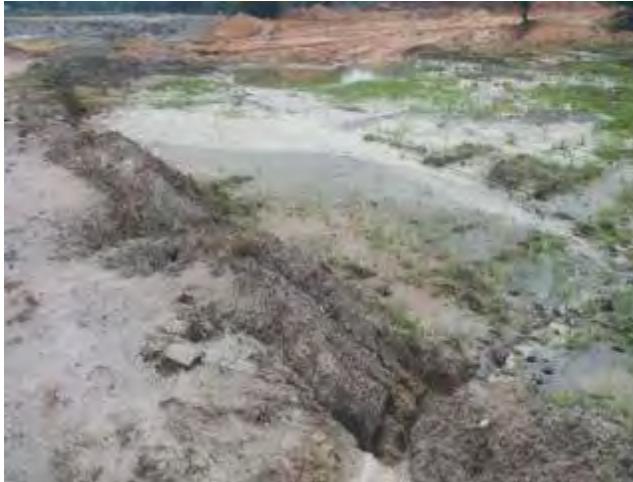
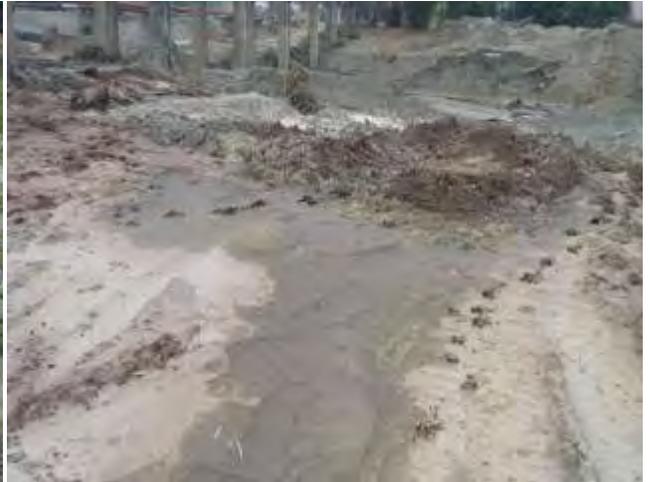
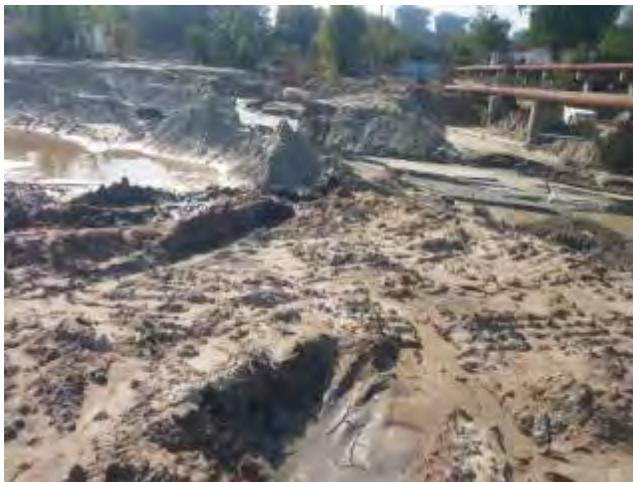
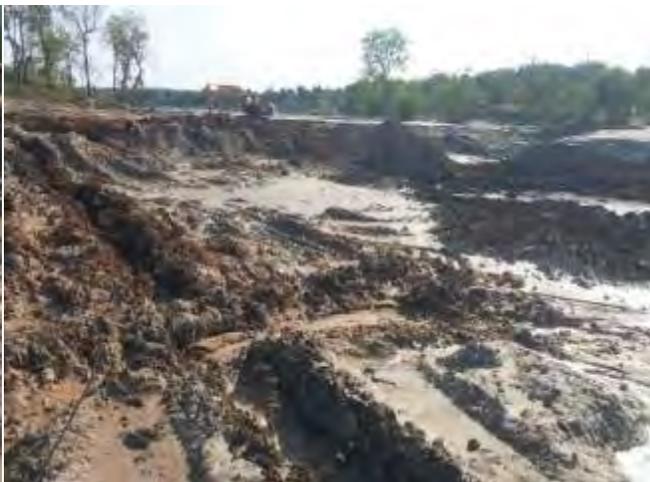
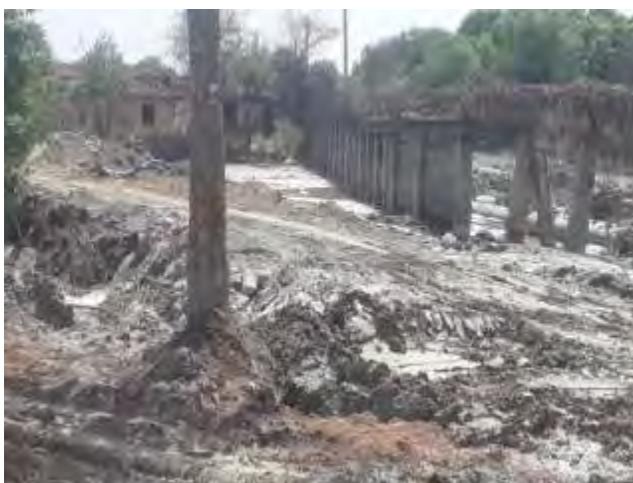
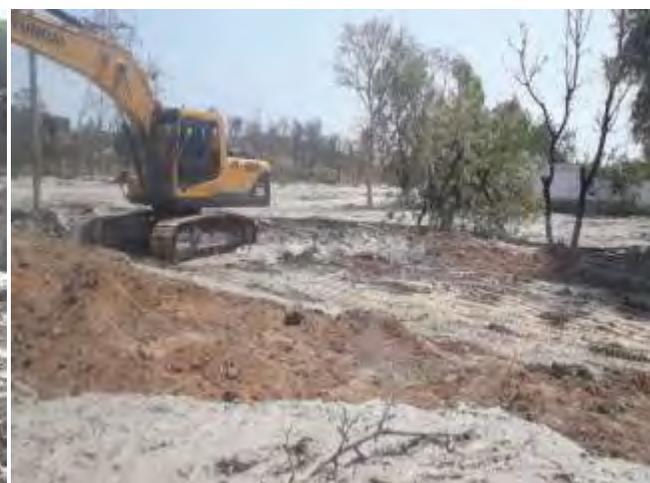
A. Ash Spread Areas and Restoration Work under Progress (Then)

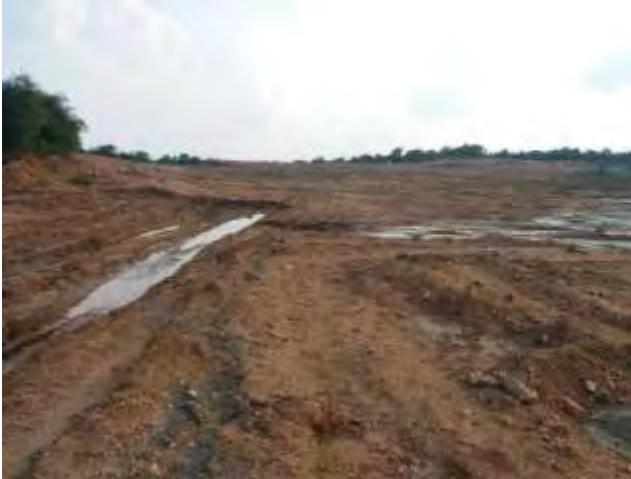
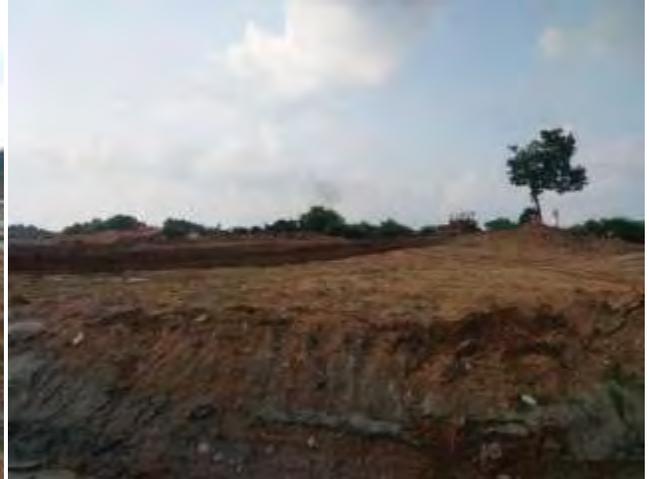
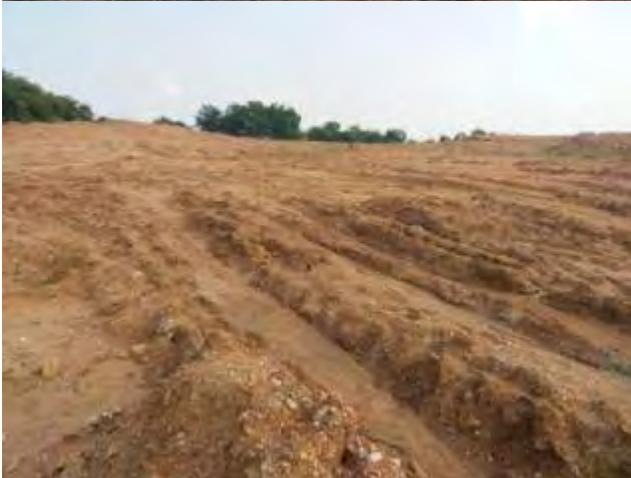
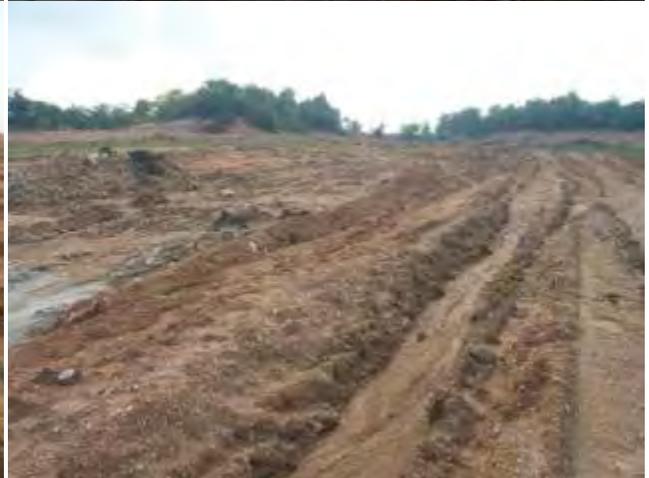
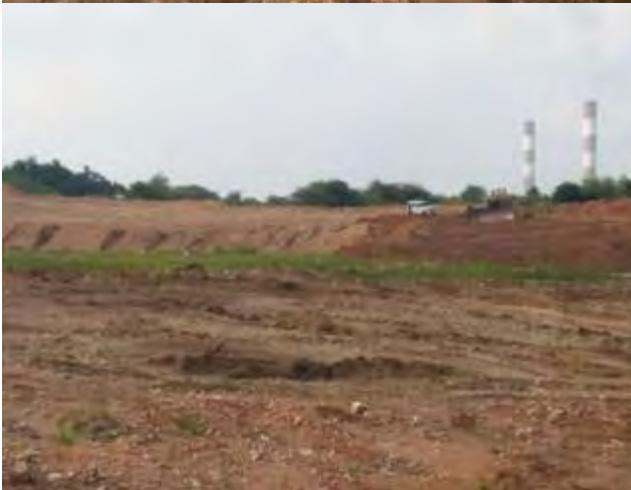
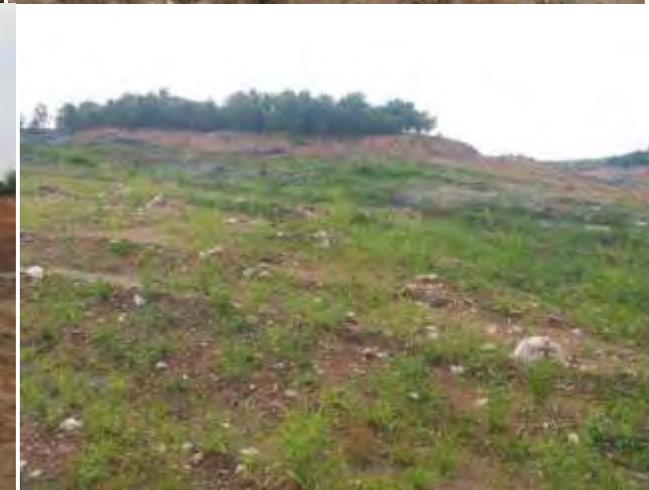
1. Low Lying Area (Island – 4): Ash removed and covered with soil leaving a channel for the safe exit of ground / rain water.

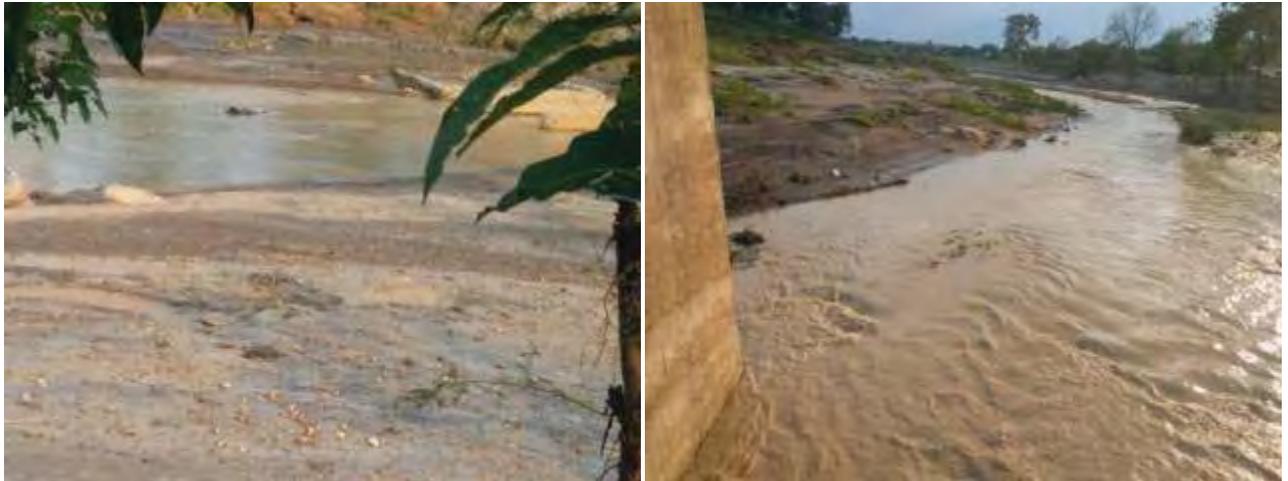
2. Island – 4 drain and Gabaiya nalla co influence up to AWRS Culvert: All area (nalla and land) cleared and paddy cultivation going on. Some part of ash lifting pending because of internal family conflict of land owners.

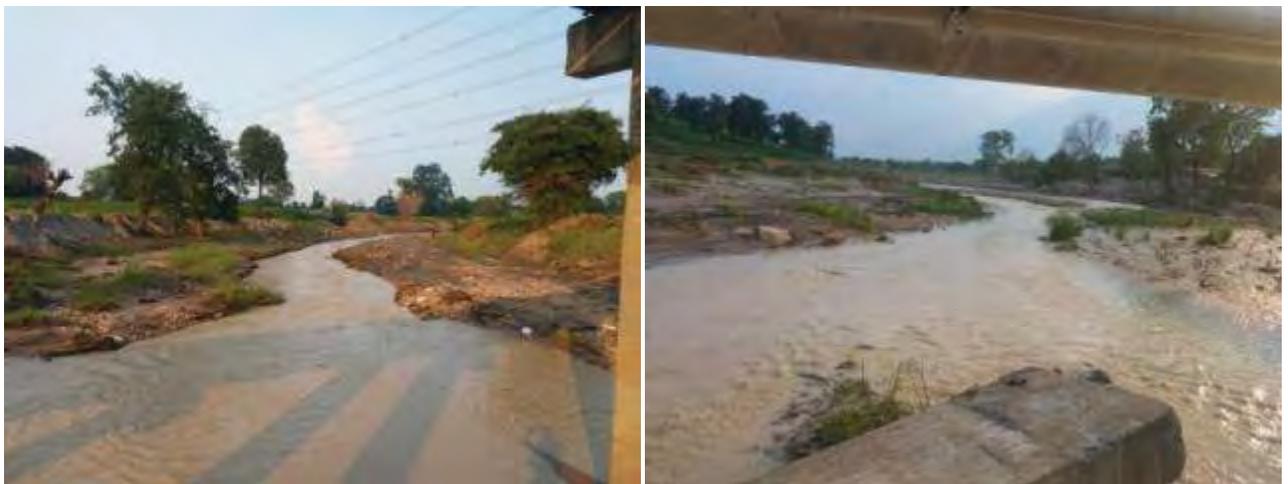
3. AWRS Culvert Area: All area (nalla and land) cleared.

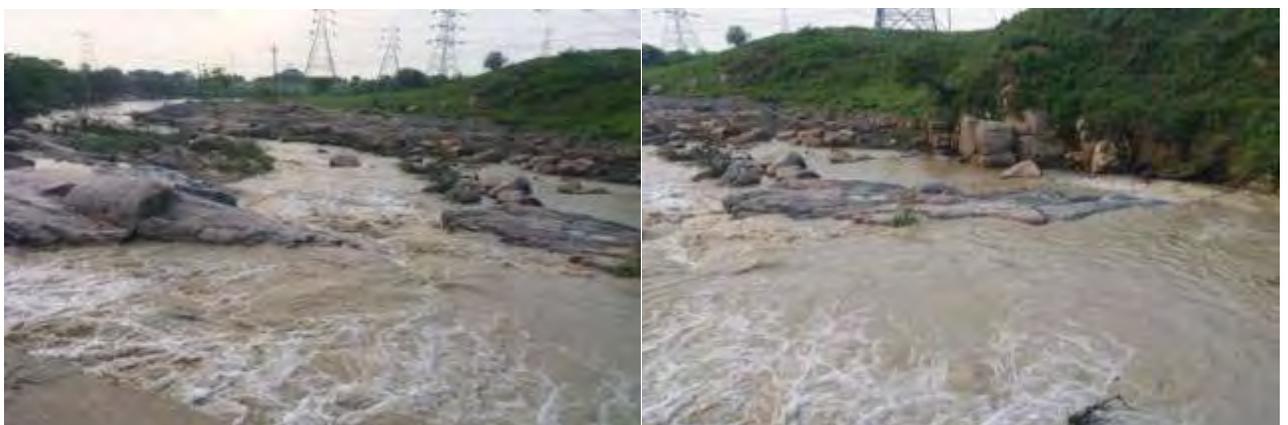
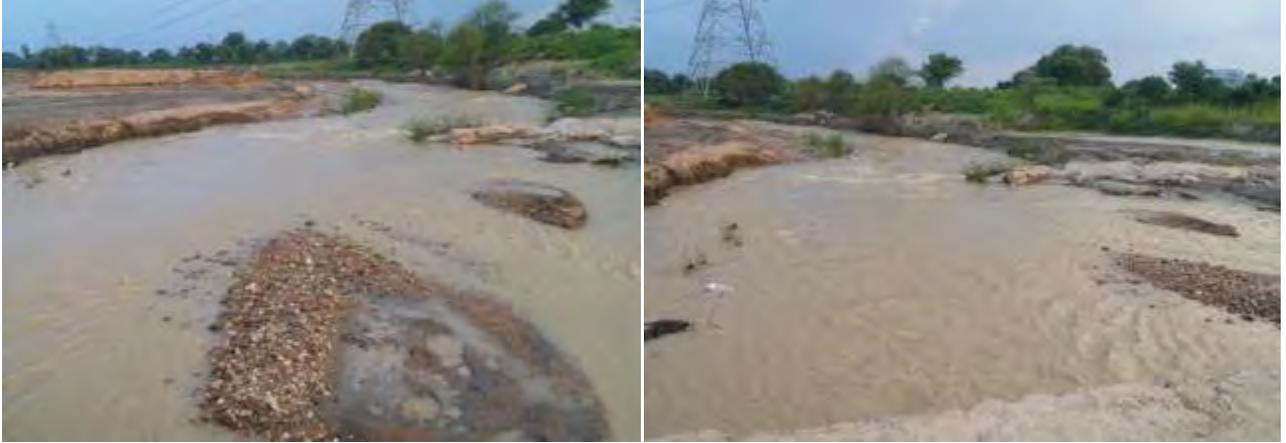
4. Gabaiya nalla main culvert area: All area (nalla and land) cleared.
