**BEFORE THE NATIONAL GREEN TRIBUNAL
PRINCIPAL BENCH NEW DELHI
ORIGINAL APPLICATION No. 134 of 2020**

In re: Massive Fire engulfs Vizag Chemical Plant, explosions heard, injuries reported, published in India Today, Dated:13th July, 2020

The Styrene Vapour Release Accident at
M/s LG Polymers India Pvt. Ltd.

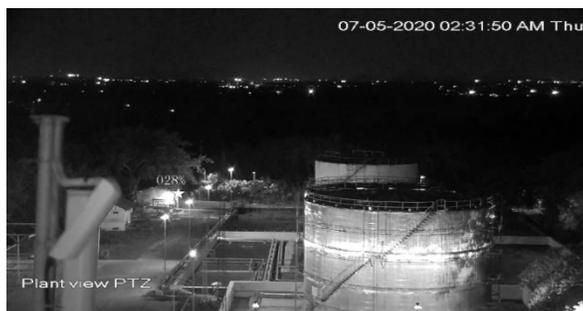
- 02:31 a.m.: No Styrene vapour release captured in the CCTV Figure 2.1

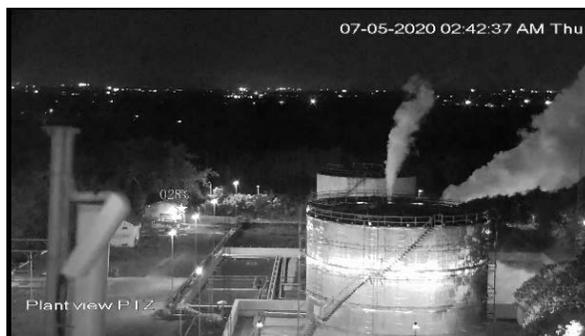
- 02:42 a.m.: Styrene vapour release captured in the CCTV Figure 2.2

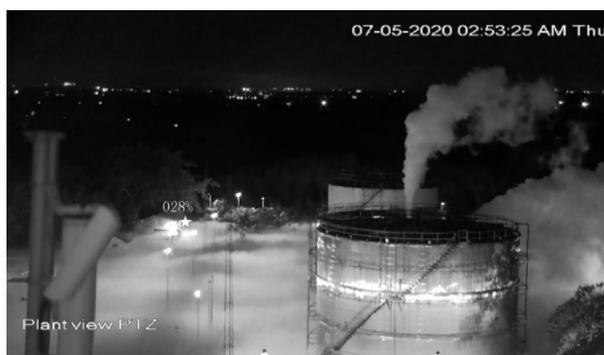
Figure 2.3

- 02:53 a.m.: Styrene vapour cloud formation captured in the CCTV (Figure 2.3)

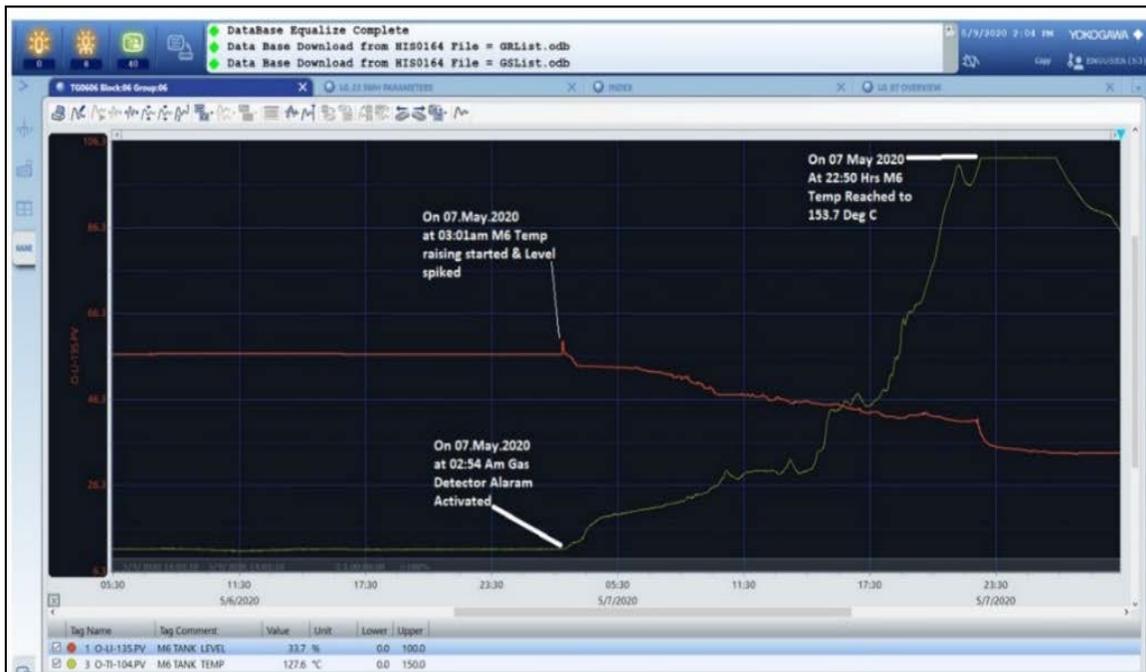
- 03:01 a.m.: Sudden spike in Styrene level in M6 Tank Figure 2.5

Figure 2.5: DCS log for level and temperature in M6 Tank

- 03:02 a.m.: M6 Tank temperature started rising rapidly, refer figure 2.5 above
- 03:04 a.m.: The premises covered with dense Styrene vapour cloud

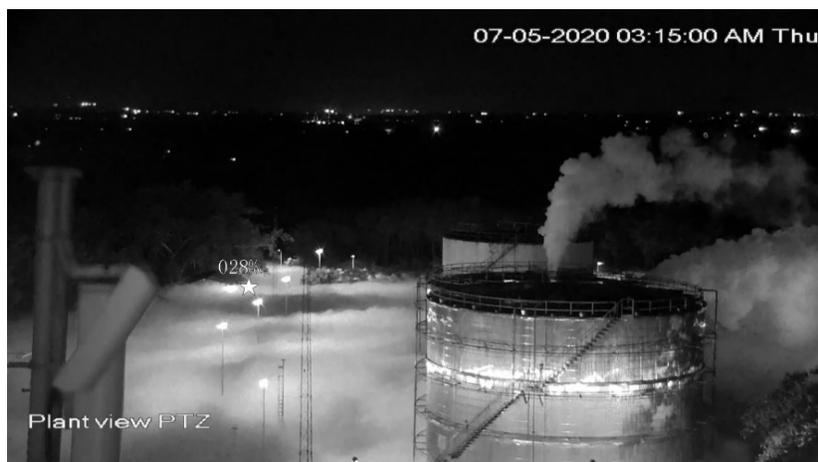
Figure 2.7

- 03:15 a.m.: The premises covered with dense Styrene vapour cloud

From the above the Committee noted that from 02:42 a.m. (CCTV time) onwards, Uncontrolled Styrene Vapour Release occurred from the M6 Tank. The further actions are covered in chapter 3 dealing with Emergency Response.

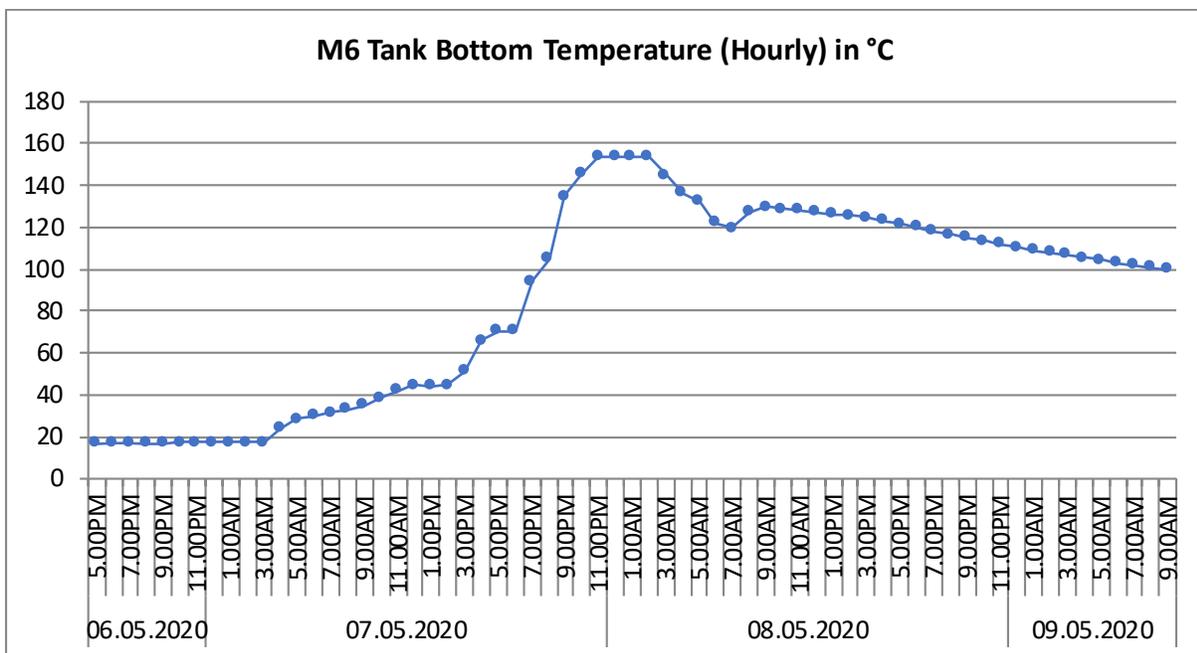
The temperature recorded in the M6 Tank from 05:00 p.m. of 6th May 2020 to 09:00 a.m. of 9th May 2020, by the DCS is placed in Annexure 2.1 of this report. The data is shown graphically below:

Graph 2.1: Temperature Profile

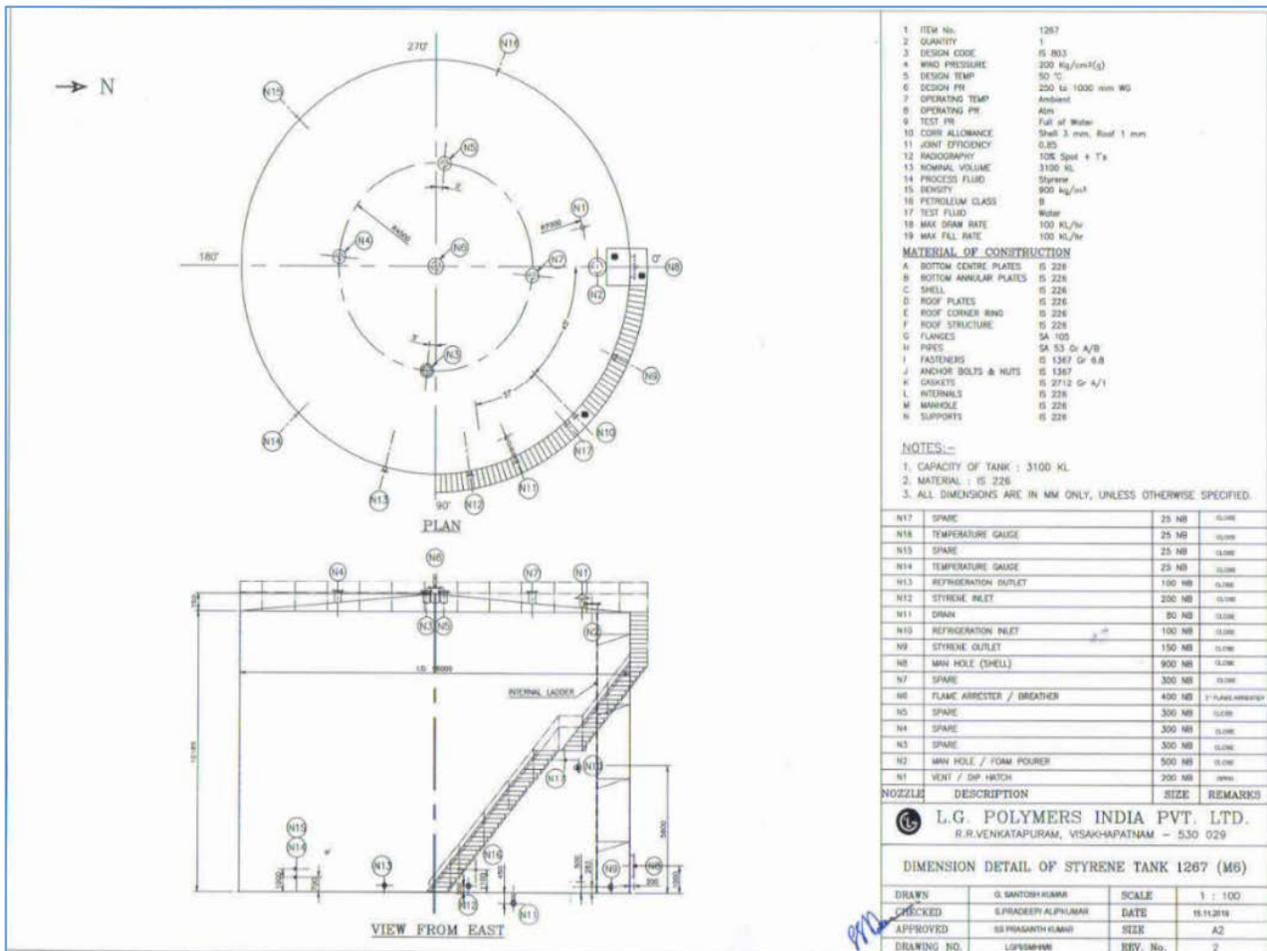
The figure 2.8 below provides the plan and view from the east of the M6 Tank.

Figure 2.8: M6 Tank Drawing

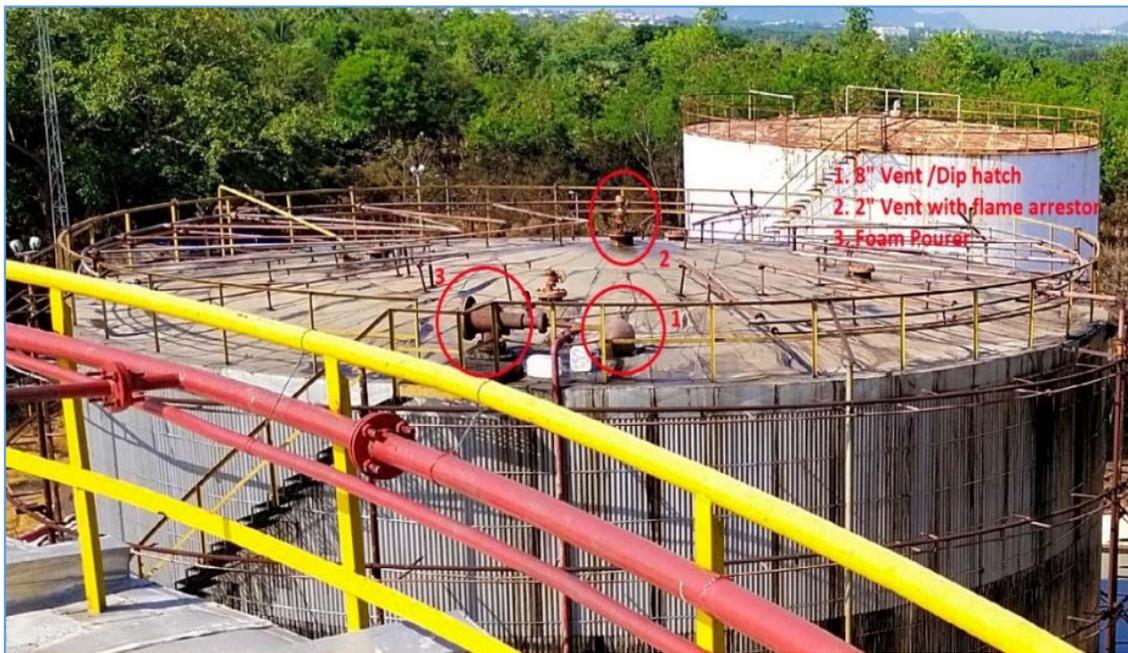
The photograph of the top of the tank, showing N1: Vent / Dip Hatch (S.No. 1 below), N6: Flame Arrestor / Vent (S.No. 2 below) and N2: Manhole / Foam Pourer (S.No. 3 below) is as below in Figure 2.9.

Figure 2.9: Roof Top of M6 Tank Showing Vents

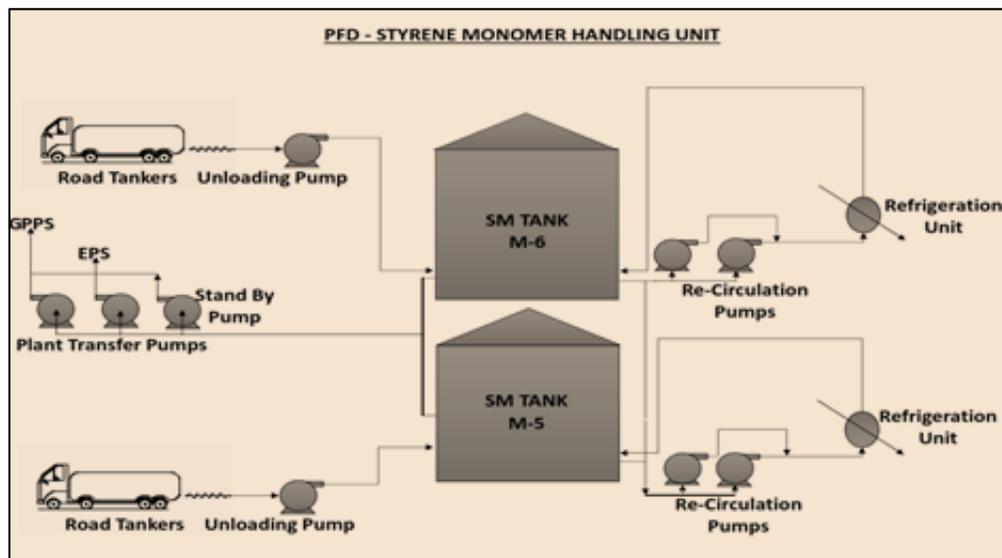
The Process Flow Diagram (PFD) of the M6 Tank and M5 tank is as below.

Figure 2.10: Styrene Handling Plant

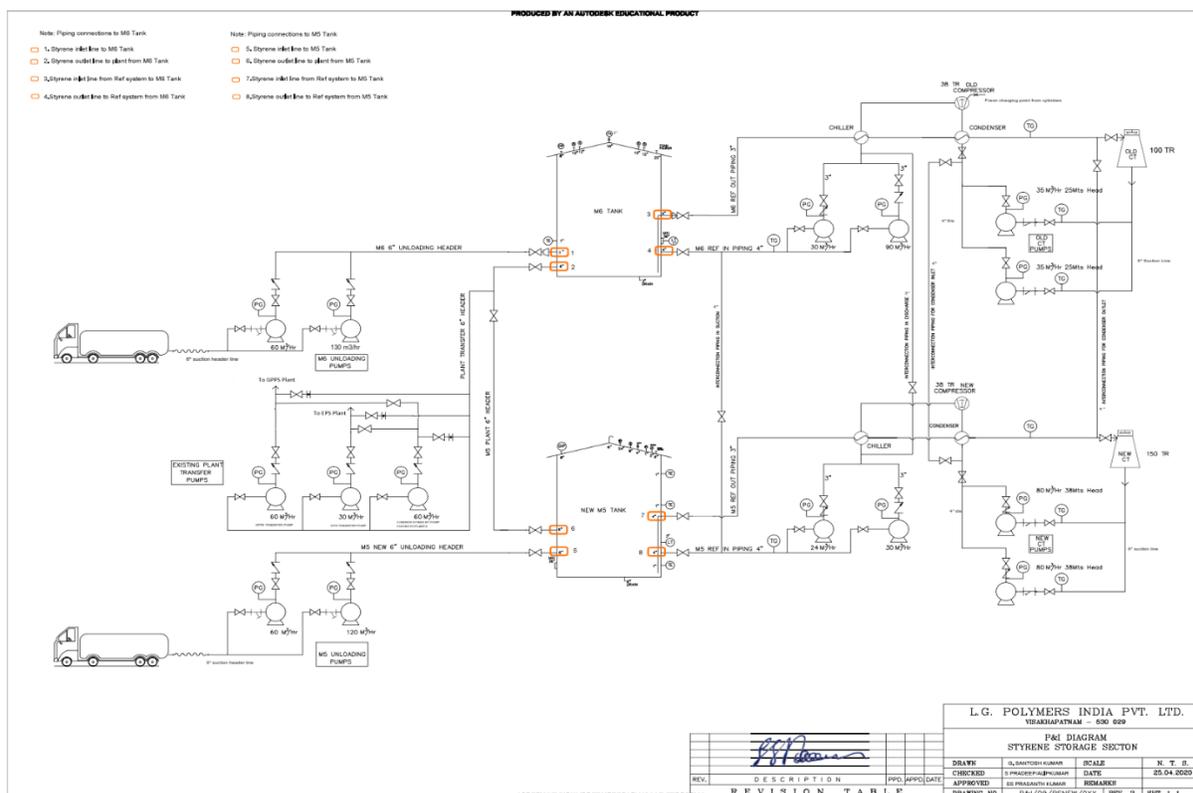
A recirculating system with a pump, with a capacity of 30 m³/hr is provided for in the tank. Further, a dedicated refrigeration unit of capacity 38 TR forms part of recirculation loop to cool the Styrene. **The design range of temperature** for cooling Styrene by the refrigeration unit was given between 40°C to 20°C. But it was being used to cool the Styrene from 25°C to 17°C.

Figure 2.11. : P&I Diagram of M5 & M6 Tanks

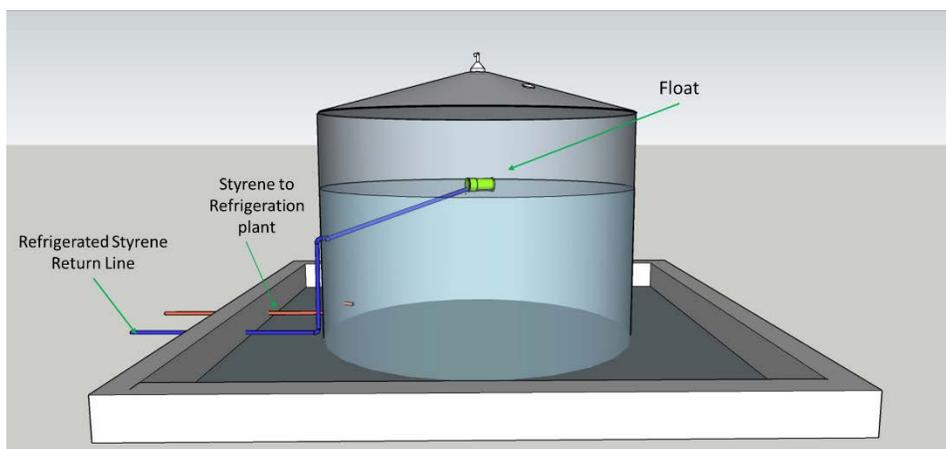
contents of the tank were well mixed by the chemical properties, as the denser cold Styrene moves down towards the bottom by gravity and natural convection, such that **the temperature would be less thermally stratified in the tank**. The management of the company has reported that the float valve got stuck in the stalactites in the M6 Tank, as a result of which, they had to discard the piping connected to the float valve and bring in alternate piping of dip leg arrangement. The alternate piping provided for the cooled Styrene monomer liquid to be delivered at the bottom of the tank. The modified system of the tank, as carried out by December 2019 and confirmed by the company management in its statement, is depicted in the diagram below in Figure 2.12 and Figure 2.13.

Figure 2.12: Before the Modification in Styrene M6 Tank

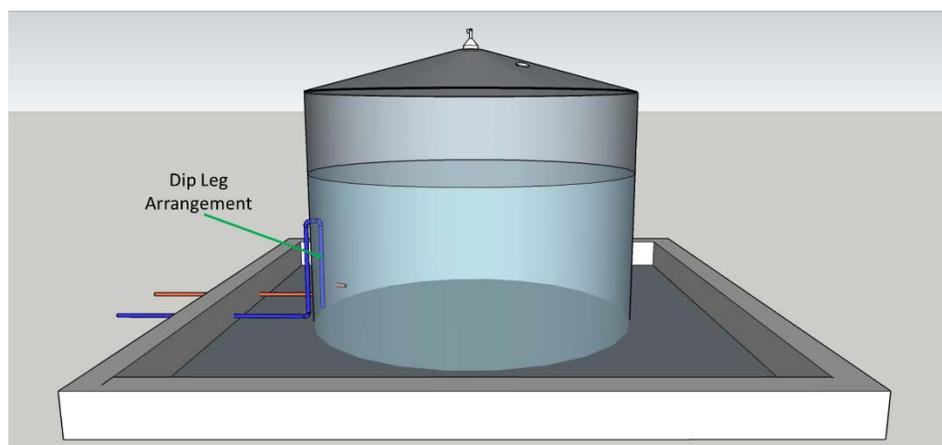
Figure 2.13: After the Modification in Styrene M6 Tank

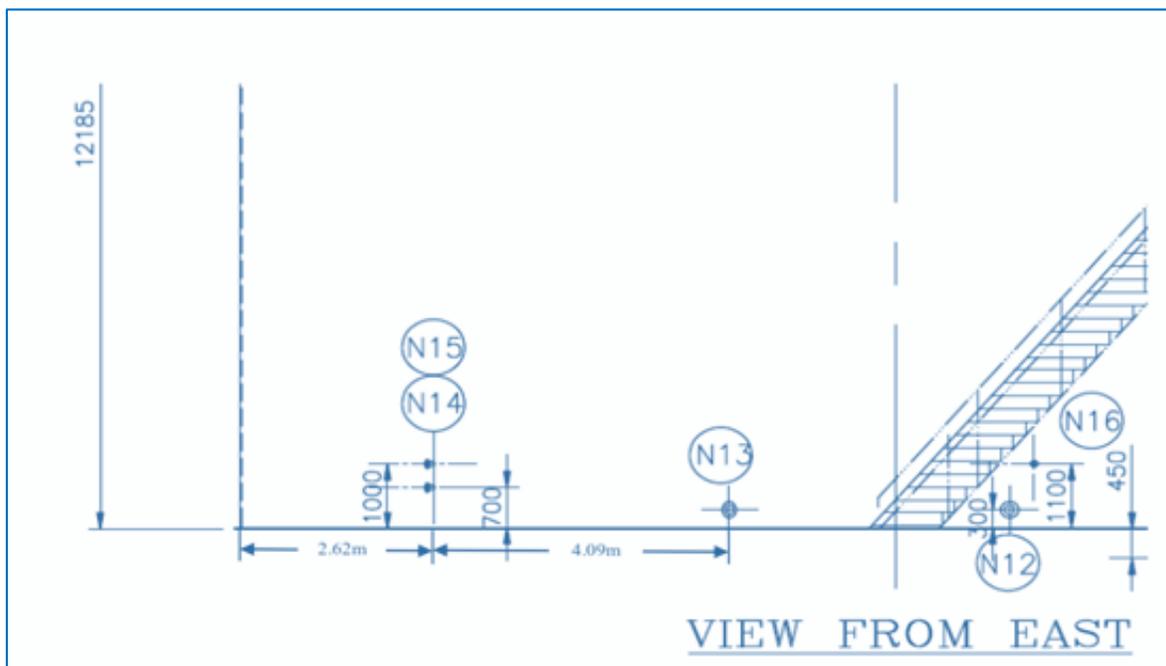
The M6 Tank is provided with a temperature measuring probe (RTD sensor) at the bottom only. The probe is located 0.7 m from the bottom and about 4.09 m distance between the discharge port, N13 and the port of the temperature probe, N14 as is shown below in **Figure 2.14** and **Table 2.3**.

Figure 2.14: The Temperature Measuring Port of M6 Styrene Monomer Storage tank

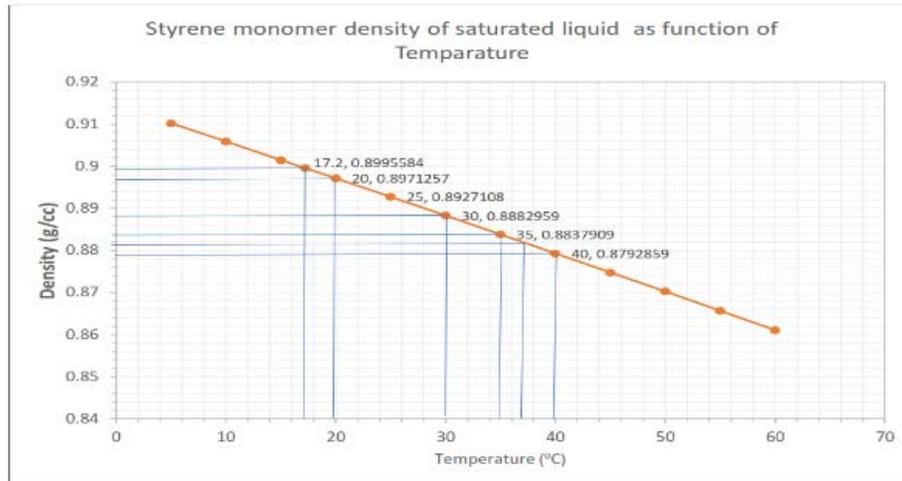
The density of Styrene is a function of its temperature.

Figure 2.15: Density of Styrene as a function of Temperature

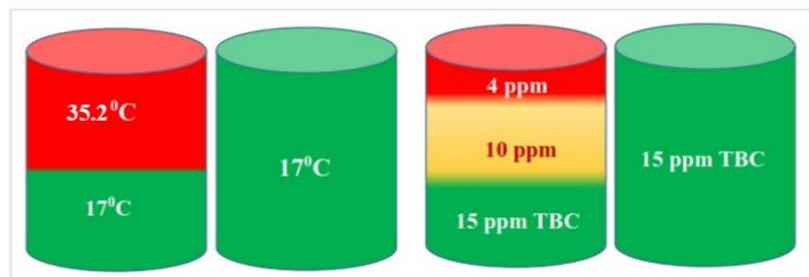
When Styrene is warmer, it gets less dense for each increment in degree celsius. This allows for thermal layering; where warmer Styrene moves on to the top of colder Styrene which is defined as “thermal stratification”. Due to this, there will always be a level of “self-induced” thermal stratification in the Styrene storage. As a matter of fact, for any large storage of any liquid is subjected to thermal stratification in the tanks or vessels. Similarly, addition of chemical compounds (like TBC) can also be stratified due to the self-induced thermal stratification. Both these scenarios of thermal stratification and TBC stratification are shown below for example in Figure 2.16.

Figure 2.16: Stratification vs fully mixed

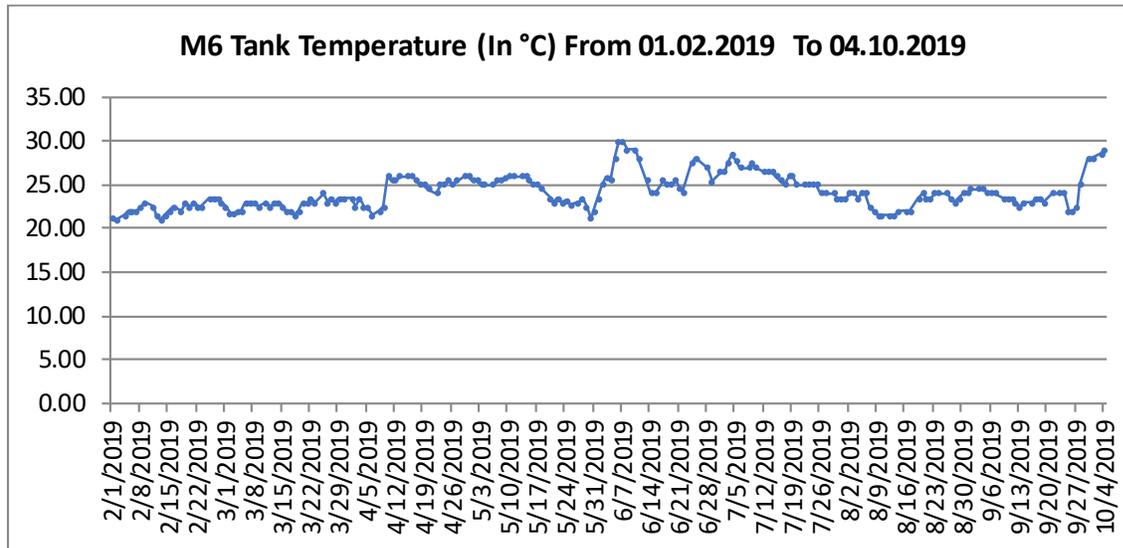
The design range of the temperatures of the refrigeration units is given for cooling Styrene from 40°C to 20°C. But in practice, especially from January 2020, it was being used to cool the Styrene up to 17°C. This was also caused due to the change in the piping design in the M6 Tank as mentioned in section 2.2.1.7. It may be seen from the discussions in section 2.2.1.7 that the float swing pipe arrangement was replaced with dip leg arrangement with release of cooled Styrene Monomer liquid at virtually at the bottom of the tank viz., 300 mm from the bottom. Similarly, the liquid Styrene monomer is taken into the refrigeration cooling system from the N13 port, located at nearly the bottom of the tank at 100 mm. As explained in Section 2.2.1.7. it totally destroyed the natural chemical circulation (mixing) system. Moreover, it resulted in cooled liquid Styrene Monomer being pumped for further cooling in the refrigeration system. This is the cause why the temperatures at the bottom of the M6 Tank recorded low temperatures in the range of 17°C. This is also borne by the temperature reading in the M6 Tank in the year 2019 and the year 2020, which is shown in the Graph 2.2 and Graph 2.3 below:

Graph 2.2: M6 Tank temperature reading for year 2019

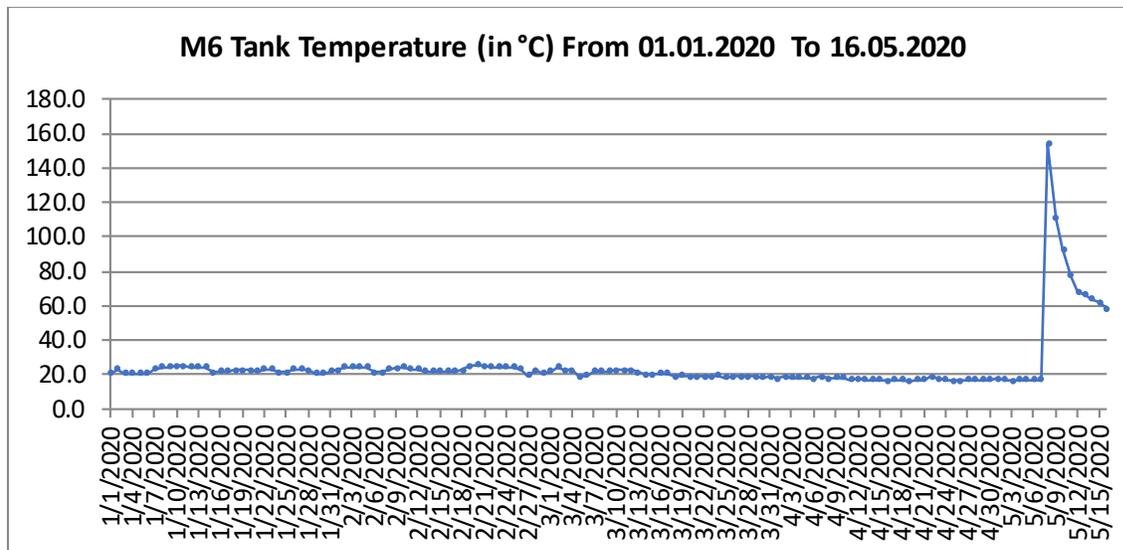
Graph 2.3: M6 Tank temperature reading for year 2020

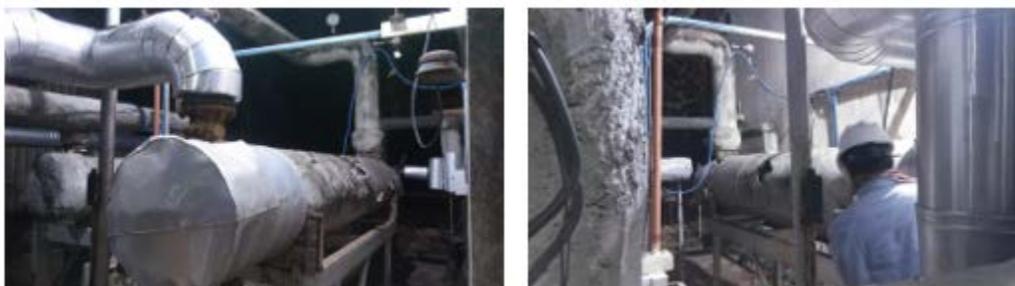
As per the report of the Technical Committee, on inspection of the refrigeration unit, it was observed that the insulation of the pipelines and equipment were damaged, and the rusted flanges can also be seen in figures 2.17 and figure 2.18 below. Under these circumstances, **the possible leak of R–22 into the recirculating Styrene cannot be ruled out.**

Figure 2.17 and Figure 2.18: Present status of the refrigeration system and the alarm

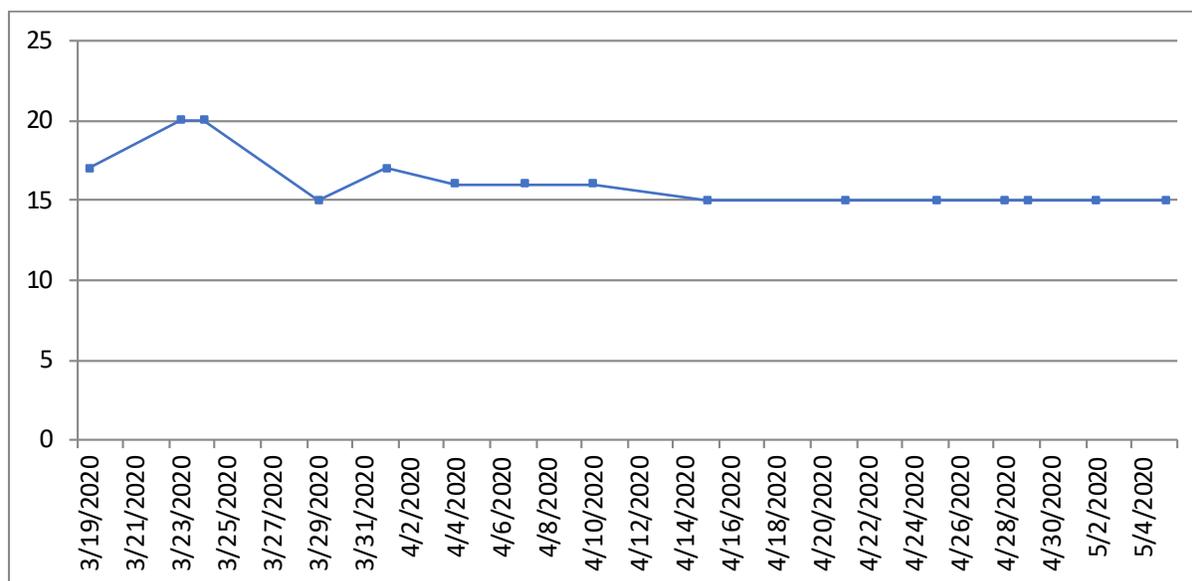
Date	TBC	Date	TBC	Date	TBC
03.01.2020	15	02.02.2020	15	19.03.2020	17
06.01.2020	15	08.02.2020	25	23.03.2020	20
07.01.2020	15	10.02.2020	15	24.03.2020	20
09.01.2020	15	11.02.2020	15	29.03.2020	15
10.01.2020	15	12.02.2020	15	01.04.2020	17
13.01.2020	15	15.02.2020	15	04.04.2020	16
20.01.2020	15	17.02.2020	15	07.04.2020	16
21.01.2020	18	18.02.2020	20	10.04.2020	16
22.01.2020	18	19.02.2020	20	15.04.2020	15
23.01.2020	18	20.02.2020	20	21.04.2020	15
24.01.2020	18	25.02.2020	20	25.04.2020	15
25.01.2020	18	27.02.2020	20	25.04.2020	15
26.01.2020	15	28.02.2020	20	28.04.2020	15
27.01.2020	15	29.02.2020	17	29.04.2020	15
28.01.2020	15	02.03.2020	17	02.05.2020	15
30.01.2020	15	03.03.2020	17	05.05.2020	15
31.01.2020	15	10.03.2020	15

Graph 2.4: M6 Tank TBC (Inhibitor) Values in PPM

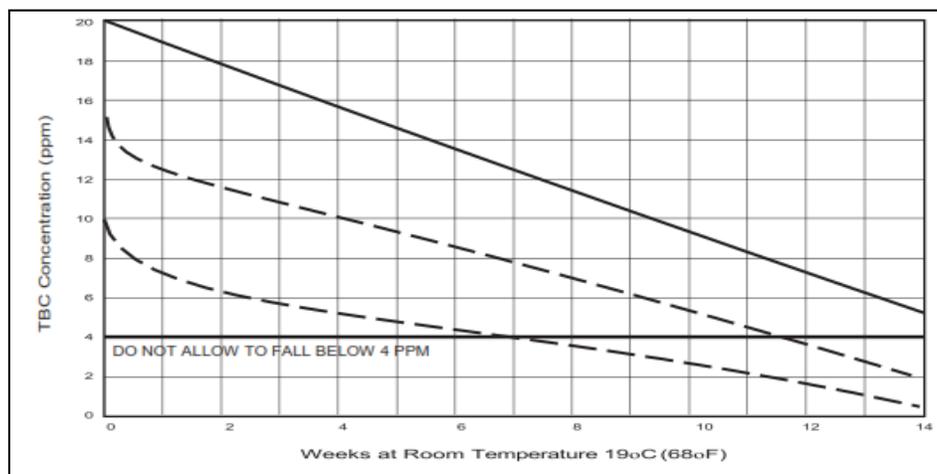
As is observed from the Figure 2.19, the 4 ppm TBC concentration is critical. If the inhibitor has been depleted and polymerisation begins, inhibitor should be added immediately. Additional inhibitor should be added when inhibitor levels drop below 10 ppm to maintain adequate inhibition. After addition, the storage tank should be recirculated until inhibitor is uniformly mixed and testing show that target levels have been achieved. Although with adding TBC and reducing the storage time, one may be able to prevent a runaway reaction, it should be realised that one of the main barriers to prevent polymerisation will be lost if the temperature cannot be controlled under all conditions.

Figure 2.19: Decrease of TBC Concentration in Styrene

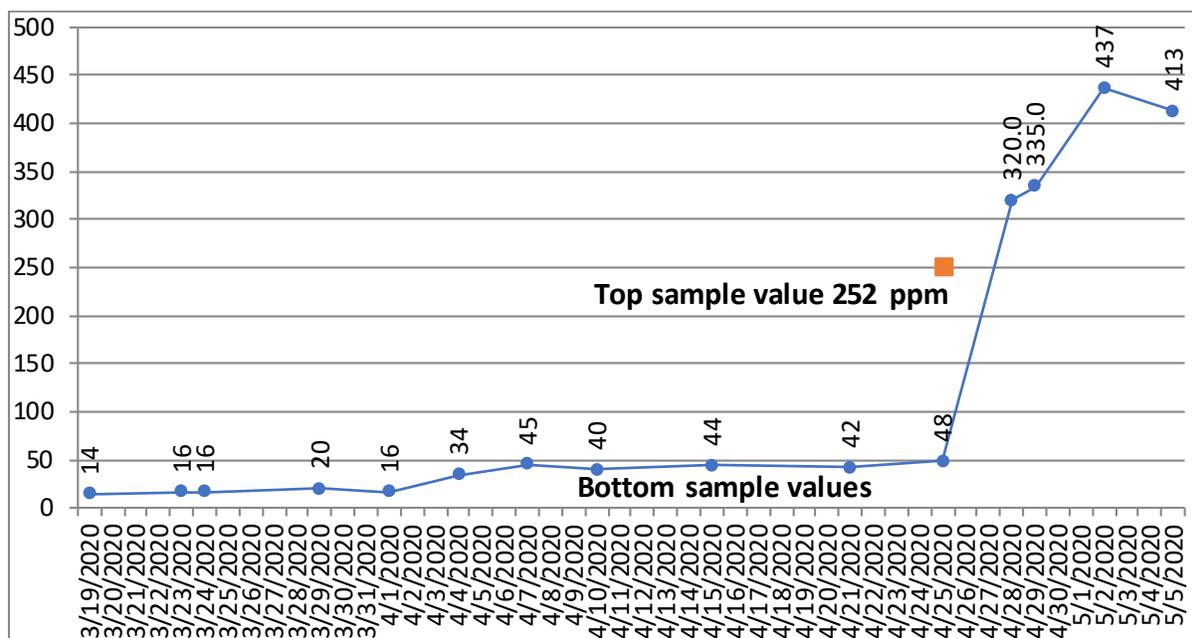
Date	Polymer	Date	Polymer	Date	Polymer
03.01.2020	18	02.02.2020	20	19.03.2020	14
06.01.2020	8	08.02.2020	15	23.03.2020	16
07.01.2020	10	10.02.2020	10	24.03.2020	16
09.01.2020	9	11.02.2020	17	29.03.2020	20
10.01.2020	8	12.02.2020	18	01.04.2020	16
13.01.2020	9	15.02.2020	10	04.04.2020	34
20.01.2020	16	17.02.2020	8	07.04.2020	45
21.01.2020	15	18.02.2020	15	10.04.2020	40
22.01.2020	18	19.02.2020	15	15.04.2020	44
23.01.2020	26	20.02.2020	17	21.04.2020	42
24.01.2020	20	25.02.2020	16	25.04.2020	252 (top)
25.01.2020	19	27.02.2020	16	25.04.2020	48 (bottom)
26.01.2020	18	28.02.2020	14	28.04.2020	320
27.01.2020	16	29.02.2020	14	29.04.2020	335
28.01.2020	15	02.03.2020	14	02.05.2020	437
30.01.2020	12	03.03.2020	15	05.05.2020	413
31.01.2020	18	10.03.2020	11

Graph 2.5: M6 Tank Polymer (bottom sample) values in PPM

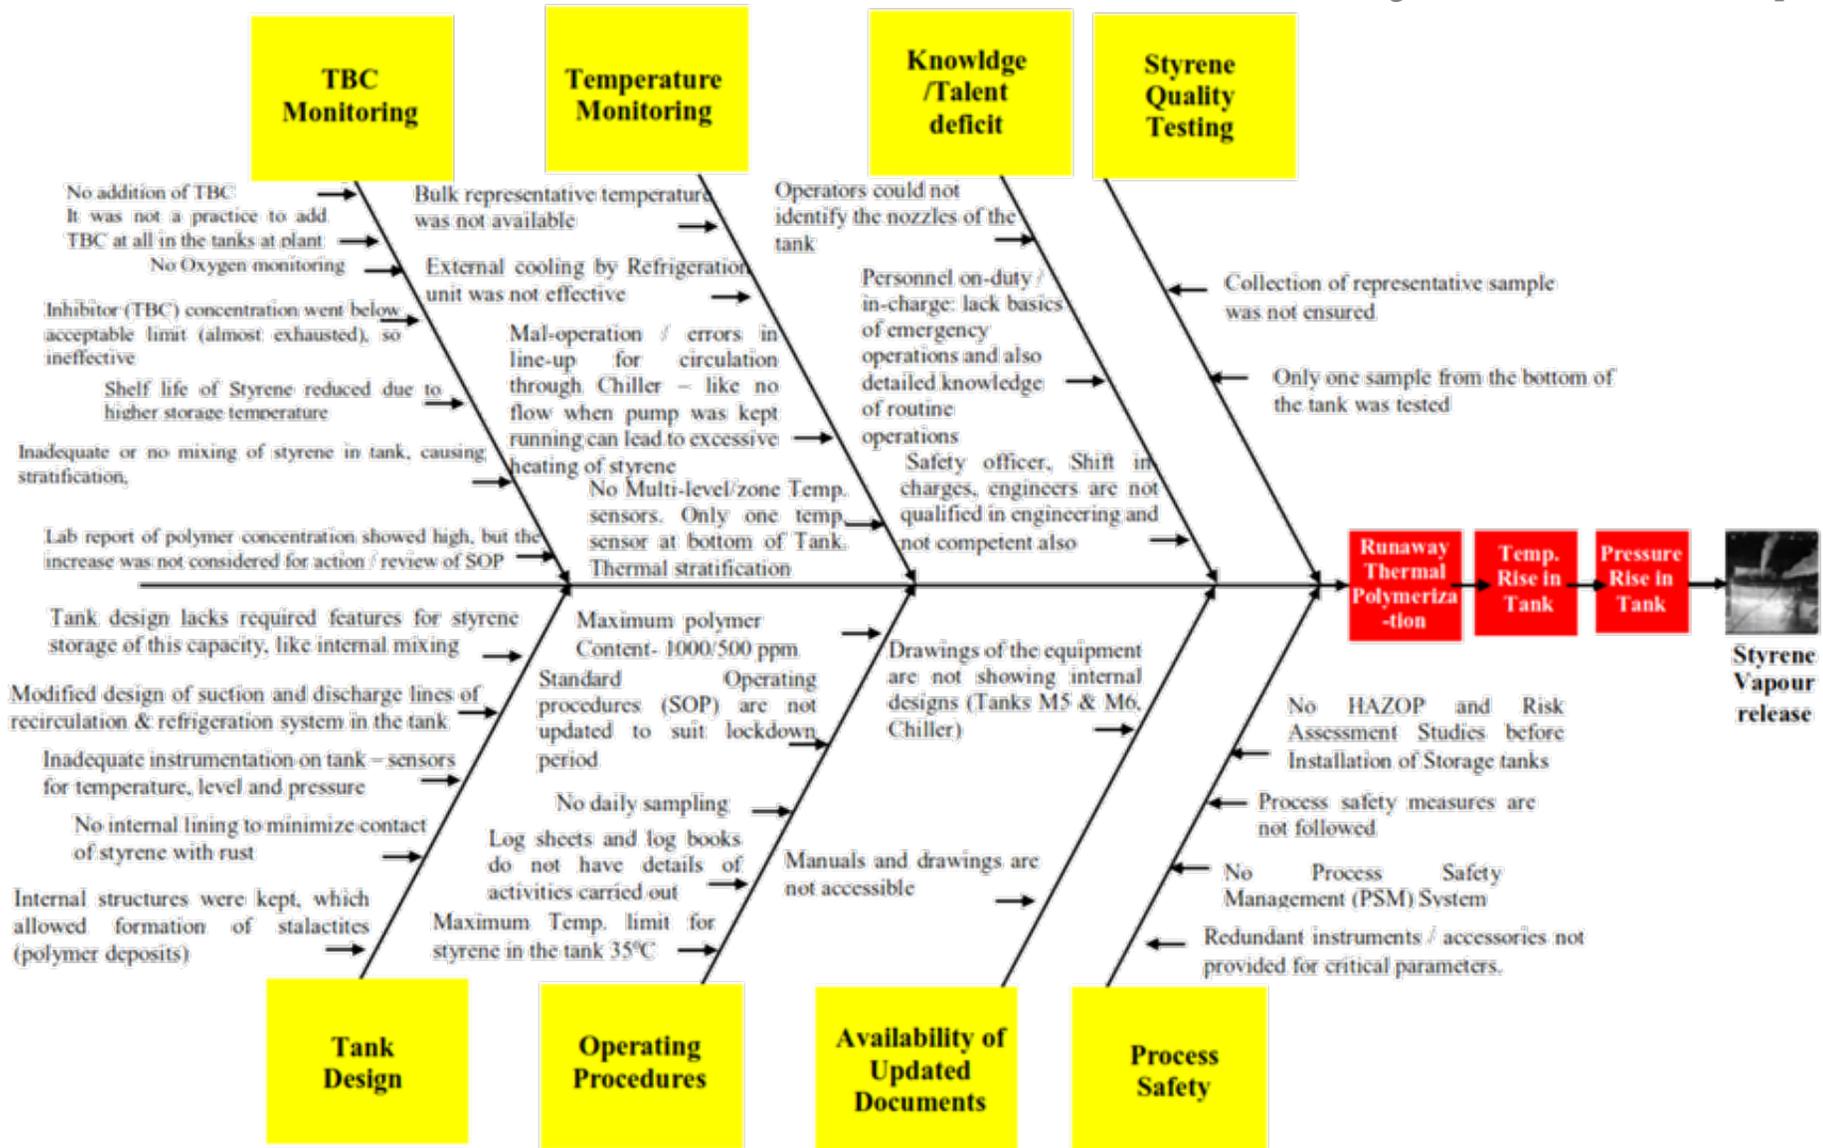
The Technical Committee has made an intensive investigation in a scientific manner and the report in Volume – I may be read as a part and parcel of this analysis. The Technical Committee has also prepared a fishbone diagram explaining the root causes (refer Volume – I) and is produced below in Figure 2.20.

Figure 2.20: Ishikawa Fishbone diagram

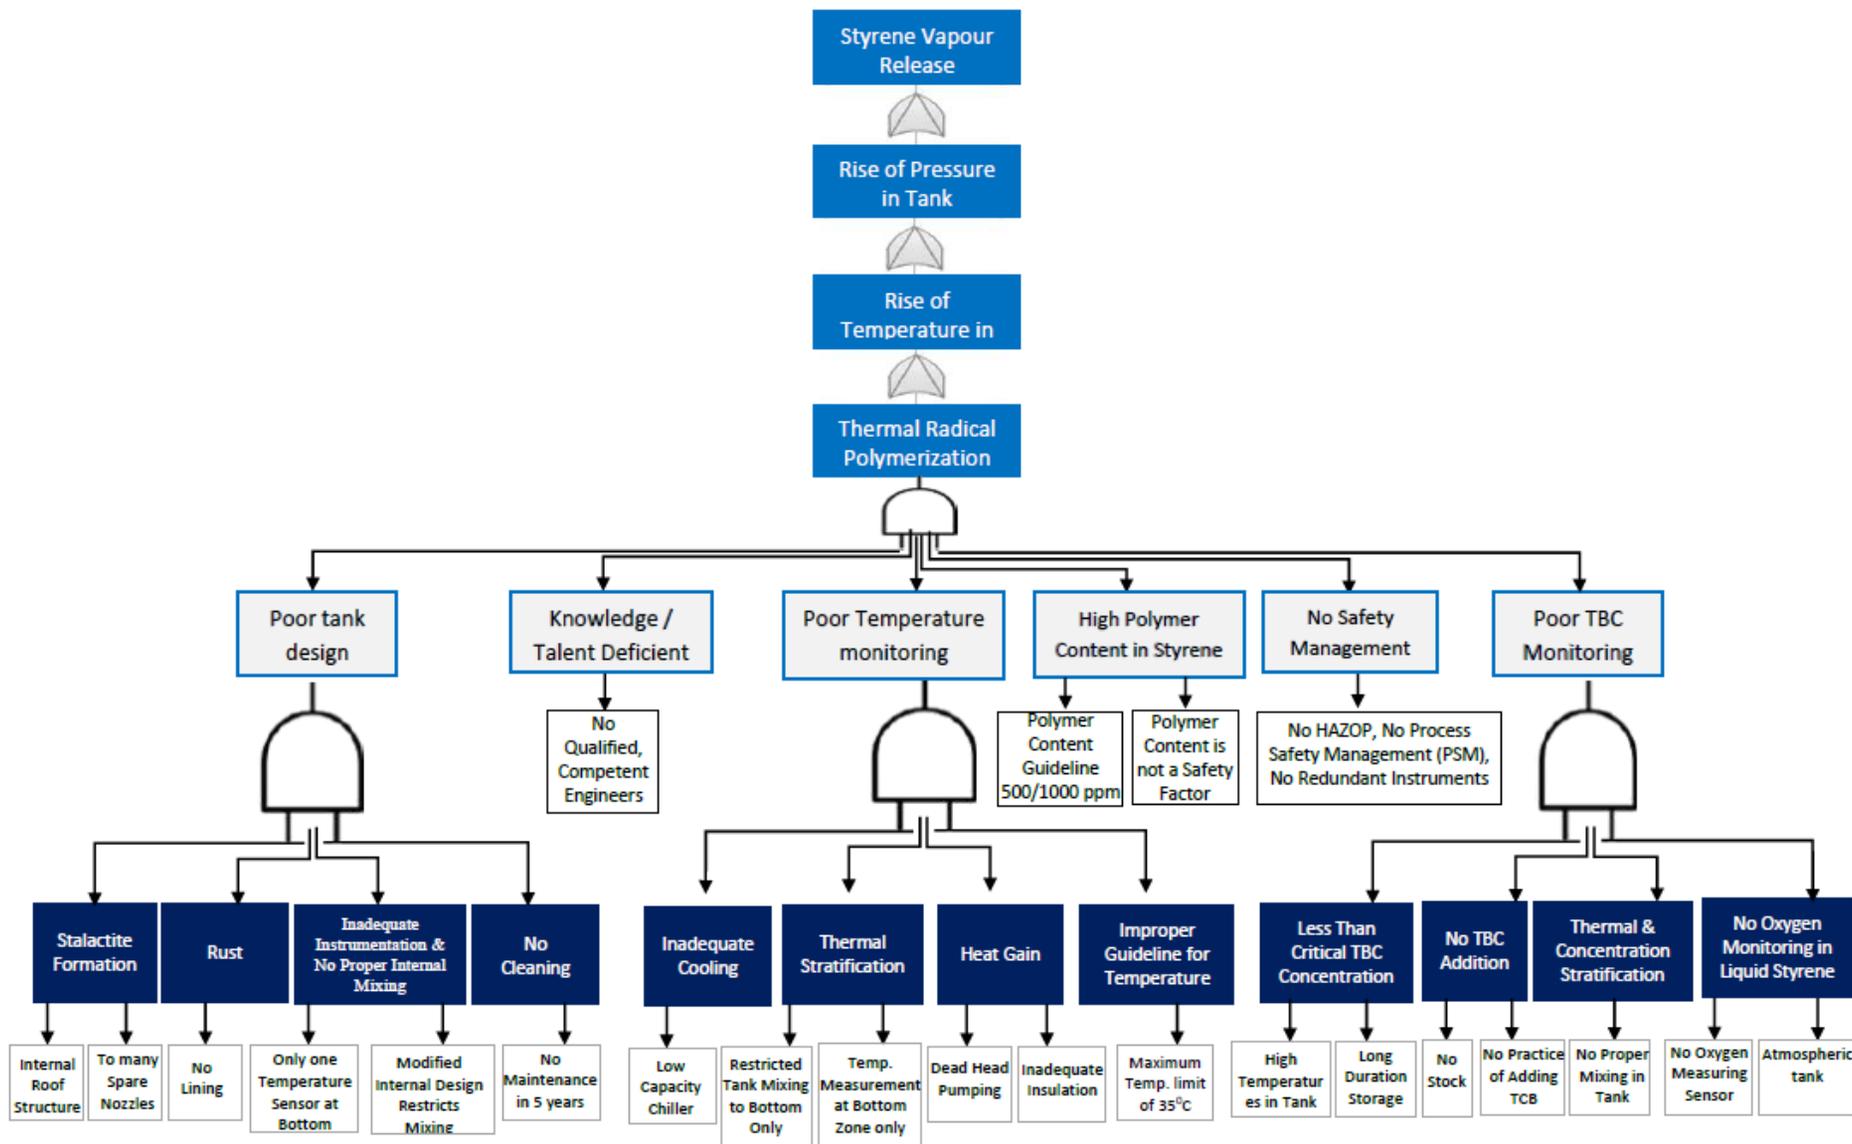
In the light of the root causes mentioned above, the Committee is of the view that the accident in the Styrene storage M6 Tank can be attributed to poor design of tank, inadequate refrigeration and cooling system, absence of circulation & mixing systems, inadequate measurement parameters, poor safety protocol, poor safety awareness, inadequate risk assessment and response, poor process safety management systems, slackness of management, insufficient knowledge amongst staff, insufficient knowledge of the chemical properties of Styrene, especially during storage under idle conditions.

Figure 21: Fault Tree Diagram

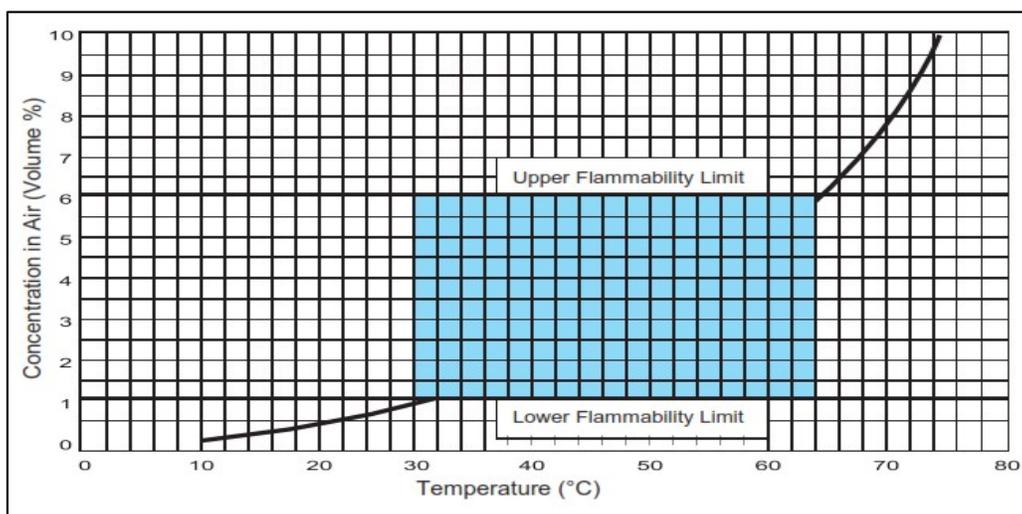
Styrene monomer is classified as a Class IC flammable liquid. The National Fire Protection Association (NFPA) Code 30 also defines Styrene monomer as a Class IC flammable liquid. Styrene monomer has a flashpoint of 31.9°C (90°F). Styrene monomer vapours are explosive in the air at concentrations between 0.9 and 6.8 per cent by volume if an ignition source is present. The flammability region (blue shade) is shown in the figure below:

Figure 3.1: Flammability Region for Styrene Monomer

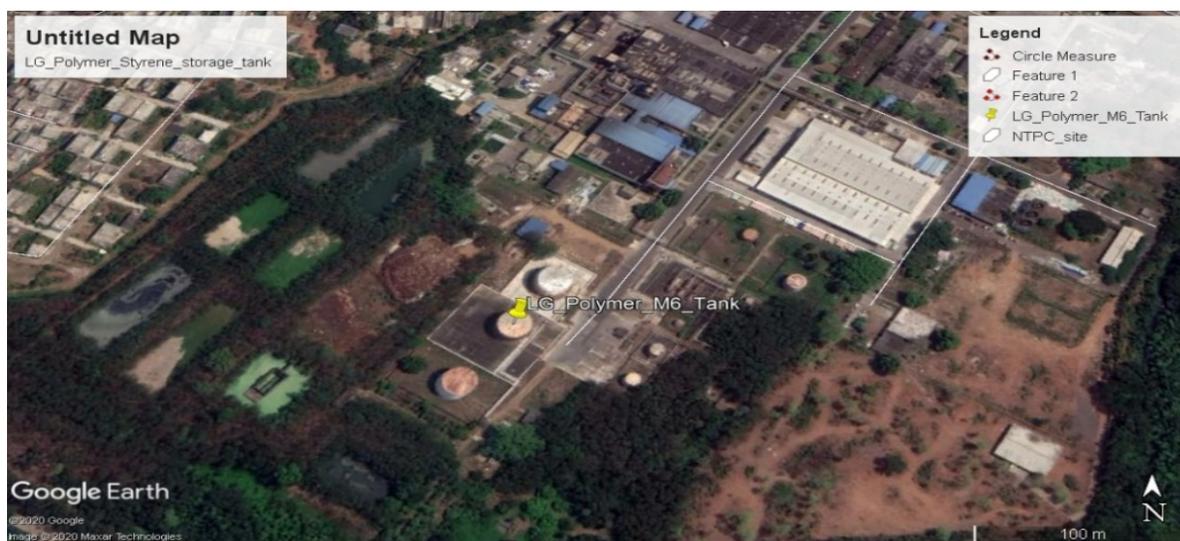
The Styrene Monomer Vapour (SMV) got emitted from the M6 Tank of LG Polymers Pvt. Ltd. (LG Polymers) plant which contains around 1800 MT of Styrene Monomer (SM) as on 6th May 2020 as stated by the industrial personal. Habitations are located at a distance of approximately 210 m to 220 m from the storage tank in the South West, West and North West direction with reference to the M6 Tank as shown in Figure 4.2.

Figure 4.2: The Styrene Monomer Storage Tank of LG Polymers and Its Proximity to Human habitations

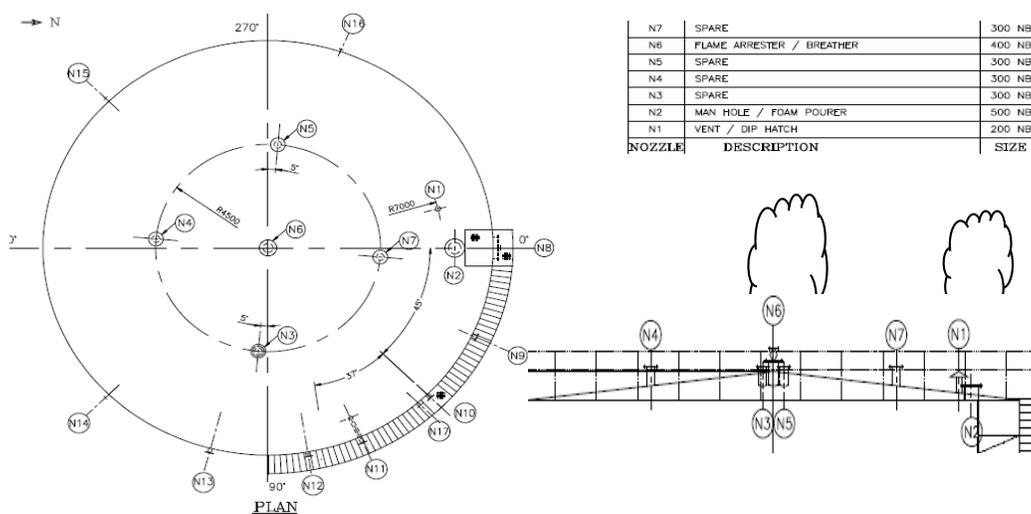
The observed wind speed in the industry at 9:00 p.m. and 10:00 p.m. on 7th February 2020 is 0.7 m/s and 0.6 m/s respectively. The Styrene Monomer vapours were emitted from the top of the M6 Tank from two different vents as evident from the photographs from various media sources, CCTV footages and these are marked and presented in Figure. 4.3. The height of the vents through which the SMV emissions took place is approximately 12.5 m. This data is useful in assessing the area of influence of the SMV emissions.

Figure 4.3: The Vents from where the SM Vapour Emissions entered into the Ambient Atmosphere

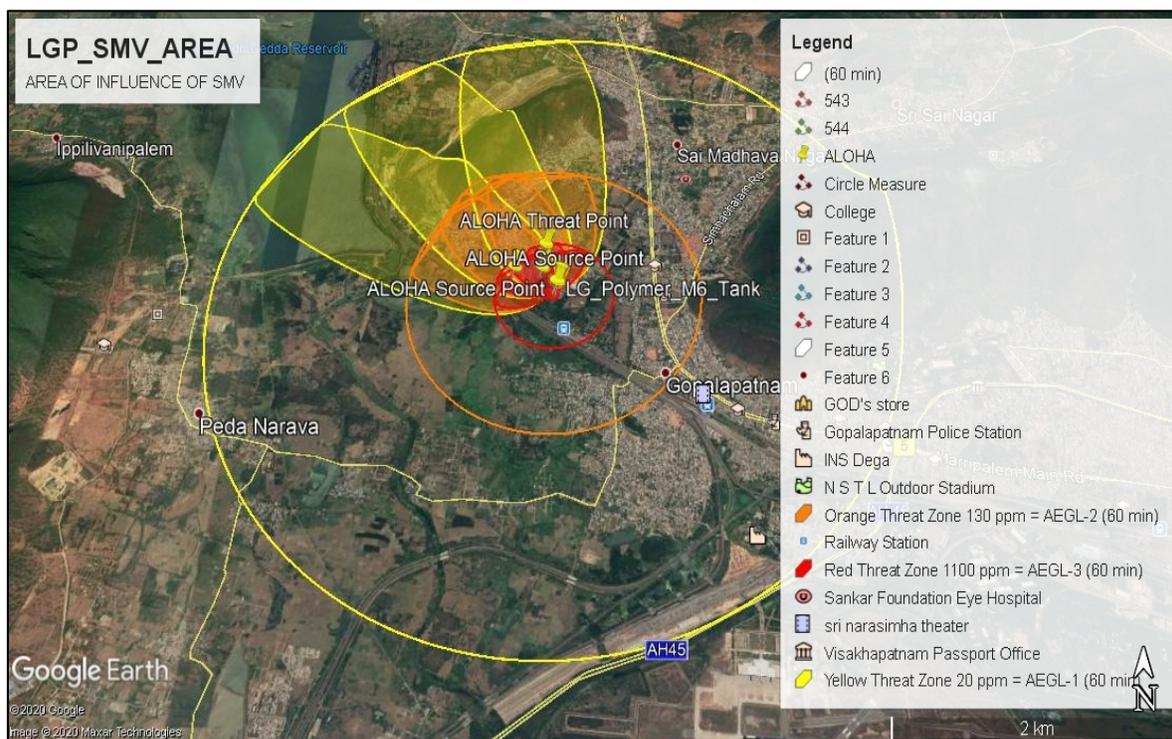
Figure 4.5 (a): The Threat Zones for the ALOHA Model Runs with Styrene Loss /Evaporation of 46MT with Change in Wind Direction. (Google Earth)

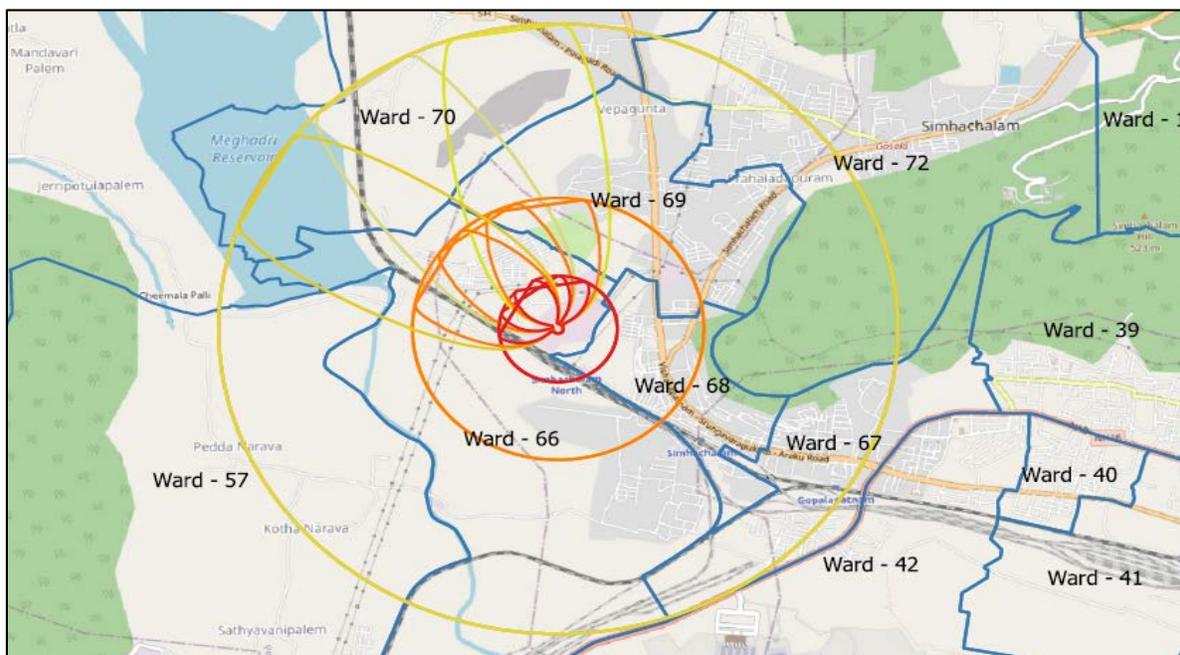
Figure 4.5 (b): The Threat Zones for the ALOHA Model Runs with Styrene Loss /Evaporation of 4MT with Change in Wind Direction. (GVMC Map)
