**BEFORE THE NATIONAL GREEN TRIBUNAL
PRINCIPAL BENCH NEW DELHI
ORIGINAL APPLICATION No. 134 of 2020**

In re: Massive Fire engulfs Vizag Chemical Plant, explosions heard, injuries reported, published in India Today, Dated:13th July, 2020

The Styrene Vapour Release Accident at
M/s LG Polymers India Pvt. Ltd.

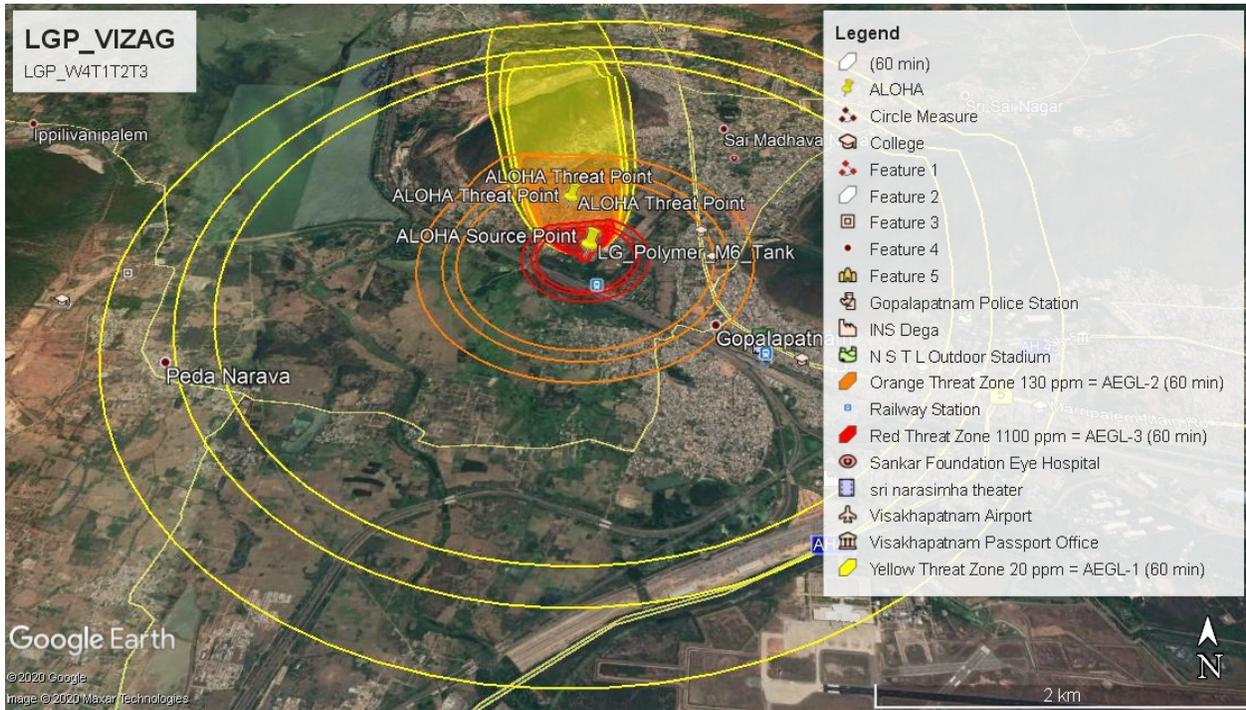
The results are represented on Google Earth, and the images are given in Figure 4.6 to Figure 4.9. Typical concentration profile and the threat zone graph are shown in Graph 4.1 and Graph 4.2, respectively.

Figure 4.6: The Threat Zones for the ALOHA Model Runs with ID LGP_T1, LGP_W4T2 and LGP_W4T3

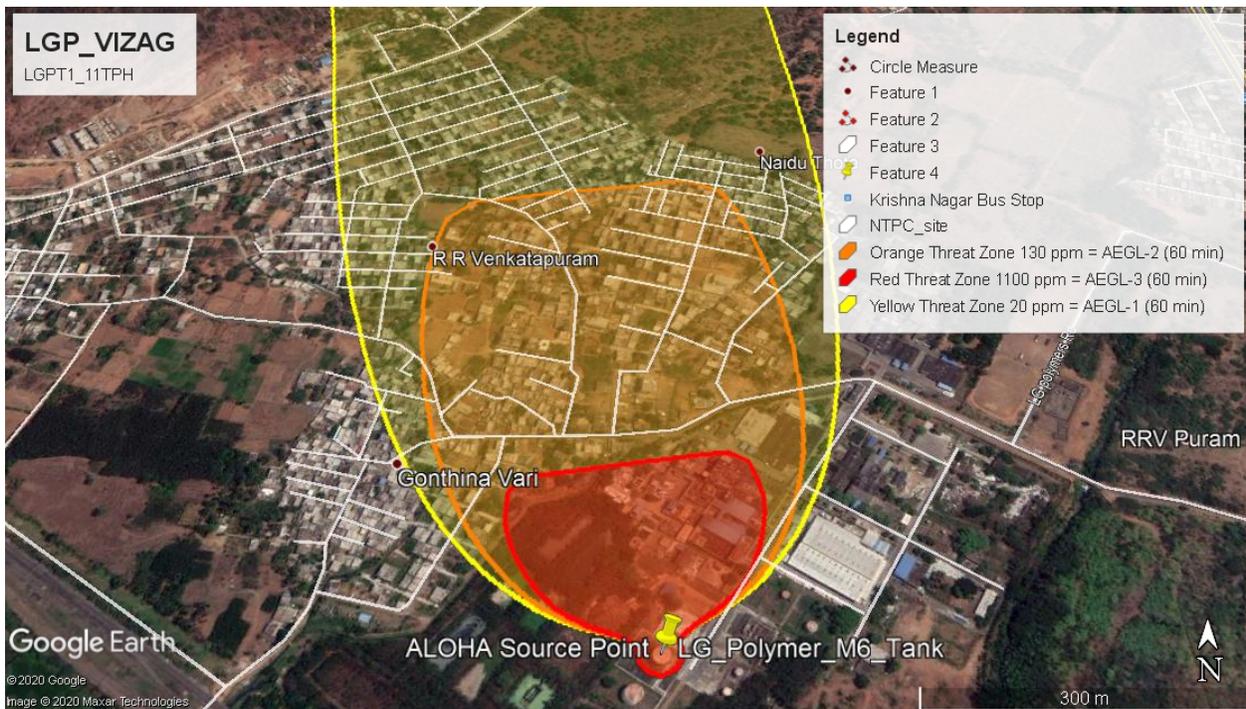
Figure 4.7: The Threat Zones for the ALOHA Model Runs with ID LGP_T1

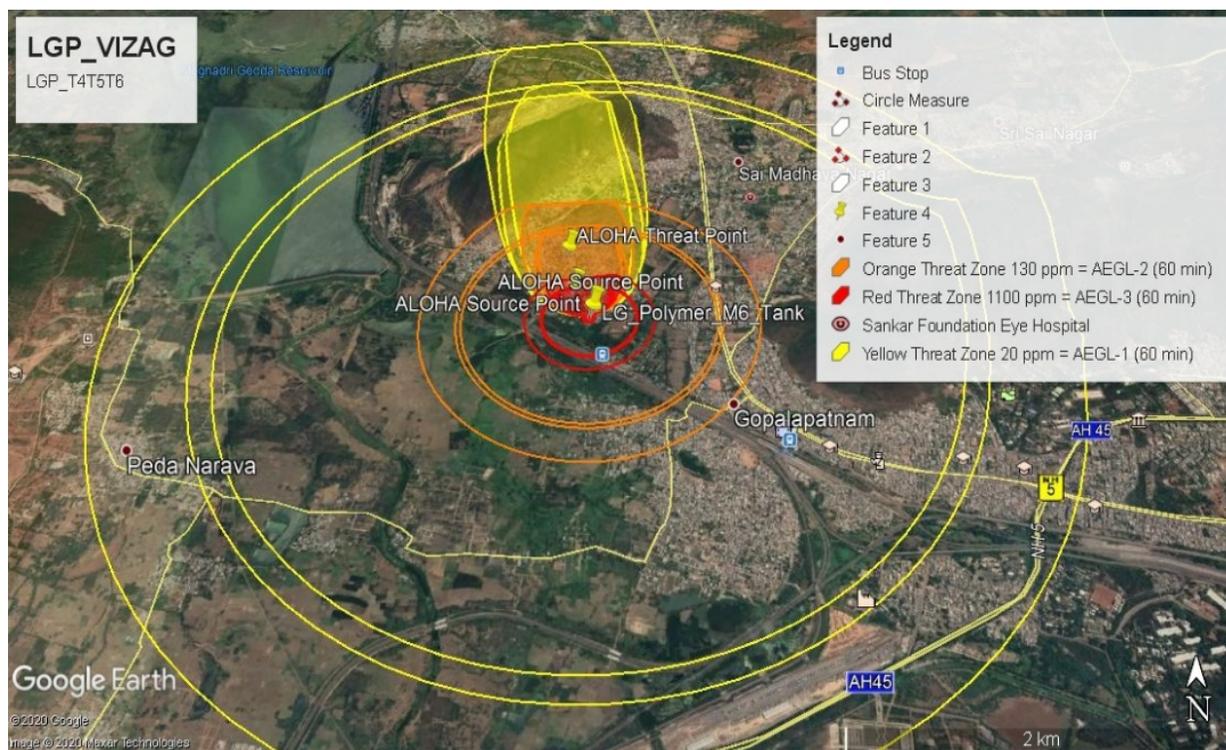
Figure 4.8: The Threat Zones for the ALOHA Model Runs with ID LGP_T4, LGP_T5, and LGP_T6

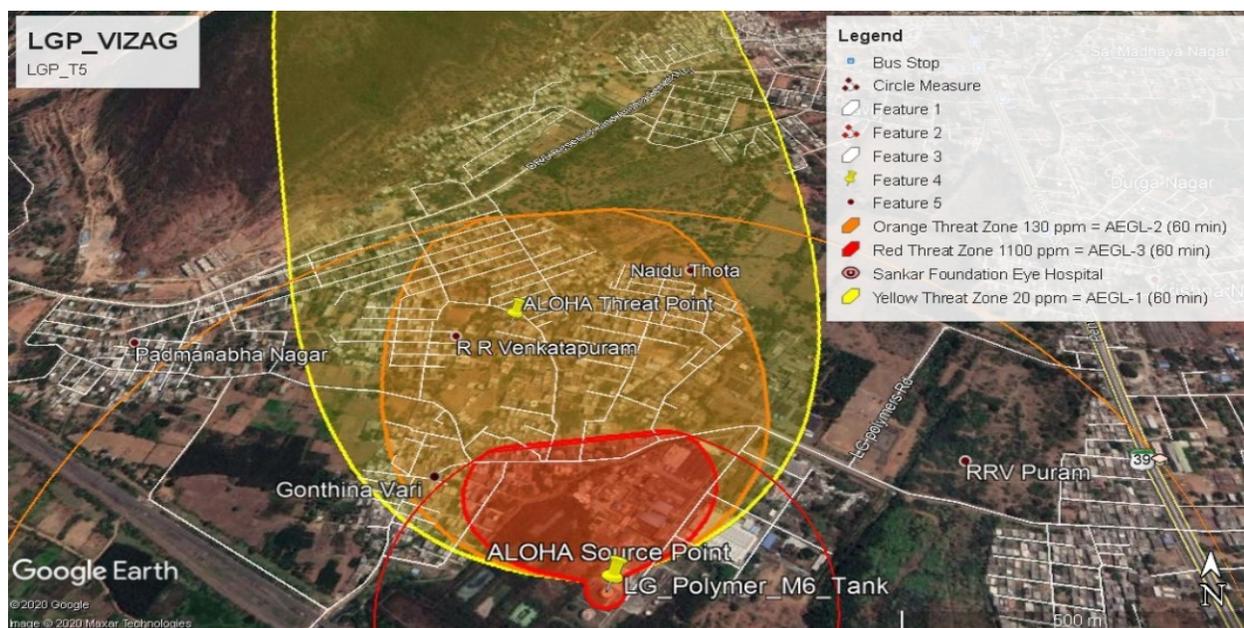
Figure 4.9: The Threat Zones for the ALOHA Model Runs with ID LGP_T5

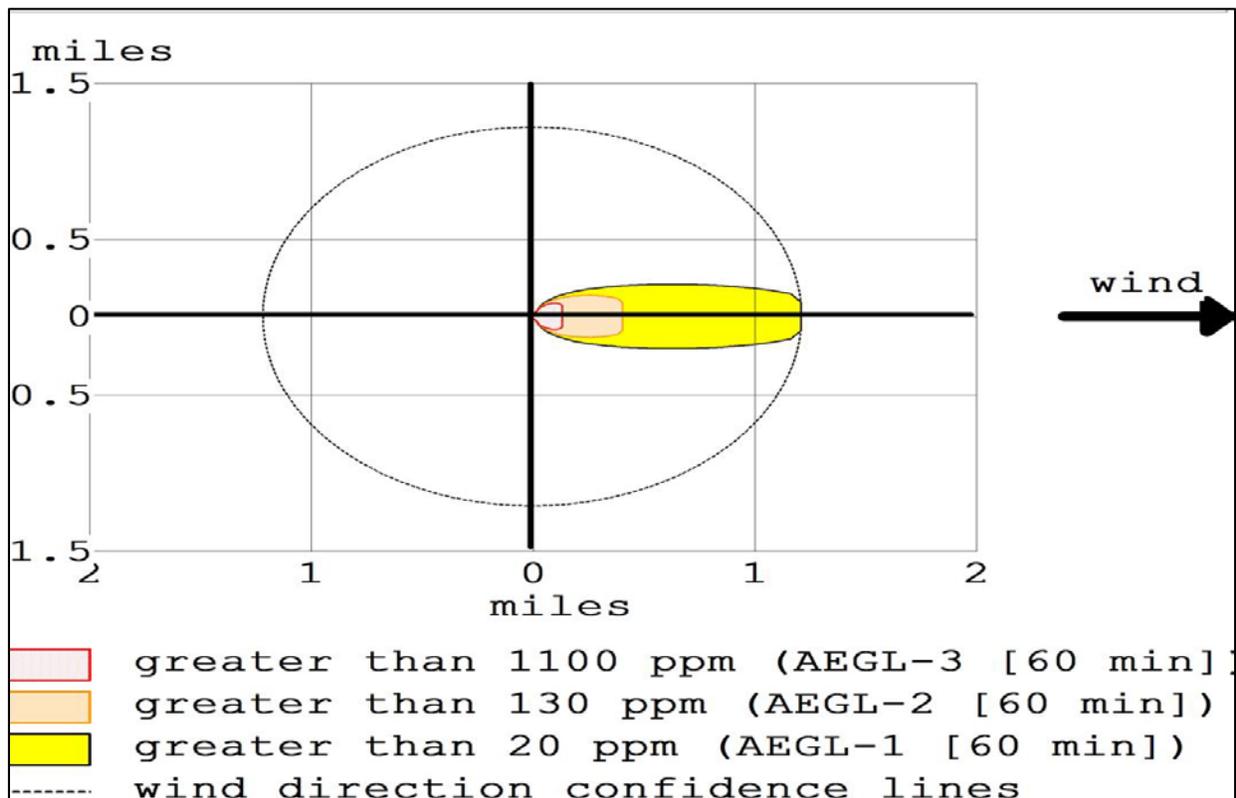
Graph 4.1: Typical Threat Zone Diagram for the ID LGP_T1 Showing the Area of Influence in the Windward Direction

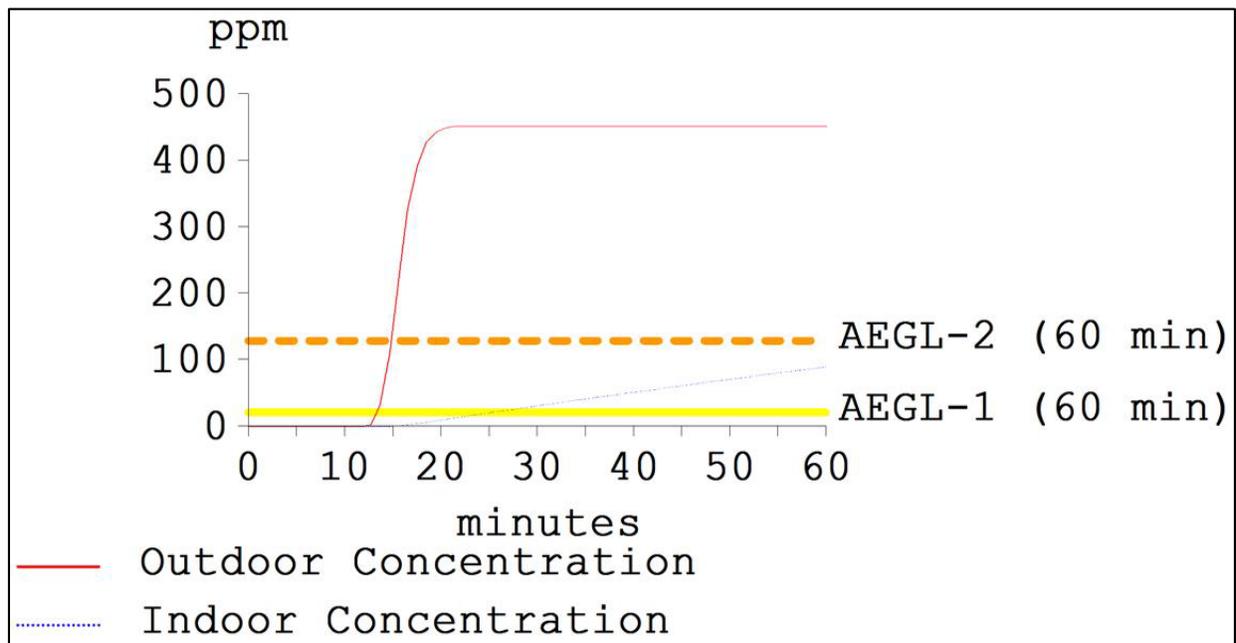
Graph 4.2: Typical Concentrations at 600m Downwind Direction from the source for the ID LGP_T6

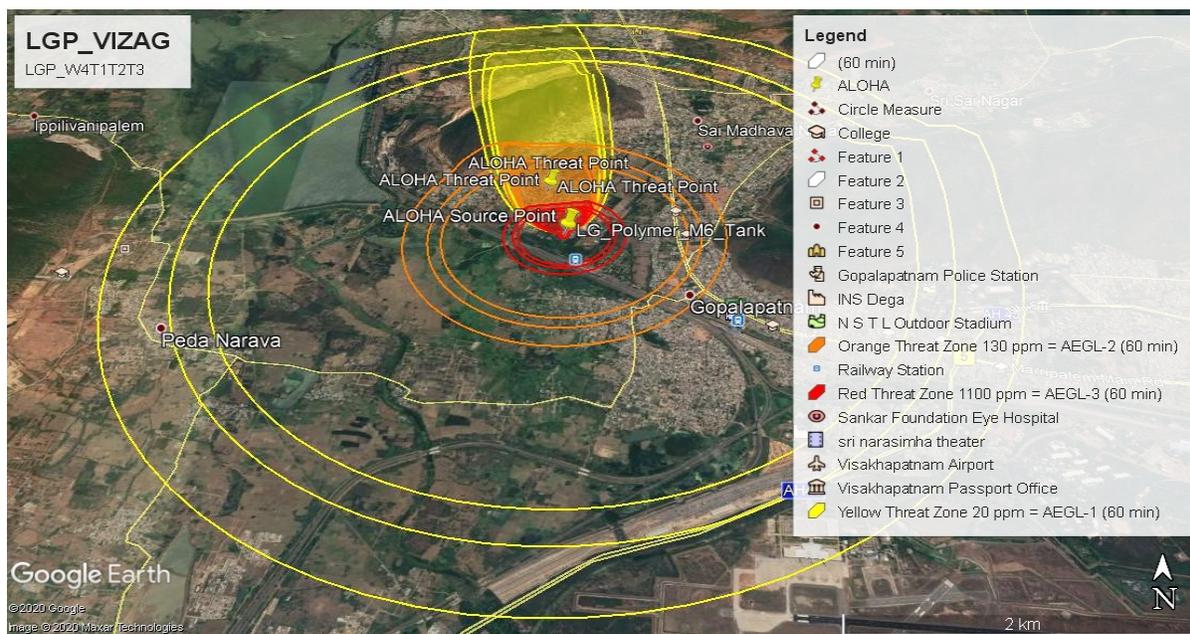
The results are represented on Google Earth, and the images are given in Figure 4.10 to Figure 4.13. Typical Styrene concentration profile and the threat zone diagrams are shown in Graph 4.3 and Graph 4.5, respectively.

Figure 4.10: The Threat Zones for the ALOHA ModelRuns with ID LGP_T1, LGP_W4T2 and LGP_W4T3

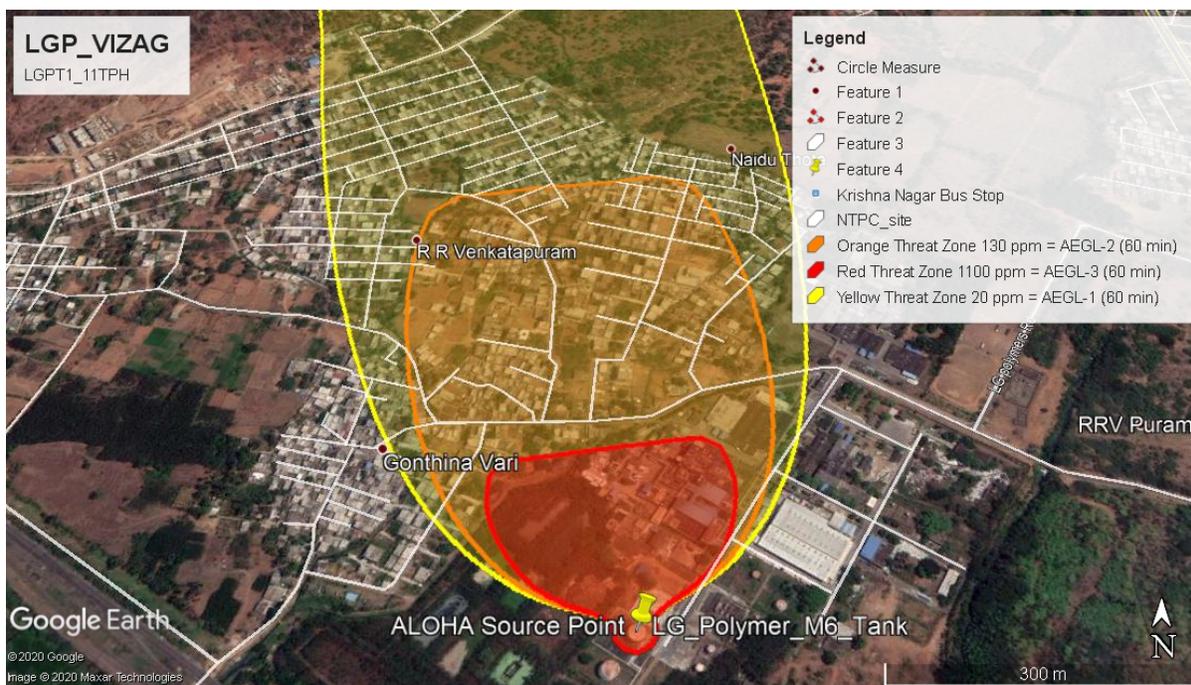
Figure 4.11: The Threat Zones for the ALOHA Model Runs with ID LGP_T1

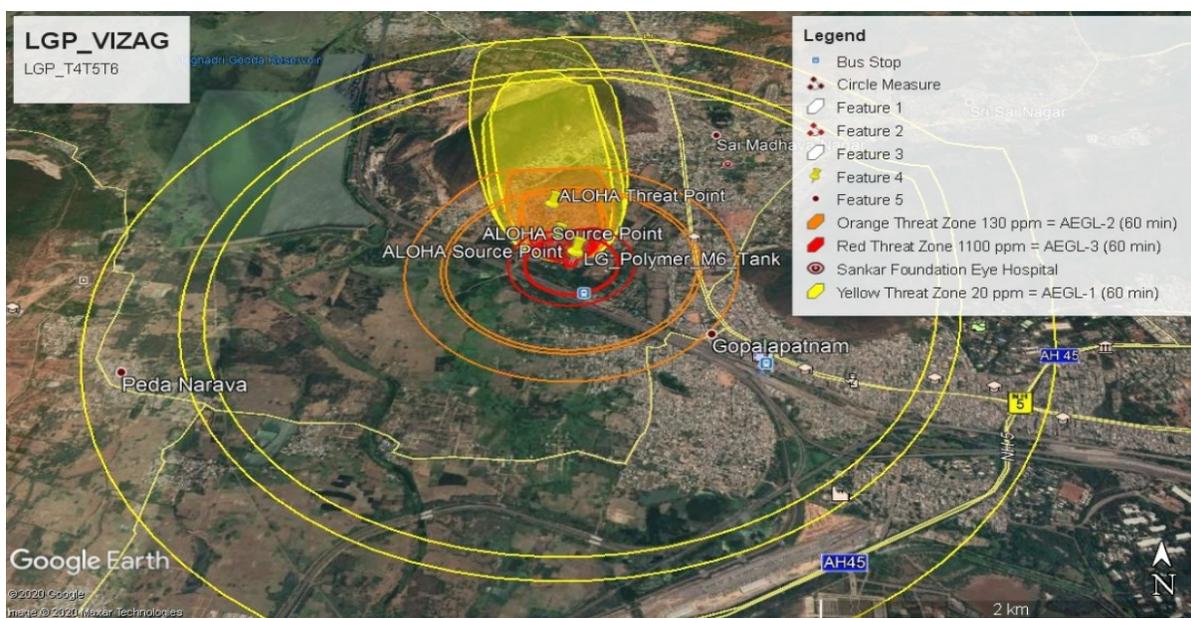
Figure 4.12: The Threat Zones for the ALOHA Model Runs with ID LGP_T4, LGP_T5, and LGP_T6

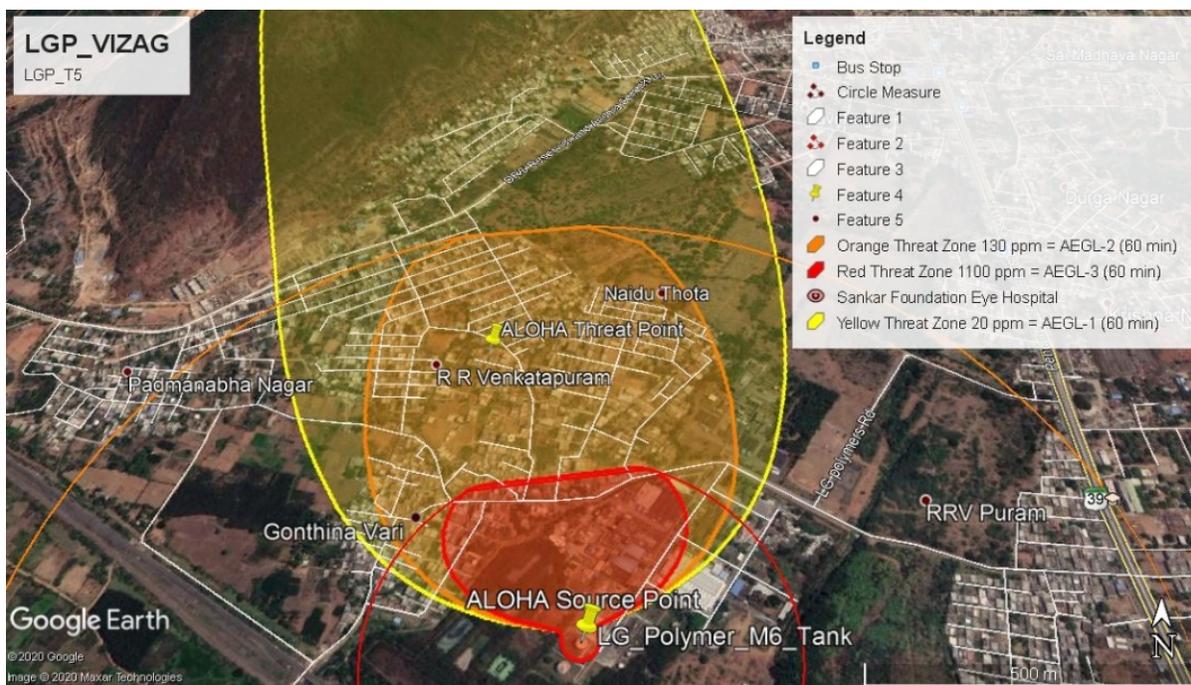
Figure 4.13: The Threat Zones for the ALOHA Model Runs with ID LGP_T5

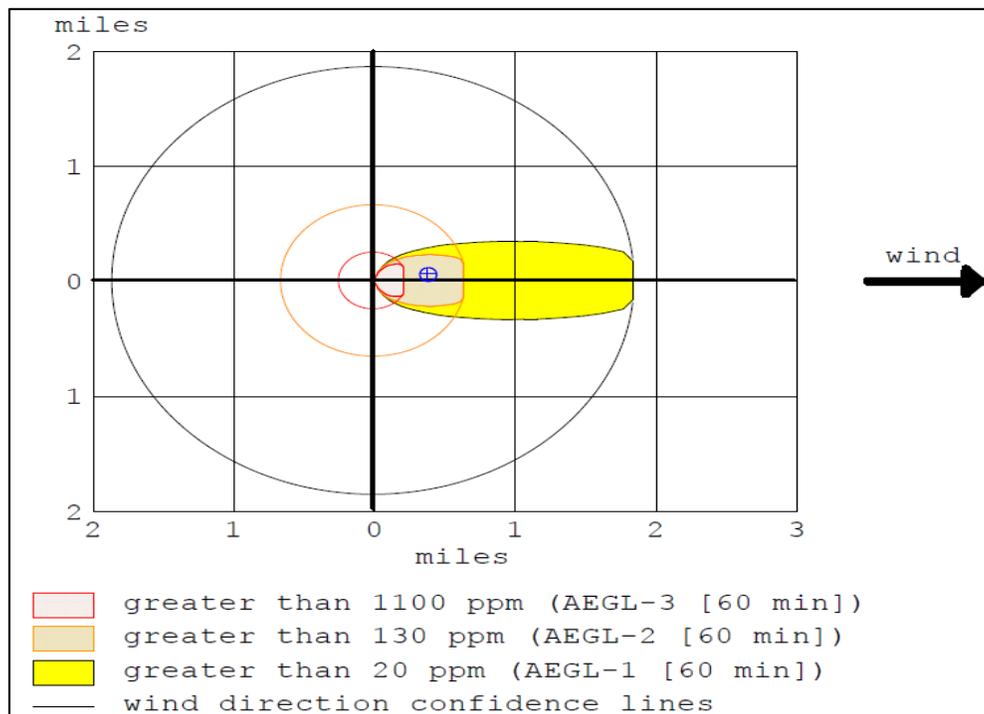
Graph 4.3: Typical Threat Zone Diagrams for the ID LGP_WT4 Showing the Area of Influence in the Windward Direction

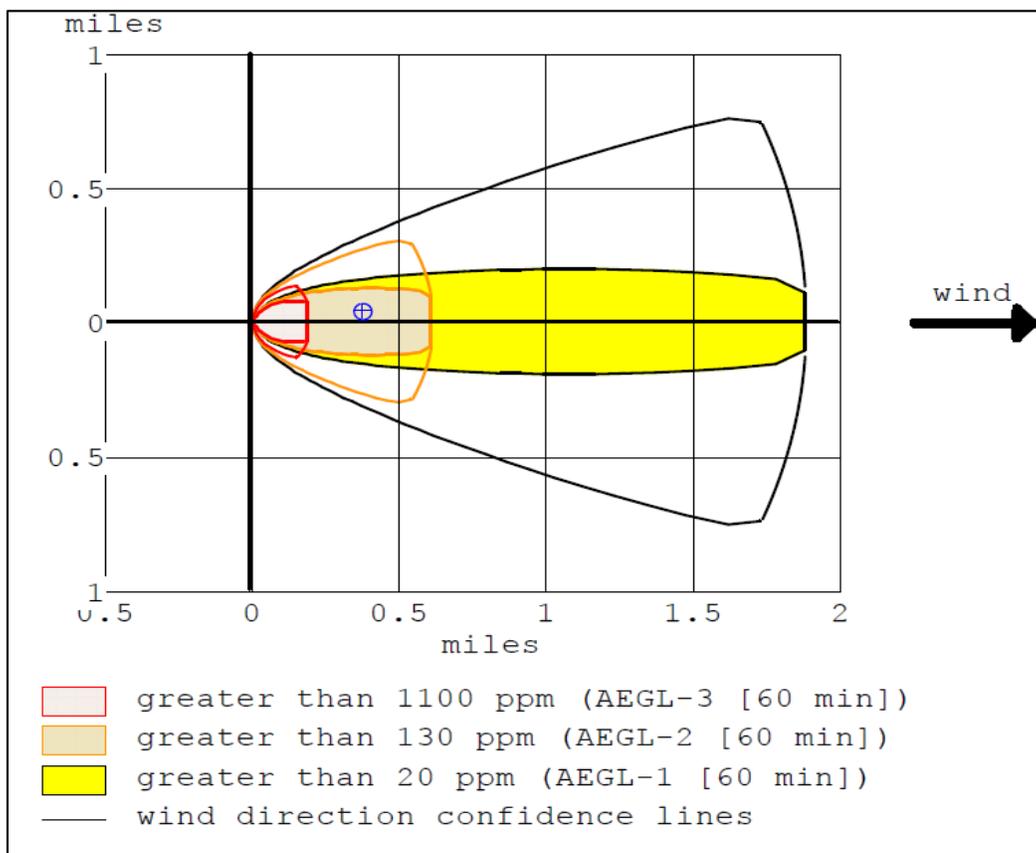
Graph 4.4: Typical Threat Zone Diagrams for the ID LGP_W2T4 Showing the Area of Influence in the Windward Direction

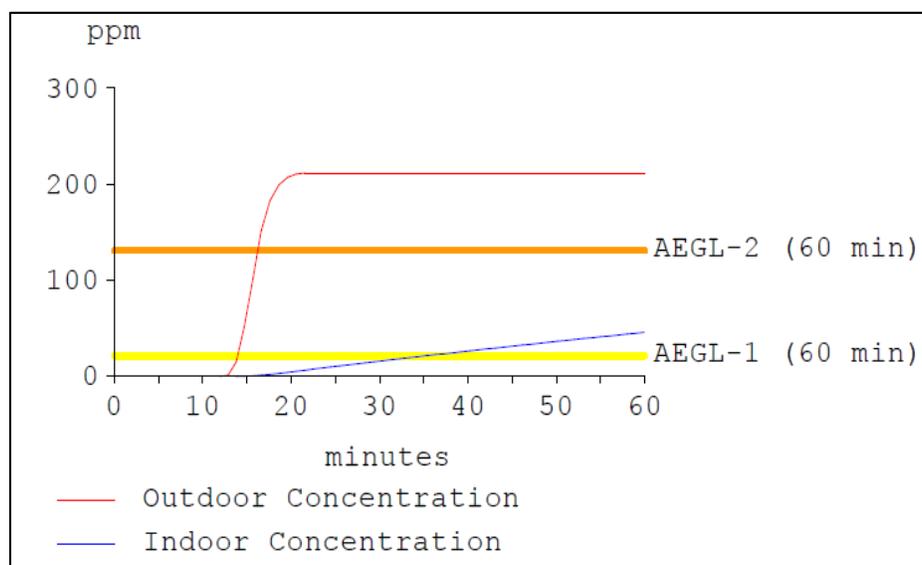
Graph 4.5: Typical Concentrations at 600m Downwind Direction from the source for the ID LGP_W3T1

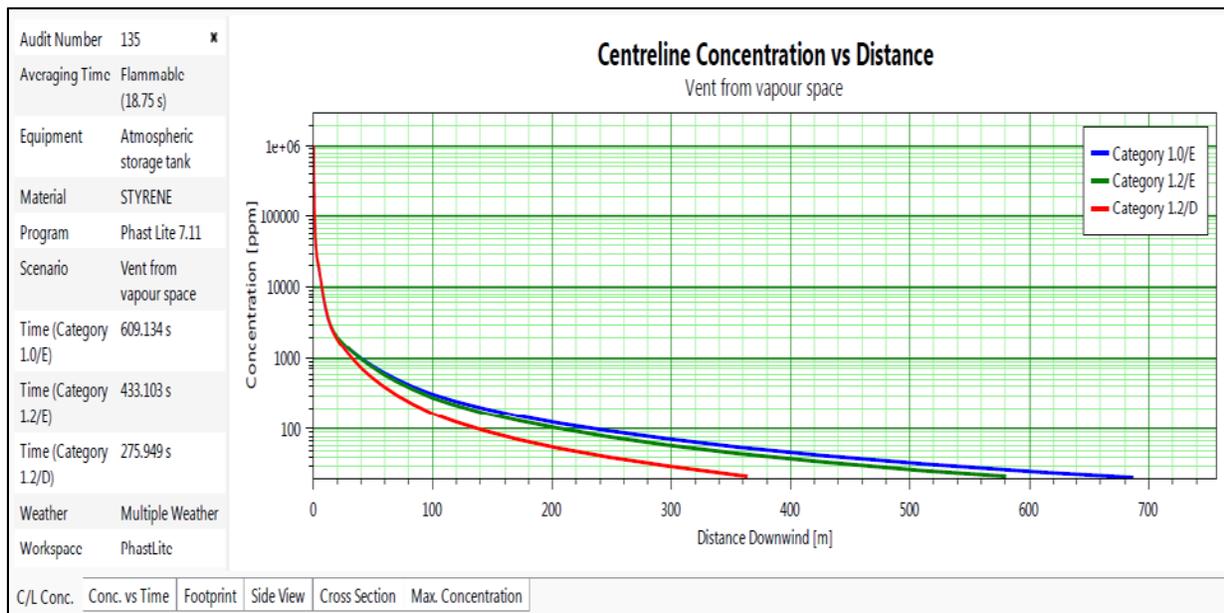
Vapour emission Volume, m ³ /h	Concentrations for different wind speeds, ppm			Distance, m
	1 m/s	1.2 m/s	1.2 m/s	
	127.78	107.64	57.35	200
	72.24	59.33	30.21	300
250	342.3	308.1	182.6	100
	142.04	119.98	64.24	200
	80.86	66.68	34.1	300
300	386.83	349.96	216.1	100
	164.17	139.41	75.76	200
	94.66	78.1	40.34	300

Graph 4.6: The centerline concentration at different distances from the source for a Styrene vapour release of 220 m³/hour

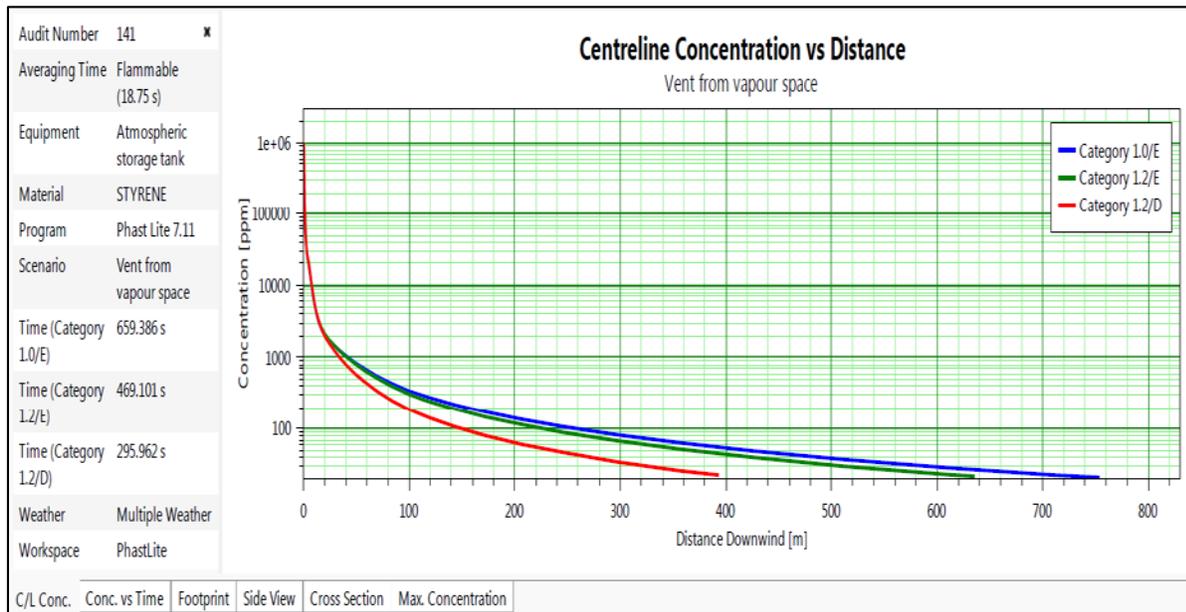
Graph 4.7: The centerline concentration at different distances from the source for a Styrene vapour release of 250 m³/hour

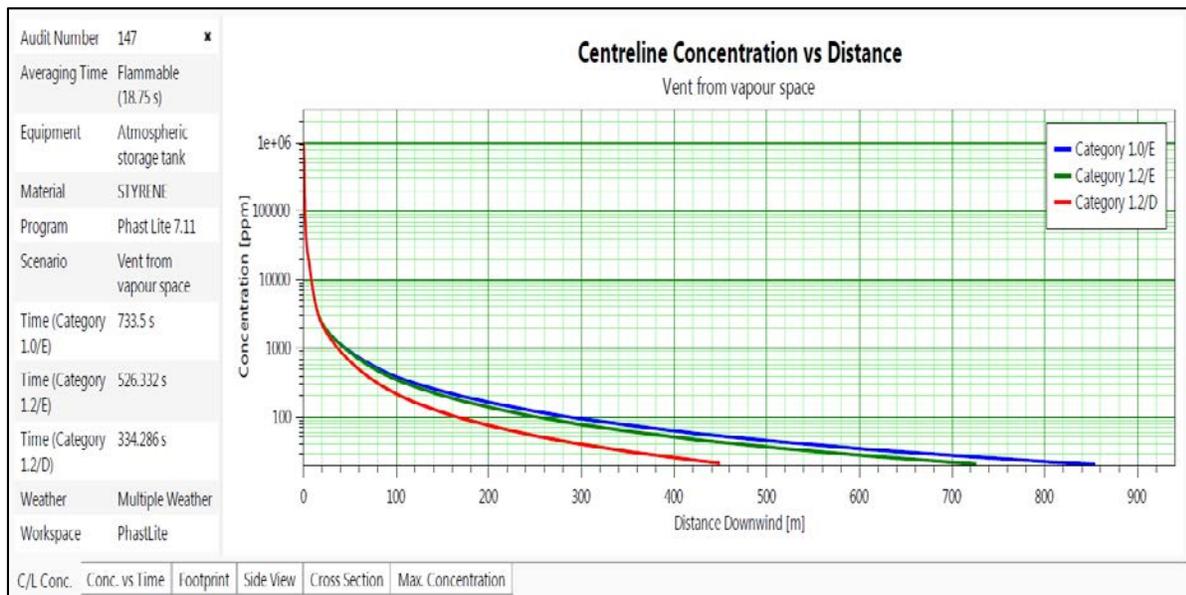
Graph 4.8: The centerline concentration at different distances from the source for a Styrene vapour release of 300 m³/hour

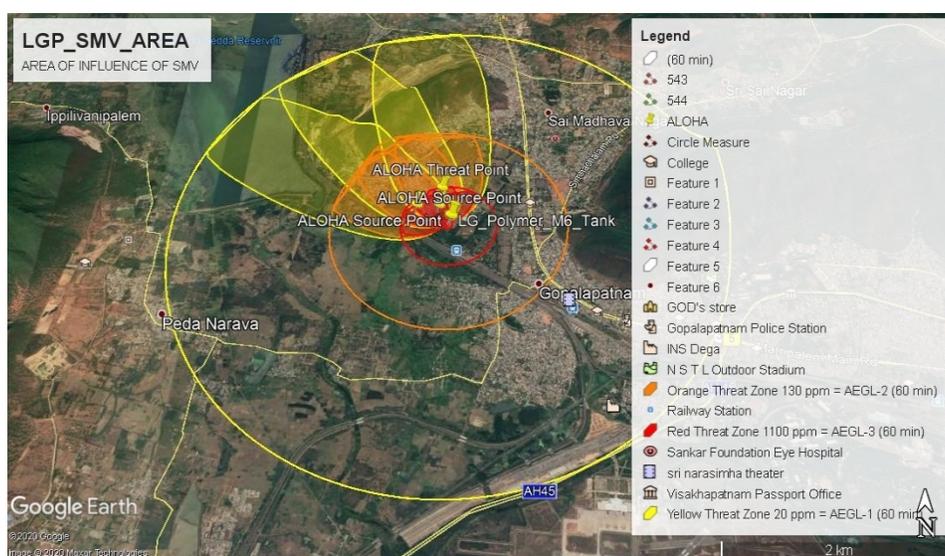
Source MT	Strength,	Predicted Area of Influence, ha		
		Red	Orange	Yellow
46		31.08	166.29	715

Figure 4.14 (a): The Threat Zones and Area of Influence for the ALOHA Model Runs with Styrene Loss / Evaporation of 46 MT with Change in Wind Direction

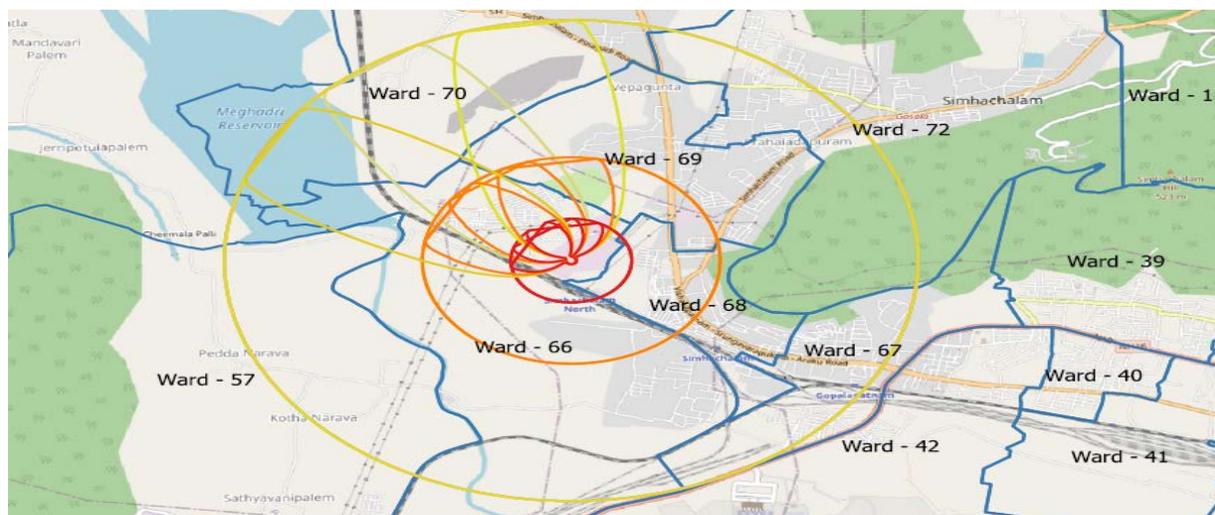
Figure 4.14 (b): The Threat Zones for the ALOHA Model Runs with Styrene Loss / Evaporation of 46MT with Change in Wind Direction (Blue Lines Are Ward Boundaries)

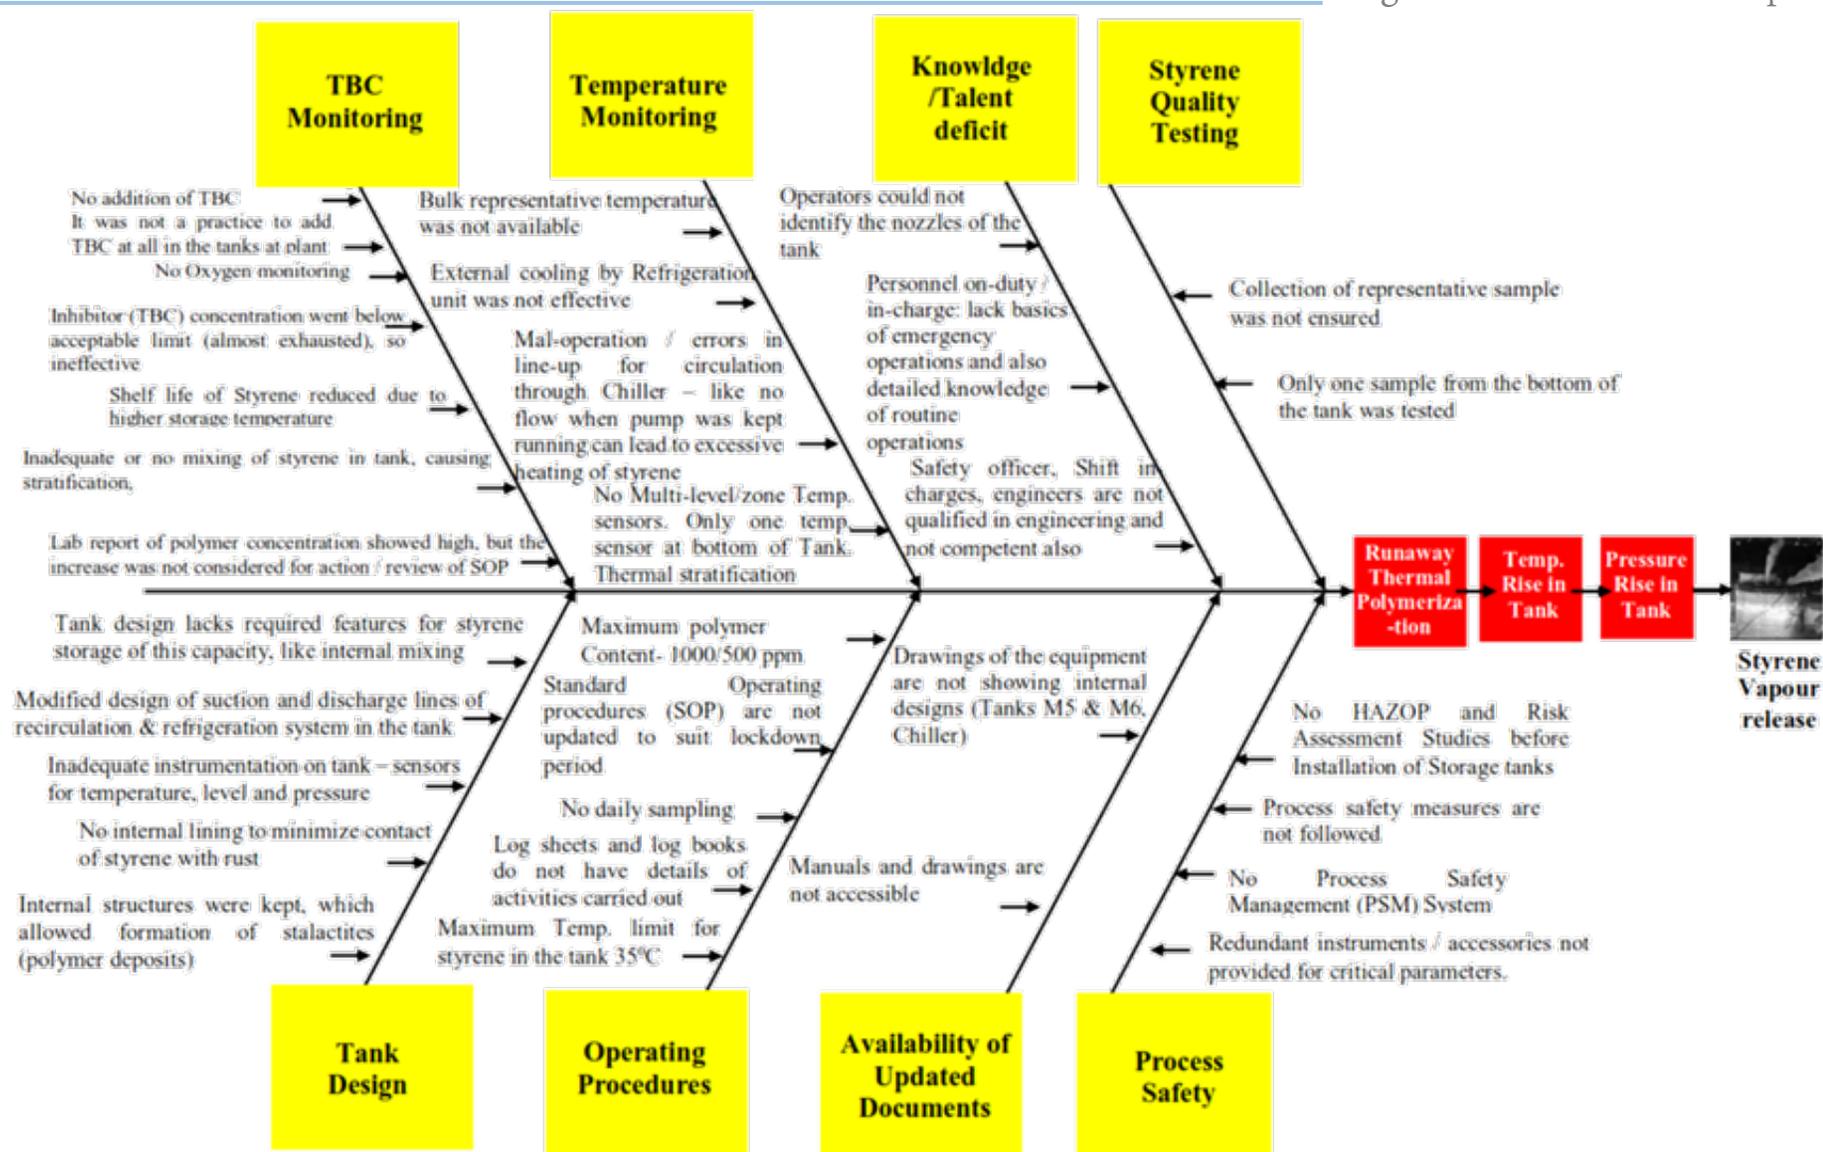
Figure 9.1: Ishikawa Fishbone diagram

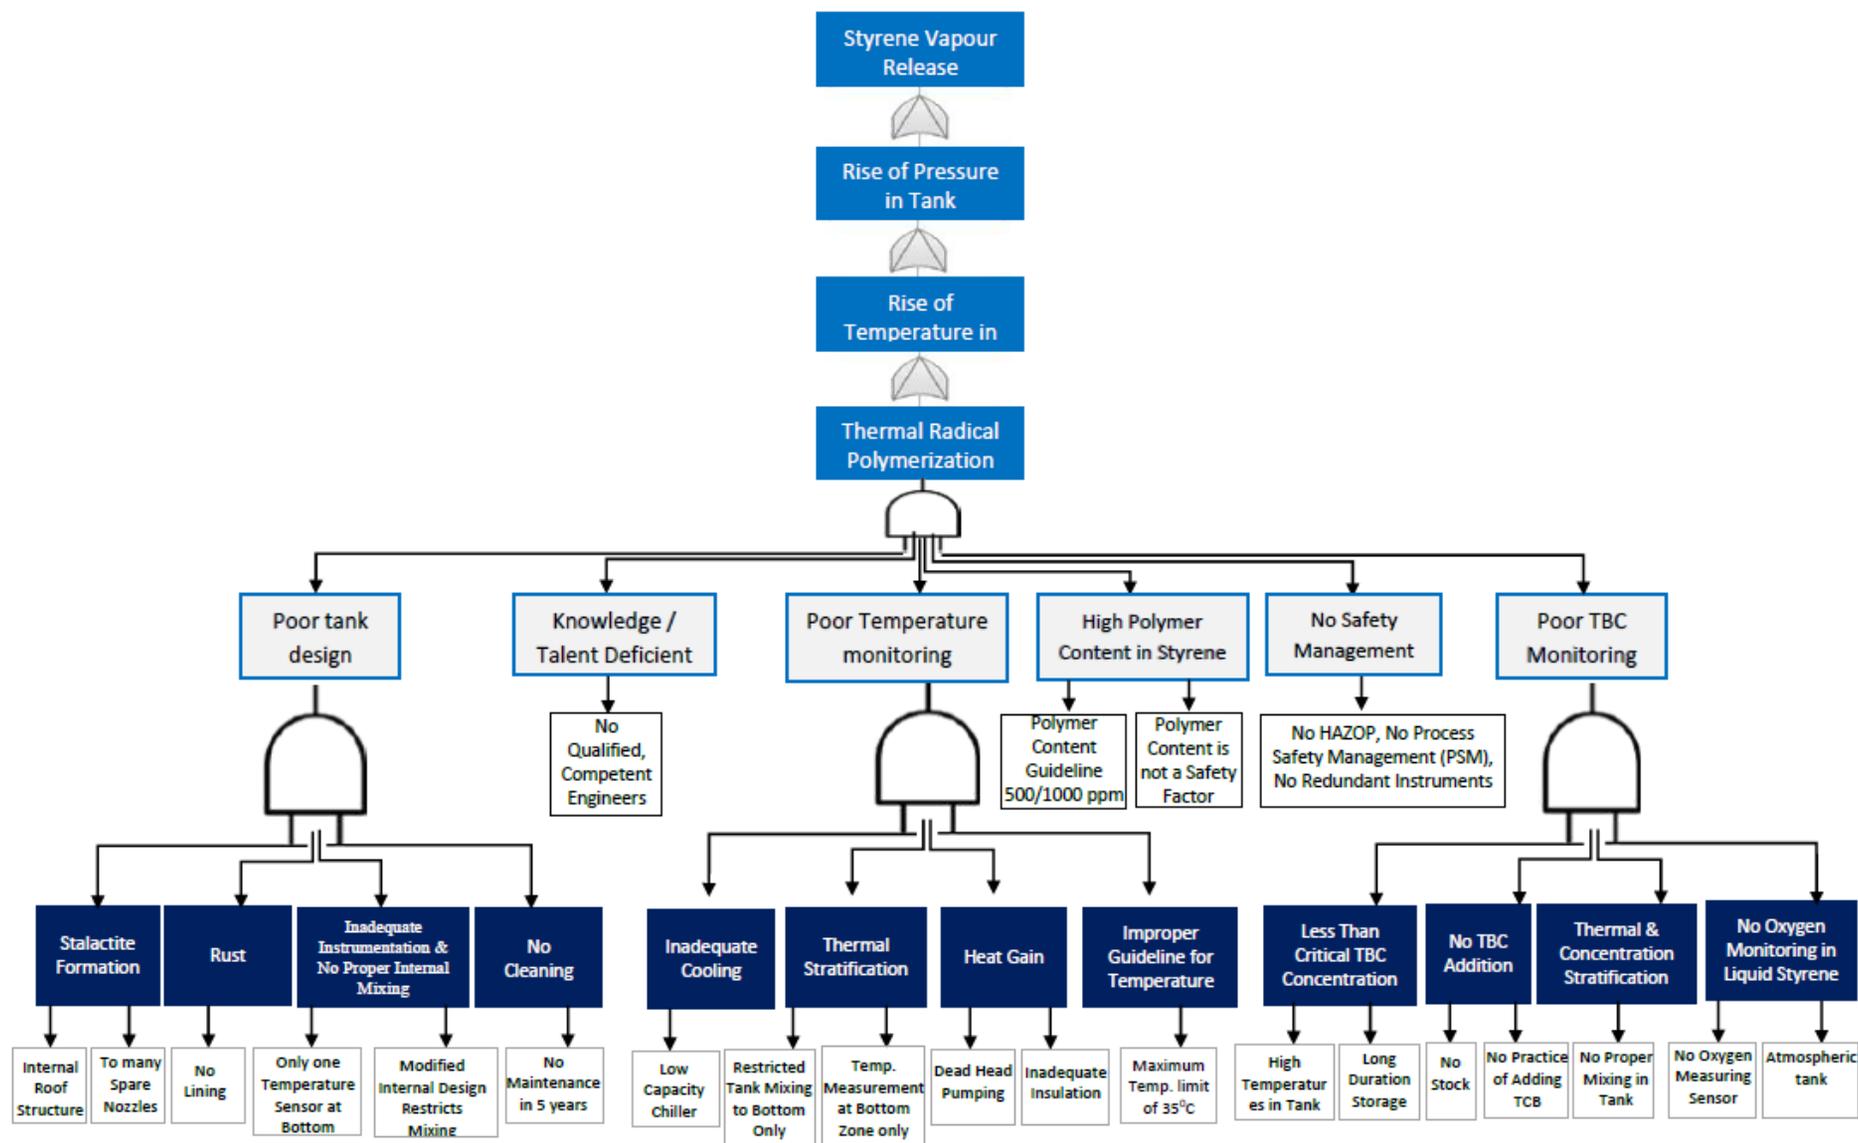
Figure 9.2: Fault Tree Diagram

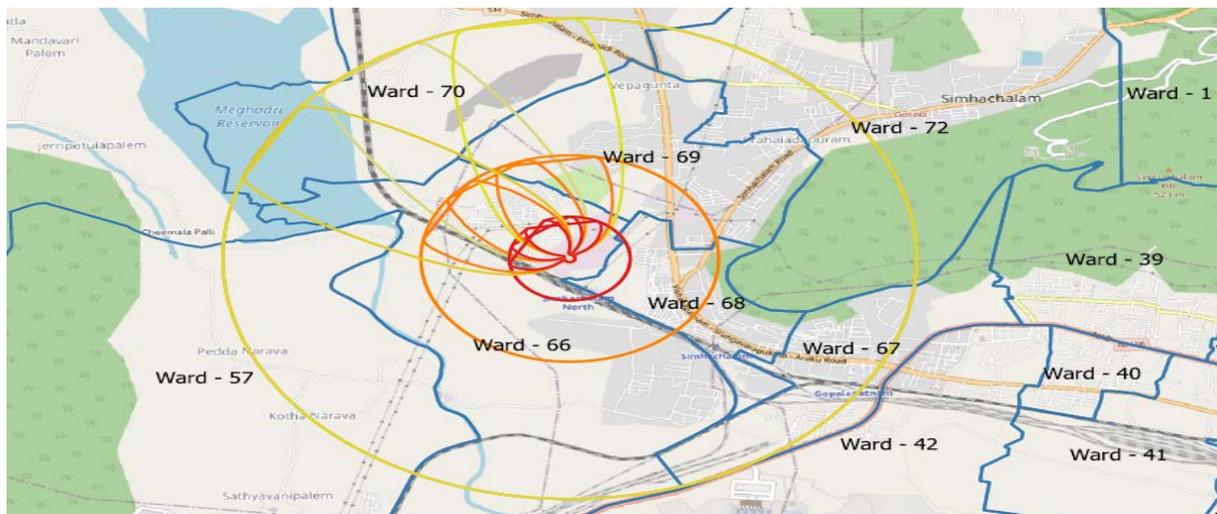
Figure 9.3: The Threat Zones for the ALOHA Model Runs with Styrene Loss / Evaporation of 46 MT with Change in Wind Direction (Blue Lines Are Ward Boundaries)
