**REPORT OF THE OVERSIGHT COMMITTEE, NGT, U.P, LUCKNOW**

**ORIGINAL APPLICATION NO. 102/2021**

**IN RE: ACHARYA DAMODAR SHASTRI & ANR.  
VERSUS  
UNION OF INDIA & ORS.**

**REPORT OF THE OVERSIGHT COMMITTEE IN COMPLIANCE OF THE ORDER OF  
THE HON'BLE NATIONAL GREEN TRIBUNAL PASSED IN O.A. NO. 102/2021 IN RE:  
ACHARYA DAMODAR SHASTRI & ANR. VERSUS UNION OF INDIA & ORS.**

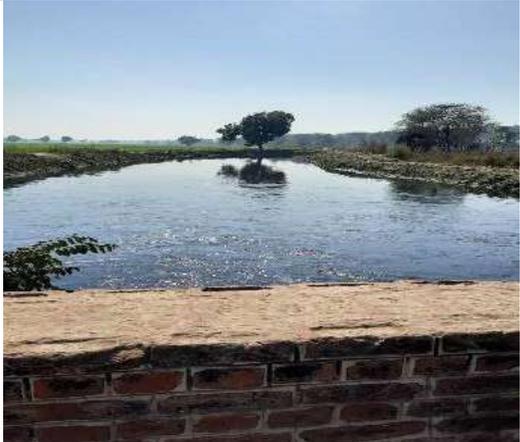
Location/ Co-ordinates	Photograph	Observations
U/S of Kosi Drain at Kharauth (27°50'20" N & 77°25'45" E)

<ul style="list-style-type: none"> <li>▪ This location is at the u/s of the Kosi town.</li> <li>▪ The colour of the water flowing in the drain was black</li> </ul>
U/S of Kosi Drain at Kharauth (27°50'20" N & 77°25'45" E)

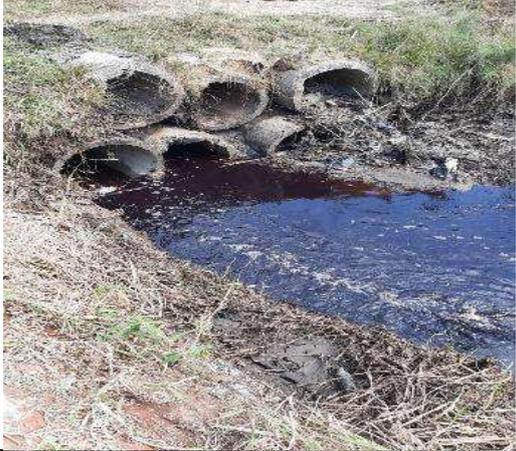
<p>Industrial Effluents (27°48'41" N 77°25'47" E)</p>

<ul style="list-style-type: none"> <li>▪ Significant bubbles were observed</li> <li>▪ Obnoxious odour observed</li> </ul>

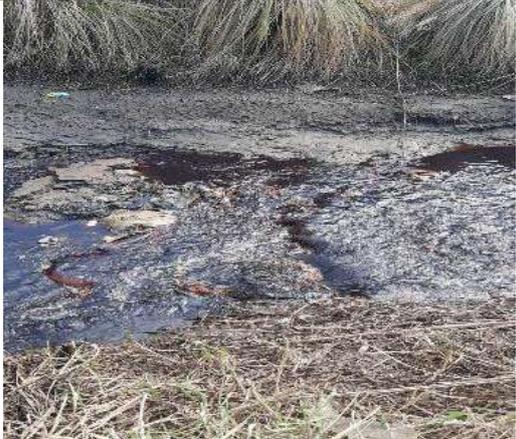
<ul style="list-style-type: none"> <li>▪ This is an industrial drain discharging its effluent to Kosi drain</li> <li>▪ The colour was found red during site visit</li> </ul>
<p>Industrial Effluents (27°48'41" N 77°25'47" E)</p>

<ul style="list-style-type: none"> <li>▪ Red colour indicates the possibility of untreated industrial effluent in drain</li> </ul>
<p>Industrial Effluents (27°48'41" N 77°25'47" E)</p>

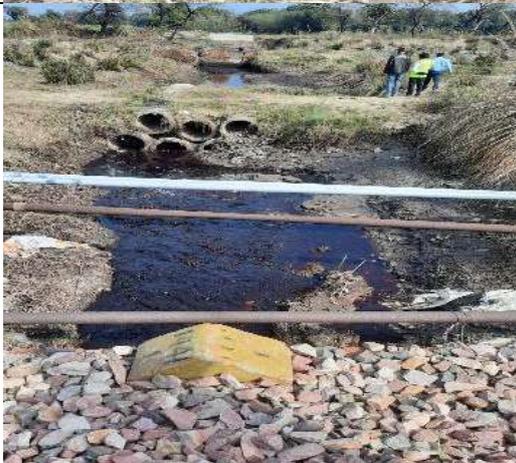
<ul style="list-style-type: none"> <li>▪ This industrial drain directly discharges its effluent to the Kosi drain</li> </ul>
<p>Kosi Nagar Palika Sewage Drain 1 (27°48'14" N 77°26'14" E)</p>

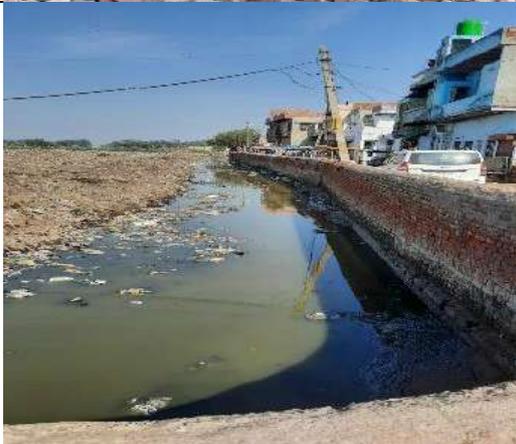
<ul style="list-style-type: none"> <li>▪ Kosi Nagar Palika Sewage drain discharges into the Kosi drain</li> <li>▪ This drain carries sewage from Kosi town</li> </ul>

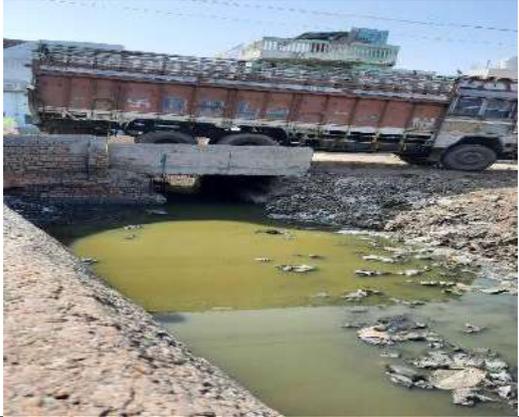
<ul style="list-style-type: none"> <li>▪ As per the engineers from UPPCB, the flow in the drain varied from 4- 8 MLD</li> <li>▪ The colour and smell indicate the possibility of flowing sewage fully</li> </ul>
<p>Kosi Nagar Palika Sewage Drain 1 (27°48'37" N 77°26'44" E)</p>

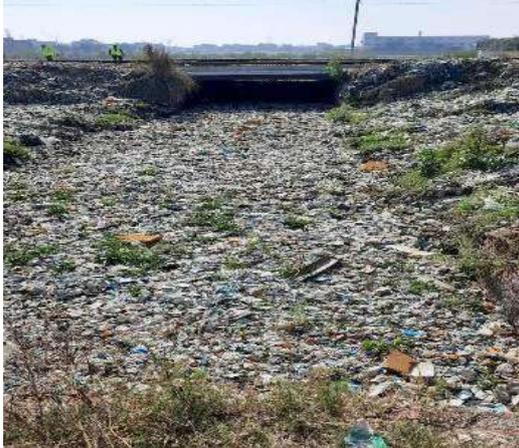
<ul style="list-style-type: none"> <li>▪ Kosi Nagar Palika Sewage drain meeting with the Kosi drain</li> <li>▪ Kosi Nagar Palika Sewage drain near proposed STP</li> </ul>
<p>D/S location of drain about 1.5 – 2 KM after Industrial Effluent and Sewage from Kosi Nagar Palika Drain meeting (27°47'44" N 77°26'42" E)</p>

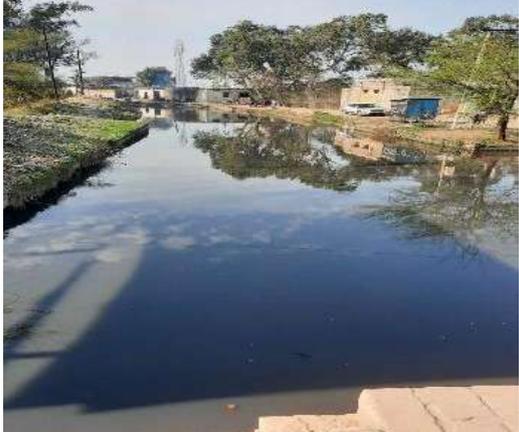
<ul style="list-style-type: none"> <li>▪ The red colour of the water flowing in drain diminishes but high suspended solids were found</li> </ul>

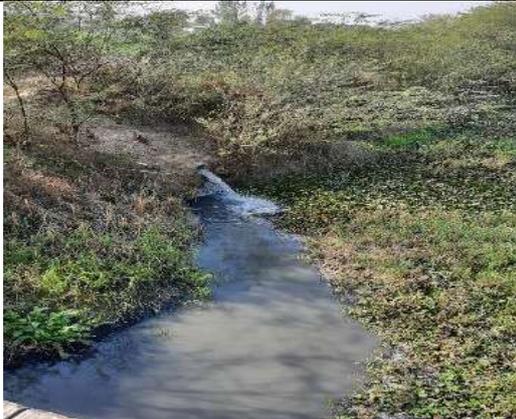
<p>Kosi drain (downstream) at Ajijpur village, U.P (27°46'24" N 77°28'17" E)</p>

<ul style="list-style-type: none"> <li>▪ No obnoxious odour found</li> </ul>

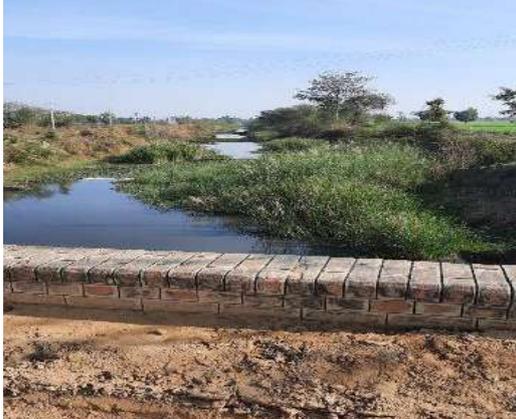
<ul style="list-style-type: none"> <li>▪ Small drain possibly sewage discharging to the drain</li> <li>▪ Colour was yellowish indicating the mixing of the sewage</li> </ul>

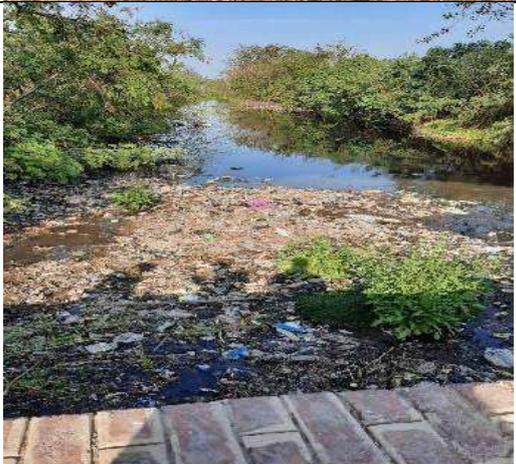
<ul style="list-style-type: none"> <li>▪ Heavy natural plant growth was observed</li> </ul>
<p>Chhatta (27°43'05" N 77°30'38" E)</p>

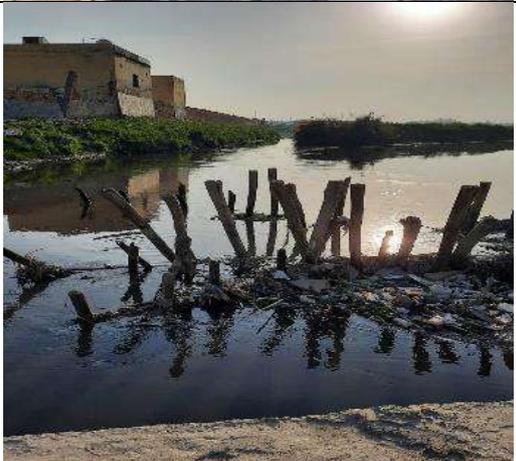
<ul style="list-style-type: none"> <li>▪ Heavy growth of plants was observed</li> <li>▪ Flow was significantly low due to the tapping of water by farmers</li> <li>▪ One drain also discharges wastewater at this location into the Kosi drain. But it was not clear whether this drain carries village domestic wastewater or Vishal Food Processing Industrial effluent</li> </ul>
<p>Confluence Point of Kosi drain with Yamuna river at Parikrama Marg, Kaliyaghat Vrindavan (27°34'58" N 77°41'13" E)</p>

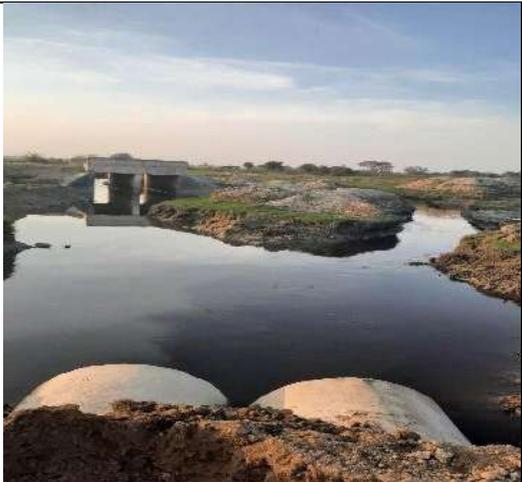
<p>Subhar Rishi Marg, near Rajpur Khadar, Vrindawan</p> <p>(27034'51" N 77040'15" E)</p>

<ul style="list-style-type: none"> <li>▪ The colour of the water at the meeting point was observed black</li> <li>▪ Significant flow from the drain entering to the river</li> </ul>

<ul style="list-style-type: none"> <li>▪ This is the location for the installation of the weir</li> <li>▪ The colour of the water in the drain was turbid having significant suspended solids</li> </ul>

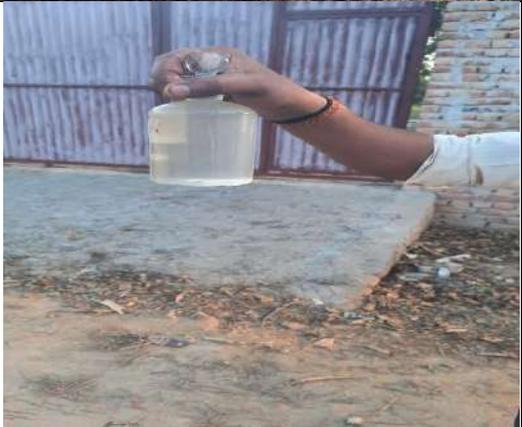
<ul style="list-style-type: none"> <li>▪ Water sample collected from the proposed location of the weir</li> <li>▪ The colour of the water in the drain was little turbid having insignificant suspended solids</li> </ul>

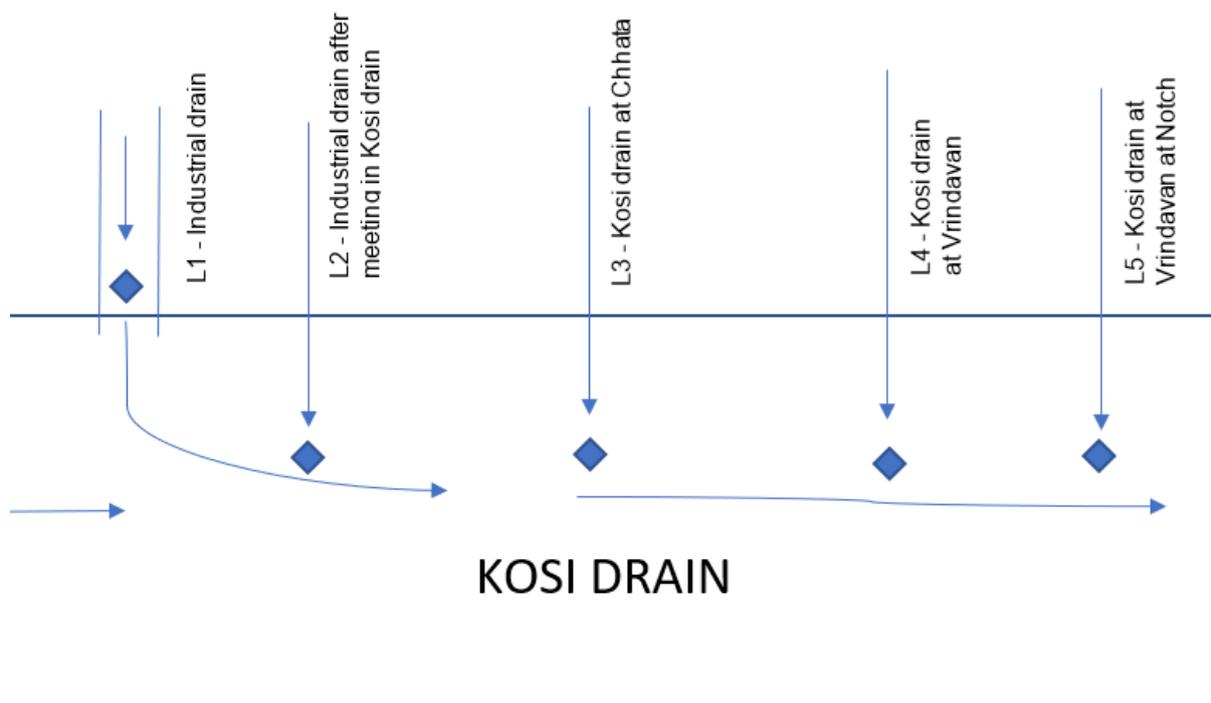
**Figure 1.0** Typical sketch of sampling locations (◆ Sample Collection Point)

- Location 1 - Industrial drain – Kosi Kotvan before entering to Kosi drain
- Location 2 - Industrial drain after meeting to Kosi drain
- Location 3 - Kosi drain at Chhata
- Location 4 - Kosi drain at Vrindavan
- Location 5 - Kosi drain at Vrindavan at Notch

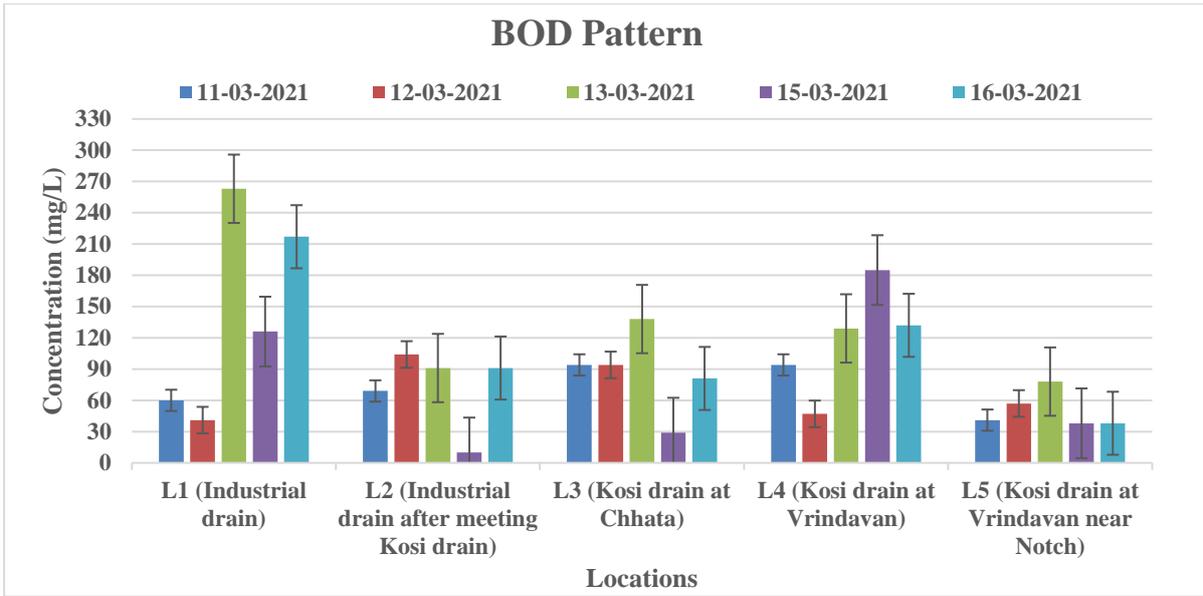
**Fig. 2.0** Variation of the BOD concentration over a week at various locations of Kosi drain

Fig. 2.0 shows the BOD concentration measured during March 11 to 16, 2021. Results indicate that the average values of BOD were measured  $141\pm 97$  mg/L at location 1 (Industrial drain);  $73\pm 37$  mg/L at location 2 (after Industrial drain merged with Kosi drain);  $87\pm 39$  mg/L at location 3 (Kosi drain at Chhata);  $117\pm 51$  mg/L at location 4 (Kosi drain at Vrindavan) and  $50\pm 17$  mg/L at location 5 (Kosi drain at Vrindavan at Notch). Significant variation in BOD concentration was observed at location 1 whilst at location 2, 3, 4 and 5 an insignificant variation was found during a week-long monitoring of the drain.

- ✚ The average values of the BOD were found 141, 73, 87, 117 and 50 mg/L at location of 1,2,3,4 and 5 respectively.
- ✚ The average values of the COD were found 493, 199, 227, 275 and 142 mg/L at location of 1,2,3,4 and 5 respectively.
- ✚ The average TSS concentration were found 148, 75, 134, 177 and 133 mg/L at location of 1,2,3,4 and 5 respectively.
- ✚ The pH values ranged 6.4 – 7.1.

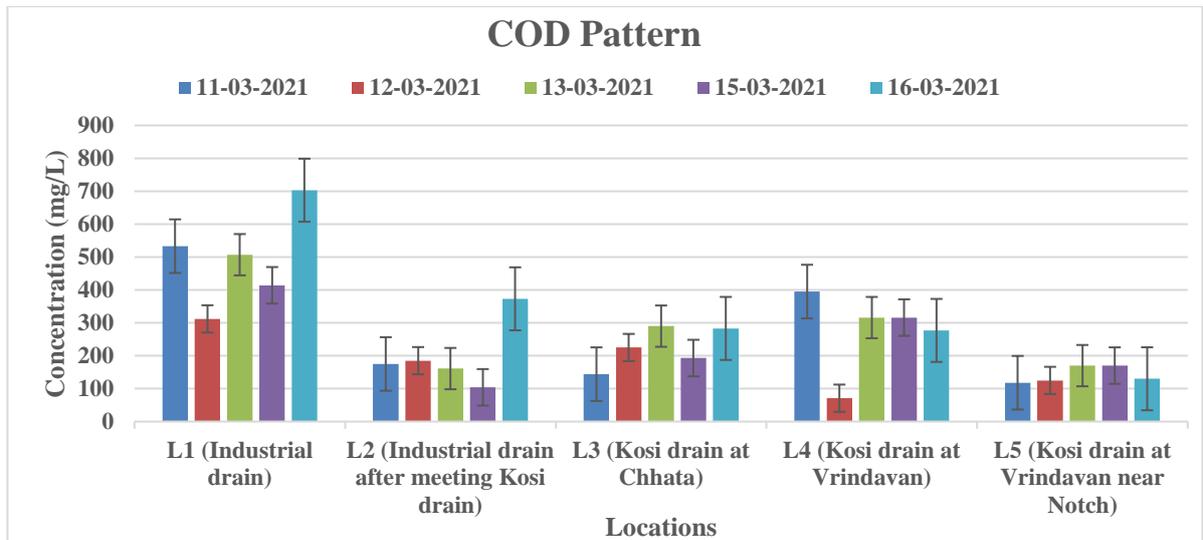
**Fig. 3.0** Variation of the COD concentration over a week at various locations of Kosi drain

Fig. 3.0 shows the COD concentration measured during March 11 to 16, 2021. Results indicate that the average values of COD were measured  $494 \pm 146$  mg/L at location 1 (Industrial drain);  $200 \pm 102$  mg/L at location 2 (after Industrial drain merged with Kosi drain);  $227 \pm 62$  mg/L at location 3 (Kosi drain at Chhata);  $275 \pm 122$  mg/L at location 4 (Kosi drain at Vrindavan) and  $143 \pm 25$  mg/L at location 5 (Kosi drain at Vrindavan at Notch). Significant fluctuation in COD concentration was observed at location 1 during a week-long monitoring of the drain. The variations in COD concentration were insignificant except only for one day at location 2 and 4.

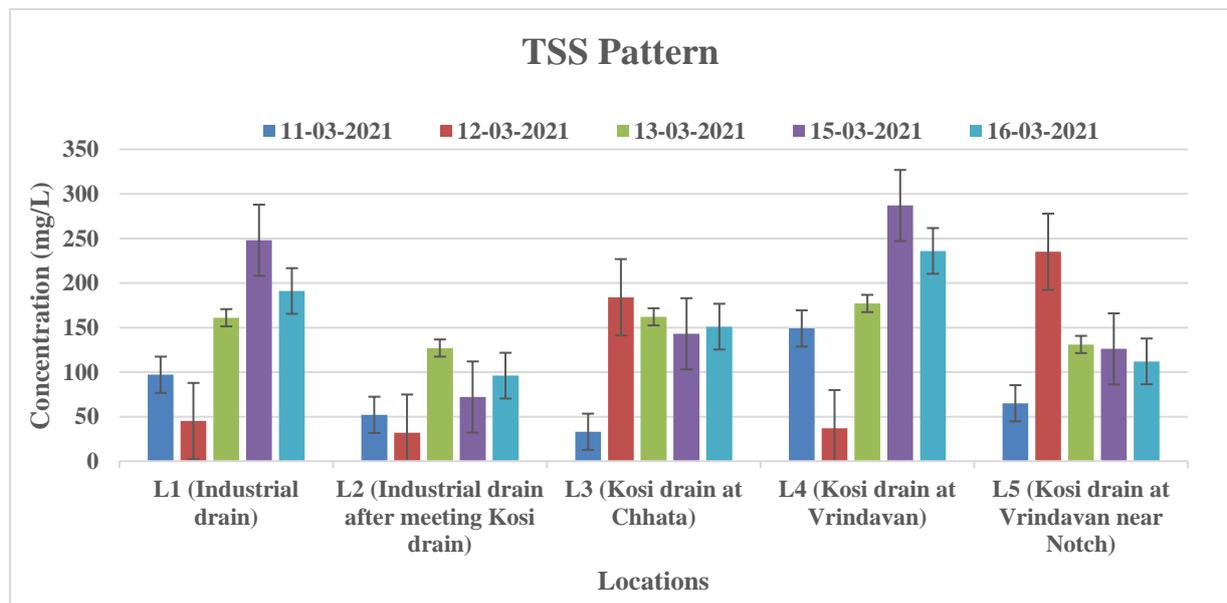
Fig. 4.0 Variation of the TSS concentration over a week at various locations of Kosi drain

Insignificant variation on TSS concentration was observed during a week-long monitoring of the drain at each sampling location.

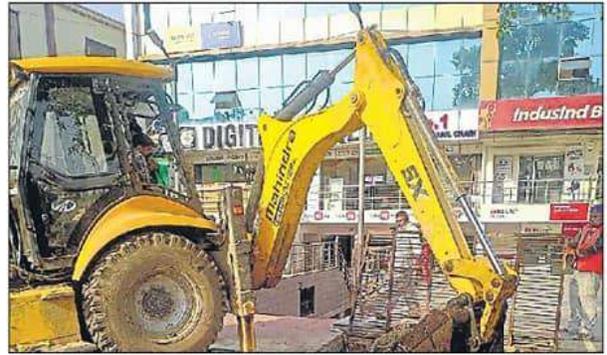
सोमवार को भूतेश्वर स्थित अतुल टावर के समीप नाले की सफाई करती नगर निगम की जेसीबी। • हिन्दुस्तान

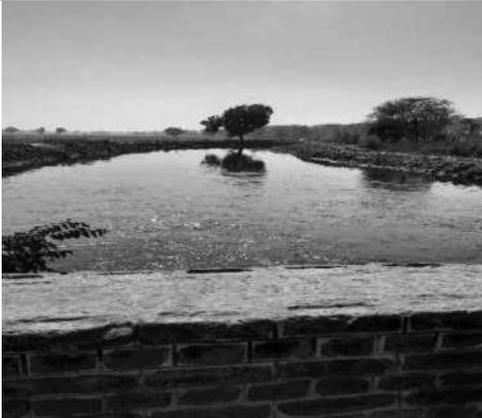
<ul style="list-style-type: none"> <li>▪ This location is at the u/s of the Kosi town.</li> <li>▪ The colour of the water flowing in the drain was black</li> </ul>
U/S of Kosi Drain at Kharauth (27°50'20" N & 77°25'45" E)

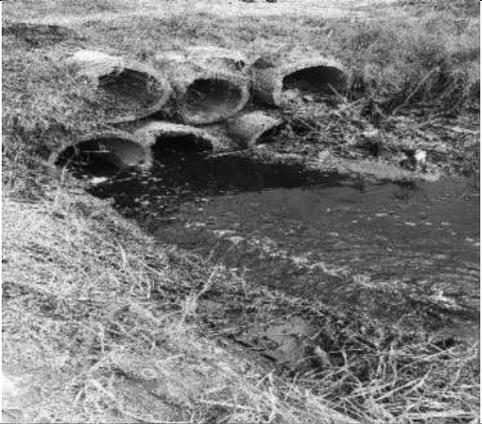
<p>Industrial Effluents (27°48'41" N 77°25'47" E)</p>

<ul style="list-style-type: none"> <li>▪ Significant bubbles were observed</li> <li>▪ Obnoxious odour observed</li> </ul>

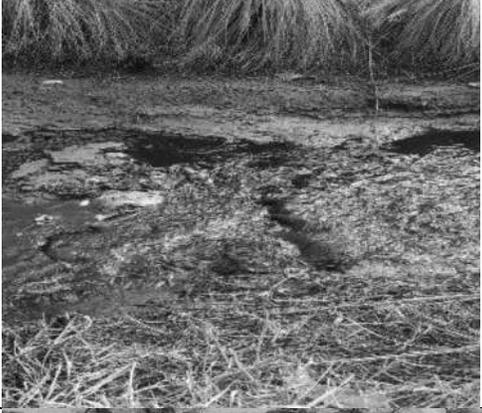
<ul style="list-style-type: none"> <li>▪ This is an industrial drain discharging its effluent to Kosi drain</li> <li>▪ The colour was found red during site visit</li> </ul>
<p>Industrial Effluents (27°48'41" N 77°25'47" E)</p>

<ul style="list-style-type: none"> <li>▪ Red colour indicates the possibility of untreated industrial effluent in drain</li> </ul>
<p>Industrial Effluents (27°48'41" N 77°25'47" E)</p>

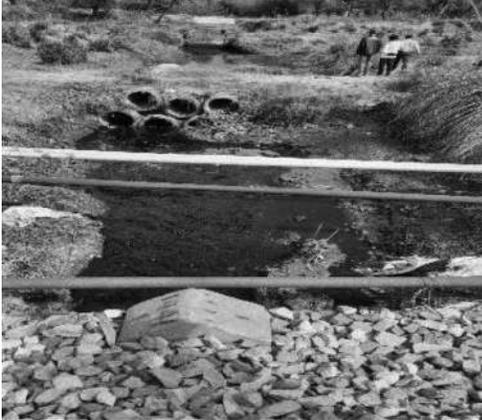
<ul style="list-style-type: none"> <li>▪ This industrial drain directly discharges its effluent to the Kosi drain</li> </ul>
<p>Kosi Nagar Palika Sewage Drain 1 (27°48'14" N 77°26'14" E)</p>

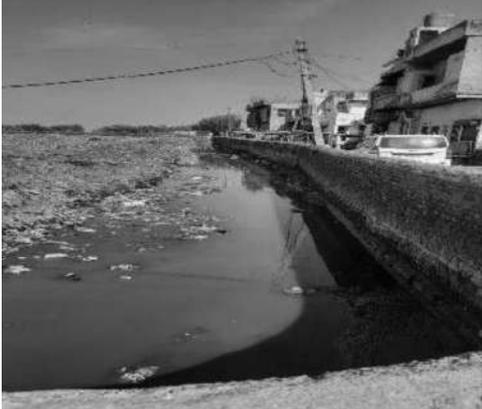
<ul style="list-style-type: none"> <li>▪ Kosi Nagar Palika Sewage drain discharges into the Kosi drain</li> <li>▪ This drain carries sewage from Kosi town</li> </ul>

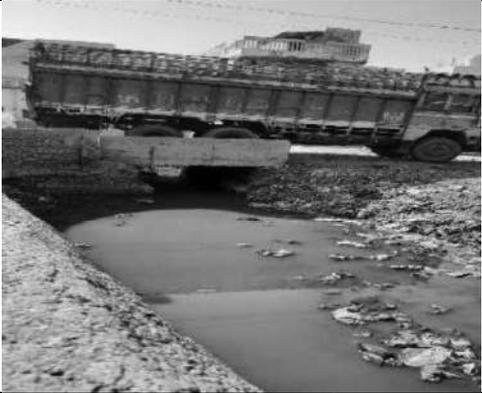
<ul style="list-style-type: none"> <li>▪ As per the engineers from UPPCB, the flow in the drain varied from 4- 8 MLD</li> <li>▪ The colour and smell indicate the possibility of flowing sewage fully</li> </ul>
<p>Kosi Nagar Palika Sewage Drain 1 (27°48'37" N 77°26'44" E)</p>

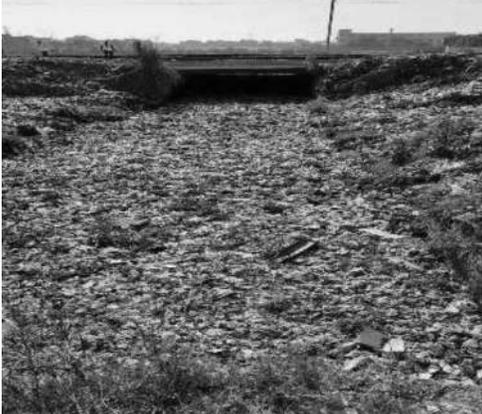
<ul style="list-style-type: none"> <li>▪ Kosi Nagar Palika Sewage drain meeting with the Kosi drain</li> <li>▪ Kosi Nagar Palika Sewage drain near proposed STP</li> </ul>
<p>D/S location of drain about 1.5 – 2 KM after Industrial Effluent and Sewage from Kosi Nagar Palika Drain meeting (27°47'44" N 77°26'42" E)</p>

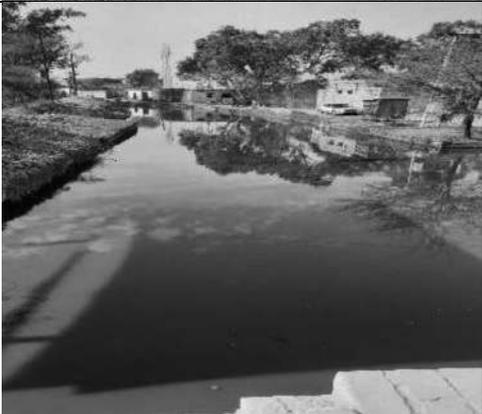
<ul style="list-style-type: none"> <li>▪ The red colour of the water flowing in drain diminishes but high suspended solids were found</li> </ul>

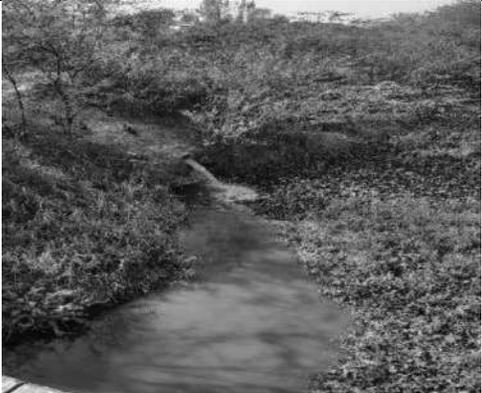
<p>Kosi drain (down-stream) at Ajjipur village, U.P (27°46'24" N 77°28'17" E)</p>

<ul style="list-style-type: none"> <li>▪ No obnoxious odour found</li> </ul>

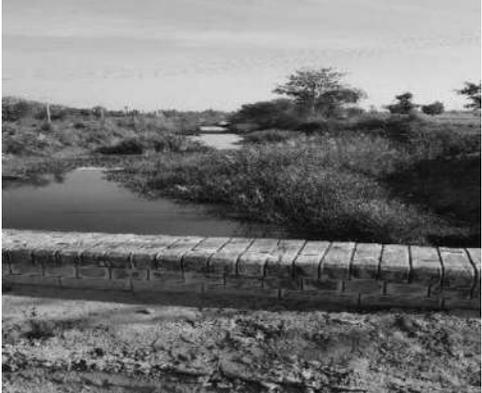
<ul style="list-style-type: none"> <li>▪ Small drain possibly sewage discharging to the drain</li> <li>▪ Colour was yellowish indicating the mixing of the sewage</li> </ul>

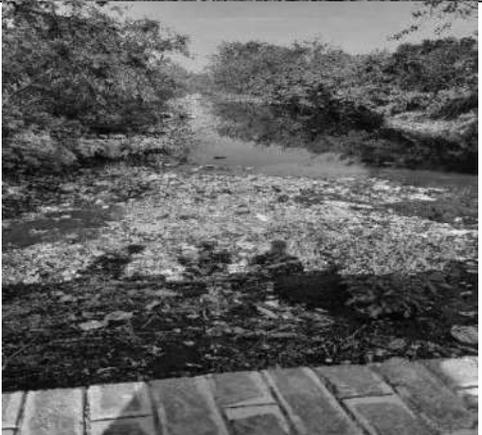
<ul style="list-style-type: none"> <li>▪ Heavy natural plant growth was observed</li> </ul>
<p>Chhatta (27°43'05" N 77°30'38" E)</p>

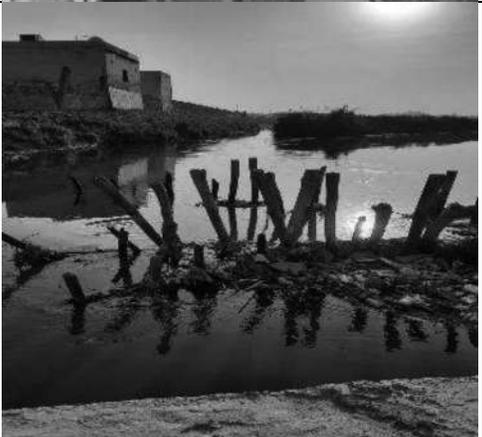
<ul style="list-style-type: none"> <li>▪ Heavy growth of plants was observed</li> <li>▪ Flow was significantly low due to the tapping of water by farmers</li> <li>▪ One drain also discharges wastewater at this location into the Kosi drain. But it was not clear whether this drain carries village domestic wastewater or Vishal Food Processing Industrial effluent</li> </ul>
<p>Confluence Point of Kosi drain with Yamuna river at Parikrama Marg, Kaliyaghat Vrindavan (27°34'58" N 77°41'13" E)</p>

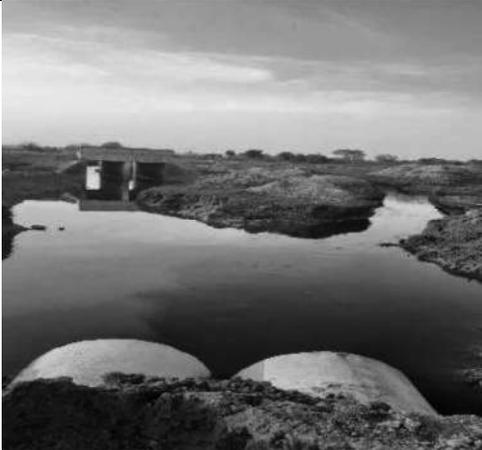
<p>Subhar Rishi Marg, near Rajpur Khadar, Vrindawan</p> <p>(27034'51" N 77040'15" E)</p>

<ul style="list-style-type: none"> <li>▪ The colour of the water at the meeting point was observed black</li> <li>▪ Significant flow from the drain entering to the river</li> </ul>

<ul style="list-style-type: none"> <li>▪ This is the location for the installation of the weir</li> <li>▪ The colour of the water in the drain was turbid having significant suspended solids</li> </ul>

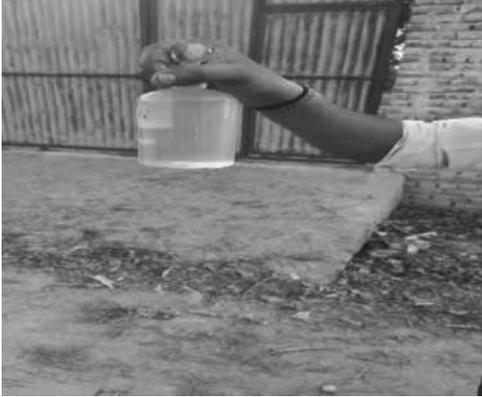
<ul style="list-style-type: none"> <li>▪ Water sample collected from the proposed location of the weir</li> <li>▪ The colour of the water in the drain was little turbid having insignificant suspended solids</li> </ul>

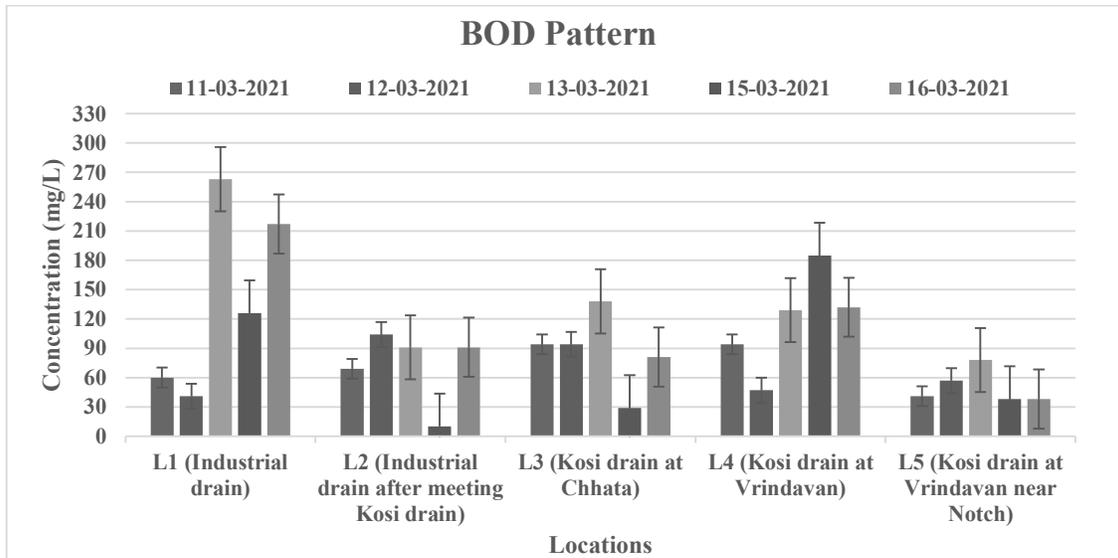
**Fig. 2.0** Variation of the BOD concentration over a week at various locations of Kosi drain

Fig. 2.0 shows the BOD concentration measured during March 11 to 16, 2021. Results indicate that the average values of BOD were measured  $141\pm 97$  mg/L at location 1 (Industrial drain);  $73\pm 37$  mg/L at location 2 (after Industrial drain merged with Kosi drain);  $87\pm 39$  mg/L at location 3 (Kosi drain at Chhata);  $117\pm 51$  mg/L at location 4 (Kosi drain at Vrindavan) and  $50\pm 17$  mg/L at location 5 (Kosi drain at Vrindavan at Notch). Significant variation in BOD concentration was observed at location 1 whilst at location 2, 3, 4 and 5 an insignificant variation was found during a week-long monitoring of the drain.

- ✦ The average values of the BOD were found 141, 73, 87, 117 and 50 mg/L at location of 1,2,3,4 and 5 respectively.
- ✦ The average values of the COD were found 493, 199, 227, 275 and 142 mg/L at location of 1,2,3,4 and 5 respectively.
- ✦ The average TSS concentration were found 148, 75, 134, 177 and 133 mg/L at location of 1,2,3,4 and 5 respectively.
- ✦ The pH values ranged 6.4 – 7.1.

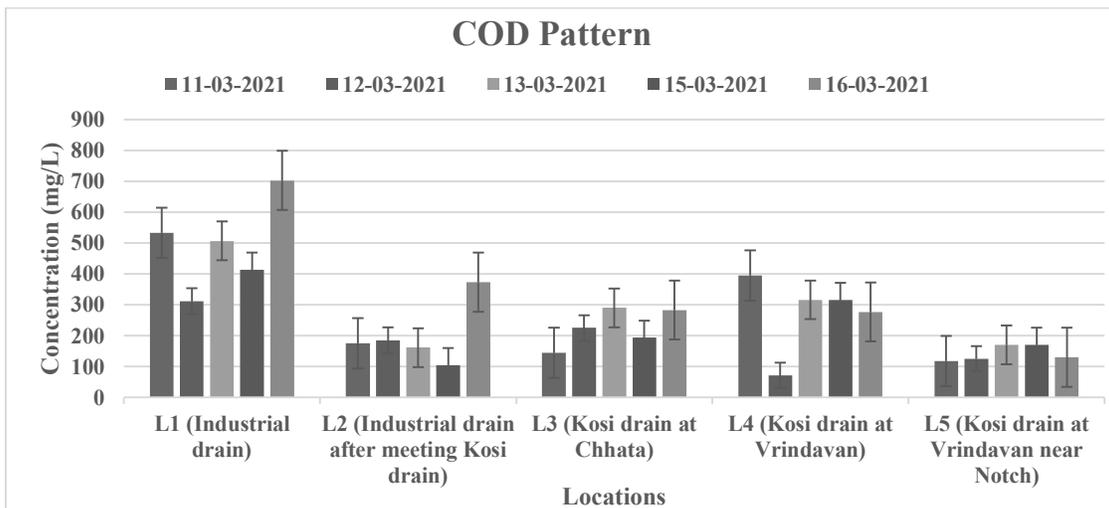
**Fig. 3.0** Variation of the COD concentration over a week at various locations of Kosi drain

Fig. 3.0 shows the COD concentration measured during March 11 to 16, 2021. Results indicate that the average values of COD were measured  $494 \pm 146$  mg/L at location 1 (Industrial drain);  $200 \pm 102$  mg/L at location 2 (after Industrial drain merged with Kosi drain);  $227 \pm 62$  mg/L at location 3 (Kosi drain at Chhata);  $275 \pm 122$  mg/L at location 4 (Kosi drain at Vrindavan) and  $143 \pm 25$  mg/L at location 5 (Kosi drain at Vrindavan at Notch). Significant fluctuation in COD concentration was observed at location 1 during a week-long monitoring of the drain. The variations in COD concentration were insignificant except only for one day at location 2 and 4.

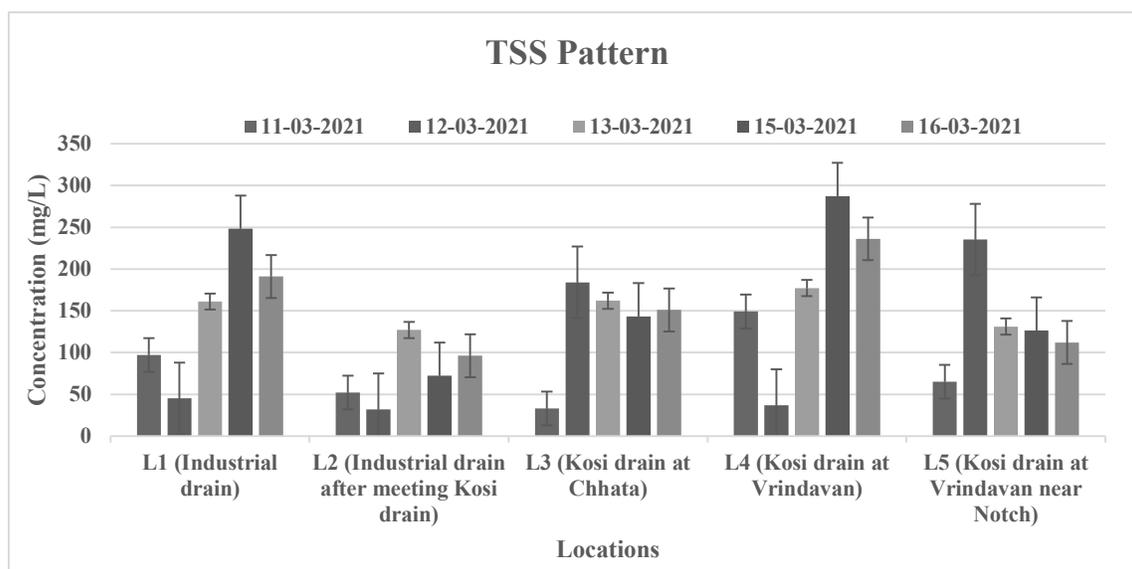
**Fig. 4.0** Variation of the TSS concentration over a week at various locations of Kosi drain

Insignificant variation on TSS concentration was observed during a week-long monitoring of the drain at each sampling location.

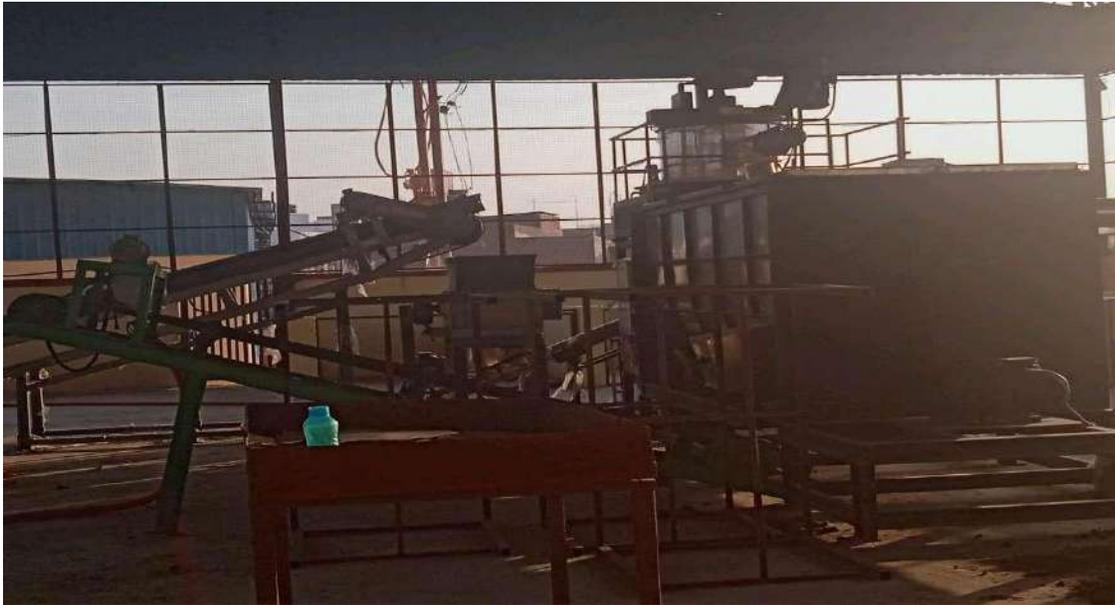
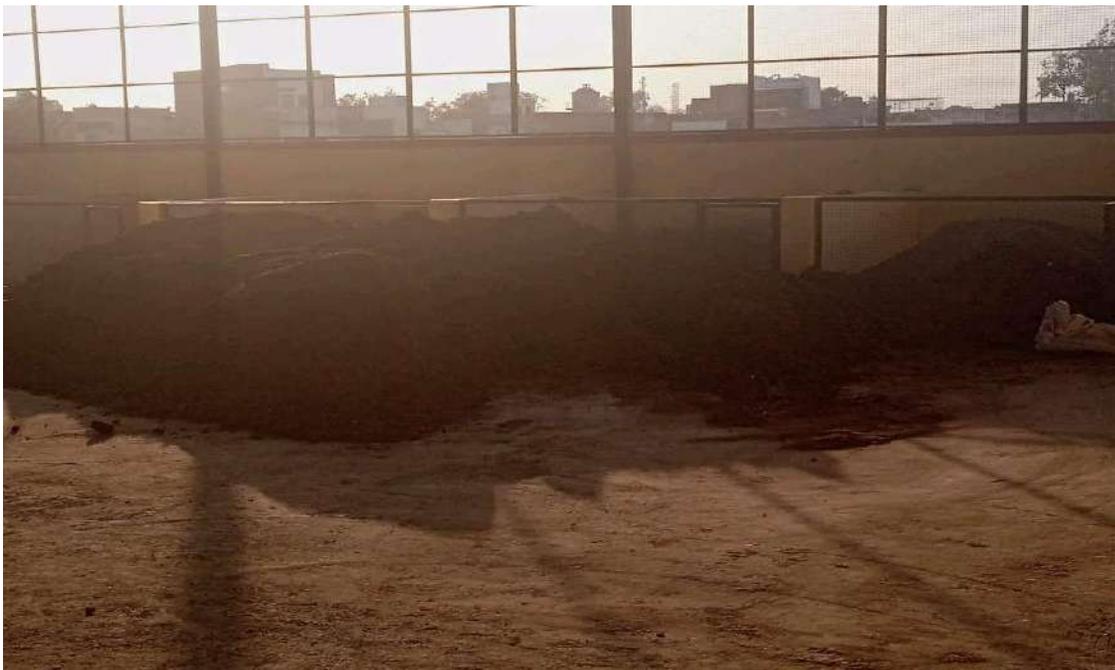
Daily fresh waste is brought here and is treated. I was informed that earlier the work of waste collection and treatment was given to a private company M/S 21<sup>st</sup> Century Polymors but its performance was not satisfactory, hence the contract was cancelled and at present Nagar Nigam is doing this work out of its own resources. Nigam has its own 104 primary vehicles and handcarts for door to door collection. Nigam also has four truck mounted road sweeping machines that are being used to clean the city. In the plant, pre-processed waste is converted into windrows. Inoculants and microorganism are then added. Lastly it is put on the conveyor belts of the trommels. Approximately 160-180 TPD waste is brought to this plant. A small park has also been developed within the premises of the plant which has been decorated with waste

materials. Small quantity of fresh waste was lying there. While I was on way to the plant, several waste collection vehicles of Nagar Nigam were seen bringing the waste to the plant. Two incinerators are also there in the plant. Some photographs of this plant are as under.

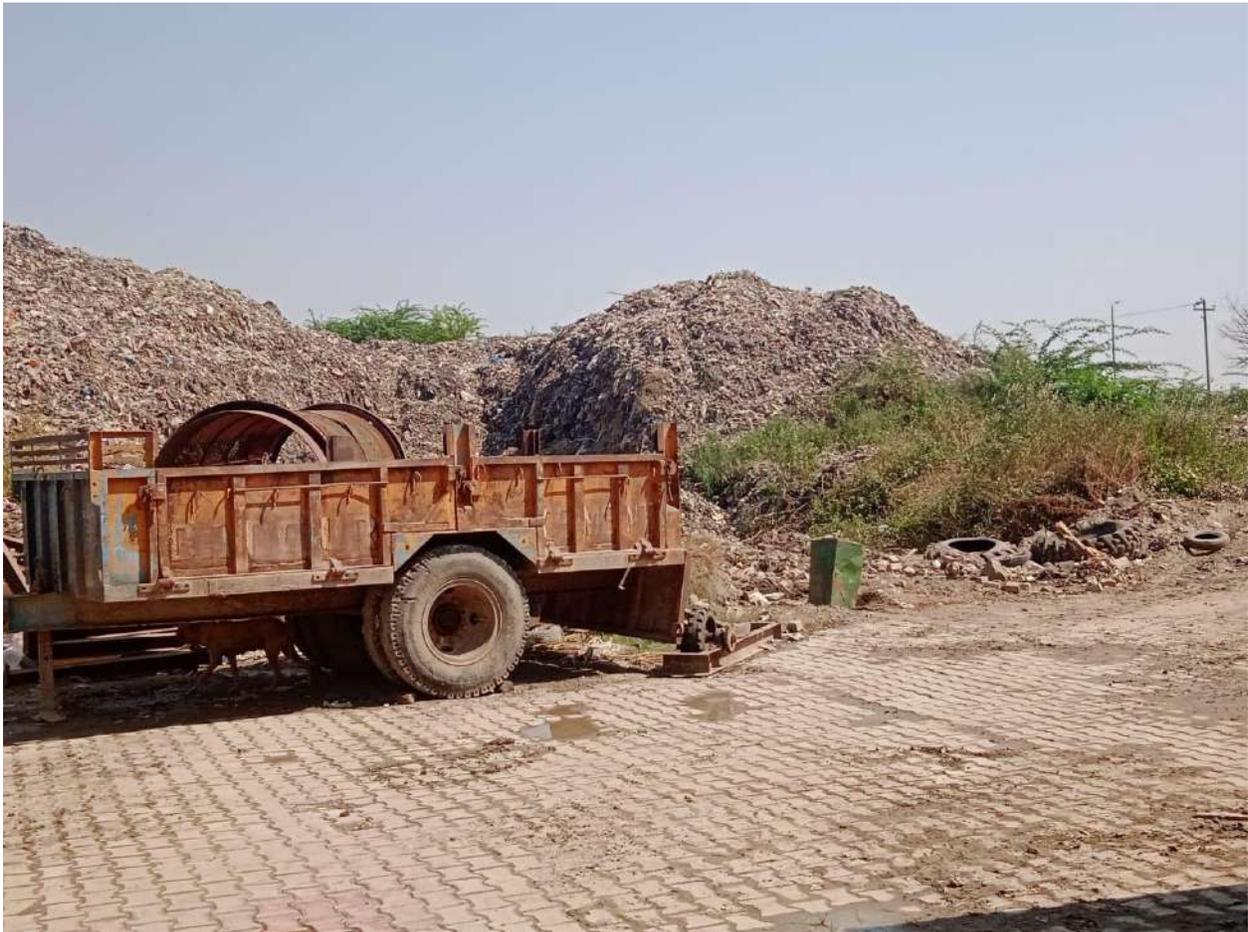
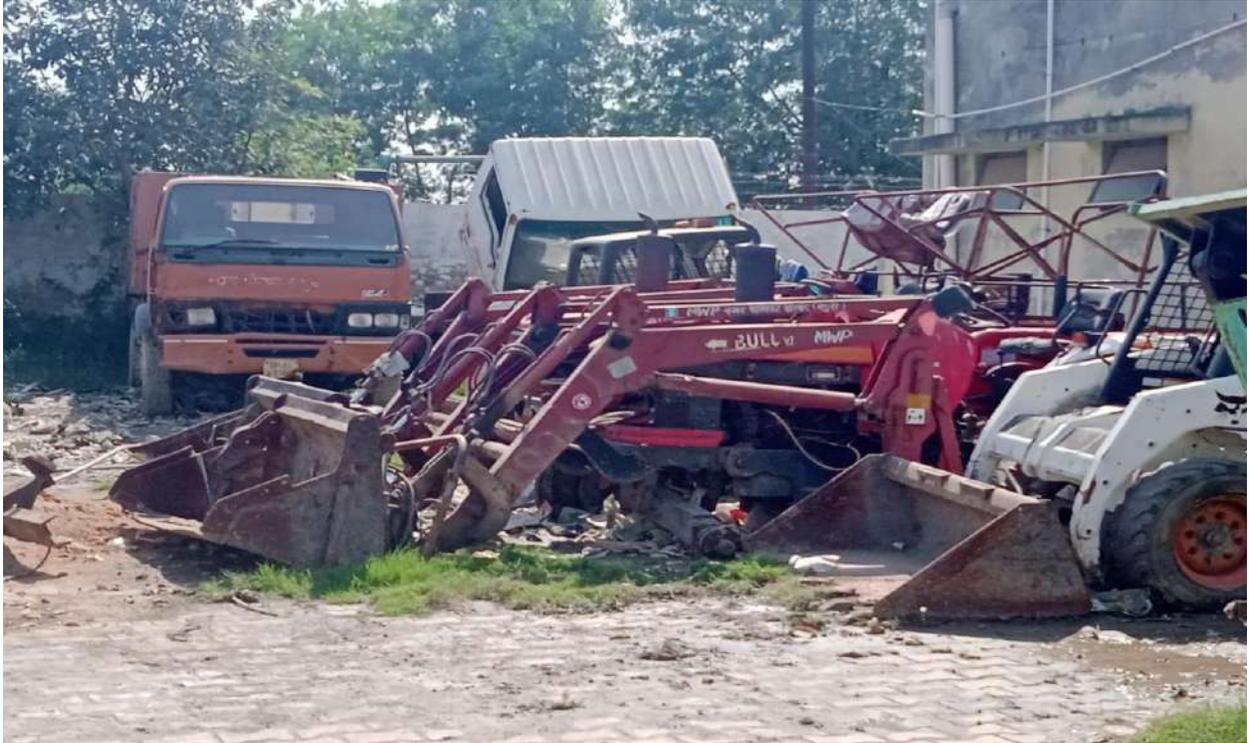
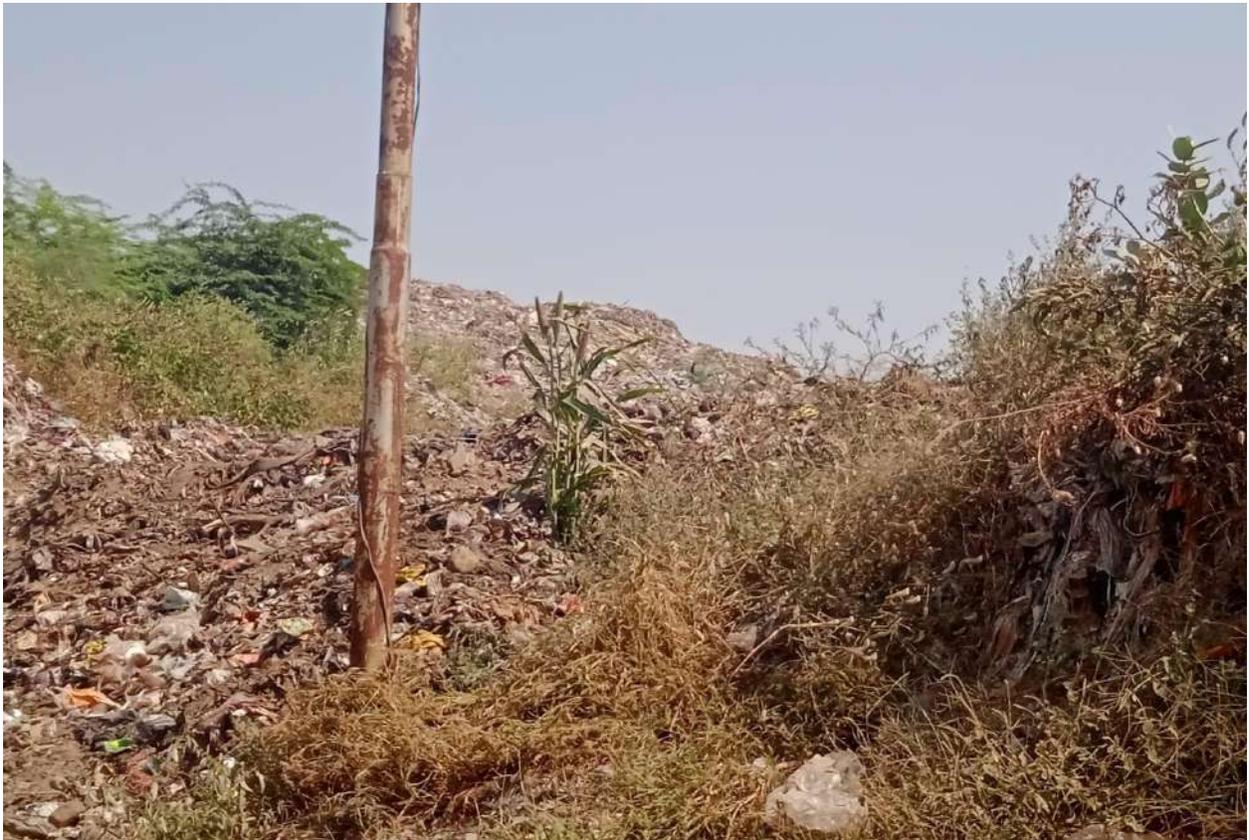
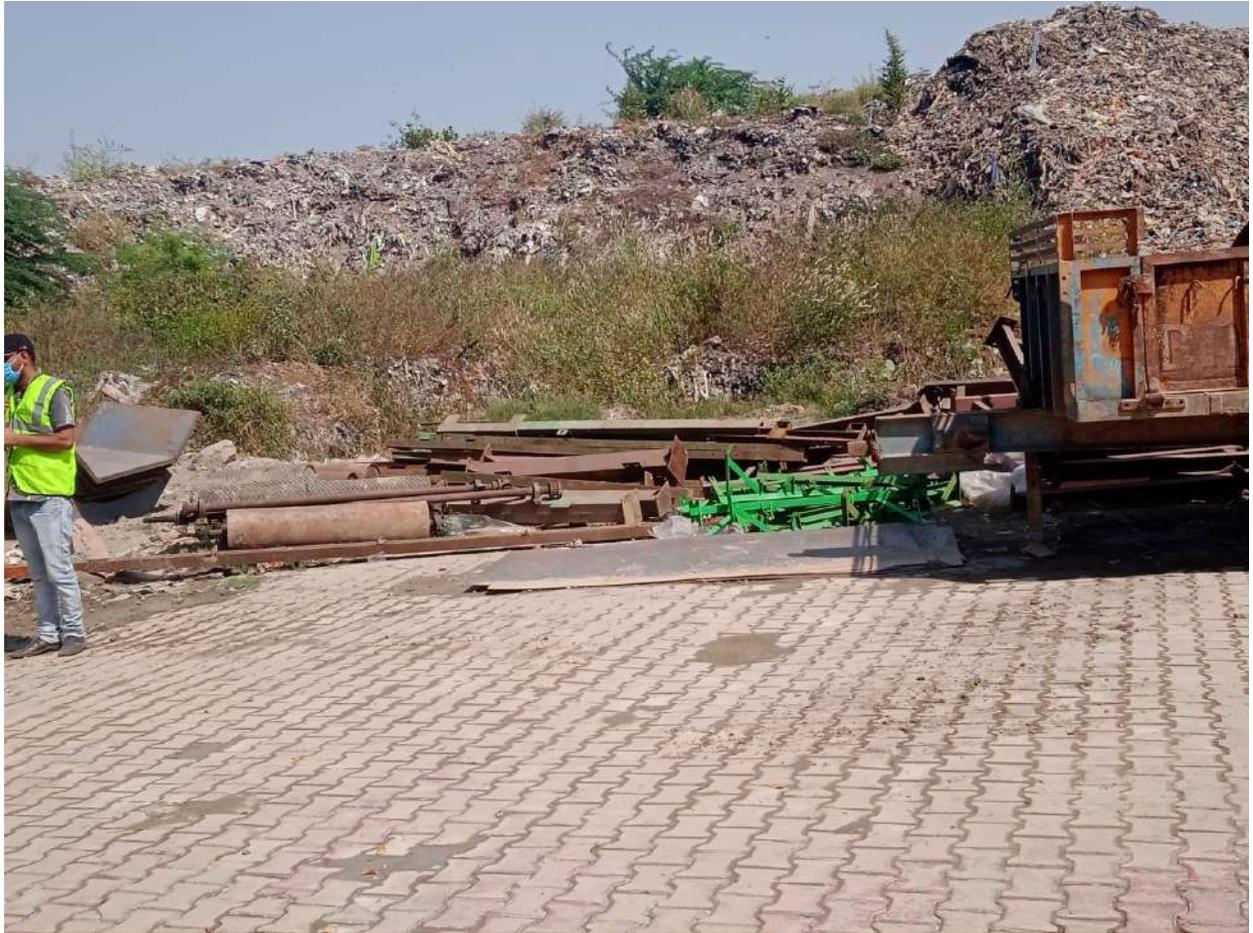
On the other side of the plant, old legacy waste was lying. No work of its processing was going on. For clearing this legacy waste, under the guidance of Urban Development Department a contract has been given to Blackberry Overseas Pvt Ltd. I was provided with the copy of said contract (Annexure 1). It was executed on 7<sup>th</sup> September 2021. As per the condition of the contract, the company had to install minimum two trommels, each of 300 TPD capacity. First trommel was to be installed within one week of signing the agreement and the other trommel was to be installed within one month and the entire site was to be cleared within one year. When Municipal Commissioner Mr Anunay Jha was asked about this non-compliance of the terms of agreement, he immediately contacted the company. It was informed that the agreement was approved by the C&DS on 15<sup>th</sup> September. The representative of the company informed that due to festive season, some delay had occurred as the workers were not available. But he promised that both the trommels shall be installed and made functional positively by 18<sup>th</sup> October. I asked the municipal commissioner to look into

it personally to ensure that the work of legacy waste remediation starts at the earliest preferably on the date as assured by the company. I was also informed that the entire waste of Maant has been cleared and the waste lying here was very old. Some photographs taken there are as under:

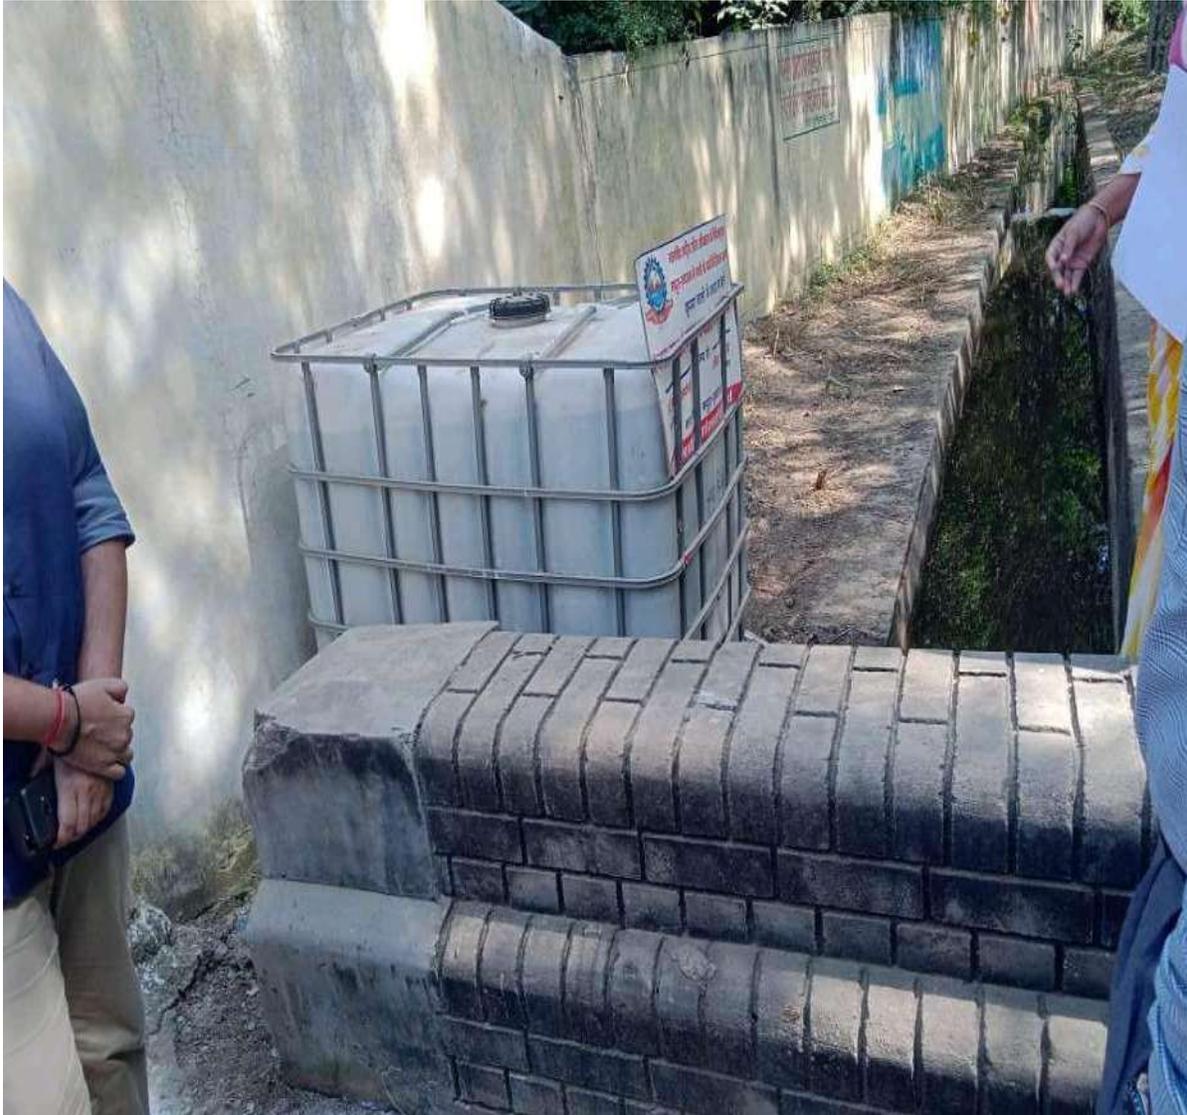
Dairy farm Drain

Two nearby drains were also inspected by me. Work of Bioremediation and Phytoremediation is being done by M/S Nextgen Info world Private Limited. Representative of the company Dr Kalpana Arora along with her team was also present. First I went to see the dosing point of Dairy Form drain. It is one of the untapped drains. Dosing work is being done in this drain at one point only. Length of this drain is only 6.2 km. It was informed that Aquantrin chemical is being used which is a product of "Nualgi" and it is an ITTR approved chemical for the purpose. At the dosing point, one big white plastic tank was placed. I was informed that daily one litre chemical is mixed in it and this tank is sufficient to dose for 24 hrs. This dosing point was installed on 13.12.2020. I was informed that the water quality has improved a lot. Some photographs taken are as under. Mr Anunay Jha Municipal Commissioner informed me that DPR for tapping the remaining drains has already been sent to NMCG and certain observations were raised by the NMCG and the same have been cleared. He is pursuing the matter
