**REPORT OF THE OVERSIGHT COMMITTEE, NGT, U.P, LUCKNOW**

**ORIGINAL APPLICATION NO. 102/2021**

**IN RE: ACHARYA DAMODAR SHASTRI & ANR.  
VERSUS  
UNION OF INDIA & ORS.**

**REPORT OF THE OVERSIGHT COMMITTEE IN COMPLIANCE OF THE ORDER OF  
THE HON'BLE NATIONAL GREEN TRIBUNAL PASSED IN O.A. NO. 102/2021 IN RE:  
ACHARYA DAMODAR SHASTRI & ANR. VERSUS UNION OF INDIA & ORS.**

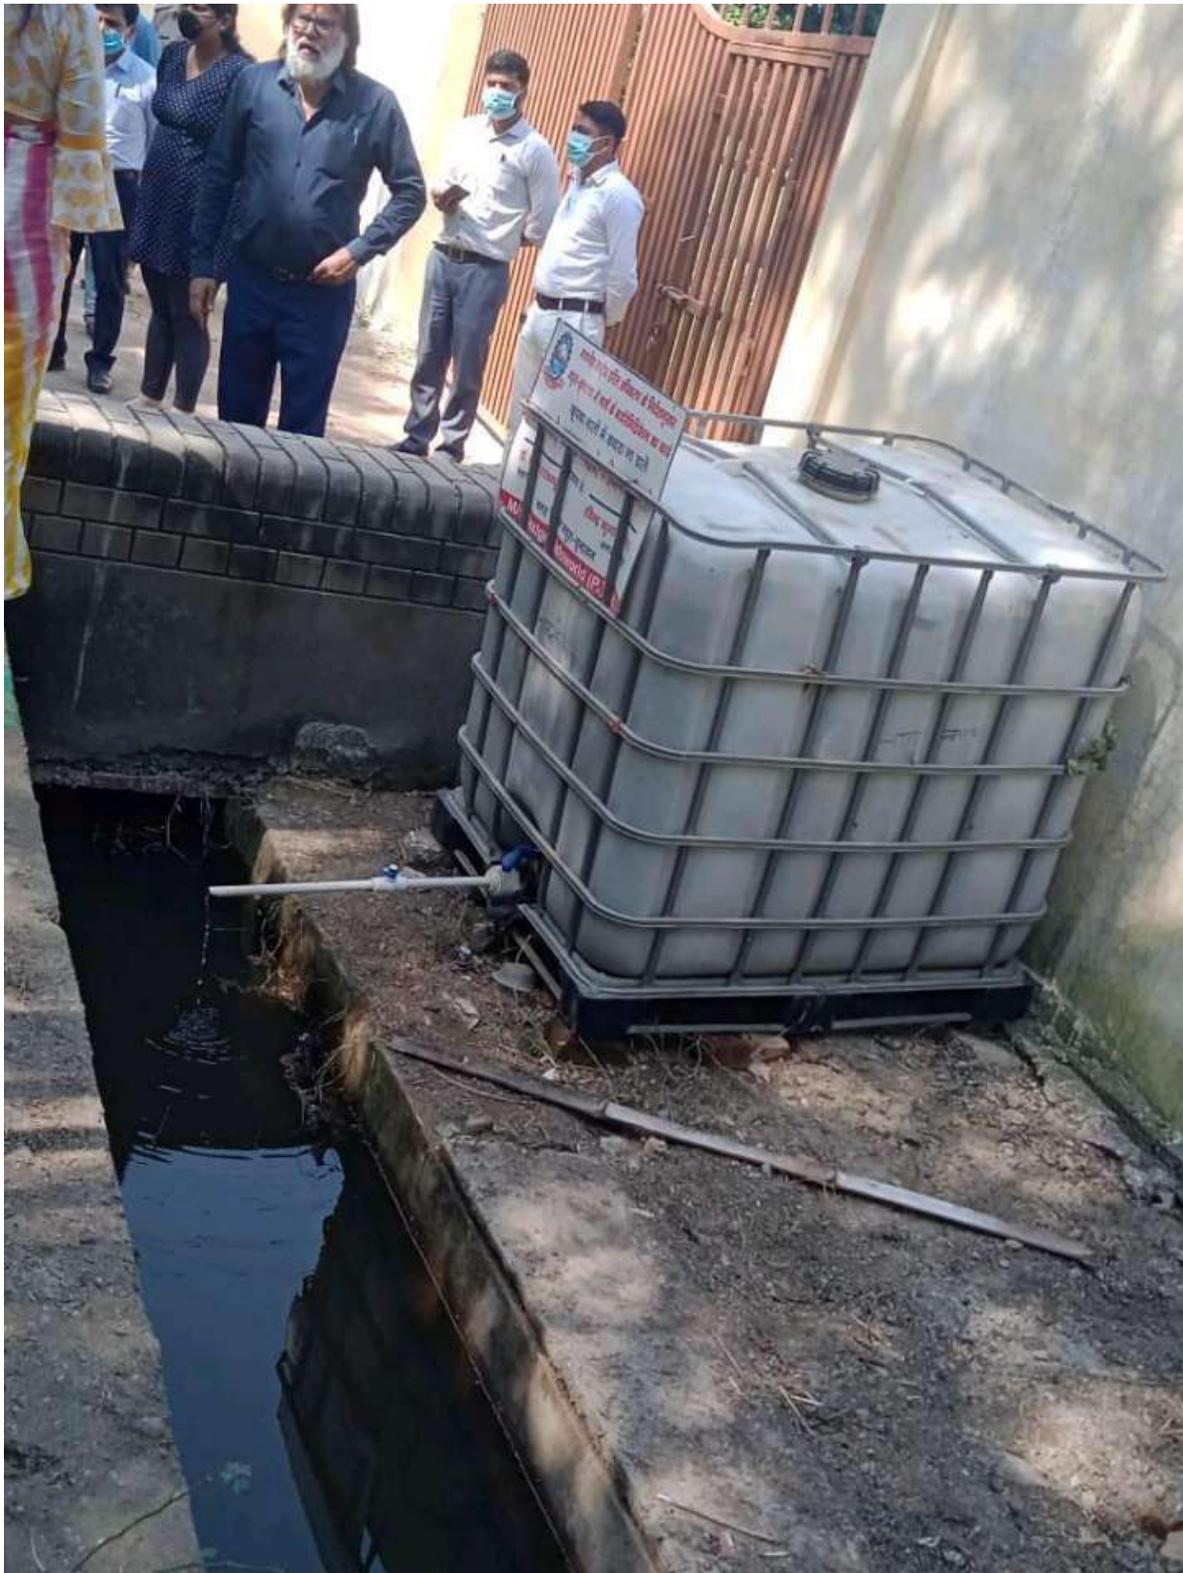
Dairy farm Drain

Two nearby drains were also inspected by me. Work of Bioremediation and Phytoremediation is being done by M/S Nextgen Info world Private Limited. Representative of the company Dr Kalpana Arora along with her team was also present. First I went to see the dosing point of Dairy Form drain. It is one of the untapped drains. Dosing work is being done in this drain at one point only. Length of this drain is only 6.2 km. It was informed that Aquantrin chemical is being used which is a product of "Nualgi" and it is an ITTR approved chemical for the purpose. At the dosing point, one big white plastic tank was placed. I was informed that daily one litre chemical is mixed in it and this tank is sufficient to dose for 24 hrs. This dosing point was installed on 13.12.2020. I was informed that the water quality has improved a lot. Some photographs taken are as under. Mr Anunay Jha Municipal Commissioner informed me that DPR for tapping the remaining drains has already been sent to NMCG and certain observations were raised by the NMCG and the same have been cleared. He is pursuing the matter

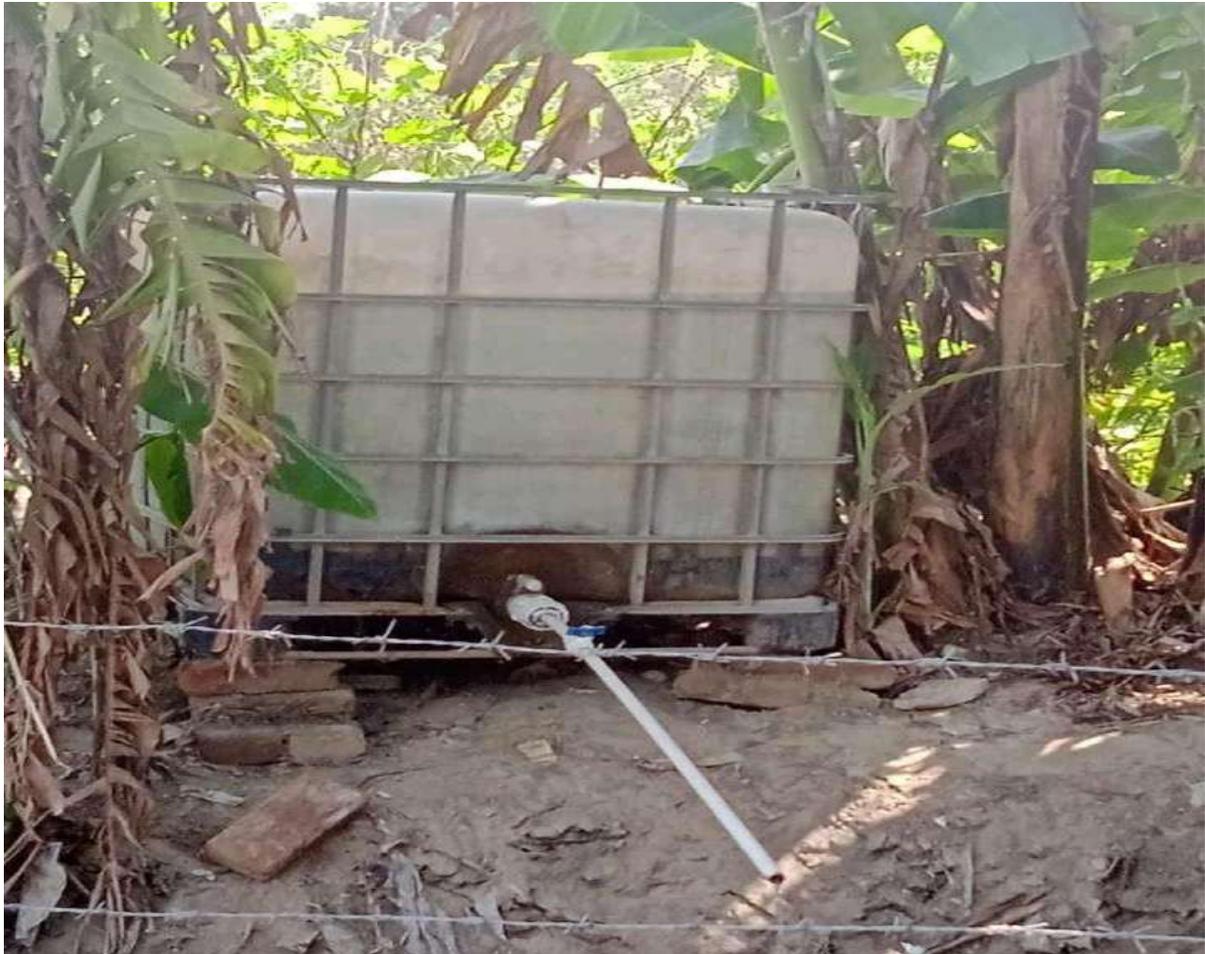
Bio remediation of Aurangabad up stream drain

Thereafter I went to Aurangabad Upstream drain. It is also one of the untapped drains of Mathura. As an interim measure, bioremediation work is being done here since 12.11.2020. It was also being treated in the similar way by dosing at one point. Its length is only about 6 km. Representative of the company informed that the results of water samples are encouraging. No foul smell was coming from any of the above two drains. Some photographs taken there are as under:

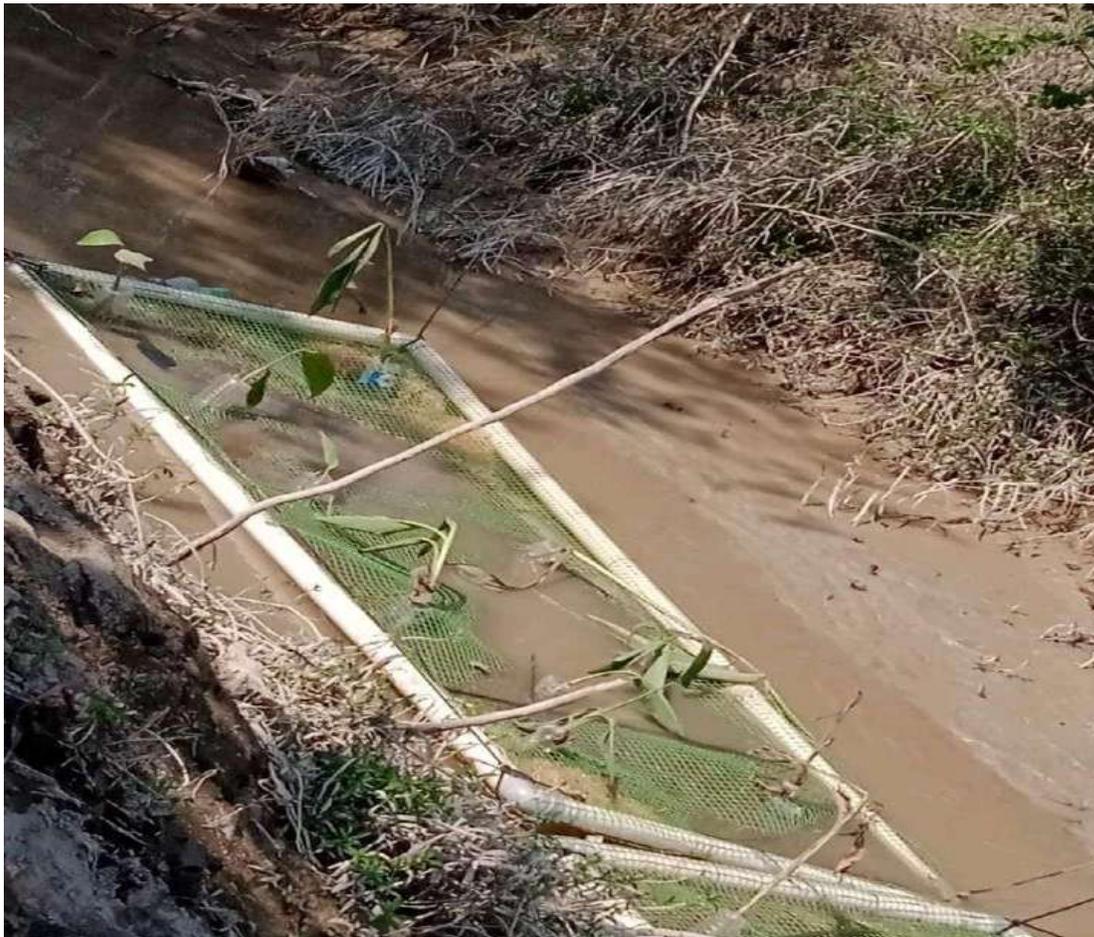
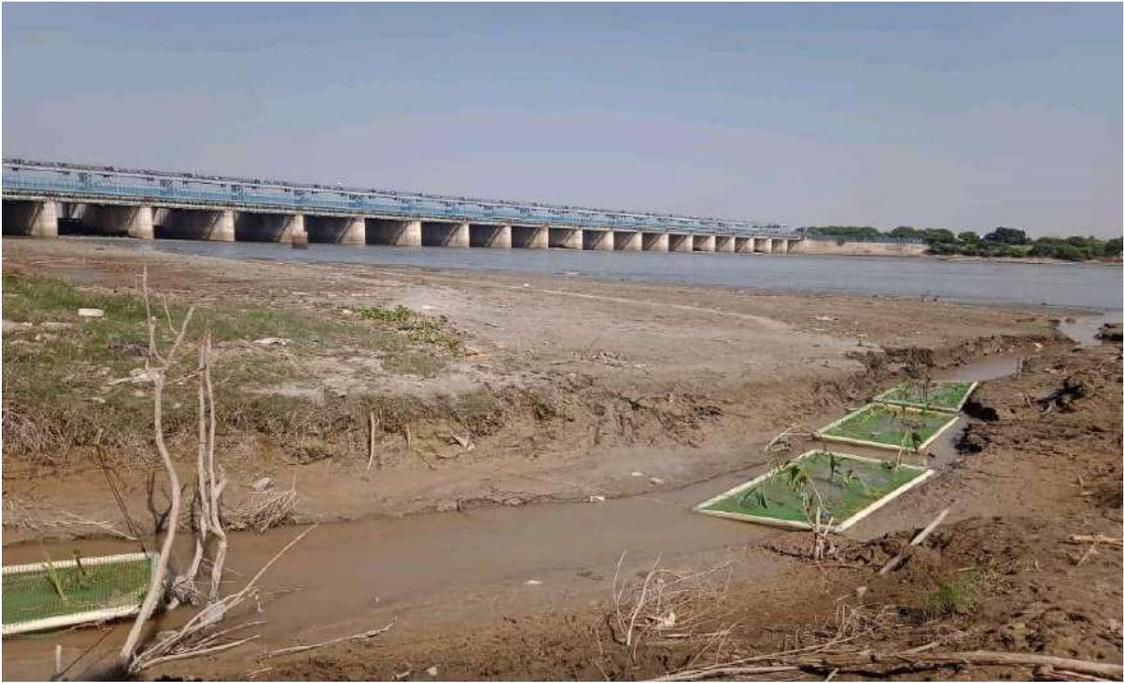
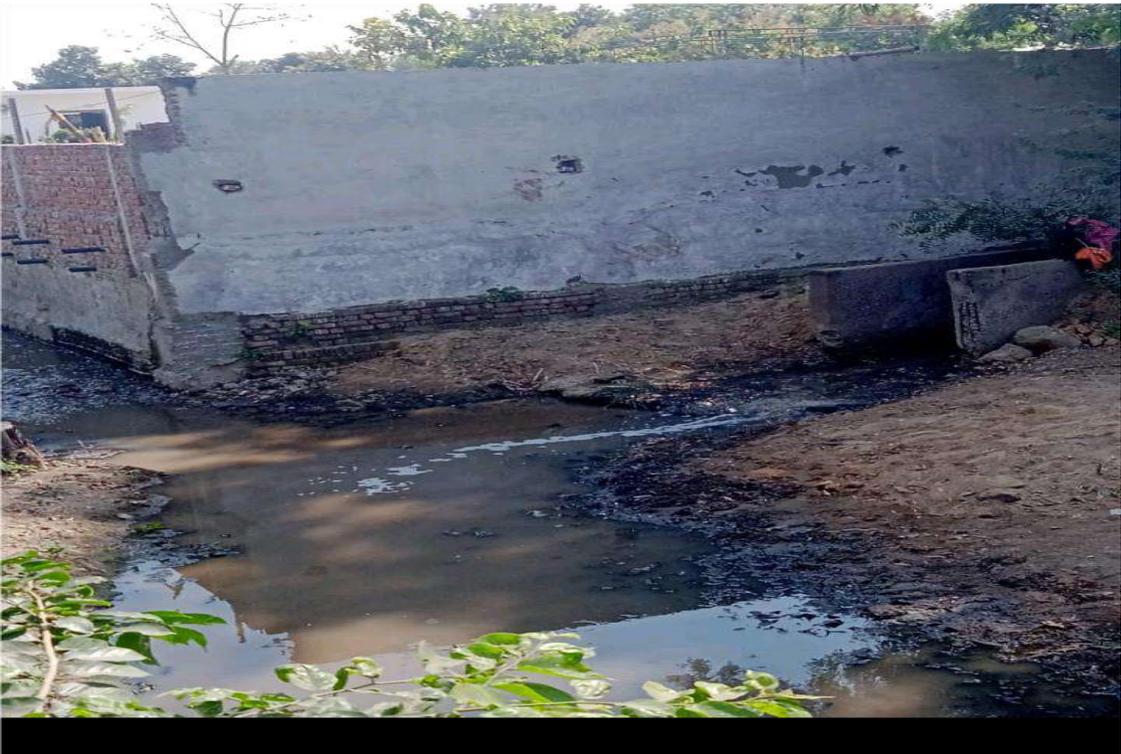
Thereafter I went to Aurangabad downstream drain. This drain is being bio-remediated at one point and the company is also doing phytoremediation of this drain at the point where it meets river Yamuna. It was informed that the company had placed several floating beds but due to recent flood, most of them are missing. However, at the time of inspection, 4 floating beds were present with plantation in it. Plantation has also been planned at both the banks of the drain. To reach this point of the drain, we had to go down stairs about 25 steps from the road level and thereafter to walk for a distance of about 500 meters alongwith drain in the field. I was informed that water quality improvement is encouraging. Some photographs taken there are as under. It appears from the bare look of the condition of the plants in the floating bed that the same have been planted recently. May be that the earlier plants might have been damaged in the floods because condition of the plants on the banks of the drain gives rise to such an inference.

**4.1 Aurangabad Downstream Drain:** Bioremediation is being done at one point only. Phytoremediation is being done at the point where drain meets river Yamuna. It was informed that the company had placed several floating beds but due to recent flood, most of them are missing. However, at the time of inspection, 4 floating beds were present with plantation in it. Plantation has also been planned at both the banks of the drain. It was informed that water quality has improved post treatment. It appears from the bare look of the condition of the plants in the floating bed that the same have been planted recently. May be that the earlier plants might have been damaged in the floods because condition of the plants on the banks of the drain gives rise to such an inference’.

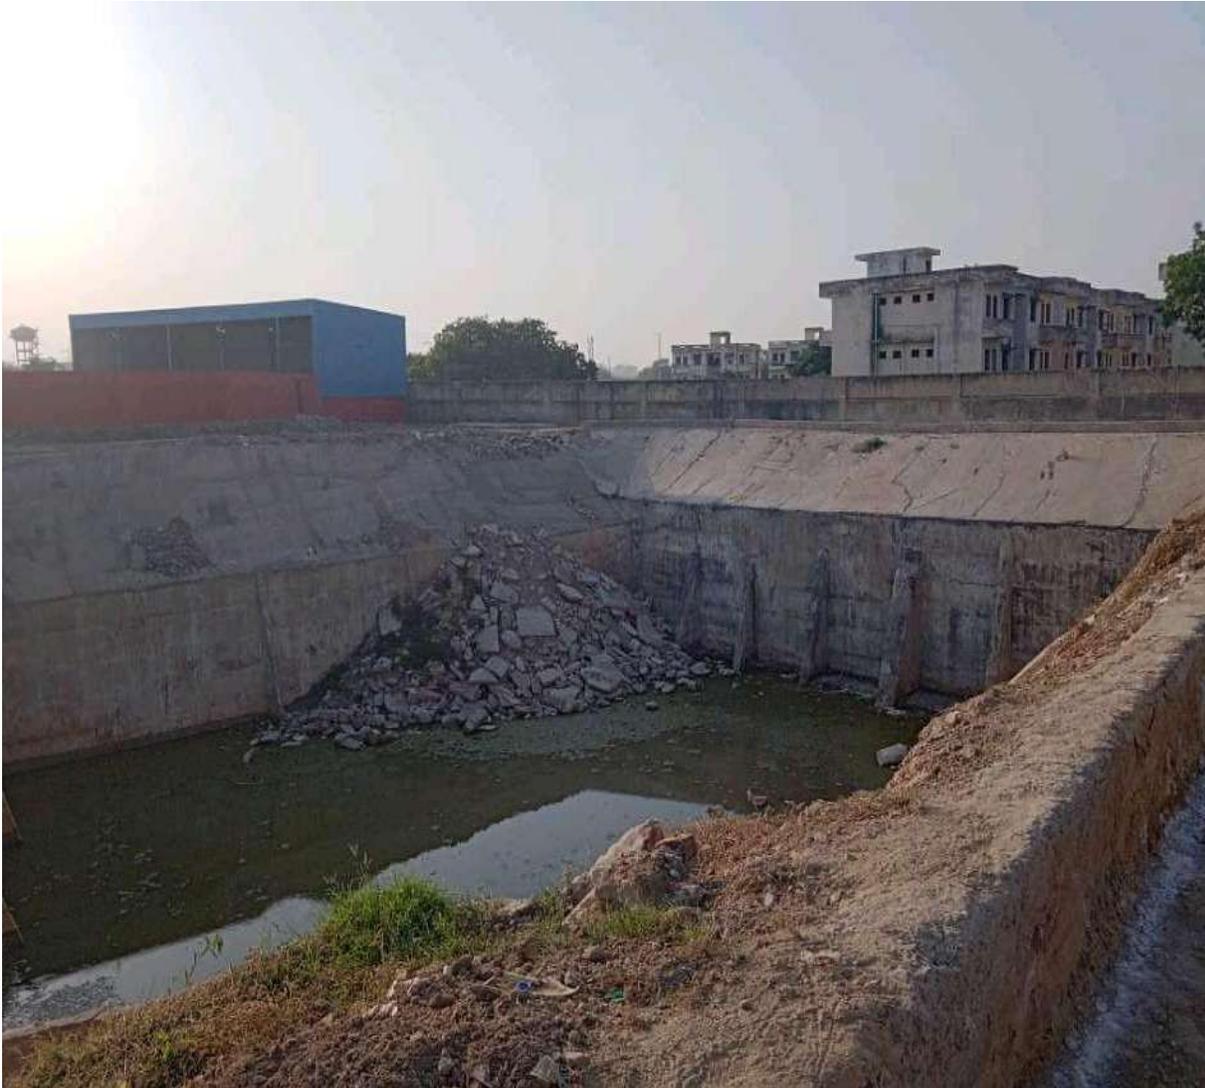
Cleared Maant Road Waste Pit

Thereafter I went to Maant Road waste site. Earlier it was full of legacy waste. But now the entire legacy waste has been cleared and the land has been reclaimed. One deep RCC big size pit was there. Its depth is around 25-30 ft. At the time of inspection, there was absolutely no waste and in the bottom of the pit, only some rain water was collected. The entire area is covered with boundary wall and is clean. I was informed that earlier there were 5 pits and all have been cleared. The reclaimed land has been used for construction of a waste transfer station.

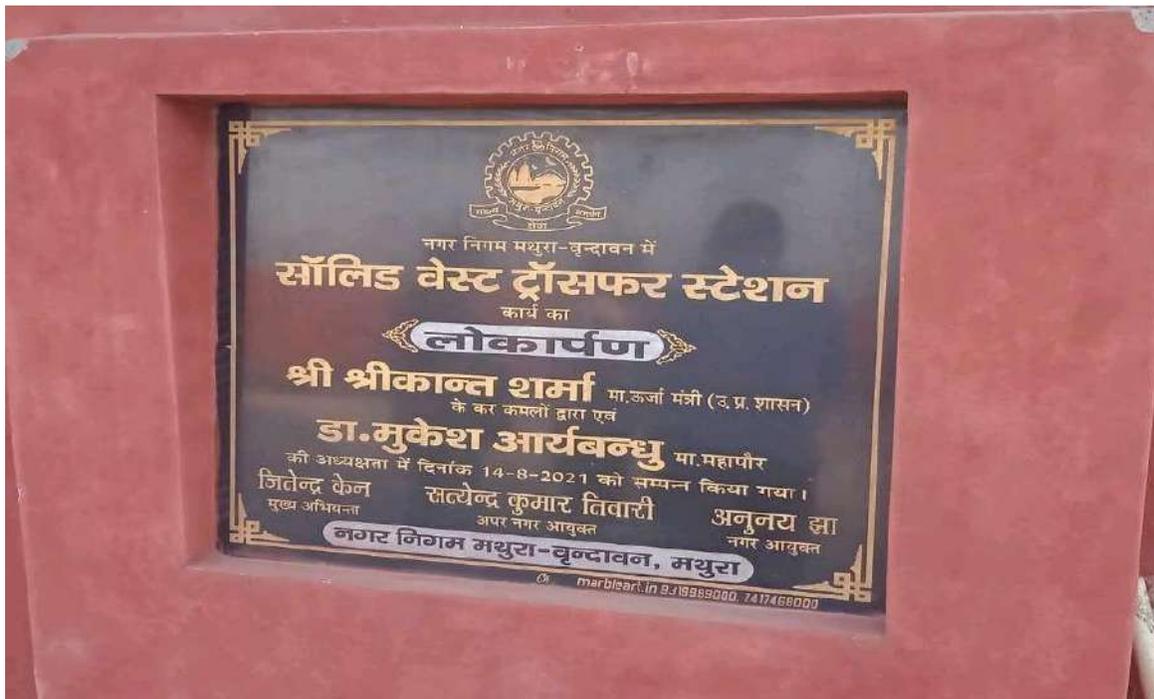
Above pictures are of the newly inaugurated waste transfer station which has been developed on one part of the land that has been reclaimed after clearing the Maant waste site. Fresh waste is brought and compacted here with the help of compactors and thereafter it is taken to Nagla Kolhu treatment site. This is a newly developed plant and all the machines are new. At the time of inspection, compactors were functional and the compacted waste was being loaded on a big truck through which it would be taken to Nagla Kolhu. I was informed that the use of compactors has reduced the diesel consumption to one fourth because now in very few rounds the entire waste is shifted to treatment site in compact form.

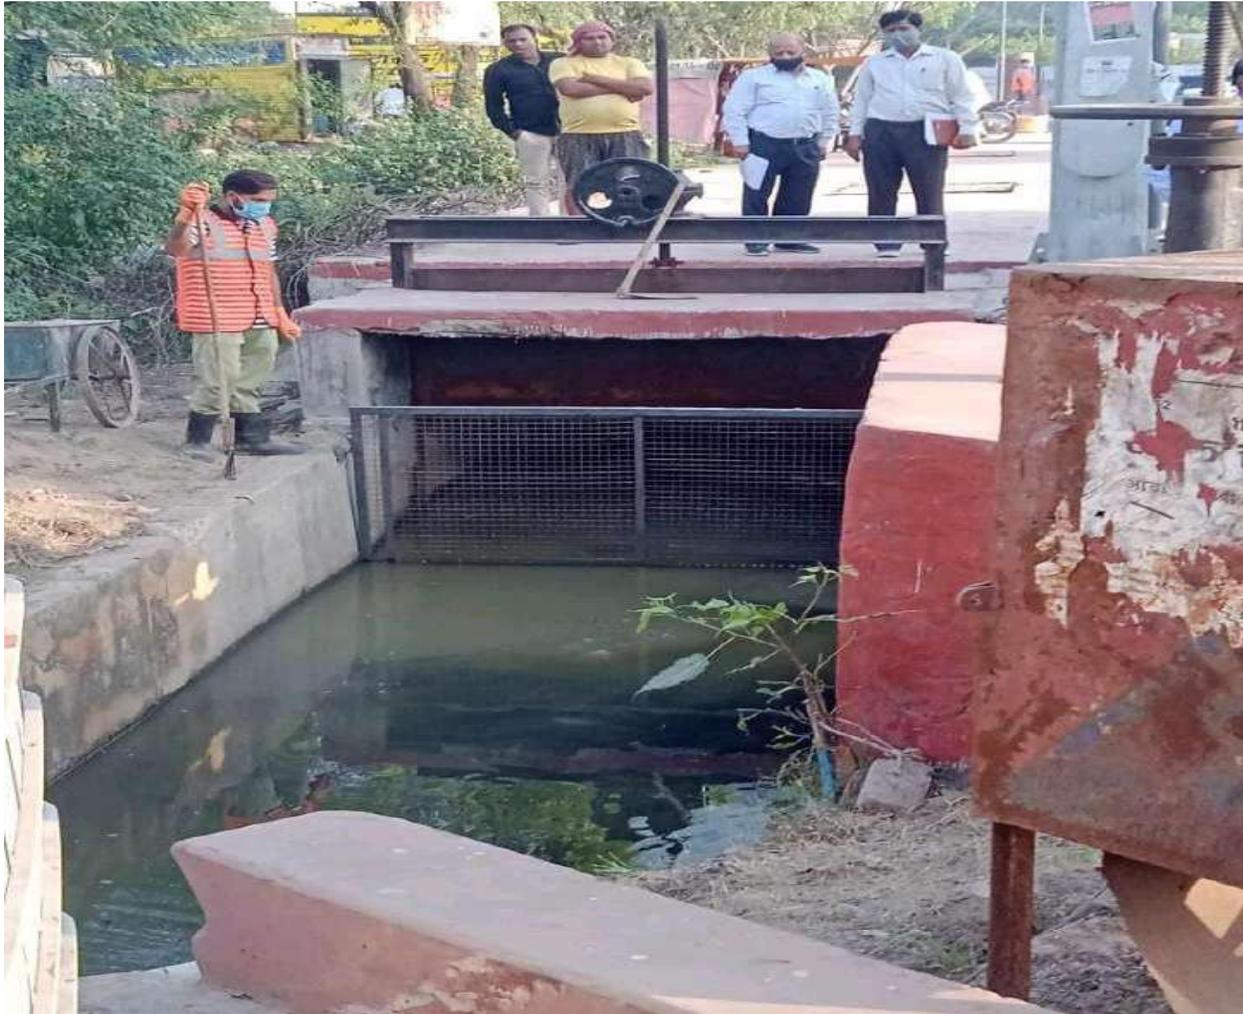
**Rajpur Khadar**

Thereafter I went to Rajpur Khadar drain. Its length is only 4 km. It's a small drain with discharge of only .17 MLD. This is one of the partially tapped drains of Mathura. Bio-remediation and phytoremediation work is being done on this drain. Bioremediation work has started since 30.06.2021. I was informed that flow of this drain shall be diverted to 8 MLD STP at Maant road. Some photographs taken there are as under.

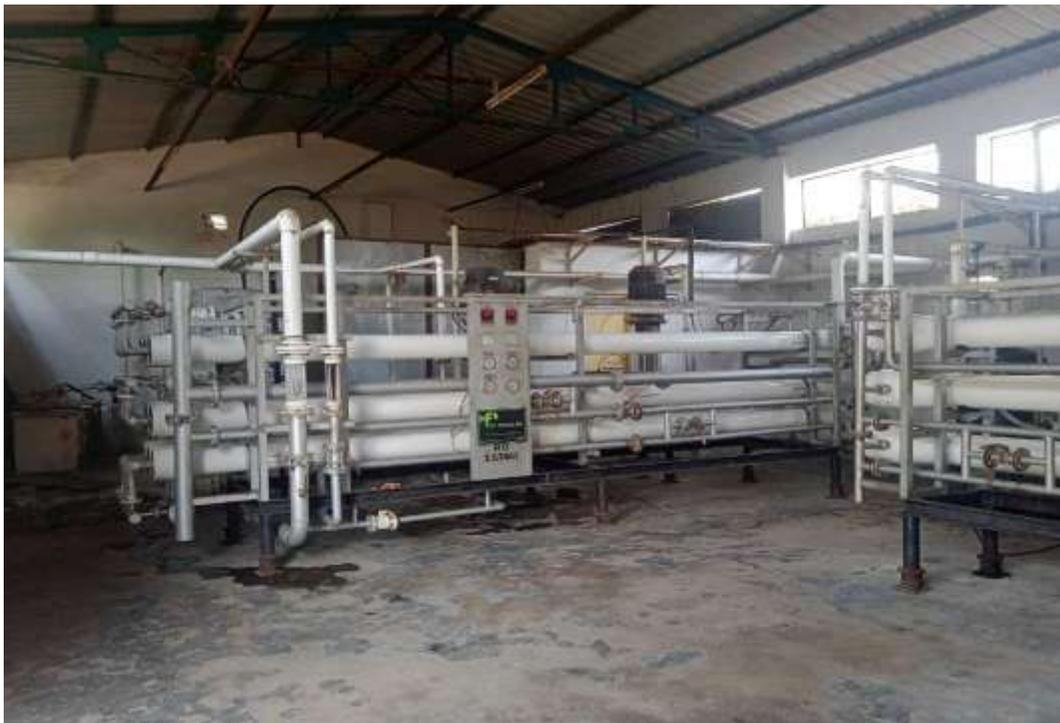
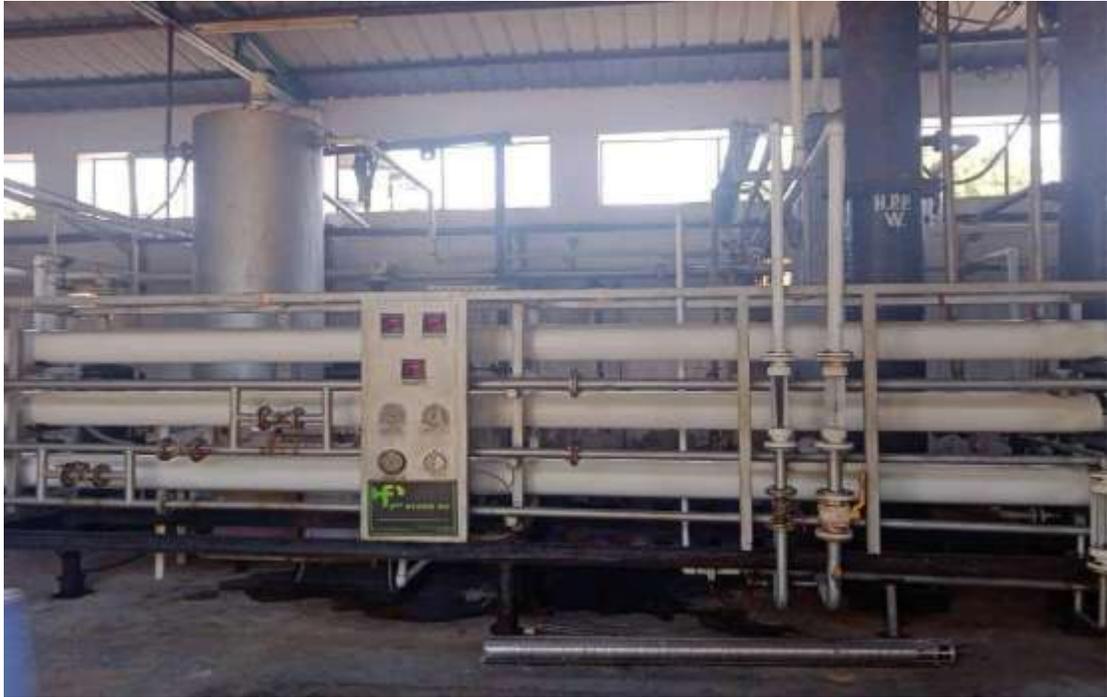
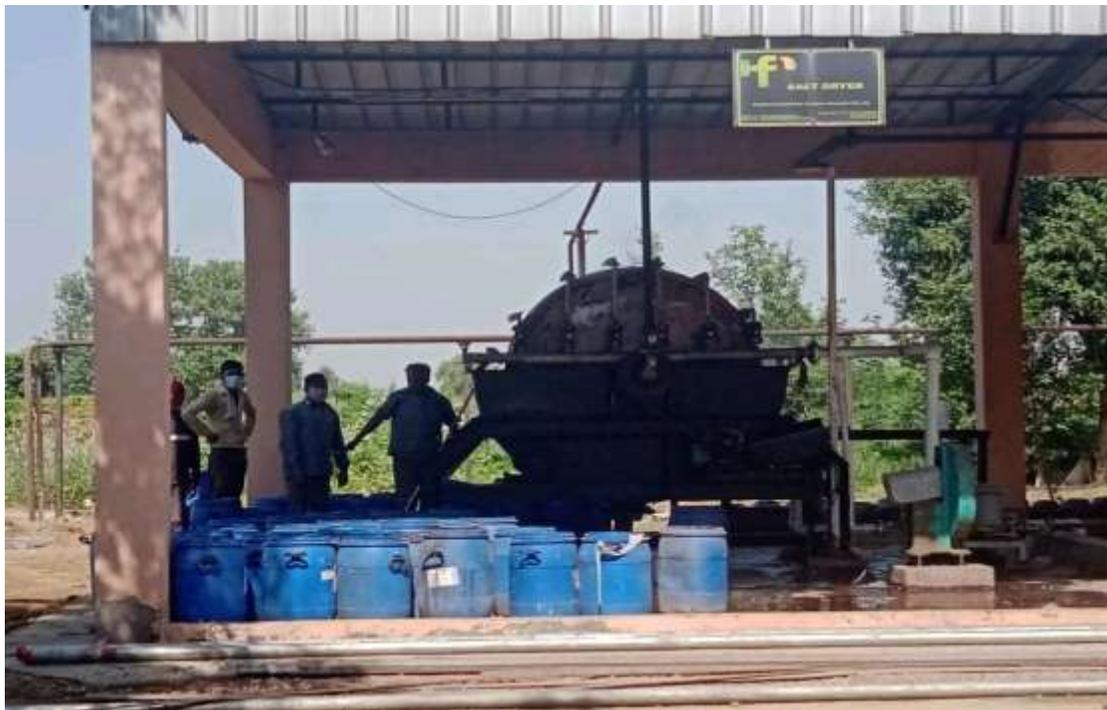
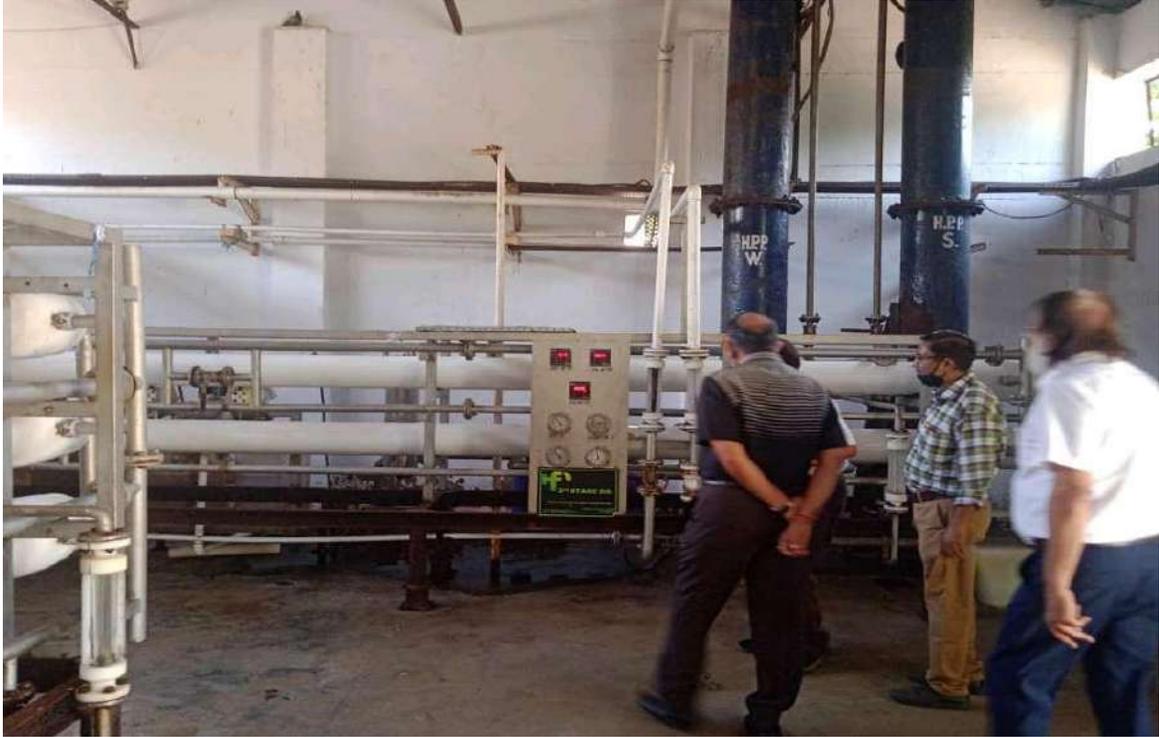
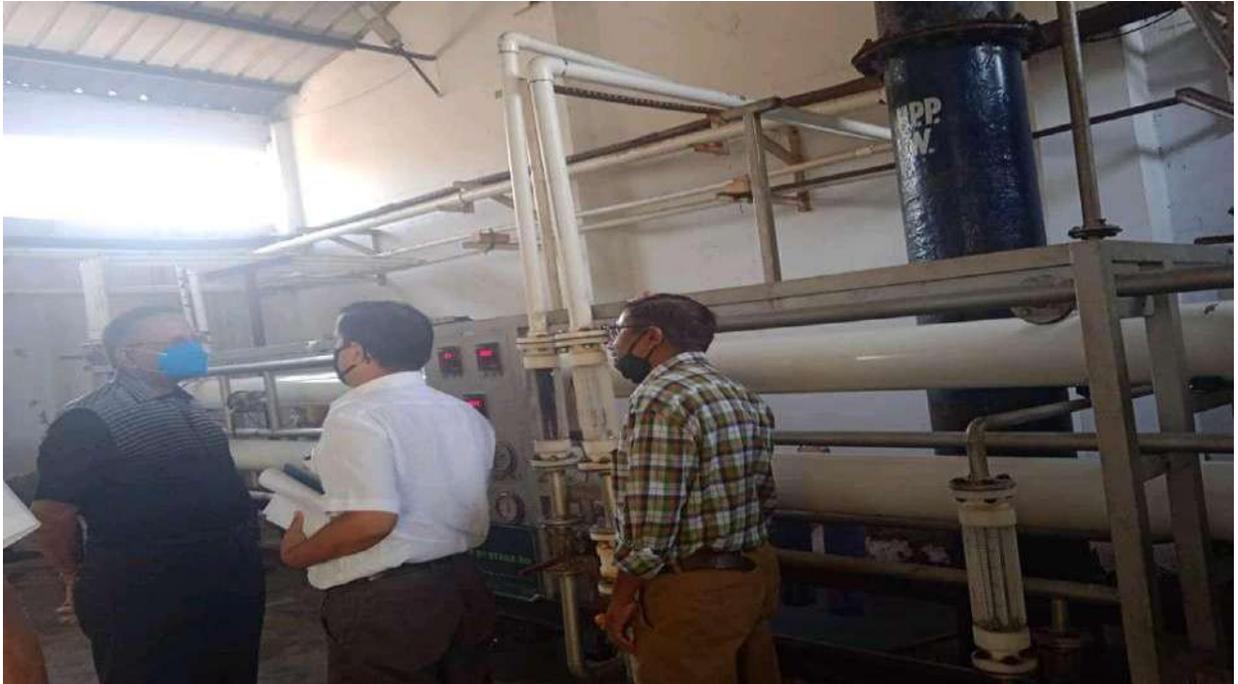
The next day, I went to visit Kosi drain. Kosi is an industrial town about 40 km away from Mathura. For certain reasons, several industries were closed. I was told that all the running industries are having their own ETPs. I went to see the ETP of Ginni Fillament factory which is said to be the biggest industry of Kosi. On the back side of this factory, the ETP is situated. It's a huge ETP. On enquiry the representative of the company told me that they maintain zero liquid discharge. Treated water is further treated in a big RO plant at three different levels with the help of three different but interconnected machines. There was a meter at the exit point which shows that the TDS of the treated water at the time of inspection was around 50. Out of total treated water 40% is reused in the factory and some water is used in the agricultural land of the company which is situated adjacent to the factory. If still the treated water remains then it is discharged through drain. In the ETP, inflow and outflow meters are fixed and at the end point, there is a panel which shows the quality of the water that comes out after treatment. All the parameters that were displayed were within permissible limits. Some photographs taken there are attached below. Representative of the company told me that they have incurred about Rs 9 crores to establish this plant. Some photos taken there are as under.

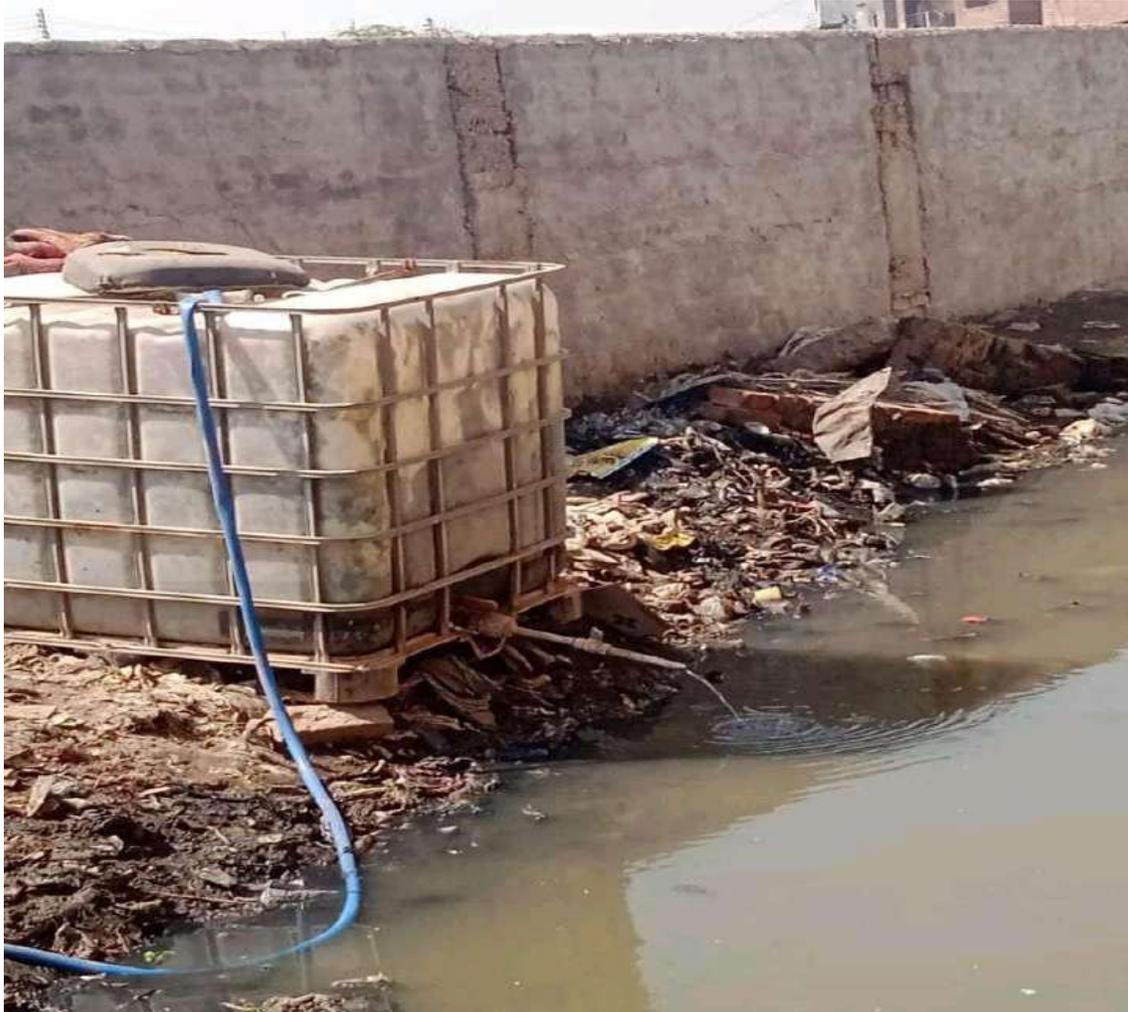
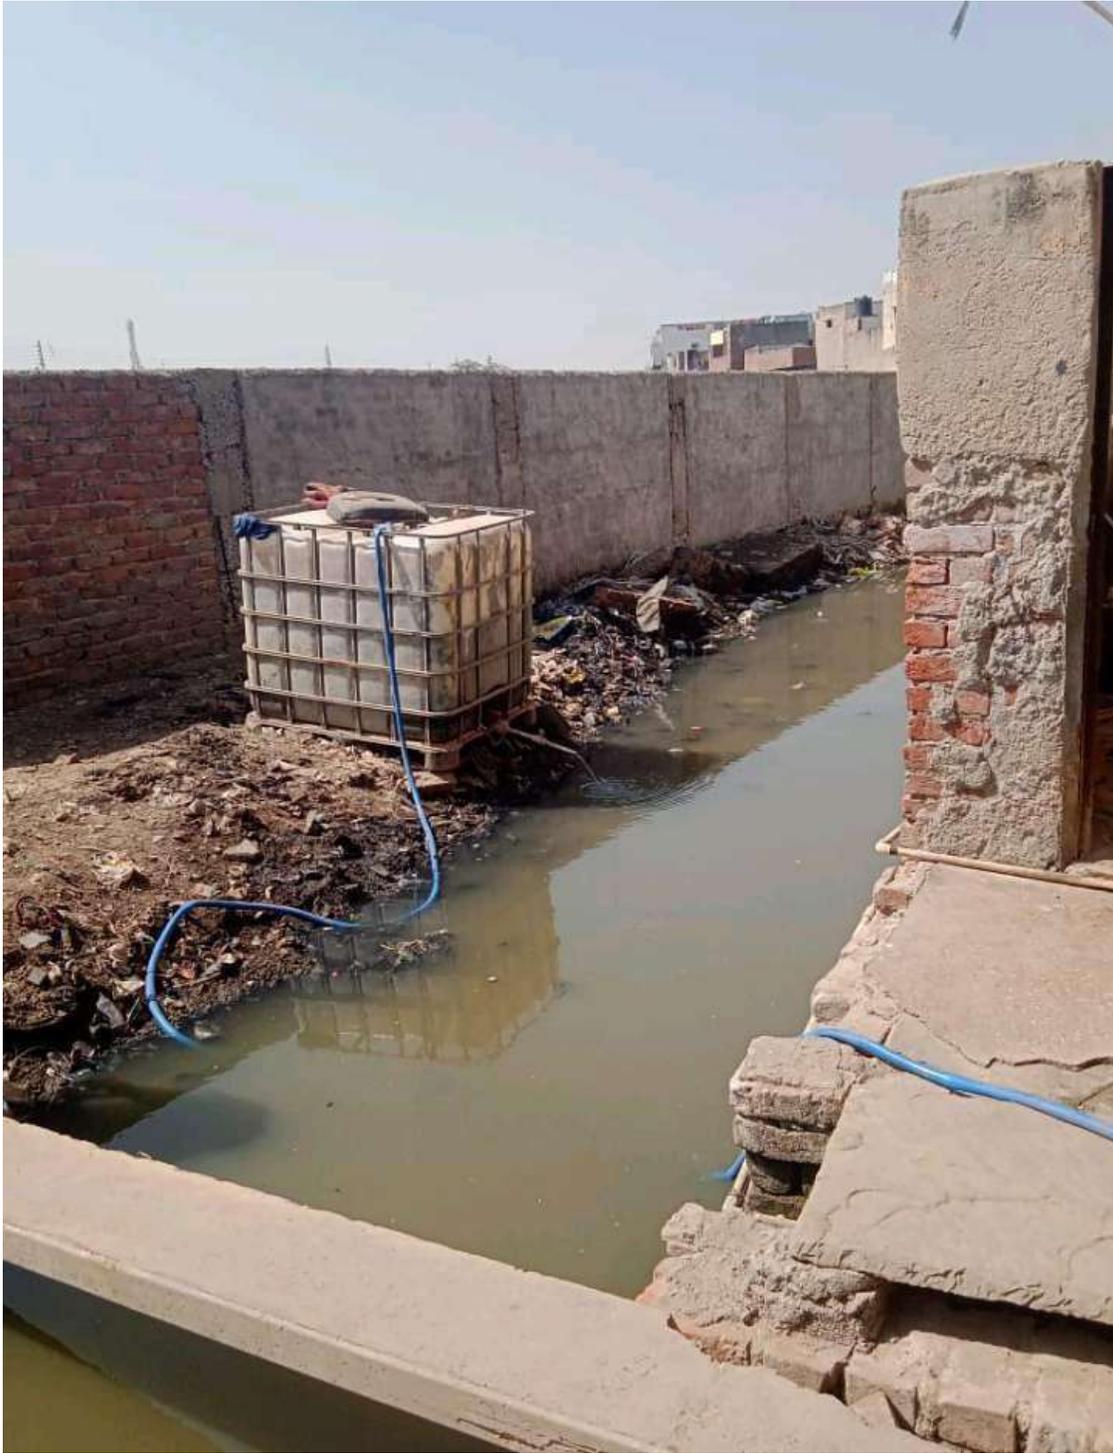
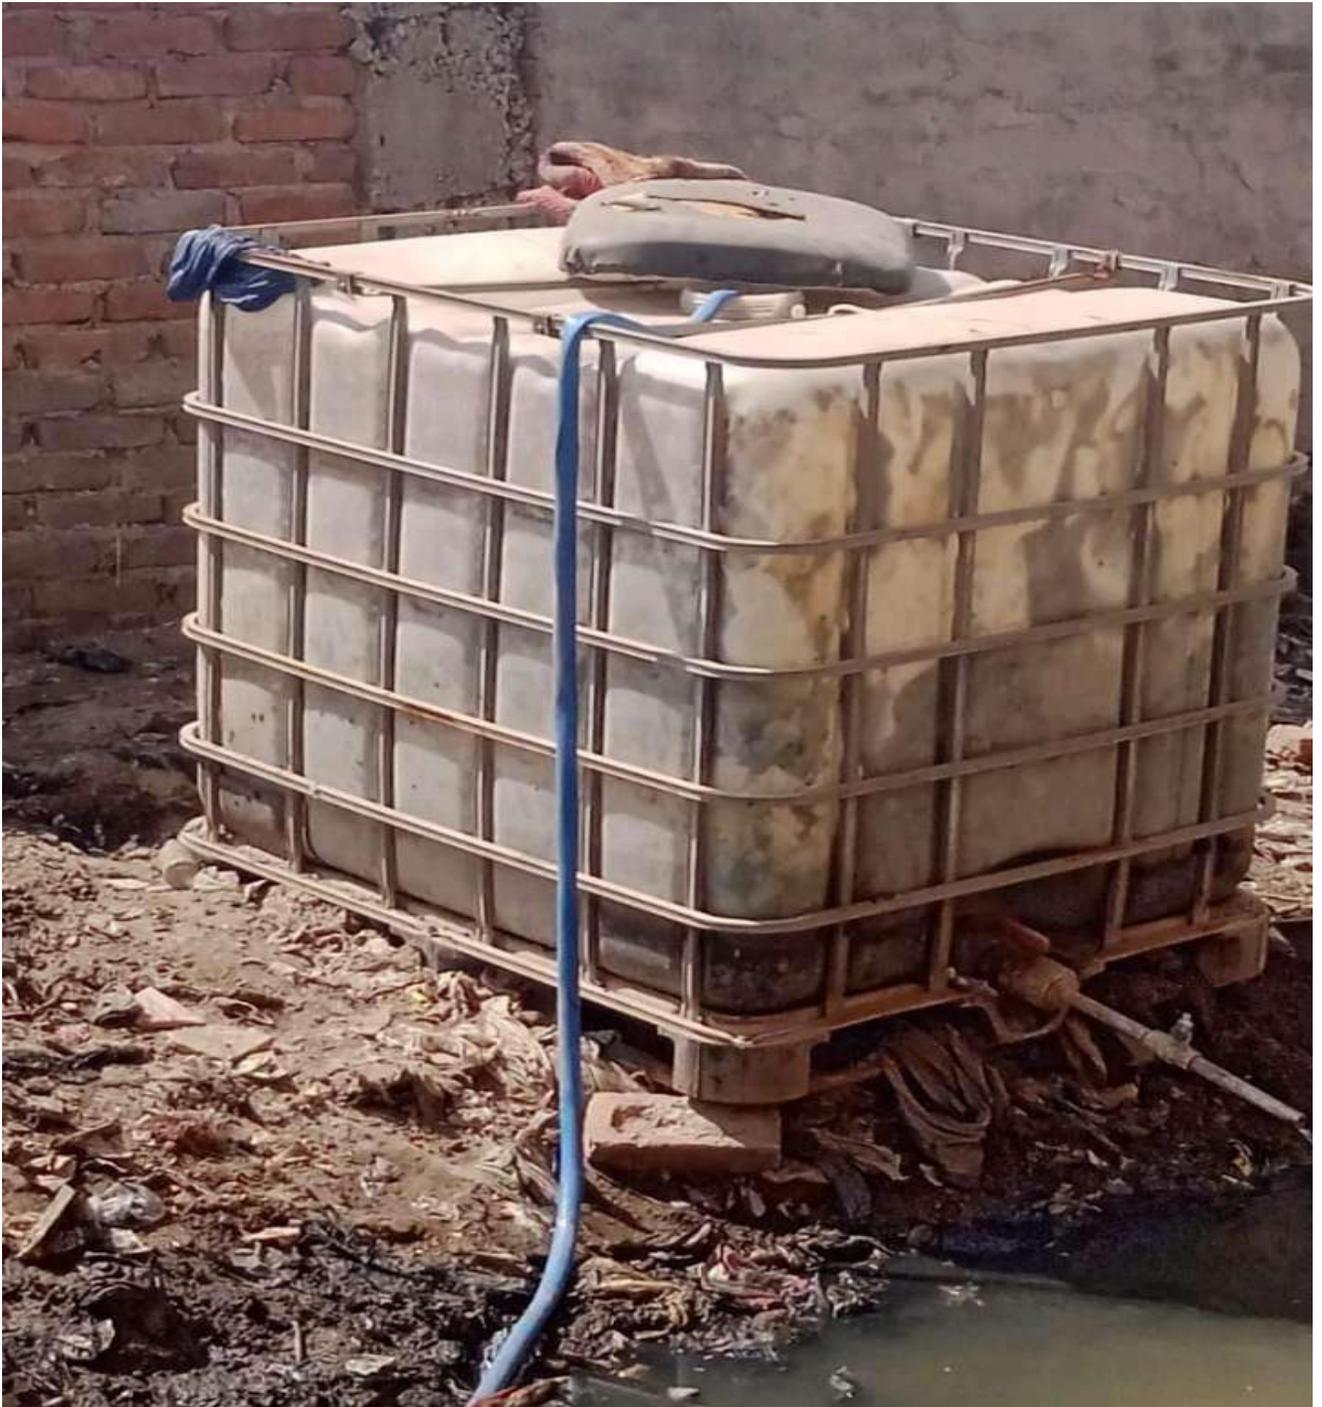
Thereafter Dr Kalpana Arora took me to the two domestic drains of Kosi town. Both were small drains and bioremediation work was being done in the same manner. In all the small drains, bandha was also made by placing the sand bags. At some places dosing work was being done by jetting. Some photographs are attached hereunder. Direction was given to the authorities concerned to remove the deposited waste on the sides of the drain without further delay otherwise it will obstruct the smooth flow of drain after some time.

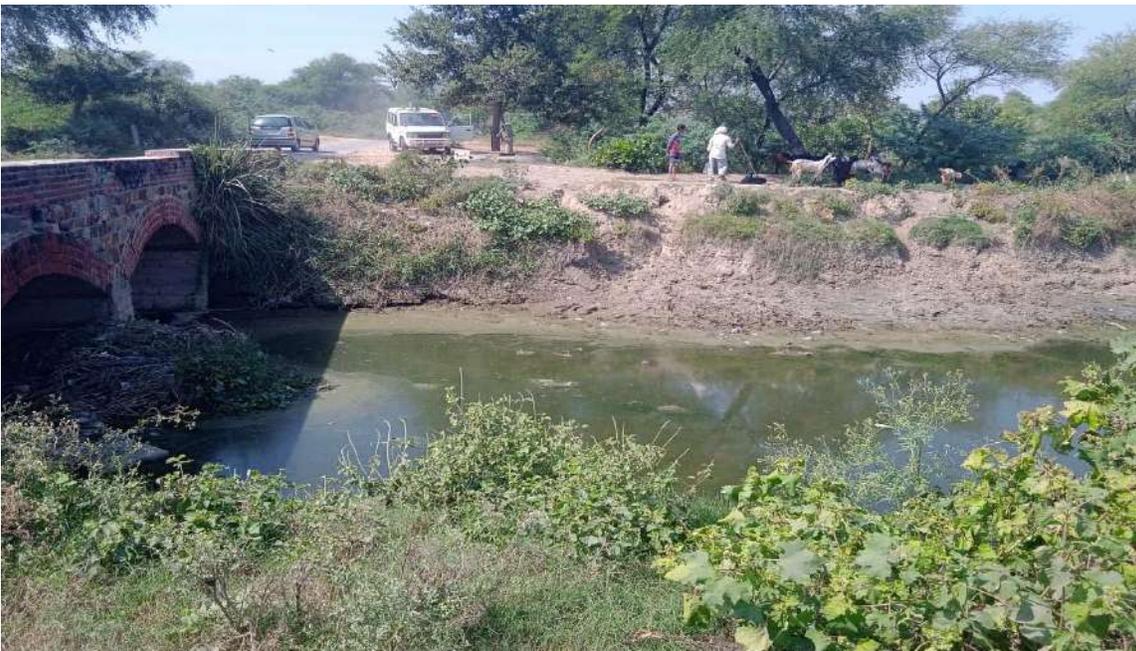
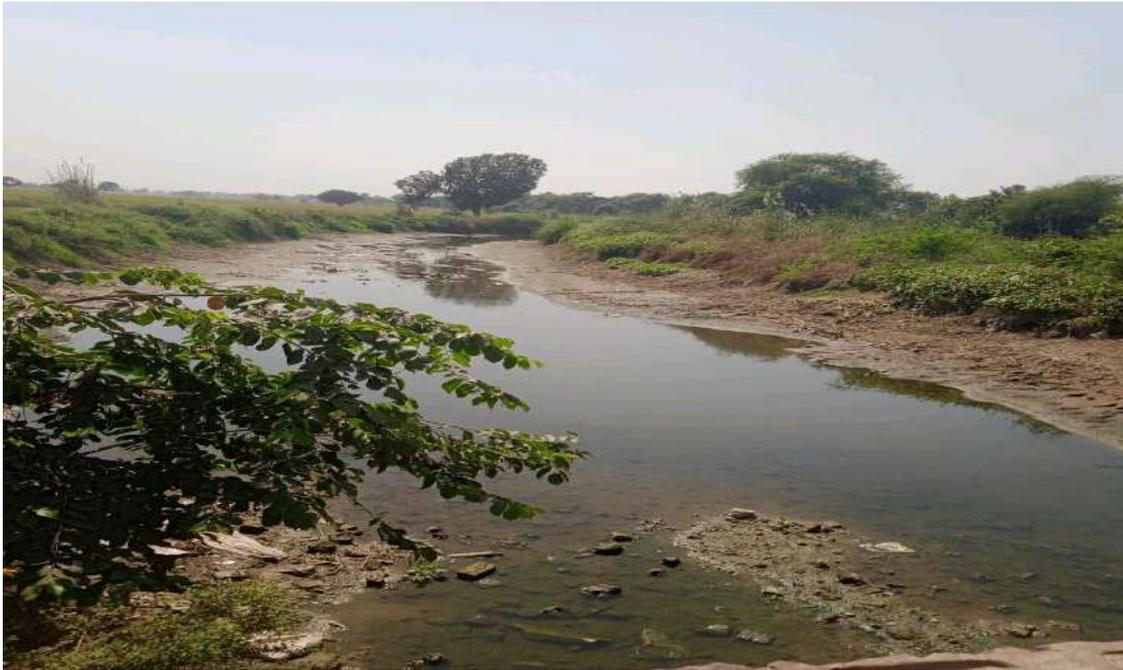
In the last I went to Kosi Drain. I was informed that the road leading to the Kosi drain start point is bad at present. However, I asked the officers to show me some point of Kosi drain. I was taken to a place situated in agricultural area all around it. At that point, three water channels were present. 1<sup>st</sup> was a Rajbaha (sub canal ). Parallel to it was Agra irrigation Canal and thereafter there was Kosi drain. At the time of inspection of Kosi drain, there was almost no water in the drain. There was absolutely no flow in it. It was informed that sometimes the water is released in this drain from the Agra canal. Said water is used by the agriculturists for irrigation purposes. At that point, there was a very little water in the Agra canal and also in the Rajbaha. After running parallel to Kosi Drain for some distance, the Agra canal turns towards NH 2. Kosi drain runs straight for some distance and there after it turns towards Vrindavan and merges in Chaitanya Vihar drain. Sunrakh drain also meets in it. Domestic discharge of Kosi town and treated Industrial discharge of industries also meets in it. I was informed that the Agra canal sometimes discharges its over flow into Kosi drain and then only the water level in the drain increases. Some photographs taken on that point are as below:
