OFFICE OF THE MONITORING COMMITTEE

Subject: Final report of the eight member Joint Committee, constituted by Hon'ble National Green Tribunal, under the Chairmanship of Justice Pritam Pal, former Judge of Punjab and Haryana High Court and now as Chairman of the Monitoring Committee regarding verification of the facts with regard to illegal mining in forest- area, mining area and unscientific mining in mining area by M/s Govardhan Mines and Minerals, Tosham, District Bhiwani in compliance to order dated 20.07.2021 and 18.1.2022 in OA No. 169 of 2020 in the matter of Kuldeep Singh V/s State of Haryana & others.

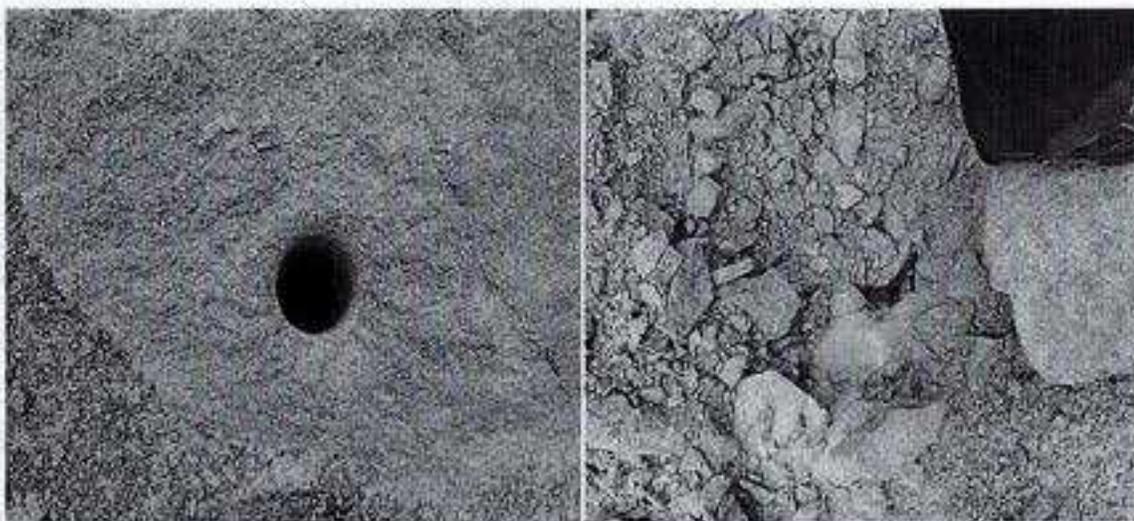
The photographs showing the bore drill holes constructed in forest area within and beyond 6 m wide pathway are mentioned as per **plates 1 and 2**. Also, the photographs, taken by Department of Forest at the time of filing FIR and seizing of vehicles, were shown to the subcommittee, and the same are mentioned as **Plates 3 to 6**.

Plates 1 and 2: The photographs showing the bore drill holes constructed in forest area within and beyond 6 m wide pathway

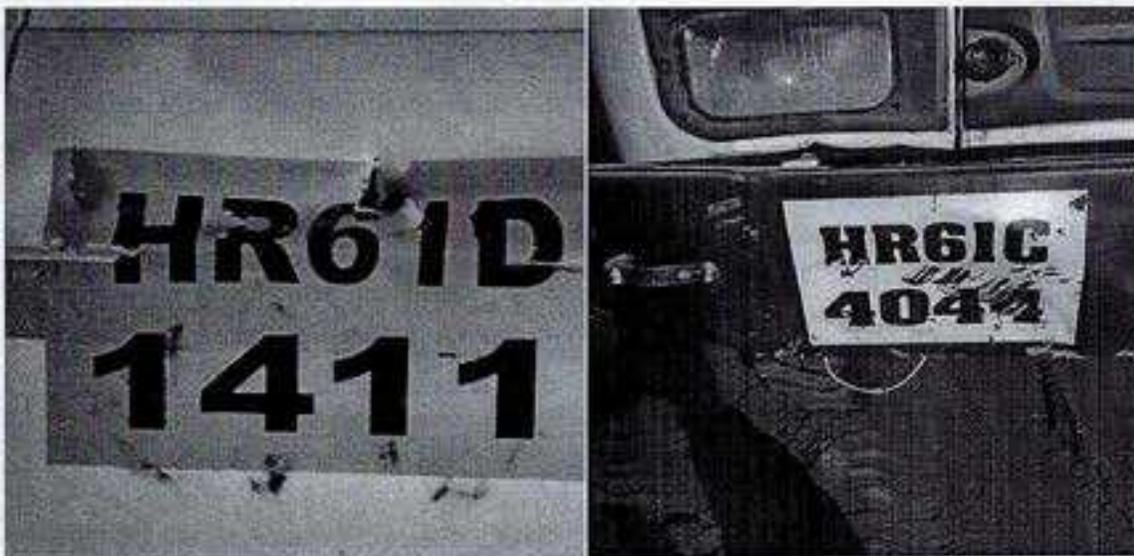
Plates 3 and 4: Vehicles used for carrying illegal mined material on the day of filing FIR against the person.

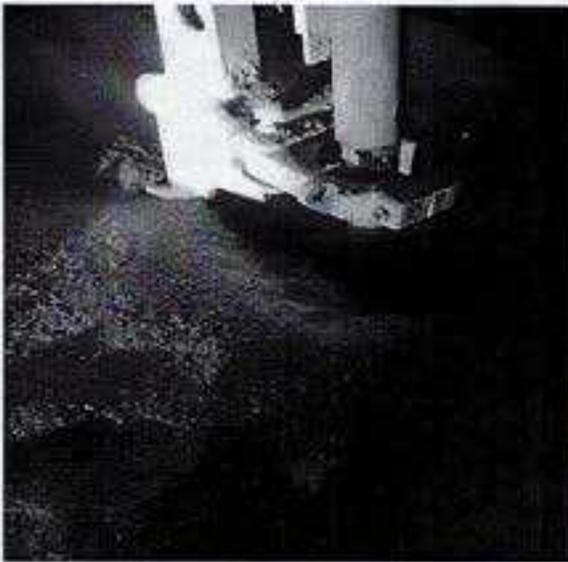
Plates 5: Drill machine used for making holes with an intention to conduct illegal mining.

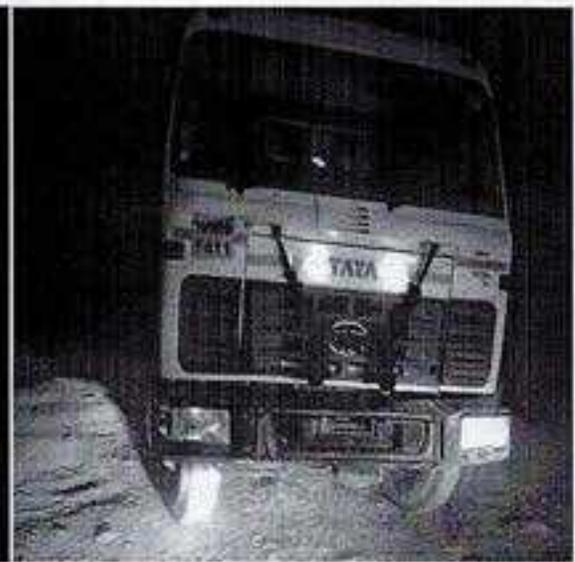
Plate 6: Vehicle found standing with an intention to carry mined material.

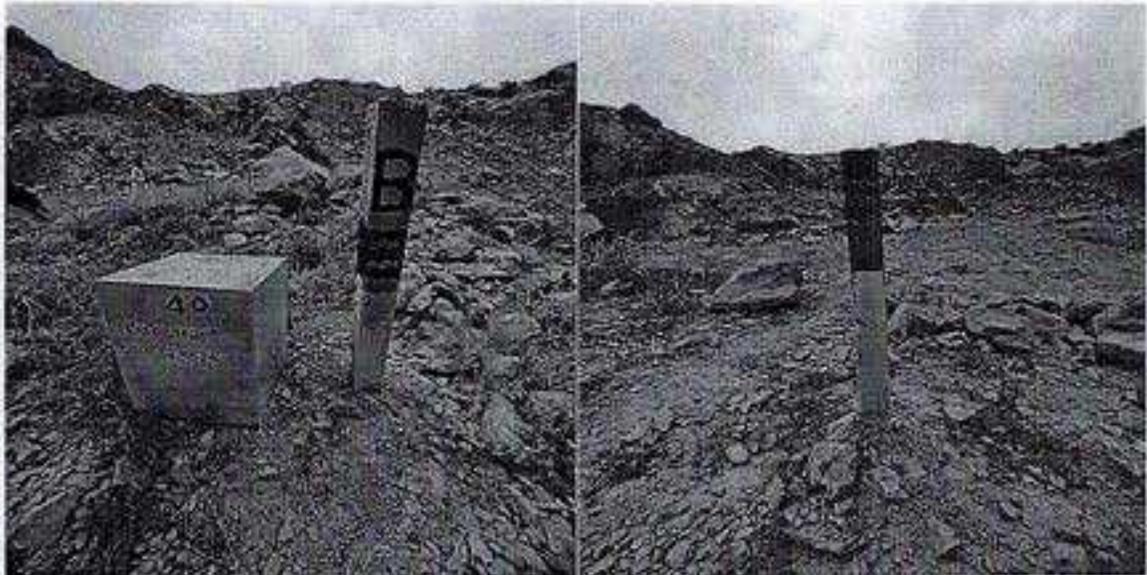
The Photographs, showing the pillars demarcating the forest and non forest area, illegal mining done at site in an approximate area of 0.8 hectares, are mentioned as per **Plates 7 to 10.**

Plates 7 and 8: Photographs, showing the pillars demarcating the forest and non forest area, where illegal mining has been done in 0.8 hectares in forest area

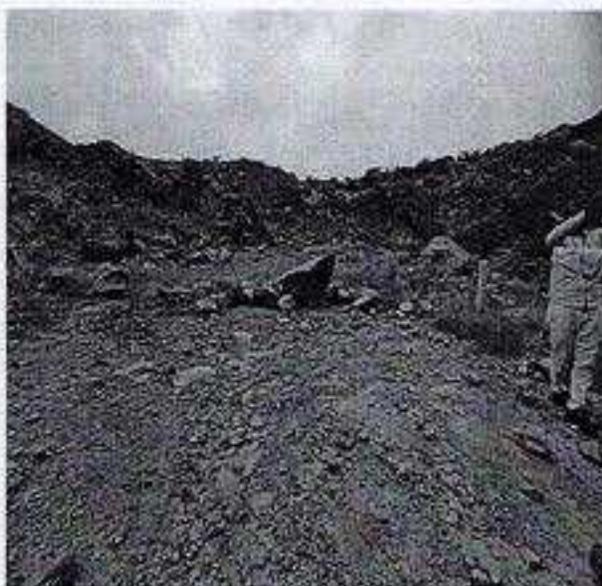
Plate 9: Photograph showing forest area where illegal mining in 0.8 hectares has been done

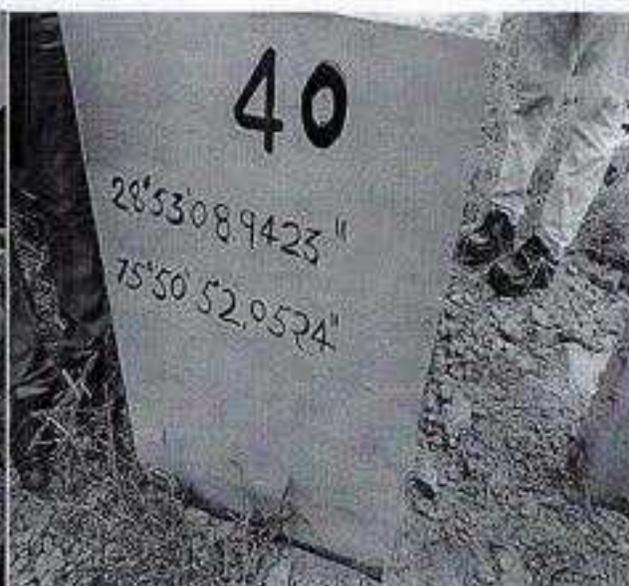
Plate 10: Photograph showing pillar demarcating forest and non-forest area

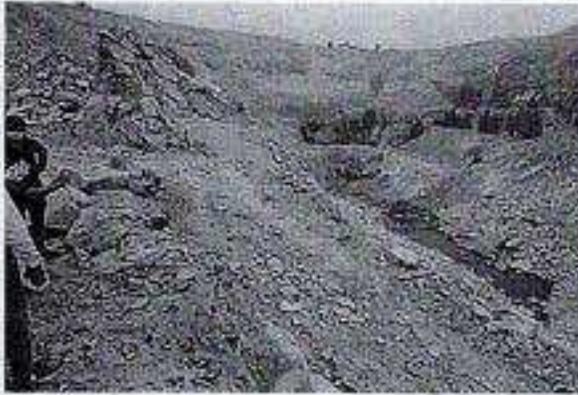
The subcommittee also observed that water was found stagnated in the form of pond at the bottom of the mining site. The photographs, showing various features at site and water stagnating in the form of pond in deep mined area, where stone mining has been done up to the depth of 109 m, are mentioned as per **Plates 11 and 12.**

Plate 11: Photograph showing water stagnating in the form of pond in deep mined area, where mining has been done up to the depth of 109m

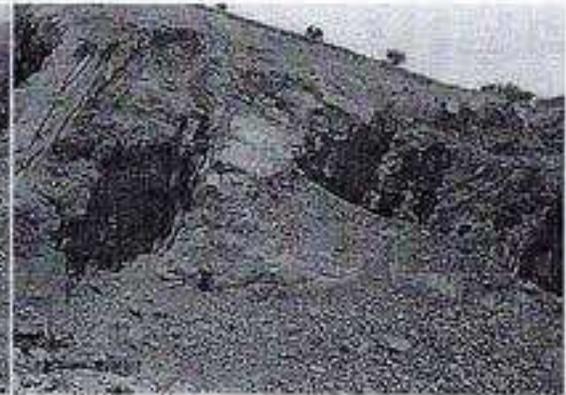
Plate 12: Photograph showing mining done in an area upto the depth of 109 m as measured by department of Mines and Geology, Haryana

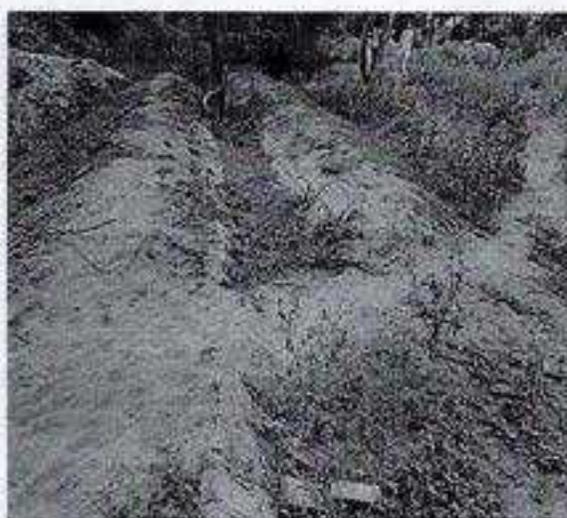
Plate 13: Photograph showing distributary/ Minor in existence

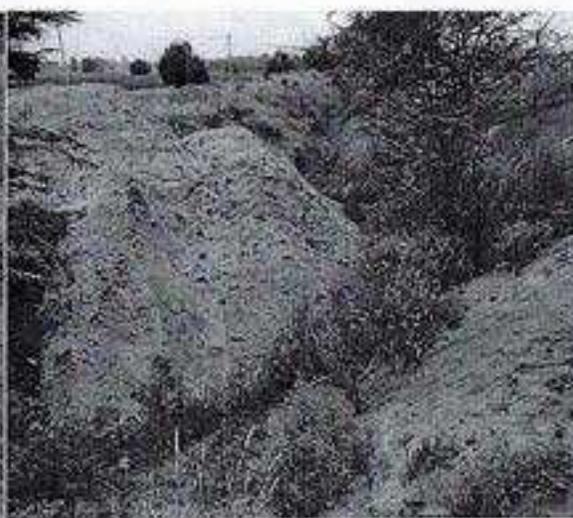
Plate 14: Photograph showing the damaged distributary/ Minor underneath the overburdened material

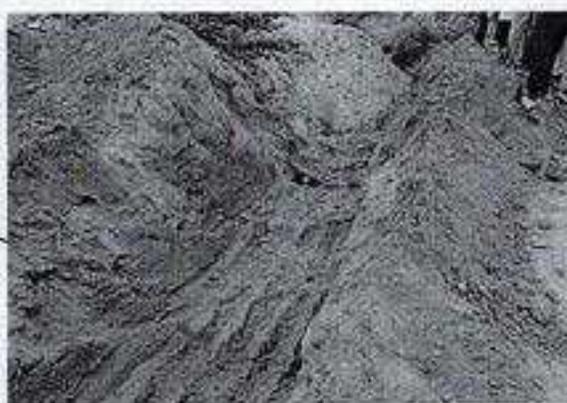
Plate 15: Photograph showing distributary/ Minor underneath overburdened material but cleared on the day of visit to show its existence to the committee.

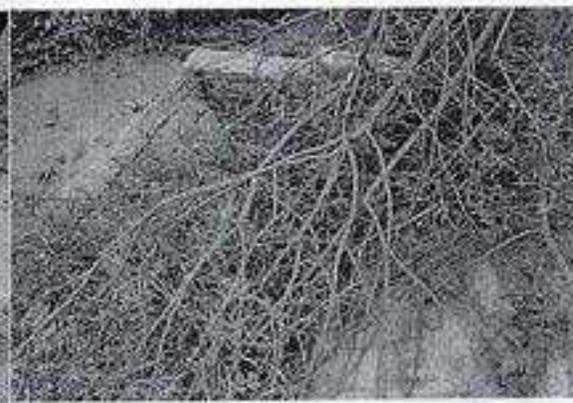
Plate 16: Photograph showing the end of distributary/ Minor.

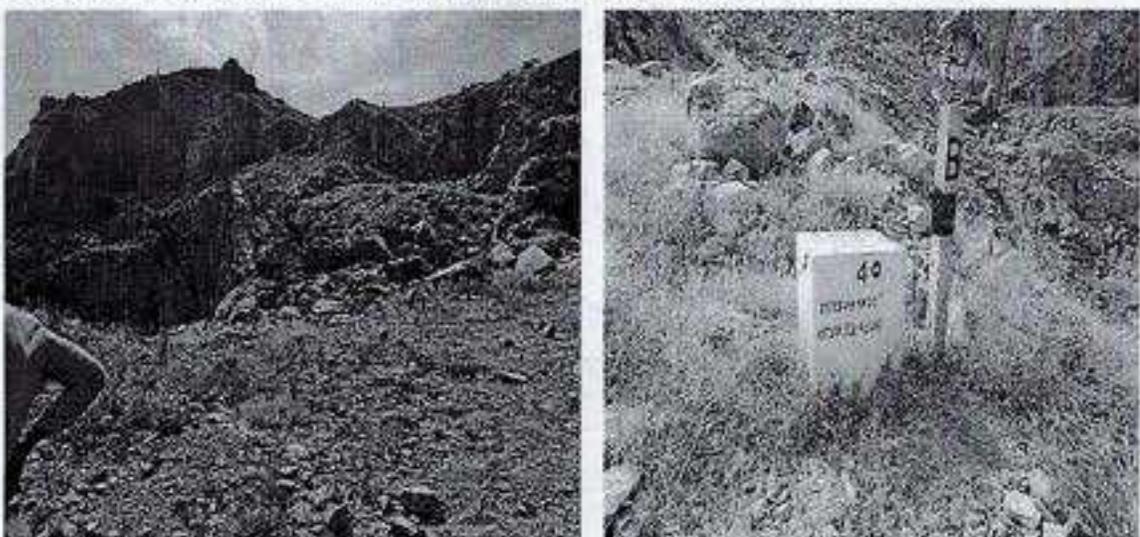
The photographs showing illegal mining done in front of pillar B (0.8 hectares of area) are mentioned as per plates 2 & 3, are mentioned as under.

Plates 2 & 3 : Photographs showing illegal mining done in 0.8 hectares of area

After inspection of the site, the Chairman of the Joint Committee directed that HARSAC, Hisar shall complete the study and submit the report based on satellite imageries so as to sort out the issue with regard to illegal mining in an area of 0.8 hectares at the earliest.

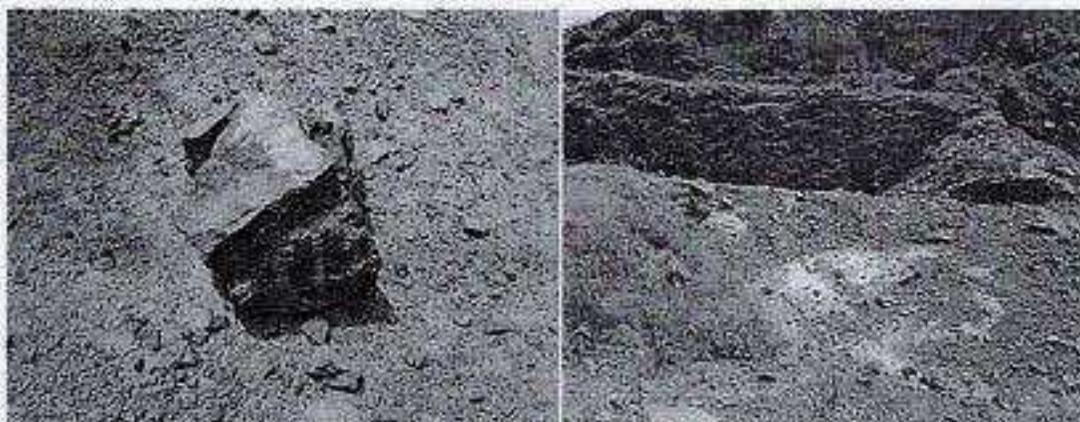
The photographs showing illegal mining in an area of 300 m² are mentioned as per plates 4 & 5, given below.

Plate 4 & 5 : Photographs showing illegal mining in an 300 m² of area

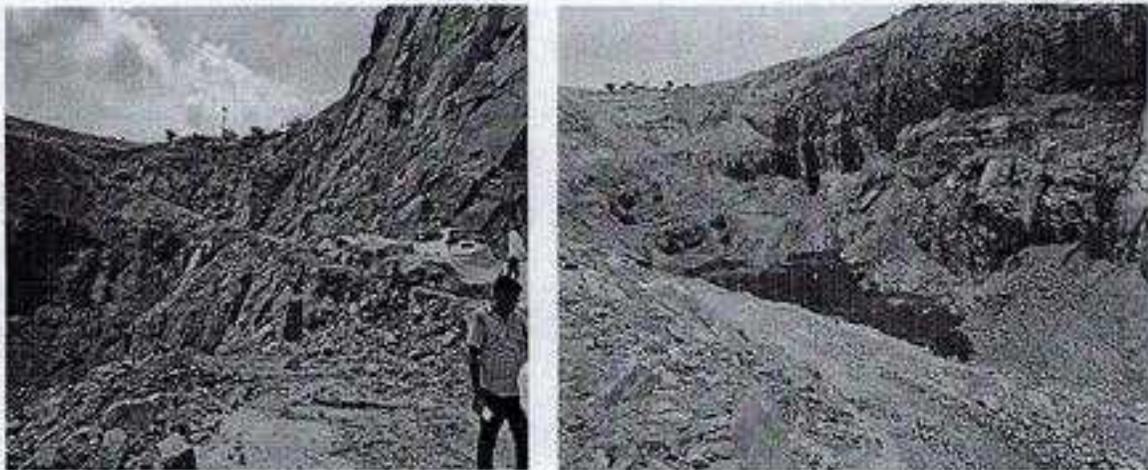
The photographs showing deep mining done upto 109 m in the mining area are mentioned as per plates 6 & 7.

Plate 6 & 7 : Photographs showing deep mining done up to depth of 109 m in the mining area

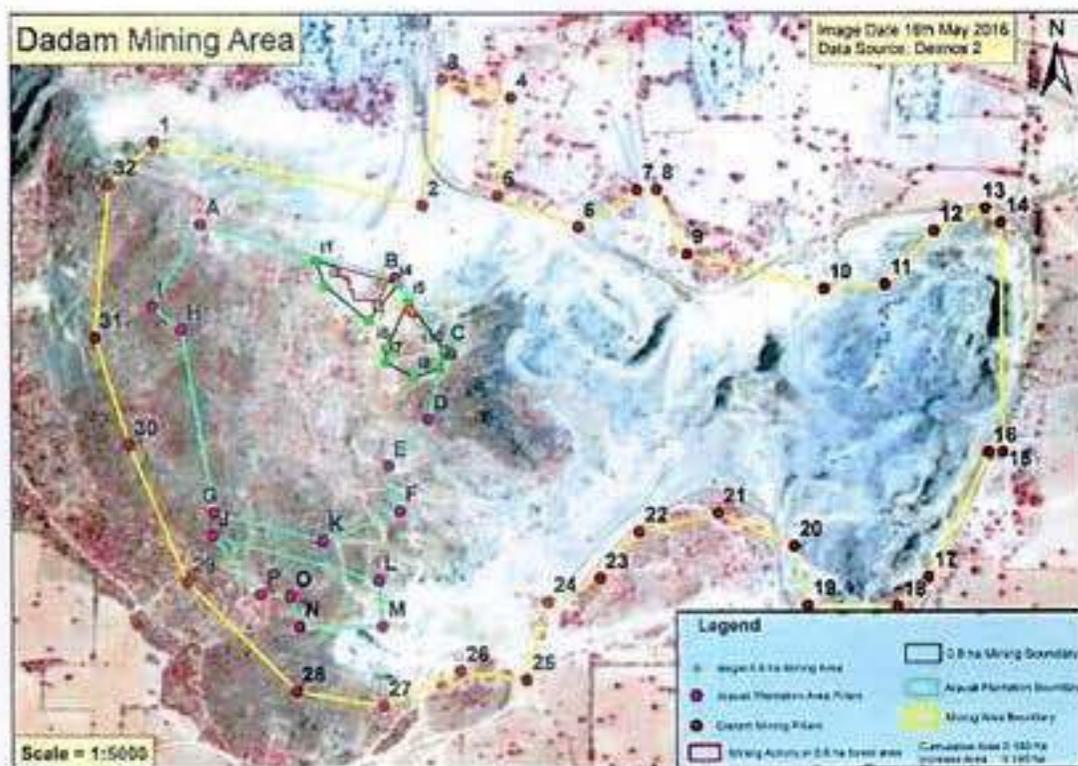
The boundary of 0.8-hectare area in Aravalli plantation is created w.r.t. the GPS coordinated provided by the Forest Department, Bhiwani. It is observed that the mining of 0.180 hectares (1797.95 Sq m) area has been done within the boundary of 0.8 hectare area. The map showing mining within the boundary of 0.8 hectare area on satellite image of dated 16th May 2016 is presented in Figure 3.

Figure 3: Map showing Dadam mining area along with satellite image of 2016

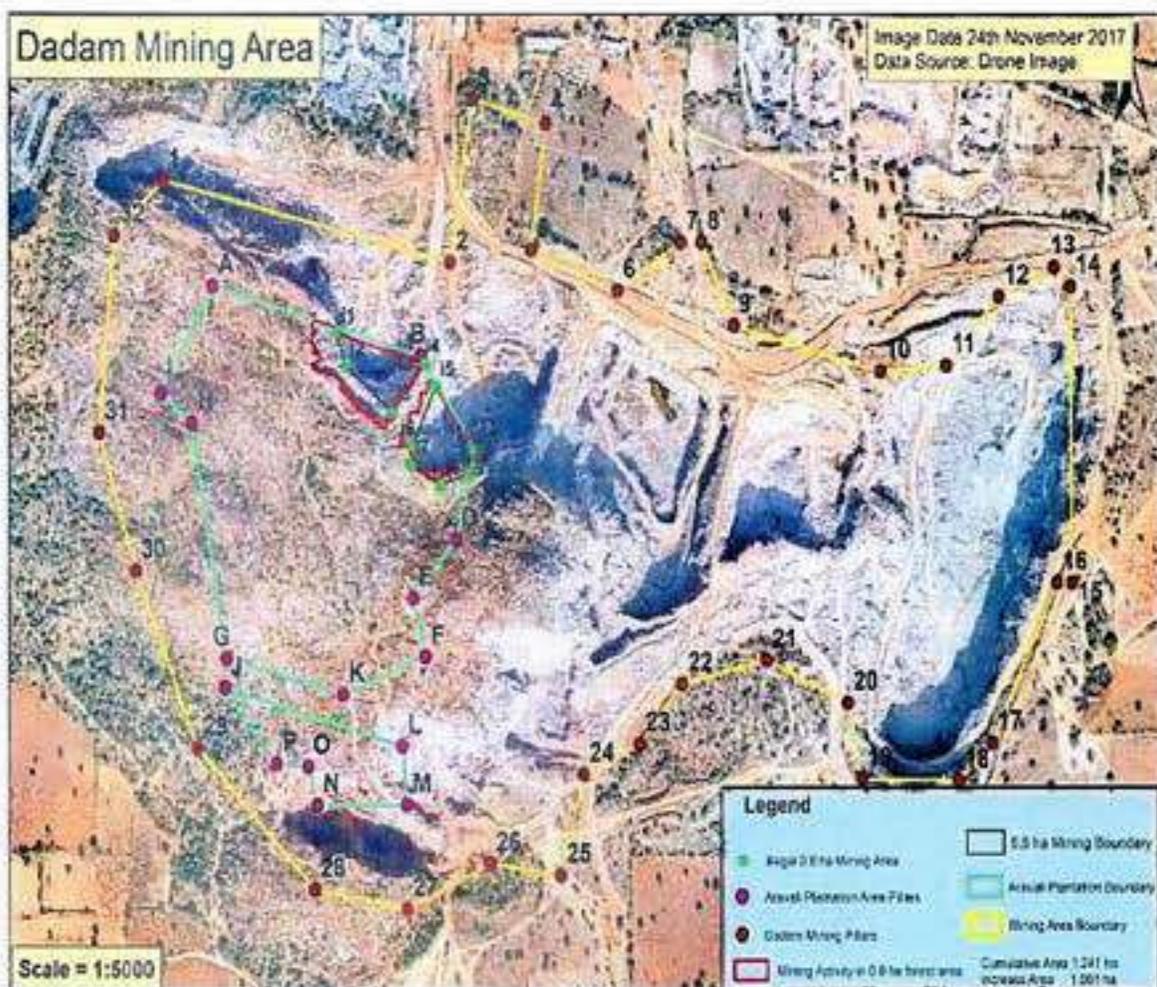
It is observed that 1.061 hectare (10611.31 Sq m) of mining area increased within and outside of the boundary of 0.8 hectare area. The map showing mining within and outside of the boundary of 0.8 hectare area on satellite image of 24th November 2017 and presented as Figure 4.

Figure 4: Map showing Dadam mining area along with satellite image of 2017

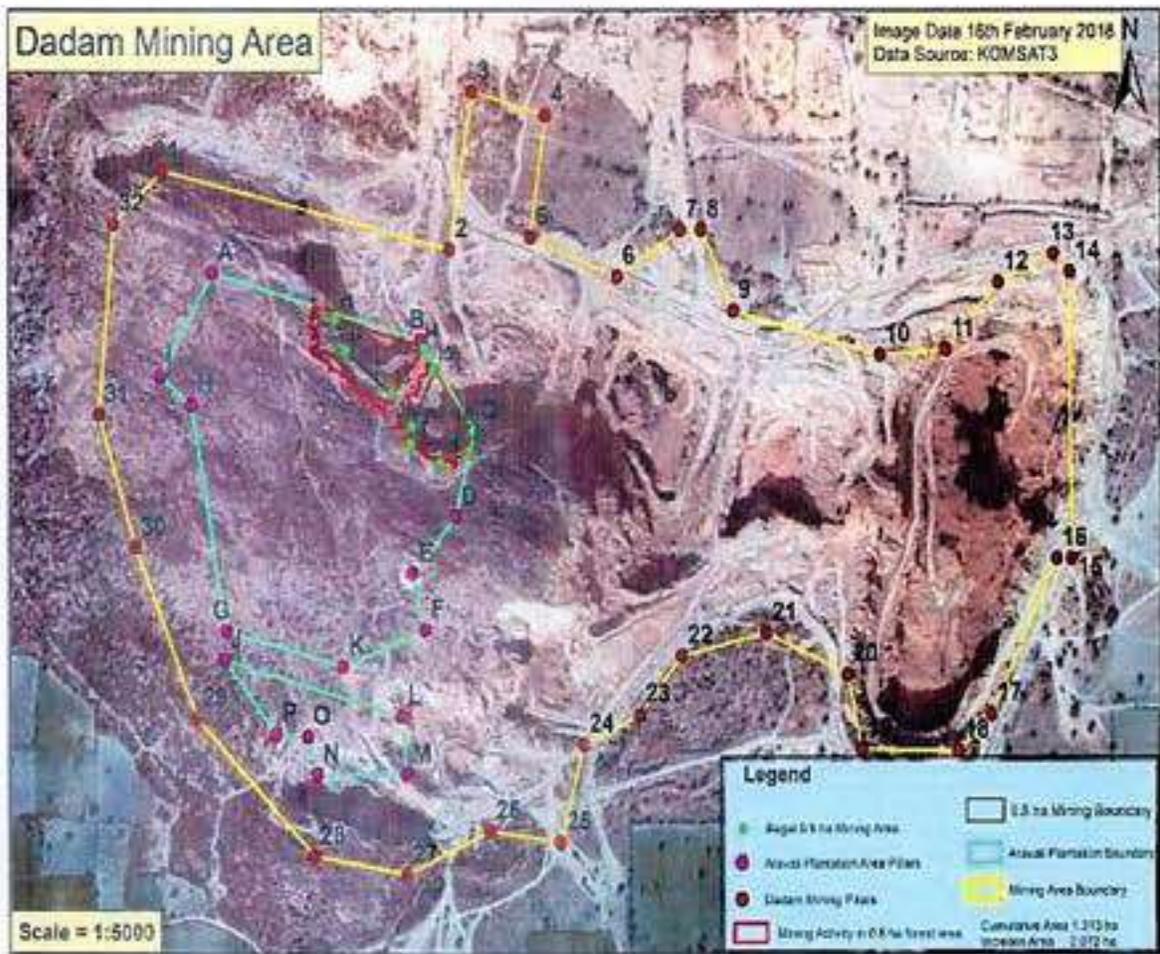
It is observed that 0.072 hectare (720.36 Sq m) of mining area increased within and outside of the boundary of 0.8 hectare area. The map showing mining within and outside the boundary of 0.8 hectare area on satellite image of 16th February 2018 and presented as Figure 5.

Figure 5: Map showing Dadam mining area along with satellite image of 2018.

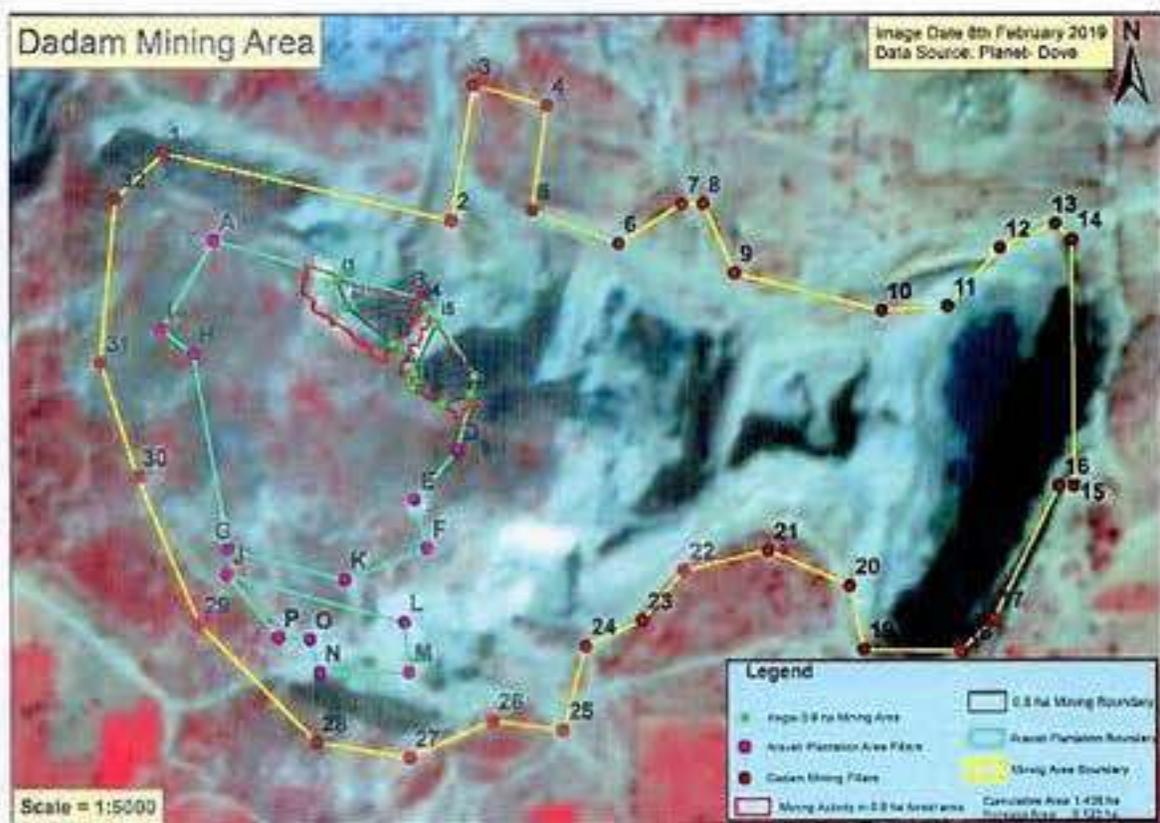
It is observed that 0.123 hectare (1227.780 Sq m) of mining area increased within and outside of the boundary of 0.8 hectare area. The map showing mining within and outside of the boundary of 0.8 hectare area on satellite image of 08th February 2019 as presented in Figure 6.

Figure 6: Map showing Dadam mining area along with satellite image of 2019.

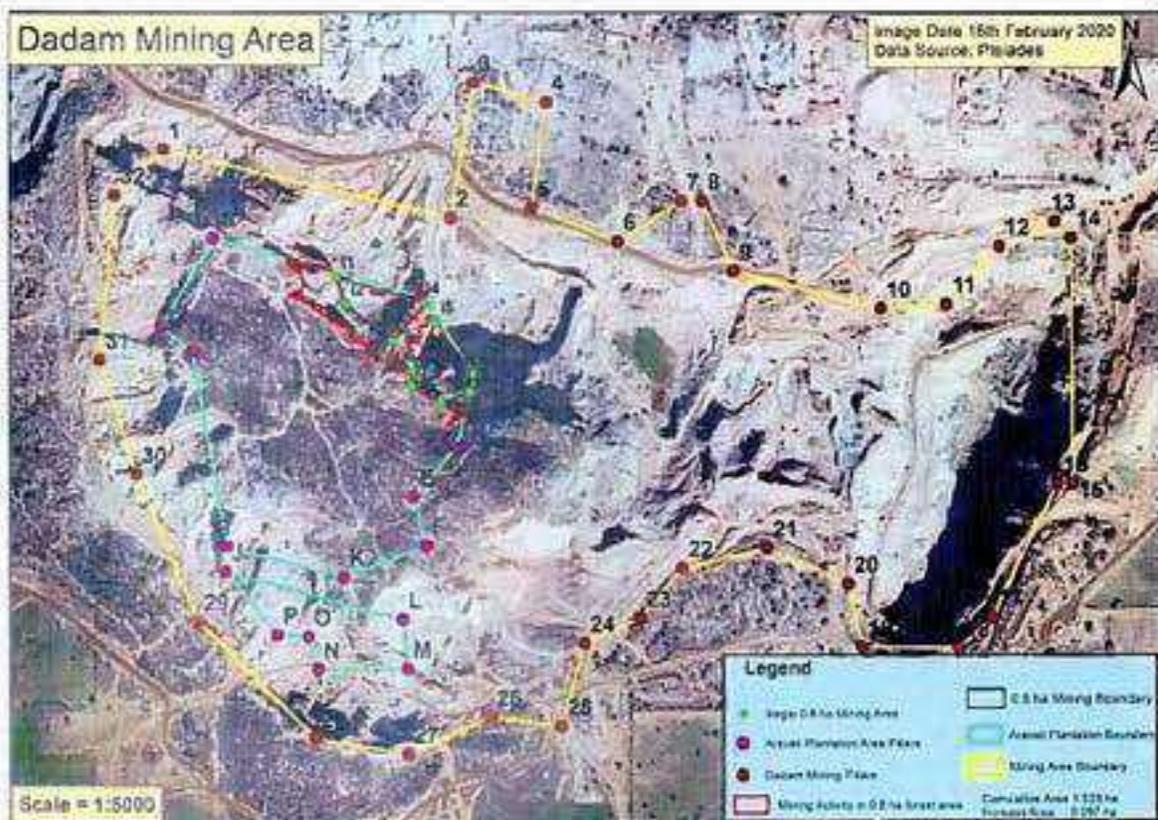
It is observed that 0.097 hectare (972.438 Sq m) of mining area increased within and outside of the boundary of 0.8 hectare area. The map showing mining within and outside the boundary of 0.8 hectare area on satellite image of dated 16th February 2020 and presented in Figure 7.

Figure 7: Map showing Dadam mining area along with satellite image of 2020.

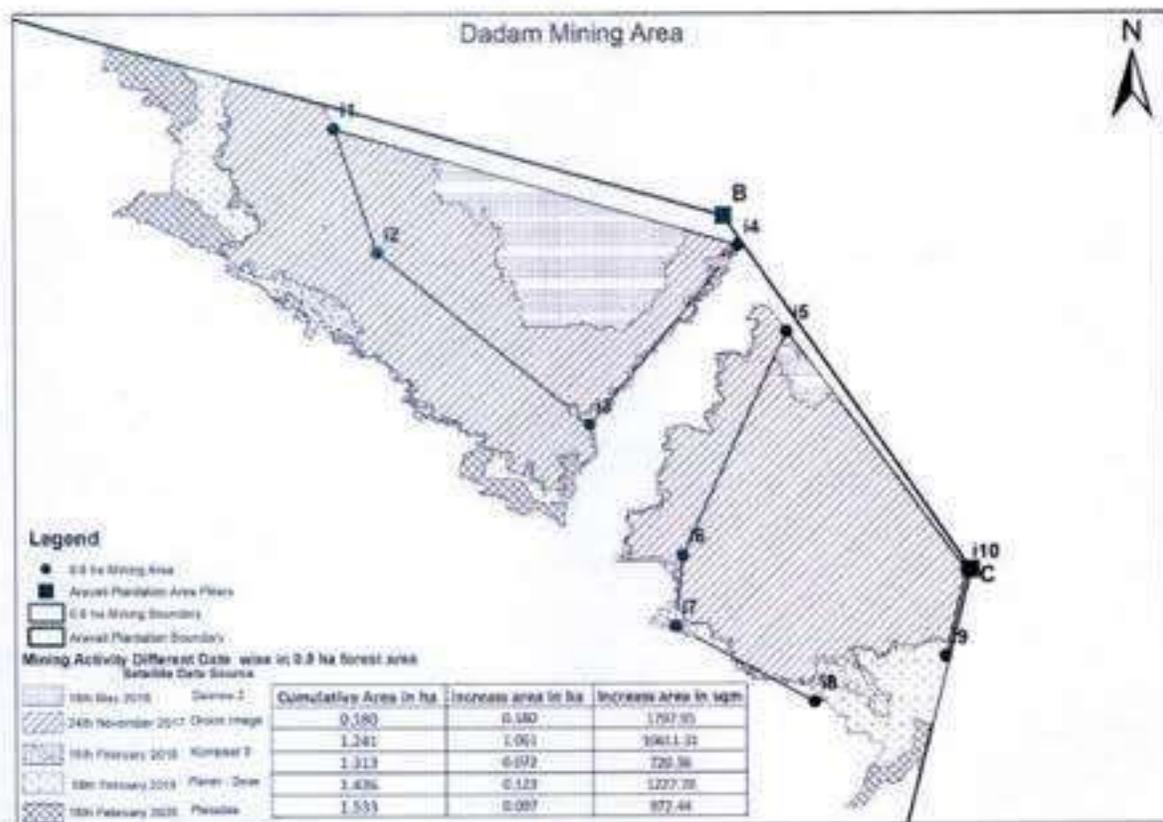
Figure 8: Mining activities identified using satellite data of years 2016-2020

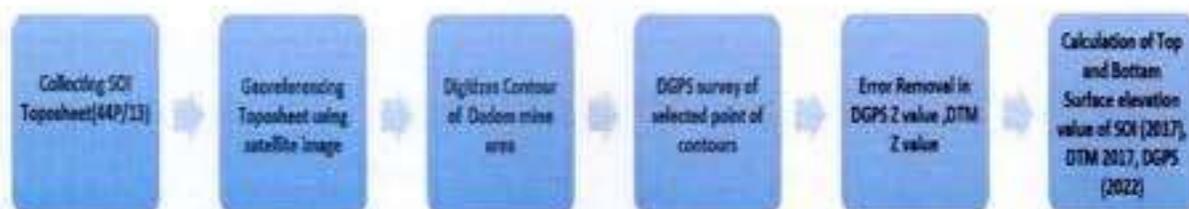
It seems that the DGPS elevation (Z) value is high (approximately 2m) from the SOI toposheet contours. The observed value of Drone-based Digital terrain model (DTM) for 2017 and DGPS surveyed points (Nov. 2021 to Feb. 2022) are subtracted by a value of 2 m to correct the Z value of DTM 2017 and DGPS surveyed points. The flow chart of adopted methodology is shown in Figure 9.

Figure 9: Methodology for calculation of Z value

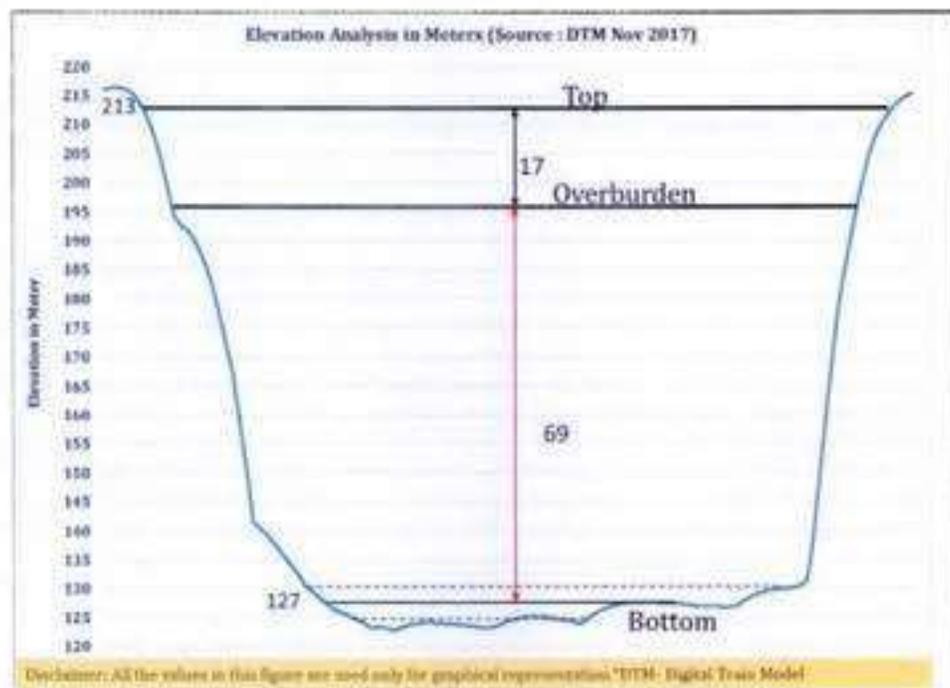
Figure 10: Graphical representation of Depth under various sections including Top, Overburden, bottom and mining depth for year 2017

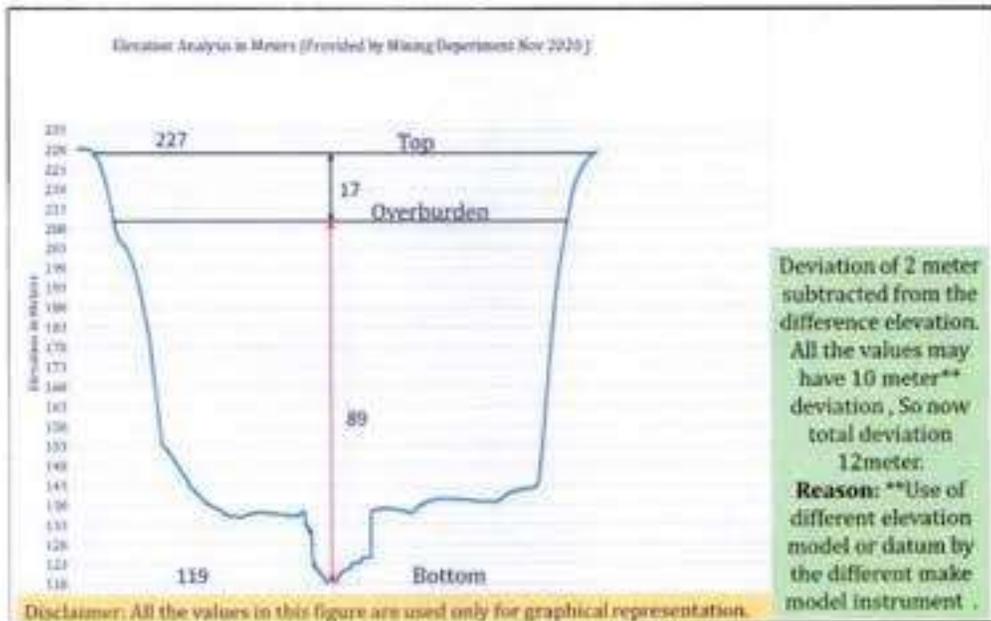
The elevation difference reported by the Mining/forest department Haryana i.e. 109 m seems to be 97 m instead of 109 m due to the tolerance of 12 m as per the reference of Survey of India (SOI) as shown in Figure 11.

Figure 11: Graphical representation of Depth under various sections including Top, Overburden, bottom and mining depth for year 2020

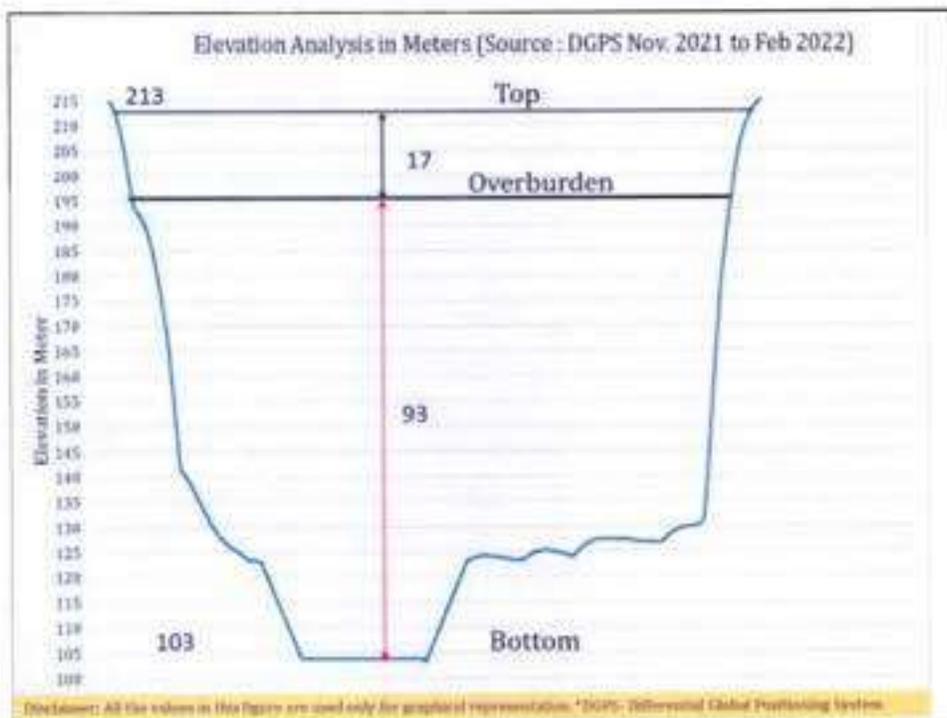
Figure 12: Graphical representation of Depth under various sections including Top, Overburden, bottom and mining depth for Nov. 2021 to Feb-2022

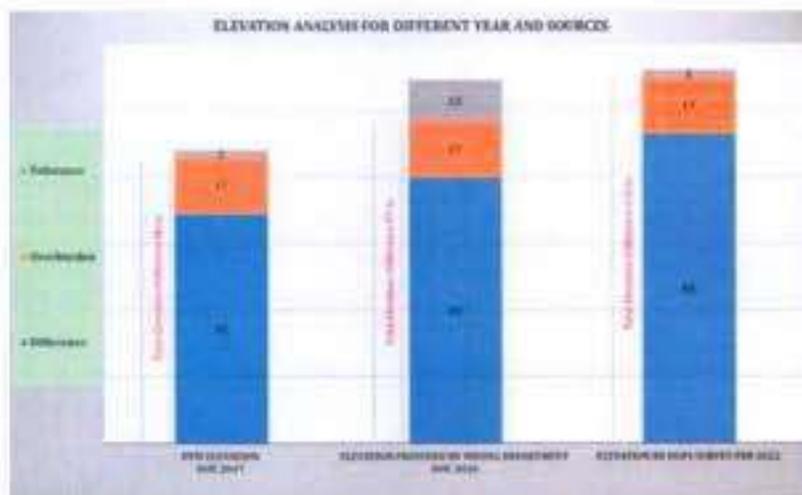
The comparative assessment of the elevations from different sources is presented in Figure 13. It is found that the depth of mining pit without overburden is 69 m in 2017, 80 m in 2020 and 93 in 2021-22.

Figure 13: Graphical representation of Depth under various sections including Top, Overburden, bottom and mining depth for Nov. 2021 to Feb-2022

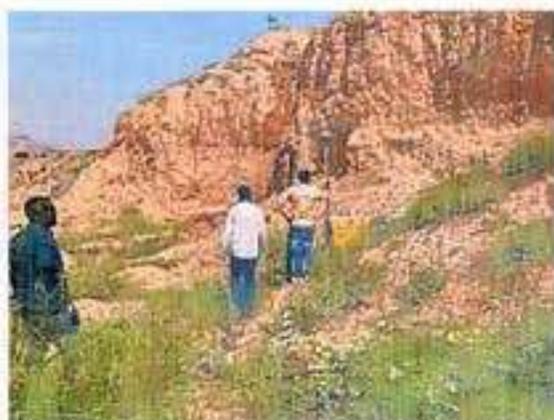
During the field survey, the HARSAC team measured the overburden height of the mining area at pillars no. 15 (as shown in Figure 14) and no. 16 (as shown in Figure 15) by DGPS instrument. It seems that the overburden height is varying in different locations due to the different thicknesses of sandy soil composition on stone. The overburden is measured by the visual interpretation of DSM, contours and DGPS survey point and onsite interpretation. Maps showing overburden on the site in 3-dimension from different angles are presented in Anneure-35.

Figure 14: Overburden measurement at pillars no 15.

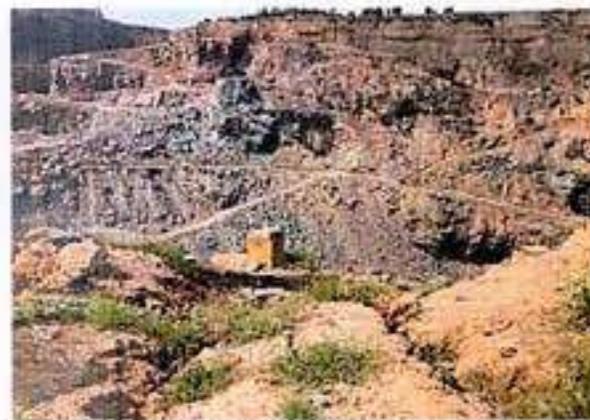
Figure 15: Overburden measurement at pillars no 16.

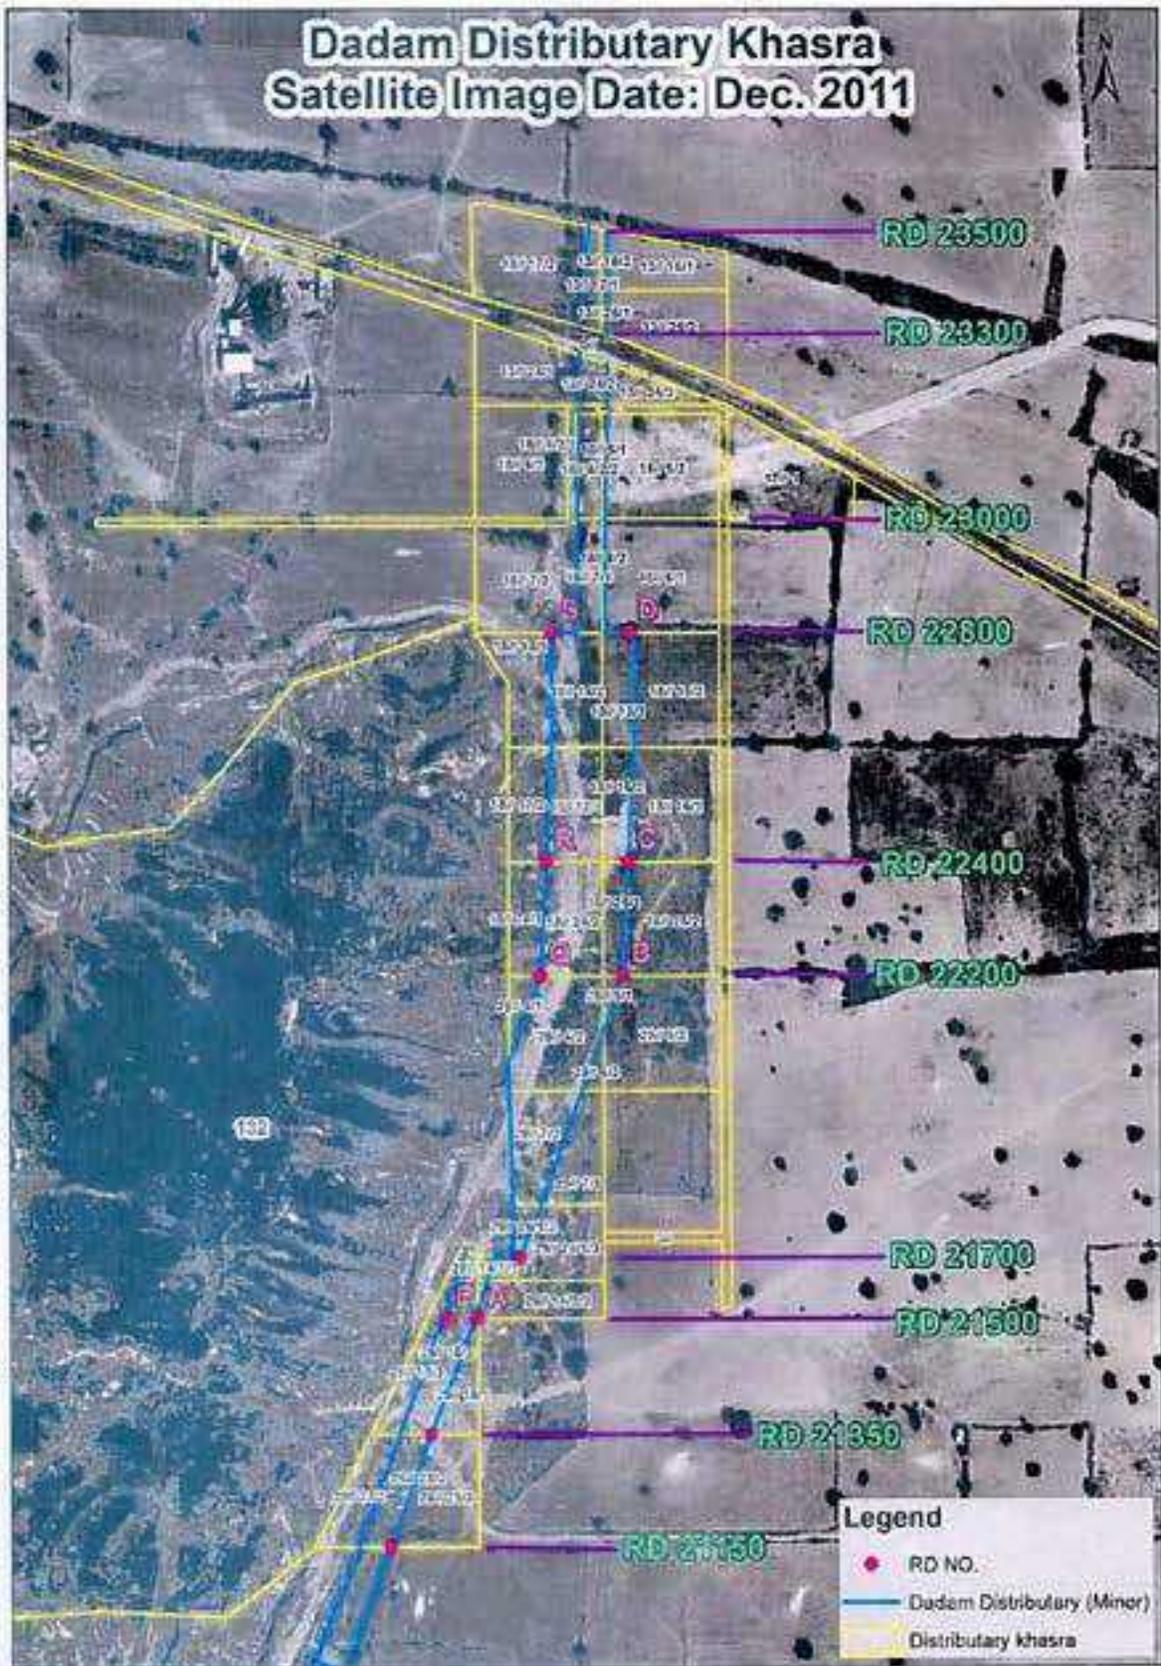
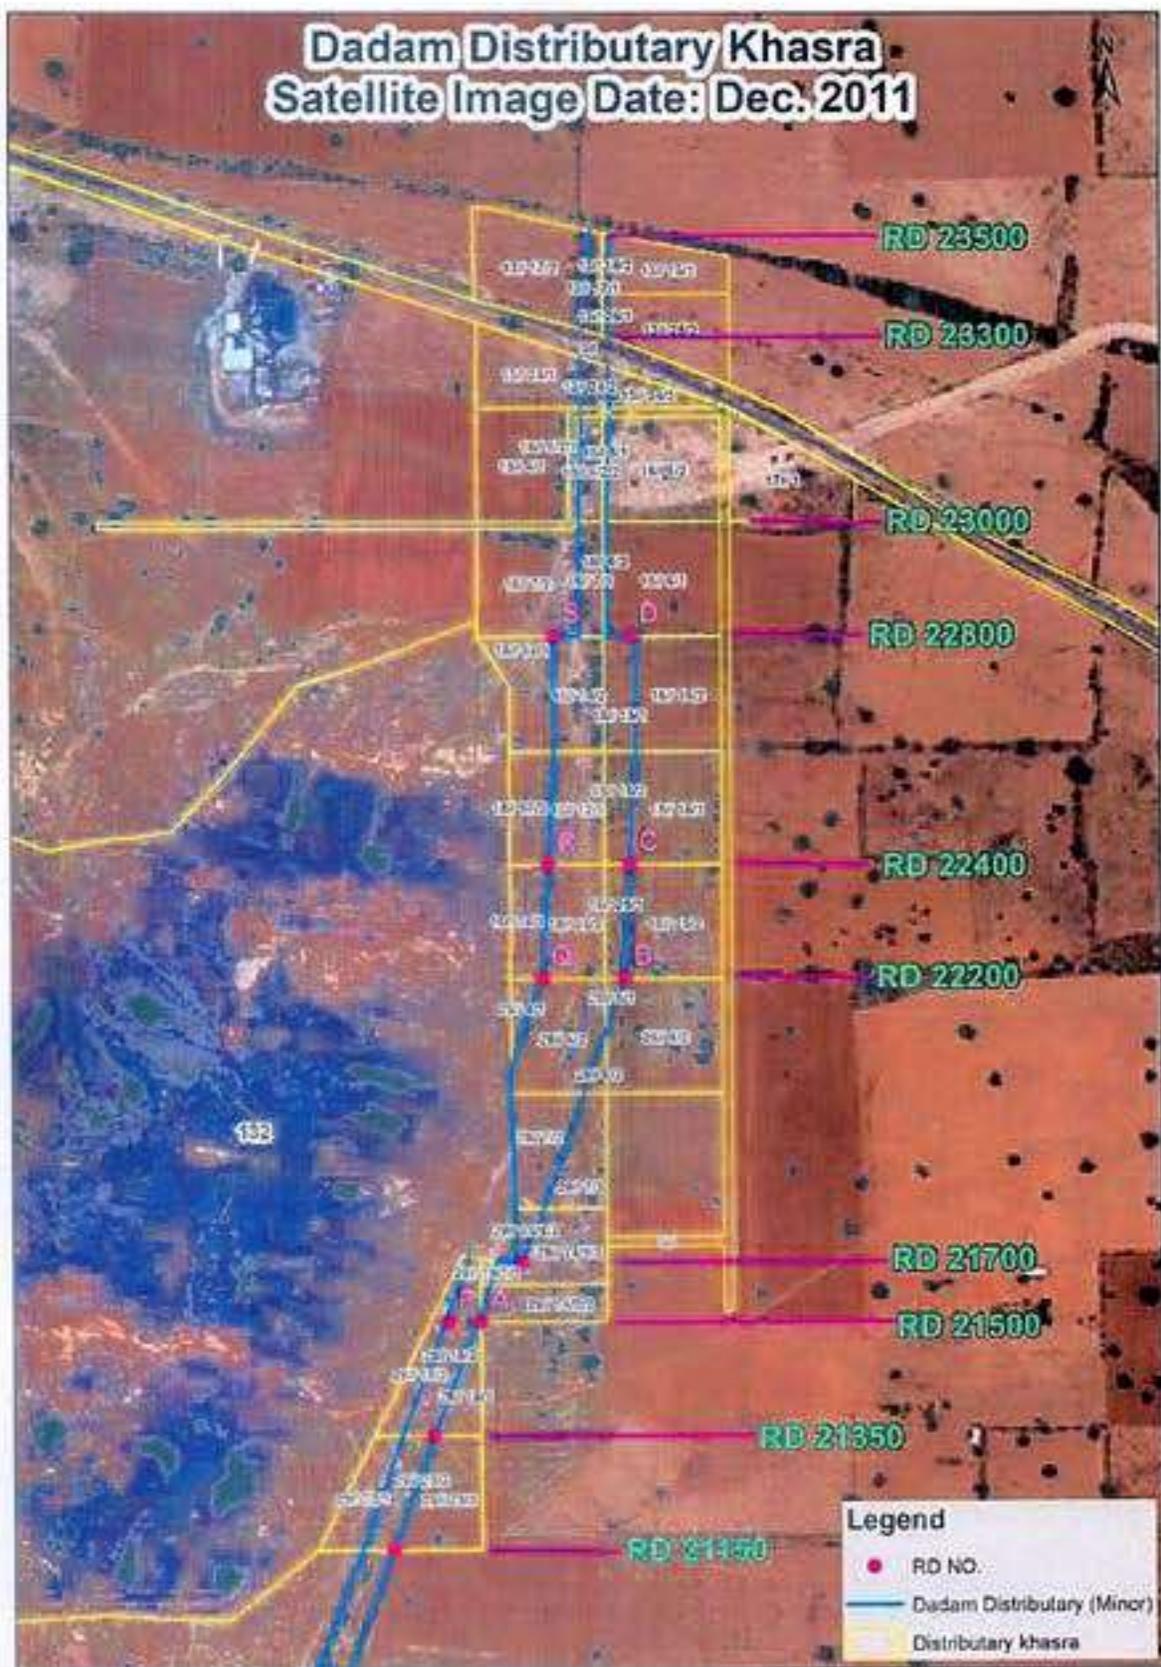
- In 2011, the PAN data from World View 2 is utilized to identify the damage in the distributary. It is observed that neither overburden is removed nor mining is there as shown in Figure 16.

Figure 16 (a): Visibility of Dadam distributary during 2011 (PAN data).

Figure 15 (b): Visibility of Dadam distributary during 2011 (NCC data).

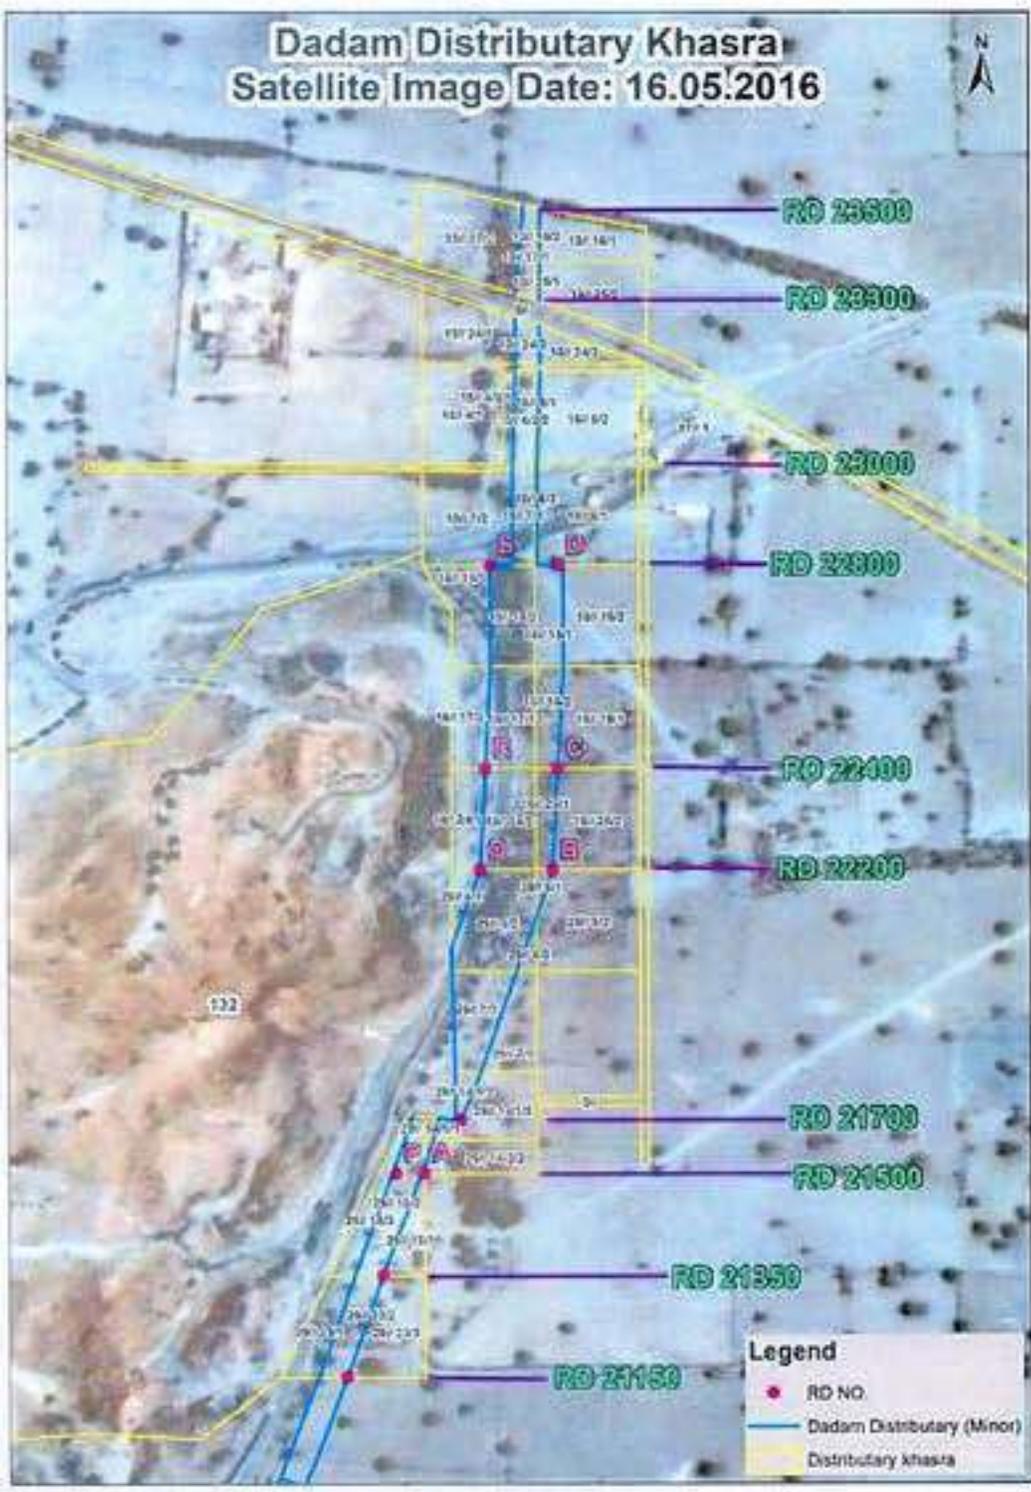
- In 2016 it is observed that overburden is partially removed in private khasra land. Mining is started in private land but no mining is visible in dadam distributary/ minor as shown in Figure 17.

Figure 18: Visibility of Dadam distributary during 2016.
