OFFICE OF THE MONITORING COMMITTEE

Subject: Final report of the eight member Joint Committee, constituted by Hon'ble National Green Tribunal, under the Chairmanship of Justice Pritam Pal, former Judge of Punjab and Haryana High Court and now as Chairman of the Monitoring Committee regarding verification of the facts with regard to illegal mining in forest- area, mining area and unscientific mining in mining area by M/s Govardhan Mines and Minerals, Tosham, District Bhiwani in compliance to order dated 20.07.2021 and 18.1.2022 in OA No. 169 of 2020 in the matter of Kuldeep Singh V/s State of Haryana & others.

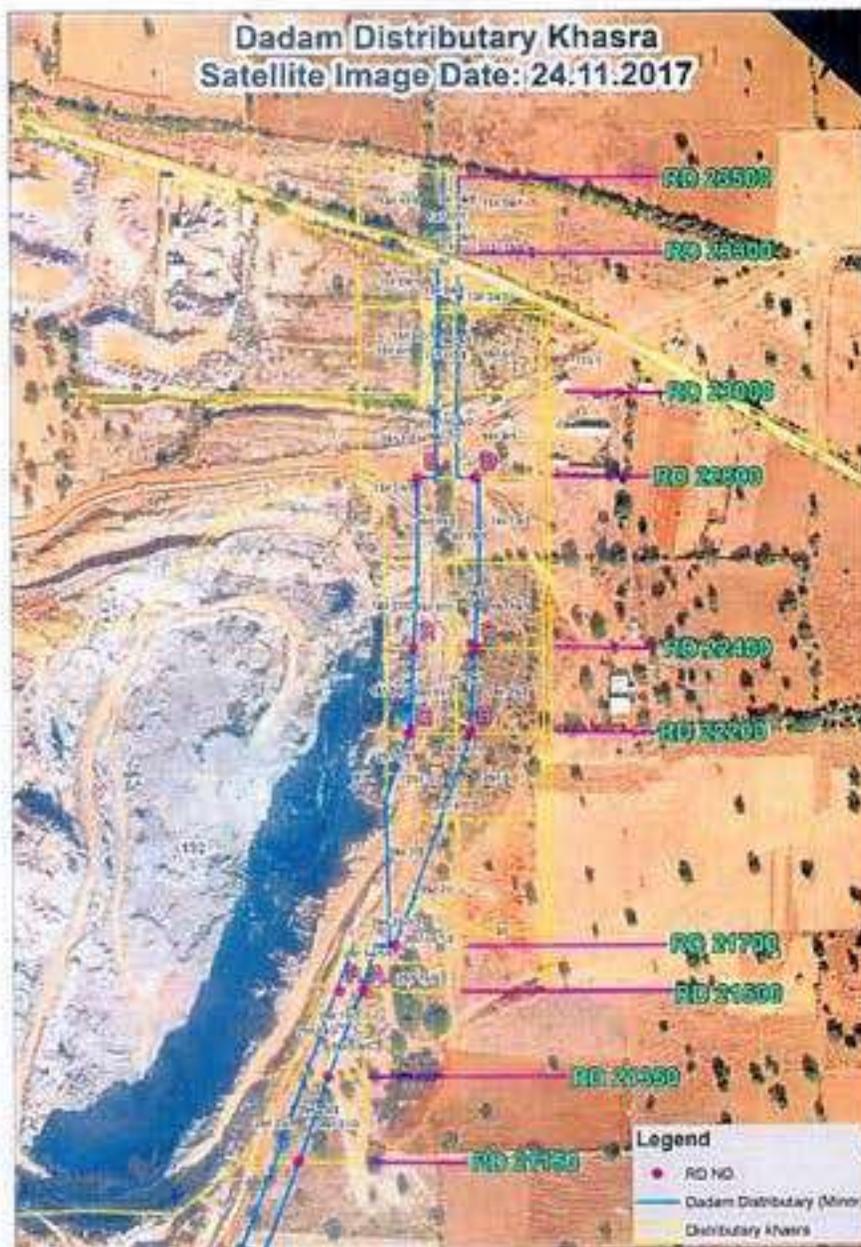
- In 2017, no mining is observed in Dadam distributary but it seems to be converted into a pathway (Within khasra no.: 29//7/2, 29//4/2, 18//24/2, 18//17/1, 18//14/2, 18//17/1) at RD 21700-22200-22400-22800. A total loss in terms of length is approximately 55 m was observed. The mining is visible on private land (khasra no.: 29//4/1, 18//17/2, 18//24/1) as shown in Figure 18. On 24th Nov 2017 it is observed that there is further damaged of 55-meter length along the Dadam distributary due to development of pathway as visible on 2017 image.

Figure 19: Visibility of Dadam distributary during 2017.

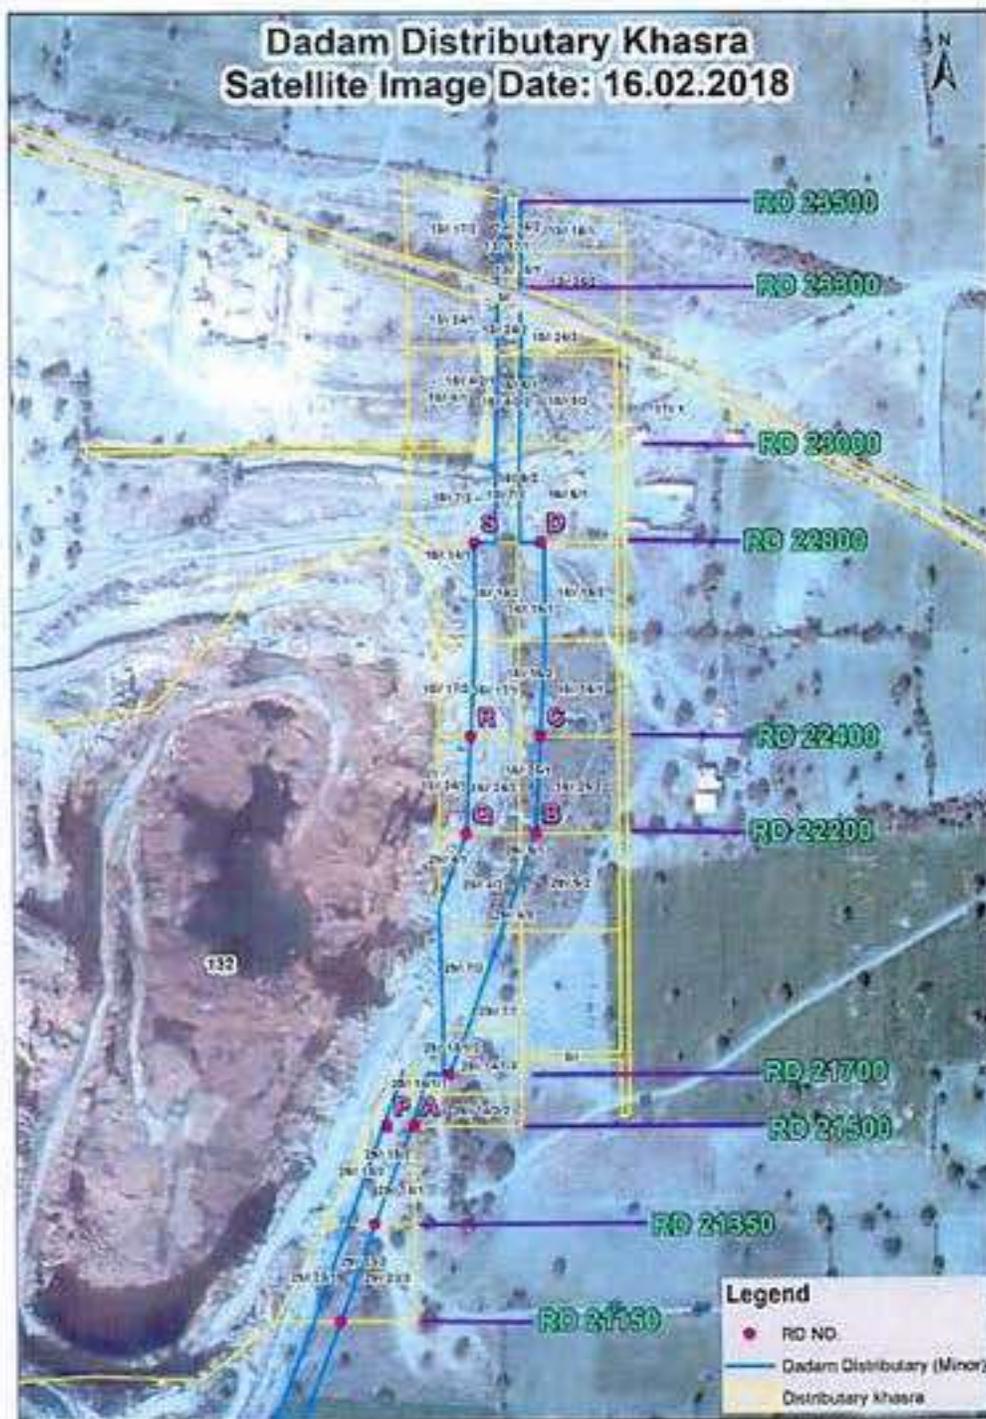
- In 2018 the damage is observed on the Dadam distributary but not due to the mining rather due to pathway (Within khasra no.: 29//7/2, 29//4/2, 18//24/2, 18//17/1, 18//14/2, 18//17/1) at RD 21700-22200-22400-22800 as shown in Figure 19. The partial mining is visible on private land (khasra no.: 29//4/1, 18//17/2, 18//24/1) as shown in Figure 19.

Figure 20: Visibility of Dadam distributary during 2018.

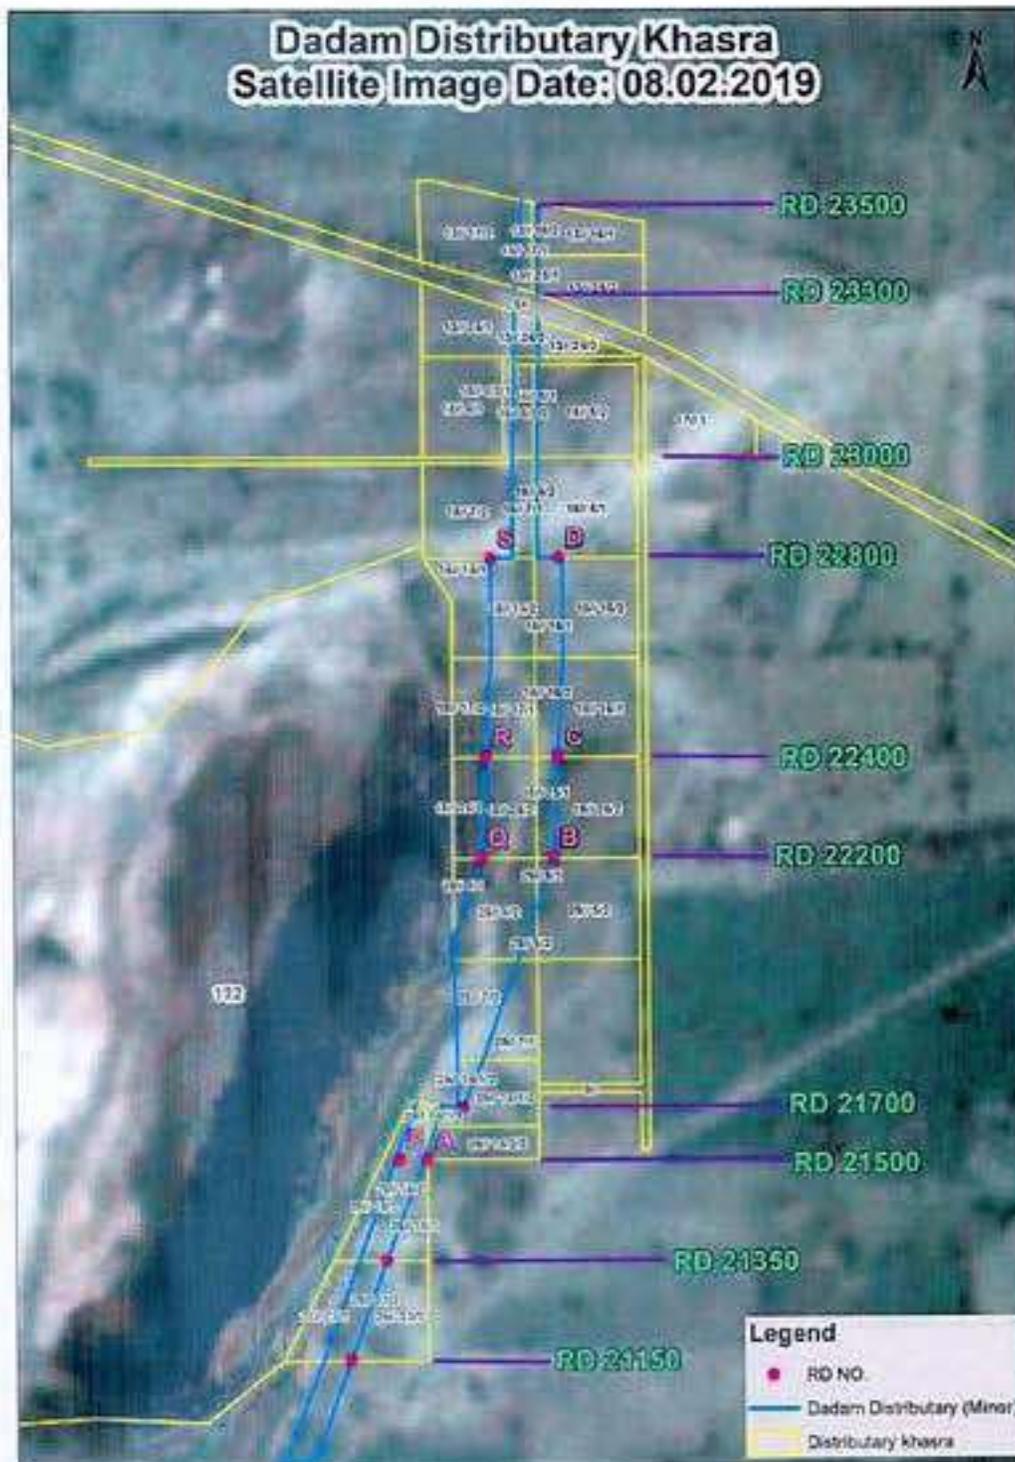
- In 2019 the damage is observed on the Dadam distributary due to pathway (Within khasra no.: 29//7/2, 29//4/2, 18//24/2, 18//17/1, 18//14/2, 18//17/1) at RD 21700-22200-22400-22800 and partial mining (khasra no.: 29//4/1, 18//17/2, 18//24/1) is visible on private land as shown in Figure 20.

Figure 21: Visibility of Dadam distributary during 2019.

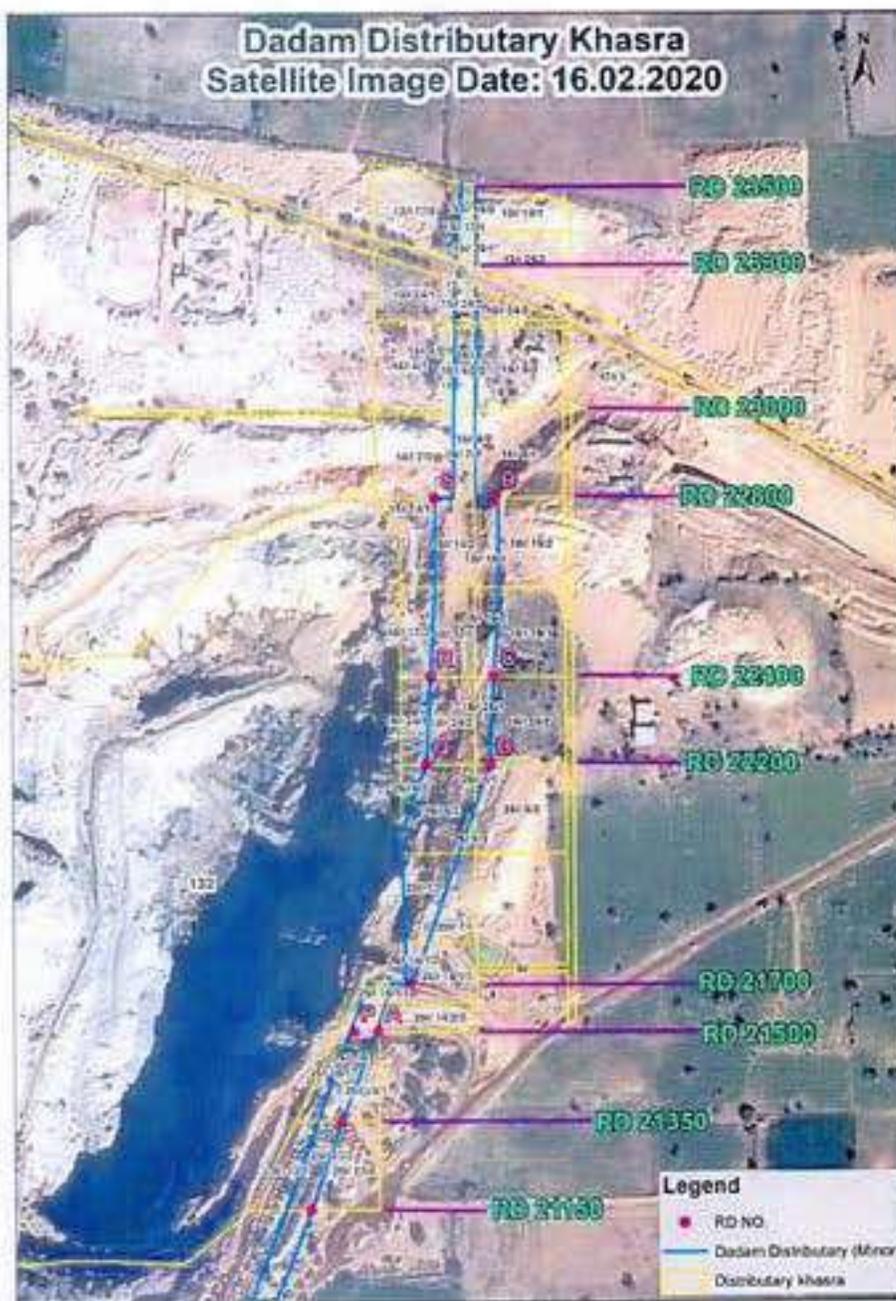
- In 2020 it seems that the damage is observed on the Dadam distributary due to pathway (Within khasra no.: 29//7/2, 29//4/2, 18//24/2, 18//17/1, 18//14/2, 18//17/1) at RD 21700-22200-22400-22800. The overburden is partially extracted and mining is visible in some area of private khasra land (within khasra no.: 29//4/1, 18//17/2, 18//24/1) as shown in Figure 20. It seems that the maximum overburden (within Khasra no.: is extracted on distributary/ minor and partial mining is visible within Khasra no.: 29//4/2-(RD 22200 - 21700).

Figure 22: Visibility of Dadam distributary during 2020.

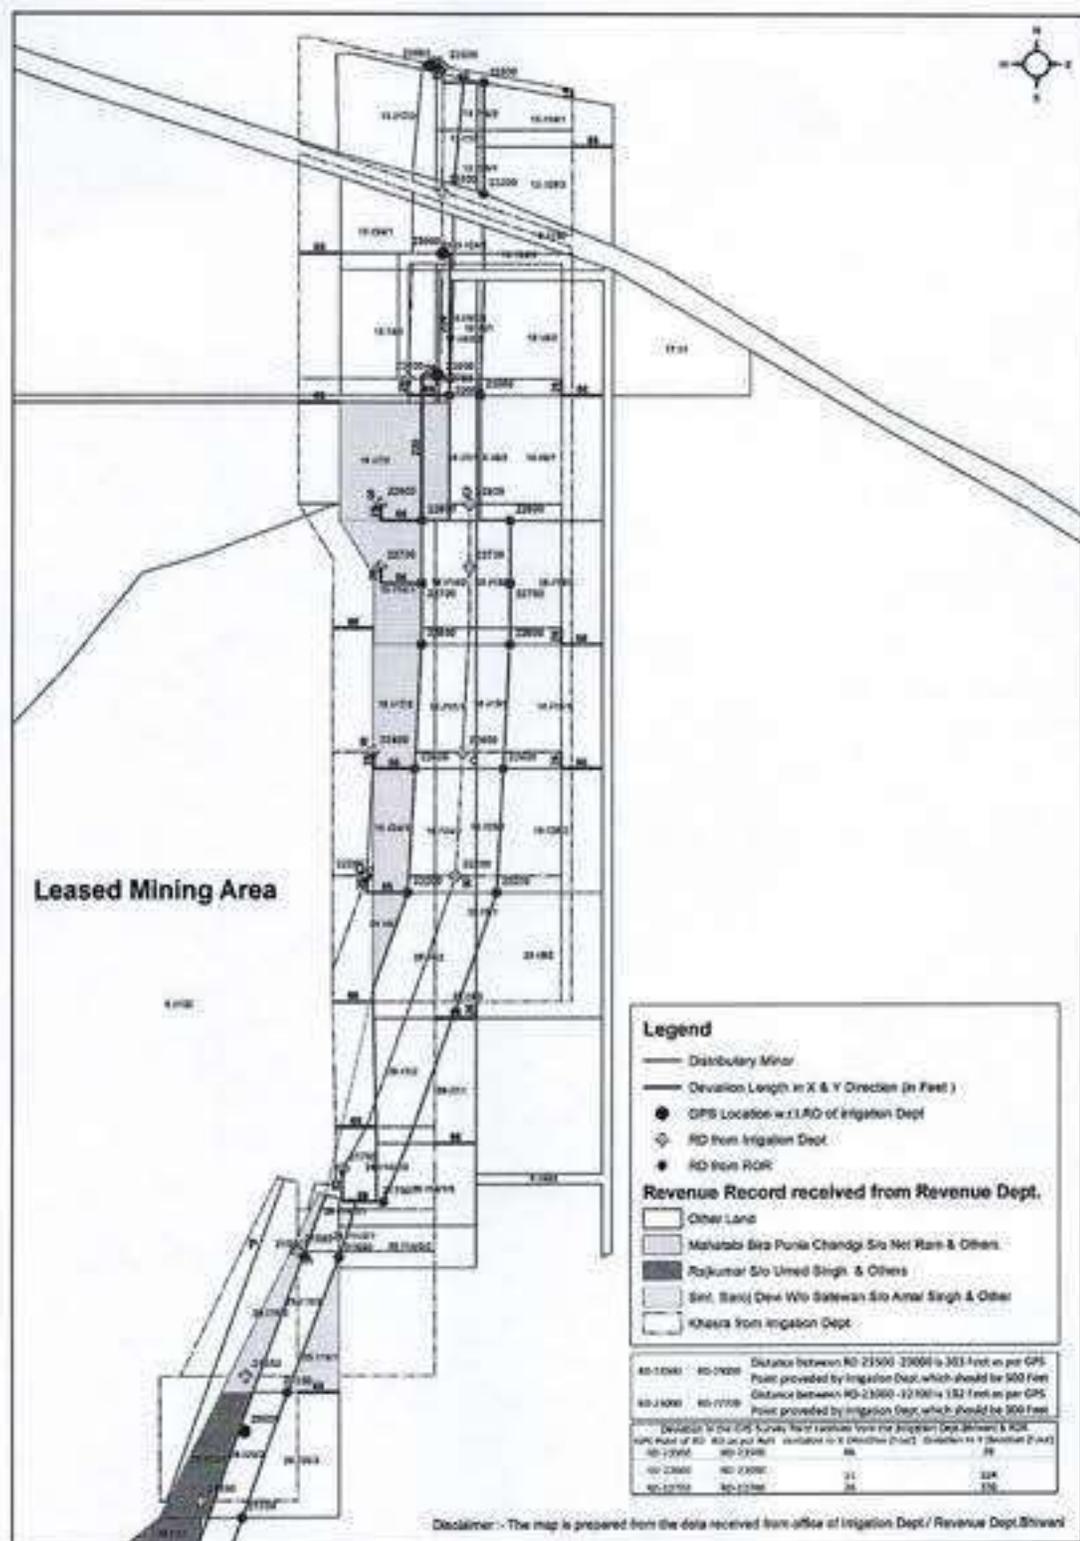
Thus, it is concluded that the survey done by the Department of Irrigation is not as per the RoR which is the only authenticated source of land record and thus major error is there in the evaluation done by irrigation department. The outputs of the analysis done by the irrigation department is not applicable as these are not on the actual geo-location as per the RoR. Most of the excavation in the form of overburden extraction and pathway creation is visible on satellite images over the part of the private land.

Figure 23: Variation in Dadam distributary database provided by Irrigation department and RoR.
