**FACTUAL & ACTION TAKEN REPORT**  
**OF**  
**JOINT COMMITTEE**  
**In the Matter of**  
**O.A. NO. 59/2023 (CZ)**  
**MAHENDRA KUMAR SAXENA**  
**V/S**  
**STATE OF MP & ORS.**

Date of visit: 19 September 2023  
Date of Report Submission: 13 October 2023

Location:  
University Bridge, AG Office Gwalior (MP)

## **Joint Committee Report**

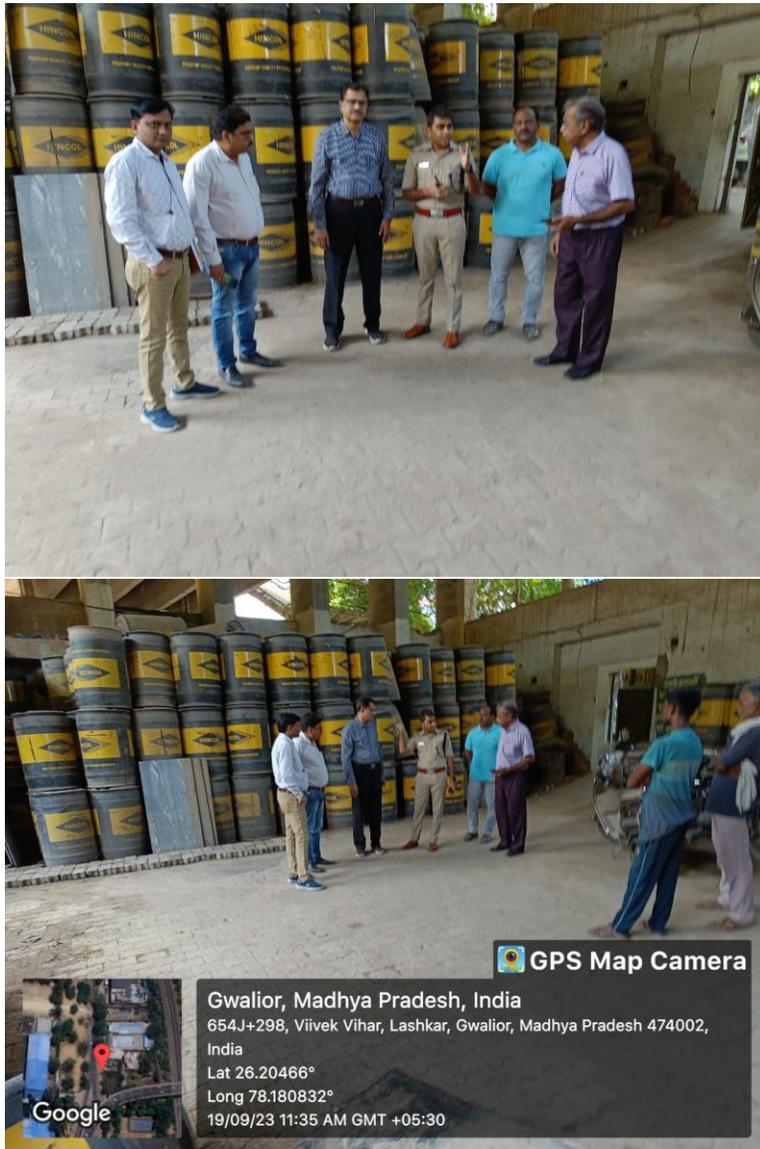
7. The GPS map showing locations of petitioner house, bitumen drum store, patch repairing material storage area, fly over, roads, railway line etc. is enclosed as **Annexure-C 1**. The distances of various important locations from petitioner house are mentioned as below as measured by GPS map :

1. Gwalior Dabra road – 40 meter in West Direction
  2. Railway Line – 50 meter in East Direction
  3. Bitumen Drum Store – 30 meter in South Direction

4. Patch Repairing Material Storage Area – 40 meter in South Direction.
  5. Other residential/commercial establishment are situated in North Direction adjoined area.

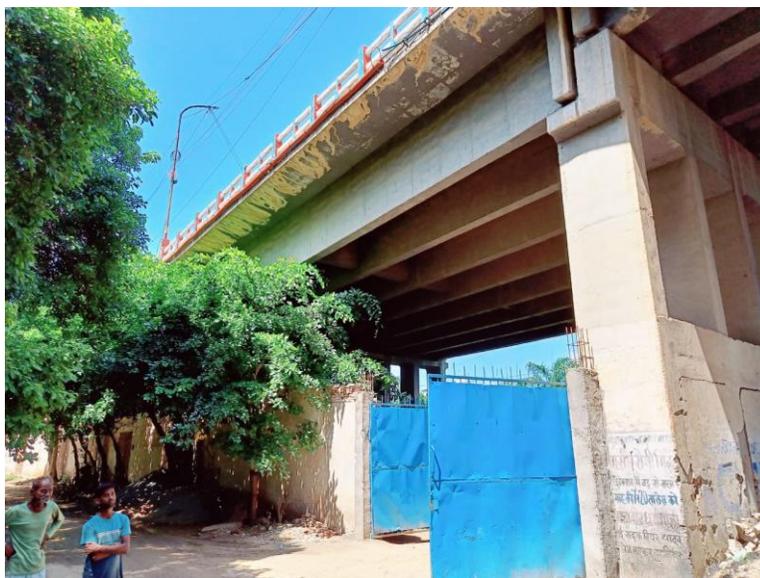
3. Bitumen drum store is enclosed by wall of height about 4 meter and situated below fly over landing. The places where other patch repairing material like WMM, Stone Metal, Murrum etc. placed was about 40 meter away and situated opposite to the petitioner house. This material storage area is not visible from petitioner house since bitumen drums storage area is situated in between.

Photograph showing Main Gate of Bitumen Drum Store Under AG Office Bridge

Municipal Corporation Gwalior submitted a proposal letter for submission of Joint Committee report to Hon'ble NGT on dated 20/09/2023. As per MCG proposal this patch repairing material store will be shifted to some other places within six month. So Joint Committee recommends that direction should be given to MCG for shifting of this store to some other suitable place within six month.

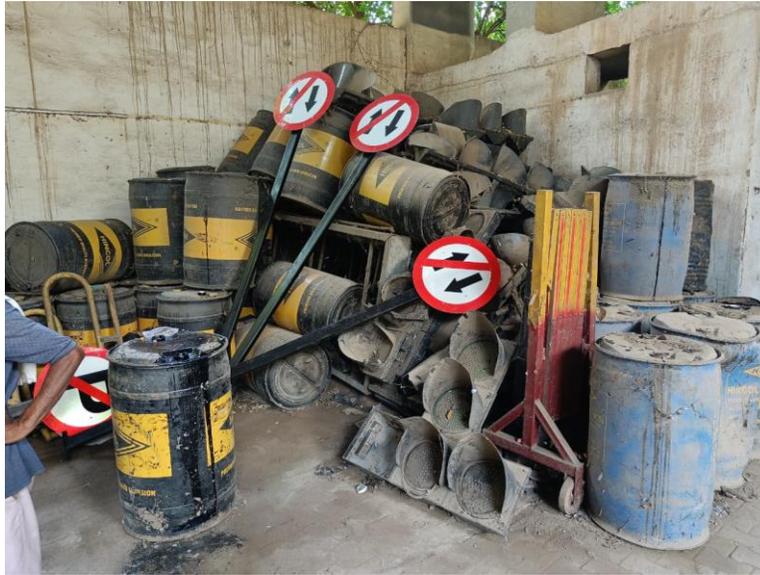
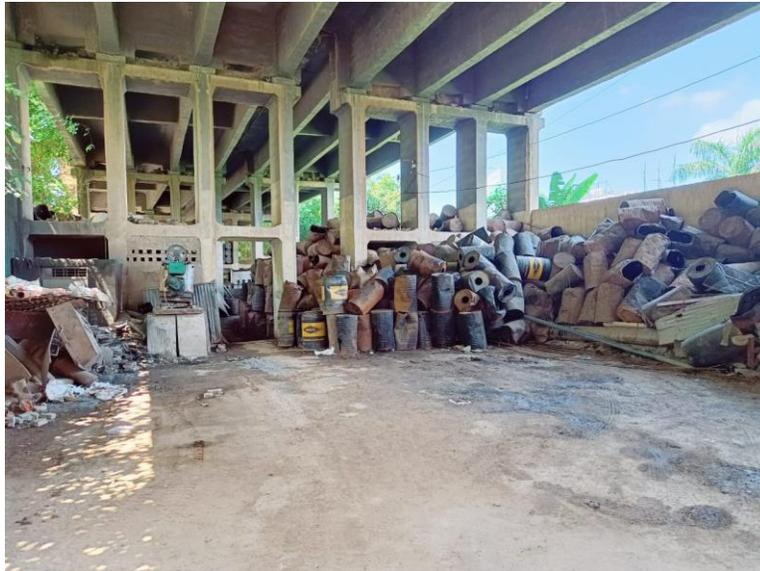
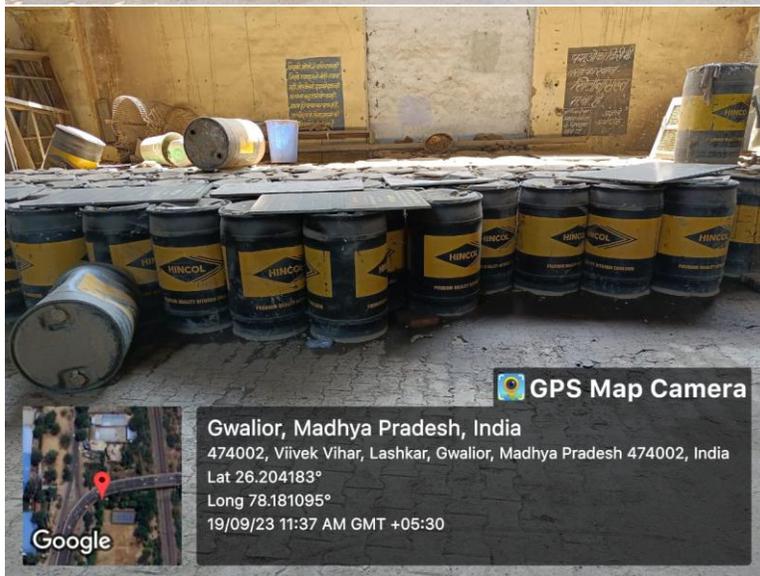
1. There is a Patch Repairing Material Store of MCG situated below University Bridge/Fly Over near AG Office in Gwalior city. This place is used by MCG for storage of bitumen drums and storage of some quantity of patch repairing material like WMM, Stone Metal, Murrum etc. This patch repairing material is used for minor repairing of roads of city as and when required.
2. During visit lot of bitumen drum were seen placed inside store area. Patch repairing material like WMM (Wet Mix Material), Stone Metal, Murrum

5. Bitumen drums are transported from this store to hot mix plant of MCG situated outside city by vehicles and empty drums also transported back to this spot and are store in this storage area. Also some quantity of patch repairing material is always kept here for use in minor repairing of roads of city. This material is also transported here time to time through transportation vehicles/dumpers. This practice is occasional since quantity of stored patch repairing material at the spot was very less about 30 cubic meter seen during inspection by Joint Committee. The photographs of vehicles enclosed by petitioner with his petition are the vehicles used for transportation of material to and fro from the site.

Photograph showing Bitumen Drums Stored inside the Store Area

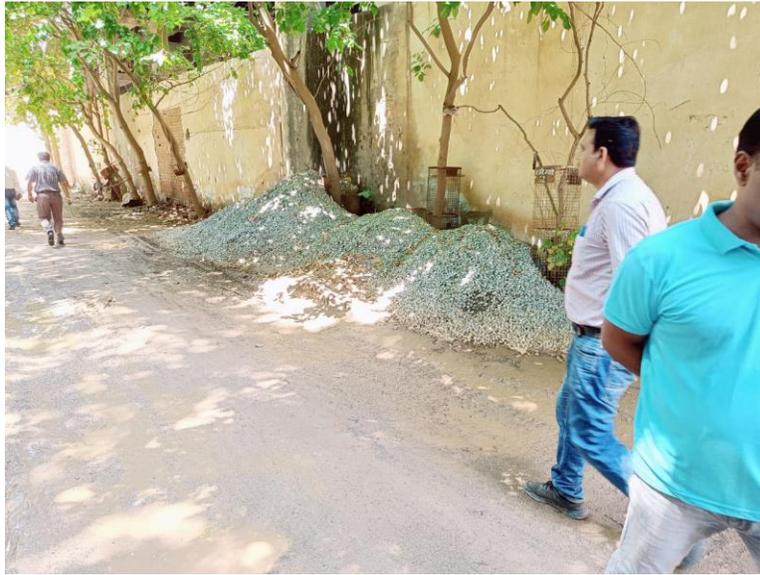
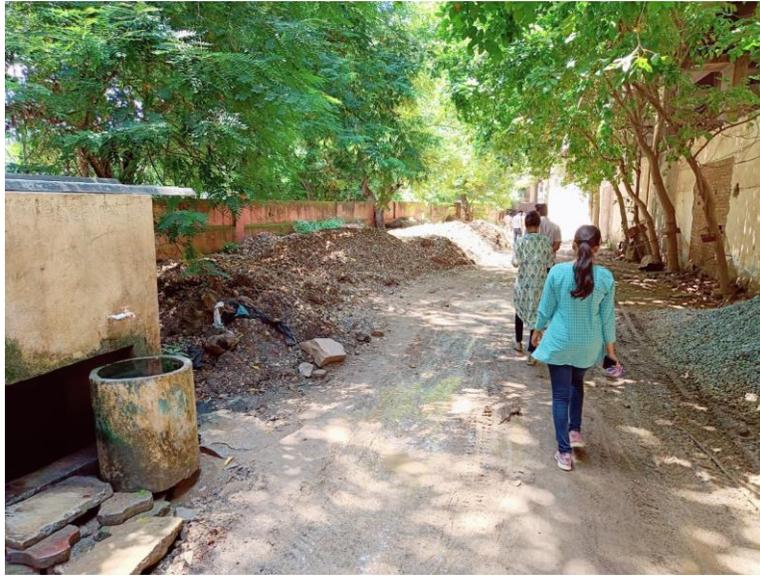
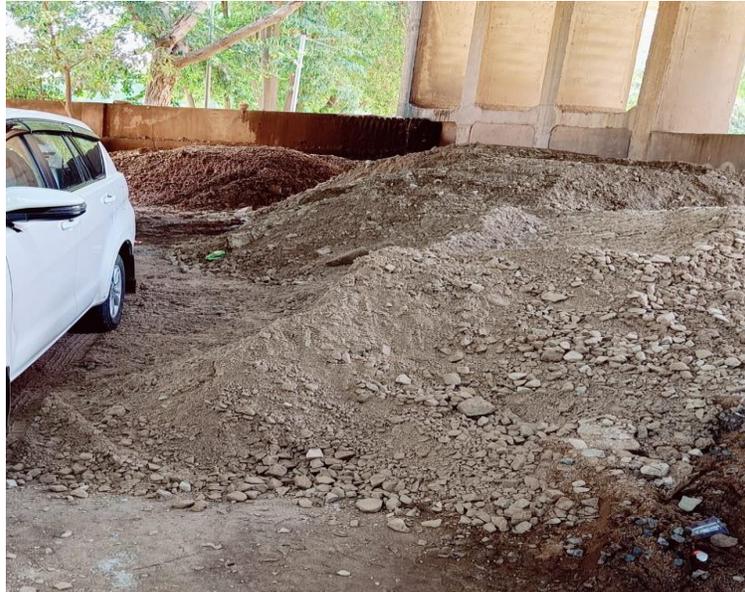
etc. were also seen placed outside bitumen drum store area which is open to sky. About 30 cubic meter of patch repairing material was seen there.

**Photograph showing Storage of Patch Repairing Material at the site**
