Gujarat Pollution Control Board

(Inspection Report) - Air, Water, Hazardous

1 Industry Details Landfill Site Rajkot Muni. Corp. (Old Name Hanjer Bio-Tech Energies Pvt.Ltd.) **Outward No: 45994-22/01/2025**

Complaint Investigation Report

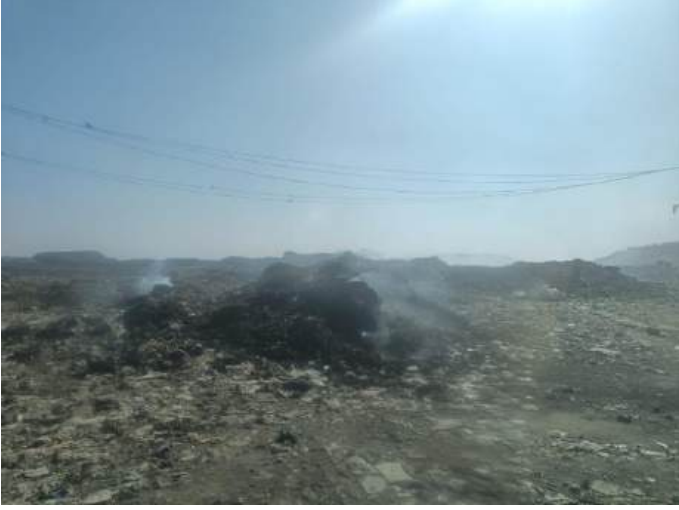
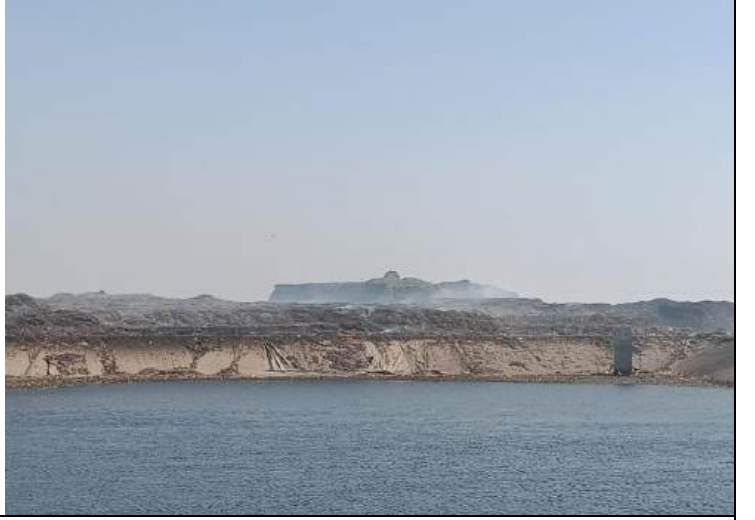
Further inspection of Nakravadi landfill site is carried out. During visit, burning of municipal solid waste is going on and smoke is observed emitted towards north-east direction. The visibility and ambient air quality at MSW processing area found poor due to burning of MSW. No any fire hydrant system or fire fighter tank is observed at this site to stop the burning of MSW. The landfill site is receiving approximately 700 MT of municipal solid waste (MSW). During visit, total five nos. of trammel machines observed at this site; out of which 3 nos. of trammel machines are observed in operation and processing of legacy waste was going on. During visit, no any records of remaining legacy waste stock are found at the site.

During visit, burning of municipal solid waste is going on

મુલાકાત દરમ્યાન ઘન કચરાના ઢગલાઓ સળગતા જોવા મળેલ છે જે બંધ કરવું તેમજ તેના માટે Fire hydrant system ની વ્યવસ્થા કરવી.

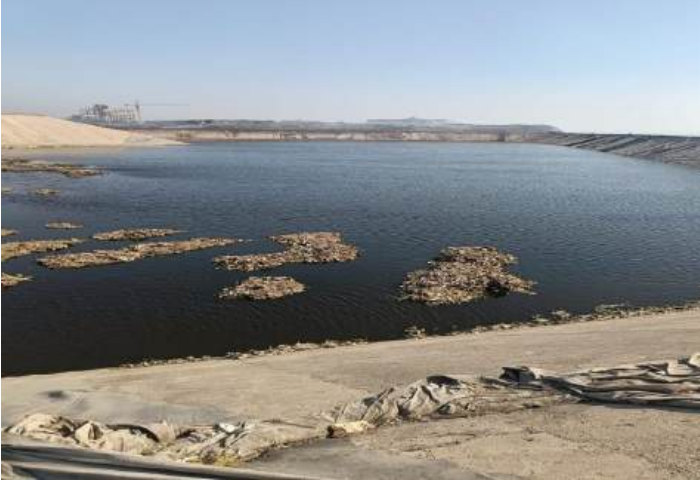
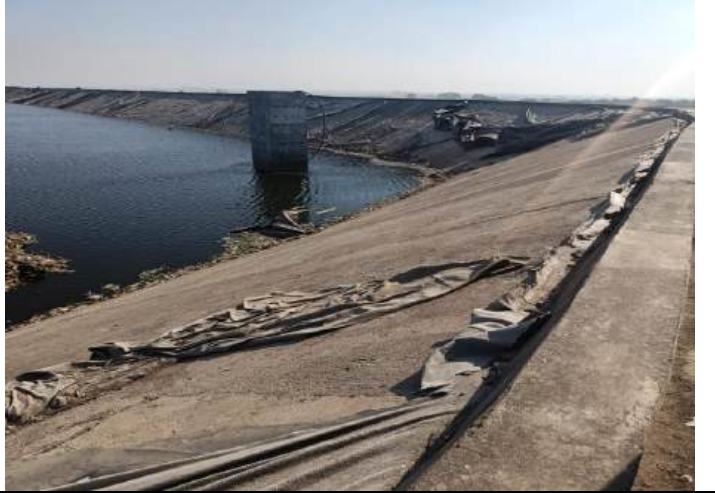
During visit, it is observed that Cell-1 is closed, while Cell-2 is in operation. Ponding of wastewater is observed in Cell-2, and the liners in this cell-2 are found to be in a broken condition. A large ponding of wastewater is observed within the landfill site, a sample of this wastewater is collected from the ponding area (pH-9 on pH strip, colour-Turbid). During visit, leachate w/w ponding is also observed at lowland area near cell no. 2 inside and outside the boundary wall; but the flow of w/w is not observed during visit. One w/w sample is collected from that ponding for analysis (pH-7-8 on pH strip, colour-light turbid).

Ponding of wastewater is observed in Cell-2, and the liners in this cell are found to be in a broken condition

મુલાકાત દરમ્યાન લેન્ડફિલ સેલ નં. ૨ પાણી ભરેલ જોવા મળેલ છે. જેને ટ્રીટમેન્ટ આપી યોગ્ય નિકાલ કરવો તેમજ સેલ નં 2 ની લાઇનર તૂટેલ જોવા મળેલ છે જે રીપેર કરવી.

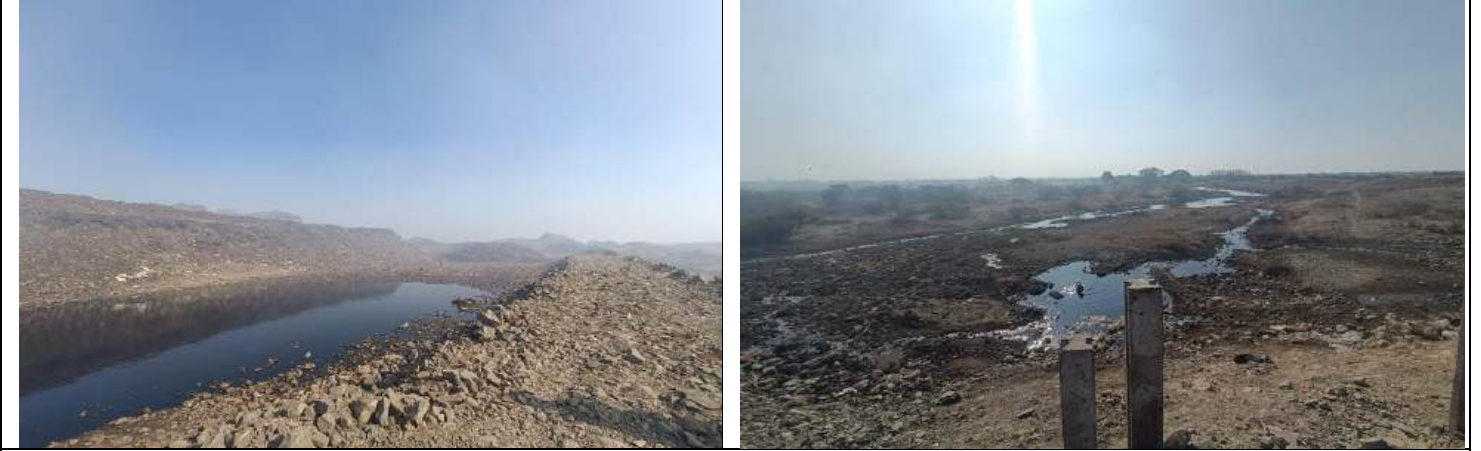
During visit, the leachate collection tank observed overflow but discharge of w/w outside the boundary wall is not observed as the unit has provided kutch wall (a raw embankment) using sand, clay and kapchi to stop the discharge of leachate w/w. one w/w sample is collected from the leachate collection tank within premises (pH-8-9 on pH strip, colour-turbid blackish). During visit, w/w ponding (stagnant) is also observed outside the boundary wall but flow of the w/w is not observed. One w/w sample is collected from the ponding outside the boundary wall of this landfill site (pH-8-9 on pH strip, colour- turbid blackish). During visit, live discharge of leachate w/w is not observed from this site. But as this site is not having leachate treatment facility at this site so the leachate w/w may discharge outside the premises during rainy season. As per the register maintained at this site; @ 32 KL leachate w/w is collected from the leachate collection tank daily by the tanker and disposed at Gavridad STP for further treatment.

Leachate ponding within premises and outside the premises

મુલાકાત દરમ્યાન લીચેટ કલેક્શન ટેન્કની બાજુમાં બાઉન્ડ્રી ની બહાર લીચેટ ના પેન્ડિંગ (Stagant) જોવા મળેલ છે. તેમજ Call no.2 ની બાજુમાં પણ નિચાણવાળી જમીન પર બાઉન્ડ્રી ની અંદર અને બહાર લીચેટ એકઠું થયેલ જોવા મળેલ છે. જેને ટ્રીટમેન્ટ આપી યોગ્ય નિકાલ કરવો.
