O.A No. 995/2019

In The Matter of:-

Joint Committee Report (Interim) in reference to Hon'ble NGT
order in the matter of OA No 995/2019
August 2020

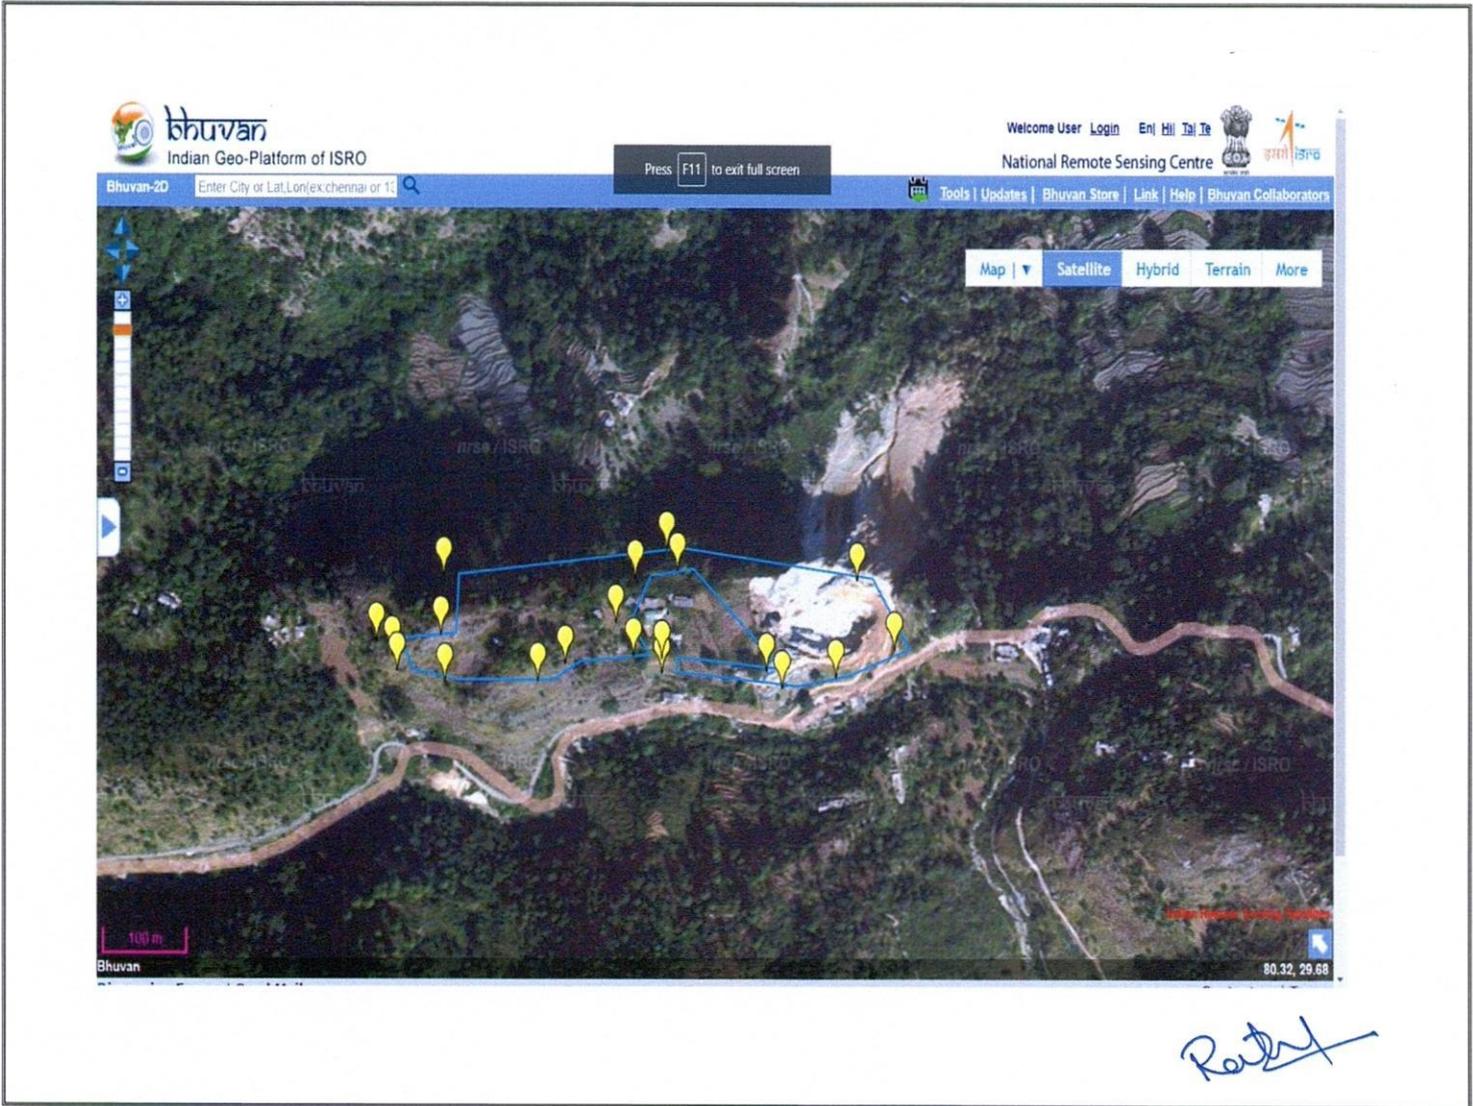
5. The following is submitted as an interim report;
 - 5.1. The coordinates of the mining area authenticated by the State Government Department, provided by Regional office of the Indian Bureau of Mines, used for visualizing the present status of land use in and around mining lease area on satellite imaginary platform. Available satellite imaginary has been viewed on Bhuvan-2D app, a Geo-portal of ISRO, the same is placed at Annexure 2.

- i. Green cover is visible during years 2004 – 2005 in the Northern western side of mining lease area, especially beyond the lease boundary line, connecting lease pillars E-F and F-G. This green cover is seen damaged during subsequent years.
- ii. The substantial portion of active mining pit is located on hillock with natural steep slope heading from south direction to north and it appears that adequate measures were not taken by the mining lease holder to stop/trap/arrest the rolling of material/rock/ muck going outside the lease area.
- iii. The material/muck is spread into the environment beyond the allotted area mainly in the north-eastern portion of mining lease especially near lease pillars F of lease area.

- 5.5.1. Not to allow mining operations till complying prescribed environmental Norms/ guidelines/ recommendations of the committee hereunder.
- 5.5.2. To carry out geo-referenced drone survey of the lease area and its surrounding affected area due to spillage of material from mine and submit the output in appropriate format for further analysis and preparation of remedial plans.

- 5.5.3. Take all appropriate immediate actions to arrest/trap the material from rolling down/flowing away outside lease area by gravity or rain or otherwise.

- i) shift the outside dumped/ rolled/ flown/ washed material/ muck to a suitable safe and secure place within mining lease area and stabilize it.
 - ii) in case of area where such material is not safe to handle such portion shall be appropriately terraced, compacted, reclaimed by plantation of local species and ensure its watch and ward till the plantation achieved self-sustained age and height.

- 5.5.6. To construct robust obstruction structures (such as toe walls, parapet walls) silting ponds etc. under the guidance of district administration, ensure that muck mixed slurry water of rain does not enter into the Dundu stream.

- 5.5.7. To develop a natural obstruction and/or construct retaining walls at the end of lowest/bottom most bench of the mine so that waste material/muck does not roll down/spillover downwards along the hillock to outside mining lease.
