**BEFORE THE HON'BLE NATIONAL GREEN TRIBUNAL  
SOUTHERN ZONE, CHENNAI**

**ORIGINAL APPLICATION NO. 144 of 2023 (SZ)**

**REPORT FILED BY ENVIRONMENTAL ENGINEER, DISTRICT OFFICE,  
KOLLAM FOR AND ON BEHALF OF THE KERALA STATE POLLUTION  
CONTROL BOARD**

**REPORT OF THE JOINT COMMITTEE FILED BEFORE THE HON'BLE  
NATIONAL GREEN TRIBUNAL, PRINCIPAL BENCH, NEW DELHI IN  
THE MATTER OF O.A. NO. 730/2022**

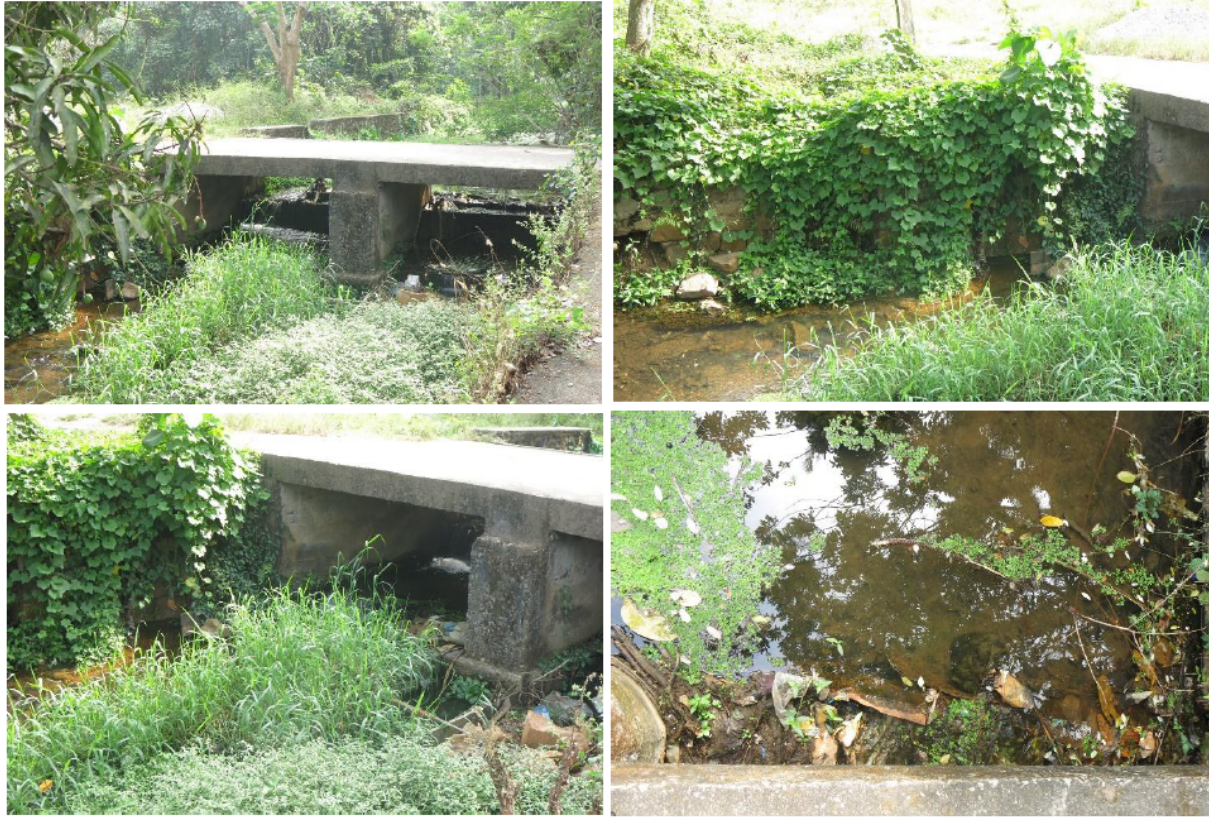
The committee noted that the canals of the river are choked with weeds that prevent the natural flushing, which can be a major problem during floods. The committee suggests removing weeds from the canal under the provisions of the “National Rural Employment Generation Scheme (NREGS)”.

Fig. 2.Choked canal and sluice with weeds.

During the visit the Chathannoor Canal which is adjoining to the Ithikkara river found chocked with silt and weeds. Necessary cleaning shall be done and ensure that solid or untreated liquid waste shall not enter to the canal.

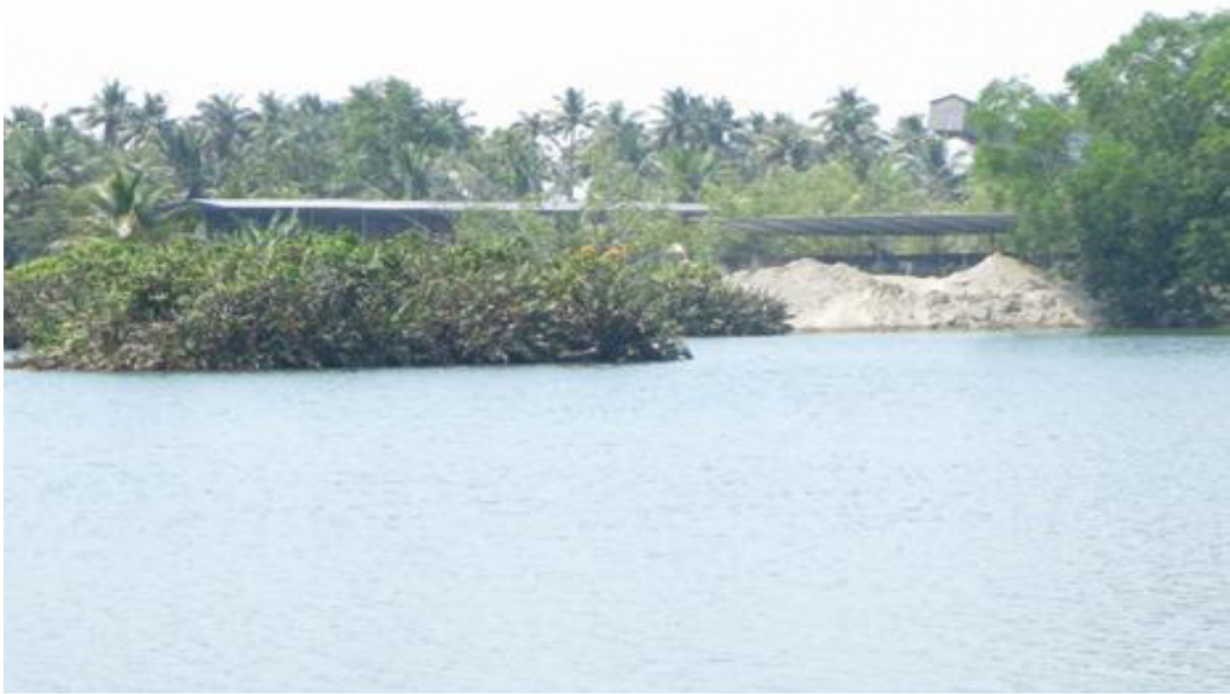
Brick kilns are a major source of livelihood for the people. The kilns mine clay from the river to manufacture bricks. However, there are brick kilns that are unauthorised or do not have a proper government recognized license. The committee decided to enquire with the local body concerning the activities and entrust the Pollution Control Board to collect the details from Chathanoor Grama Panchayath. The matter was enquired with the local Panchayath vide letter dated 04.03.2023 is attached herewith as **Annexure IV**. The committee suggests the local government to monitor the activities of the brick kilns based on the regulations of the CRZ 2011/2019 norms as applicable. Continuous mining can cause pit formations in the river bed.

Fig. 3. Water filled clay mining pits by the side of the Ithikkara River.

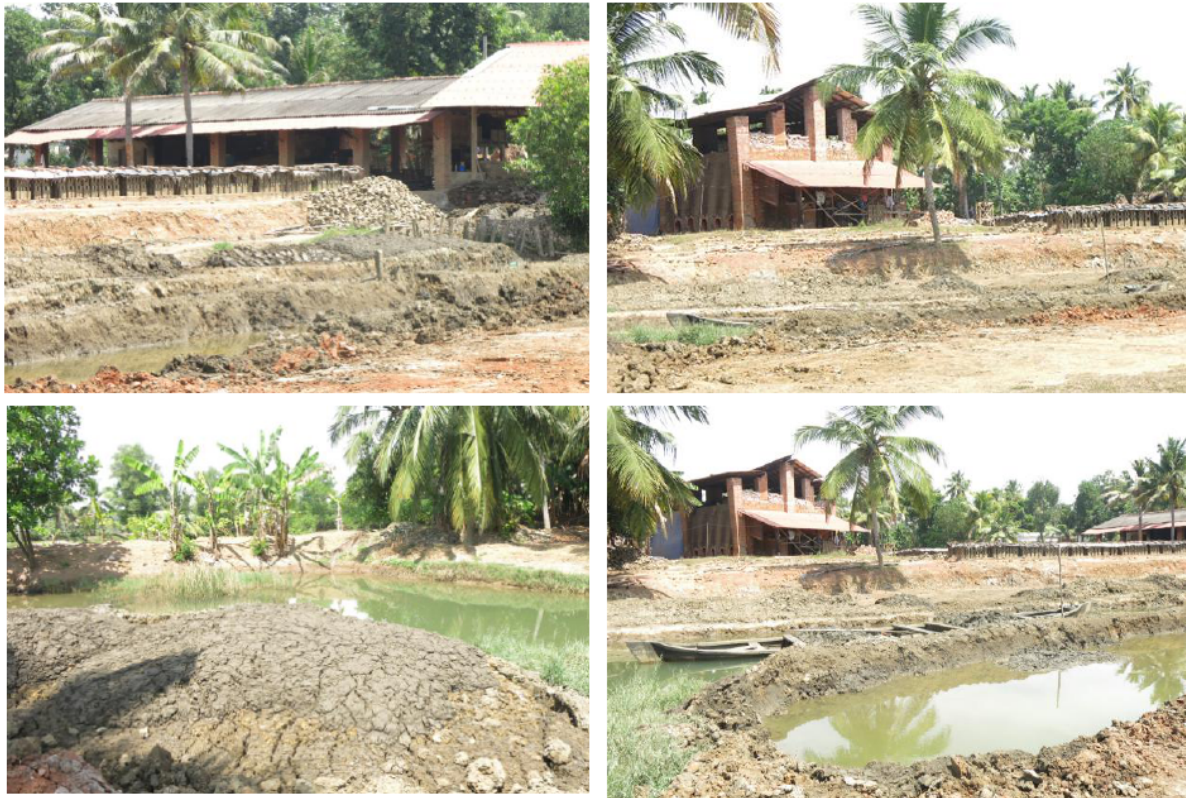
KCZMA, on verification of the geo-coordinates captured from the site ((8051'8''N & 76041'34''E) with the Coastal Zone Management Plan (CZMP), 2011, found that the area in question falls inside Coastal Zone Regulation (CRZ) line, in Survey No. 152 of Meenad Village (CZMP 2011, Map No: KL 10). The area falls in CRZ buffer- Non Development Zone (NDZ) (CRZ III category). The provisions of CRZ III region are from Clause 8(III) (A) (i, ii & iii) & clause 8 III (B) (i to xi) of CRZ notification, 2011). CRZ Notification with respect to the Kerala Coast is attached herewith as **Annexure V**. Any activity in CRZ area requires prior permission from Coastal Zone Management Authority (CZMA). If the same is not obtained from the authority, it is violation of CRZ rules. Panchayath can only issue licence/ permit after obtaining the CRZ clearance from the CZMA concerned. The above mentioned Brick Construction Unit are using the ordinary clay mined from the Ithikkara River and its surroundings, this might also attract the EIA notification, 2006 and prior Environmental Clearance (EC)

from State Environment Impact Assessment Authority (SEIAA) might also be necessary. Operation of mining activities in the CRZ region without obtaining clearances from statutory authorities (KCZMA, SEIAA) is violation of CRZ notifications, 1991, 2011 & EIA notification, 2006. Consent to operate from the Pollution Control Board is also not obtained. The Panchayath concerned may issue stop memo against all the said activities and take necessary actions.

Fig. 4. Brick kilns located along the banks of the river.

The committee visited the Meenad West area where brick kilns are found working in the CRZ area. Committee decided to seek clarification from the local body whether the unit has CRZ clearance, consent from PCB or having license from Panchayath for working. Also inform the number of unauthorized brick kiln units which is carrying out clay mining from the River.

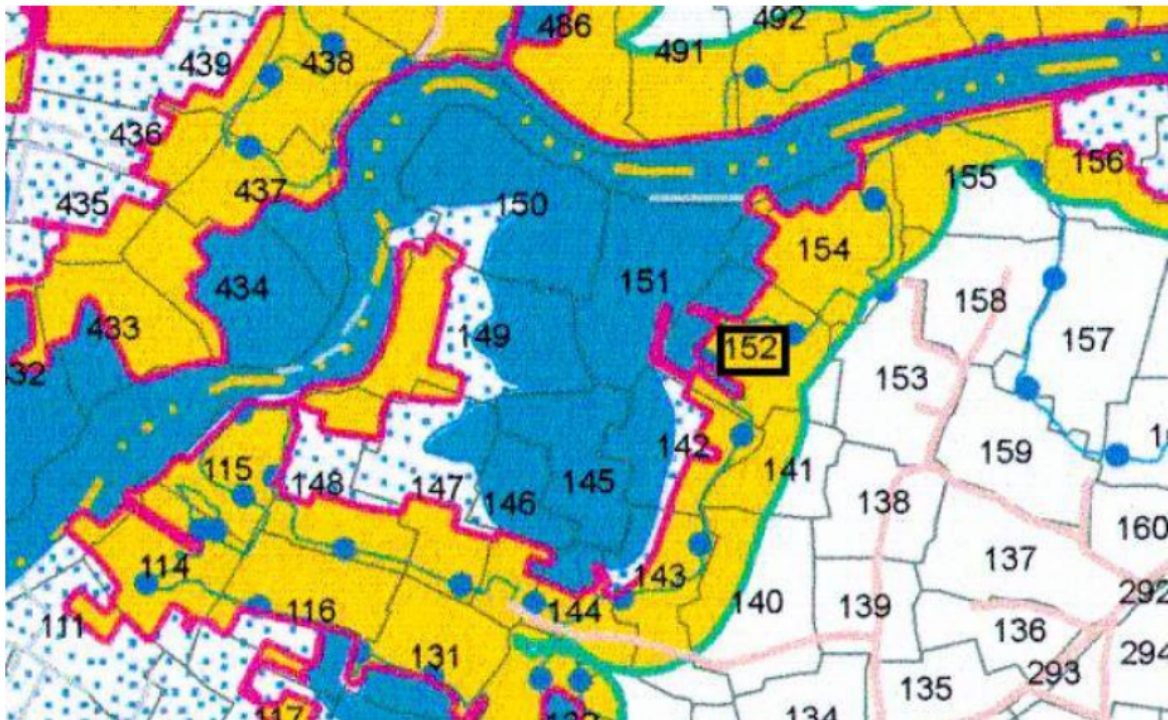
Fig.5a.The CZMP map of the region available in the website of (KCZMA)

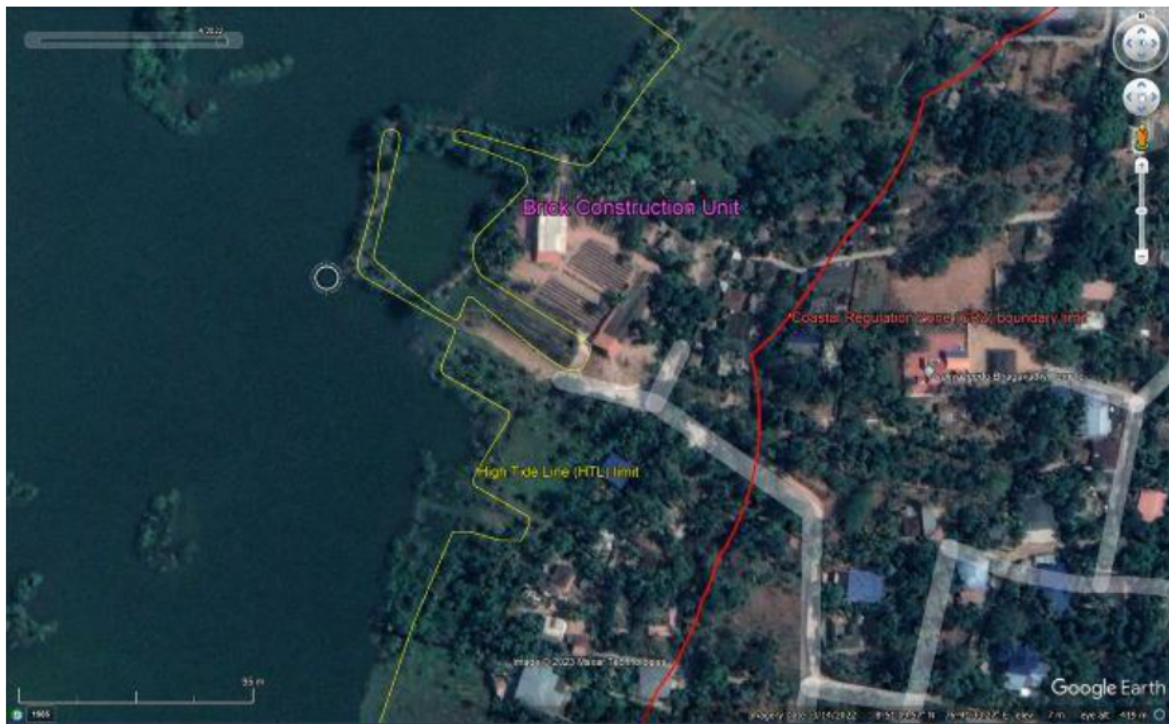
Fig.5b.The CZMP map of the region available in the website of (KCZMA)

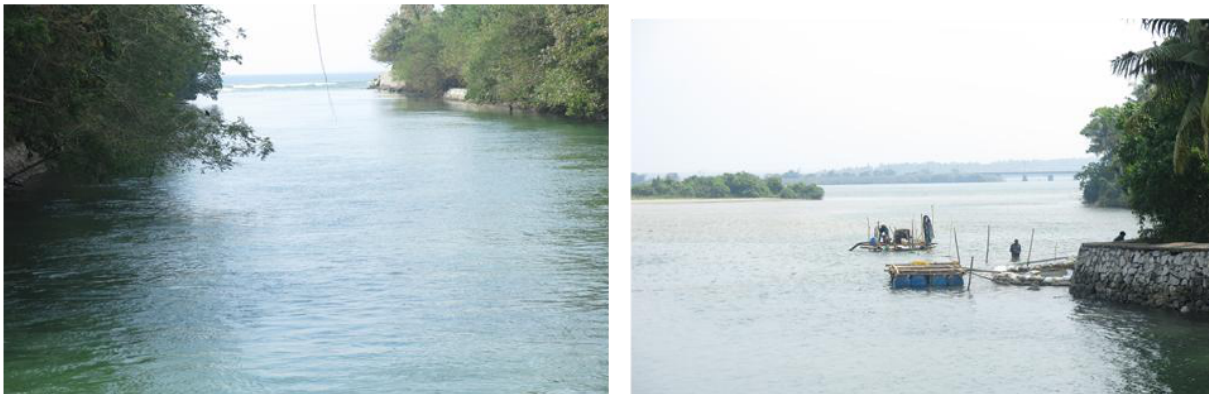
The committee noted that the spillway at ParavoorPozhy requires periodic maintenance to prevent siltation and enhance proper flushing of flood water during the monsoons. The committee observed that siltation and sandbar formation occur in the mouth of ParavoorKayal. The sandbanks formed by the accumulation of deposits at the end of IthikkaraRiver near ParavoorPozhikkara has been destroyed due to sand mining and has stopped the formation of ‘bund’. However, it is noticed that due to these sand dunes, water gets raised in Paravoor Lake during monsoon season and creates threat to the people’s life and fish farming in areas like Mukkam. Hence during monsoon season generally works are arranged to break the bunds formed at estuary. Hence it is essential to remove these sand banks. Report from the Irrigation Department is attached herewith as **Annexure VI**. The committee suggests that a study has to be carried out to reach a consensus on how much sand needs to be removed from this region for natural seawater exchange.

Fig. 6. Seawater intrusion into the river, siltation, and sandbar formation make the river shallow.

One of the major issues raised in the complaint is that the sandbanks formed by the accumulation of deposits at the end of Ithikkara river near Paravoor Pozhikkara has been destroyed due to sand mining and has stopped the formation of 'bund'. However, it is

noticed that due to these sand dunes, water gets raised in Paravoor lake during monsoon season sand creates threat to the people's life and fish farming in areas like Mukkam. Hence during monsoon season generally works are arranged to break the bunds formed at estuary. Hence it is essential to remove these sand banks.

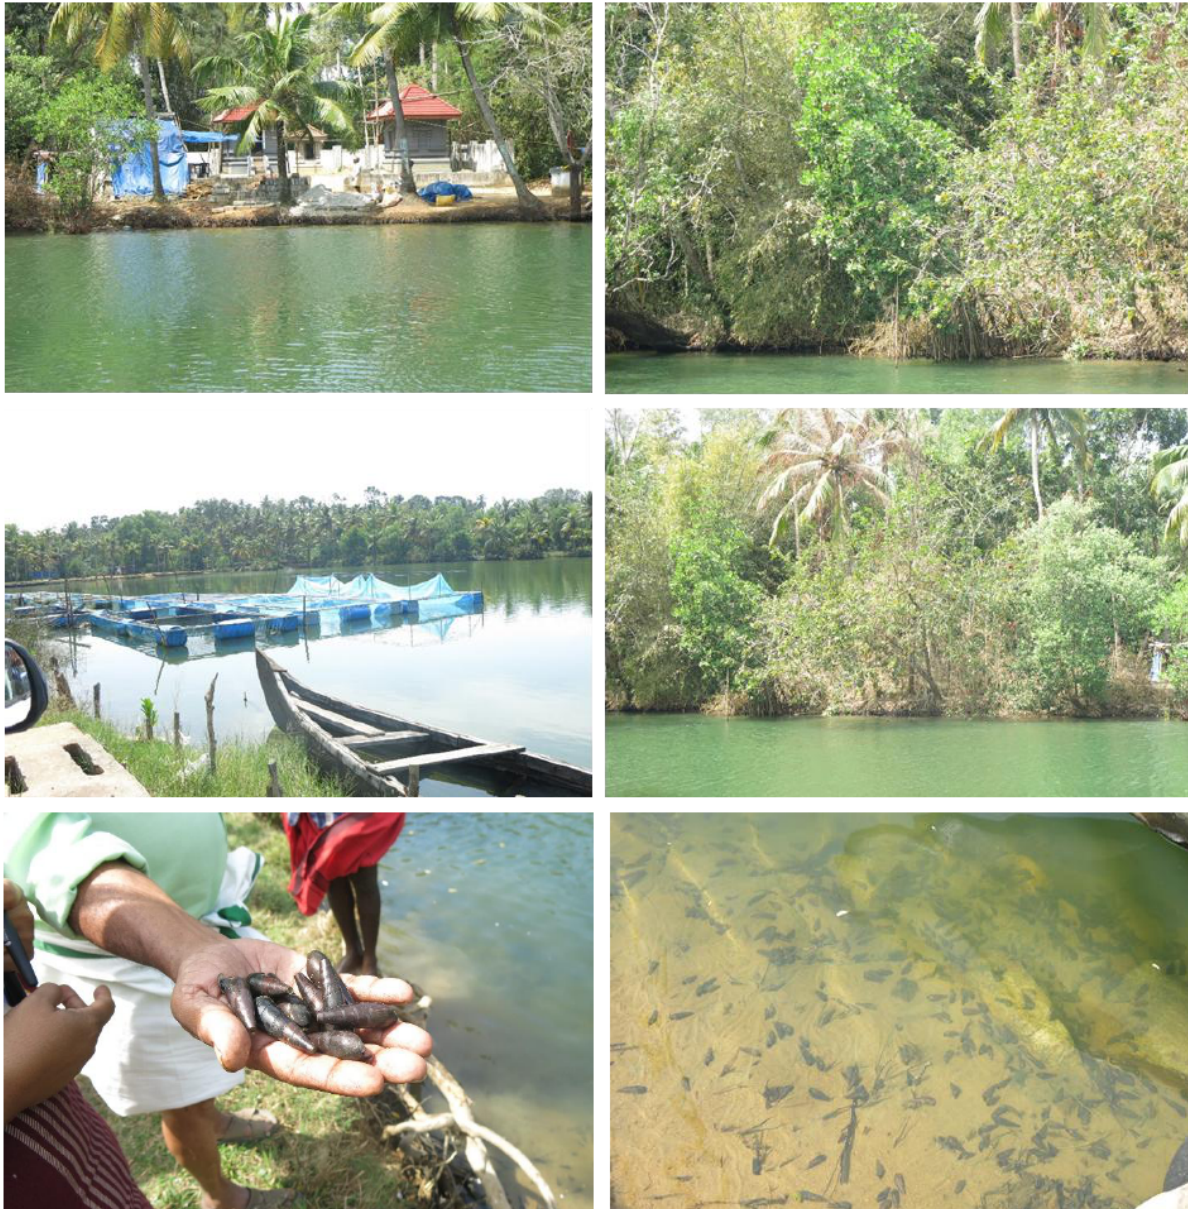
The committee observed that various mangrove plants sparsely exist along the banks of the river, while the river banks look eroded. Any future developments in

this area should be aligned with the latest approved CZMP(Annexure V&Annexure VII).Boating activities are common in the region but are not alarming enough to cause any environmental damage. The proliferation of aquaculture should be regulated.Shelled organisms such as devil snails were observed in the region. The organism exists in the mangrove region, where it feeds on mangrove leaf litter.

**Fig. 7.** River bank erosion, aquaculture ponds, sparse mangroves, and shelled organisms noticed at Chirakkara, Amavattom, and Appopankavu.

To stop erosion on the river banks, soft measures such as mangrove plantation in suitable areas shall be conducted along the estuarine banks, involving the local communities.
