**BEFORE THE HON'BLE NATIONAL GREEN TRIBUNAL  
SOUTHERN ZONE AT CHENNAI**

**Original Application No. 288 of 2024**

**Additional Report submitted to the Hon'ble National Green Tribunal, SZ by the Third Respondent - TAMIL NADU POLLUTION CONTROL BOARD (TNPCB) in Original Application No. 288 of 2024 which is filed by Mrs. P. Muthammal, W/o Ponnusamy Chinnamanali Post, Tiruchengode Taluk, Namakkal District against The Regional Director, Central Pollution Control Board and others.**

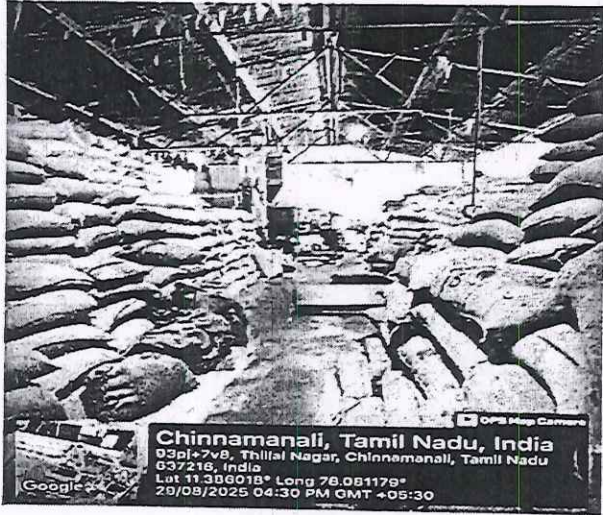
| | Dust collector system should be installed to control emissions from mixing and grinding section of the feed mill. | <b>Complied.</b><br> <p>Chinnamanali, Tamil Nadu, India<br/> 09p+7v8, Thillai Nagar, Chinnamanali, Tamil Nadu<br/> 637216, India<br/> Lat 11.306018° Long 78.081179°<br/> 20/08/2025 04:30 PM GMT +05:30</p> |

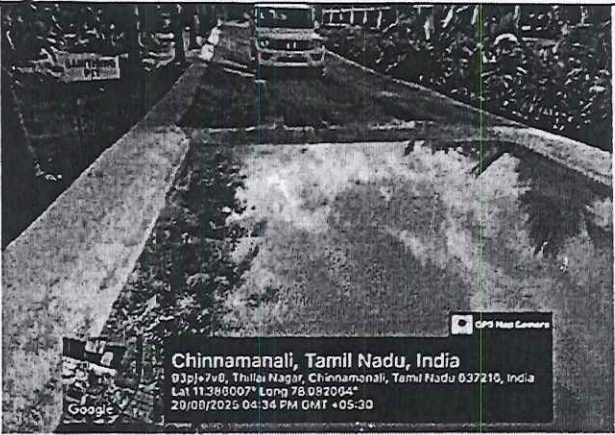
| | The litter / manure storage facilities shall be minimum 2 m above the water table and of adequate size based on type and number of birds | <p><b>Complied.</b></p> <p>The unit has provided Compost yard after collecting manure for further process. Its base was constructed with impermeable</p> |

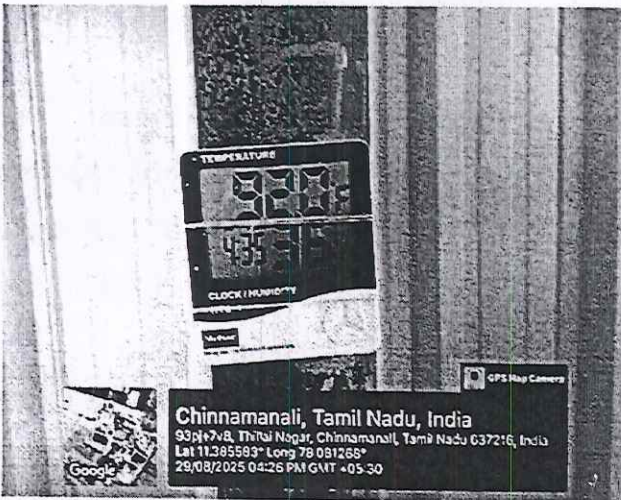
| <p>Periodic stirring of compost material should be done for its proper mixing</p> | <p><b>Complied.</b><br/>Periodic manual stirring is done by the unit.</p> |
| <p>Moisture levels should be maintained between 35 to 50%.</p> | <p><b>Complied.</b><br/>moisture monitoring device is available in compost yard.</p> |
| <p>Temperature monitoring should be done to determine composting conditions.</p> | <p><b>Complied.</b><br/>Temperature monitoring device is available in compost yard.</p> |

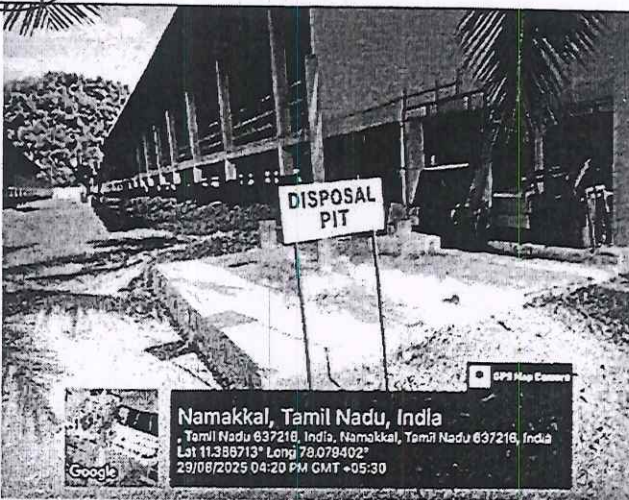
| | The dead bird burial pit shall be of minimum 3 to 4 m in depth and 0.8 to 1.2 m diameter and this size may vary as per the capacity of | <p><b>Complied.</b></p> <p>The unit has provided a burial pit 14x12x12 (ft) within the unit premises.</p> |

| | <p>poultry farm and shall be located above minimum 3 m from the ground water table.</p> | |
| | <p>The dead bird burial pit shall be provided with a vermin/fly proof cover made up of wooden / metal / concrete having a central operable lid of proper size for day to day dropping of carcasses</p> | <p><b>Complied.</b></p> <p>Burial pit has provided with a vermin/fly proof cover made up of concrete having a operable lid of proper size to dropping of carcasses.</p> |
| | <p>Carcasses shall be covered by a thin layer of soil (at least 40 cm deep) alongwith calcium hydroxide</p> | <p><b>Complied.</b></p> <p>The carcasses covered with cements and calcium hydroxide</p> |

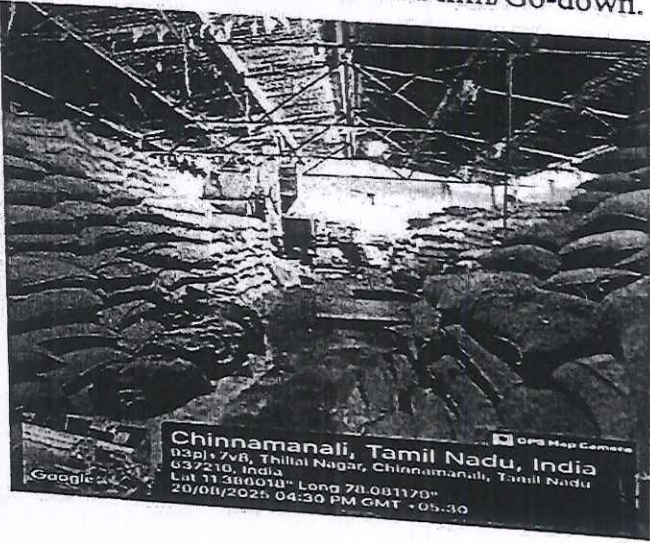
| Sl.No. | Description | Present Compliance status |
|---|---|---|
| | Dust is generated from the feed mill operation during mixing and grinding of various ingredients of feed. The feed mill operations are typically located inside the mill buildings. Dust extraction systems are generally used to collect the dust and to improve the shop floor environment. | <p><b>Complied.</b></p> <p>The unit has provided feed mill and Go-down facility inside the Closed Shed which is located near entrance of the unit. separate dust collector system was provided in the feed mill/Go-down.</p> |

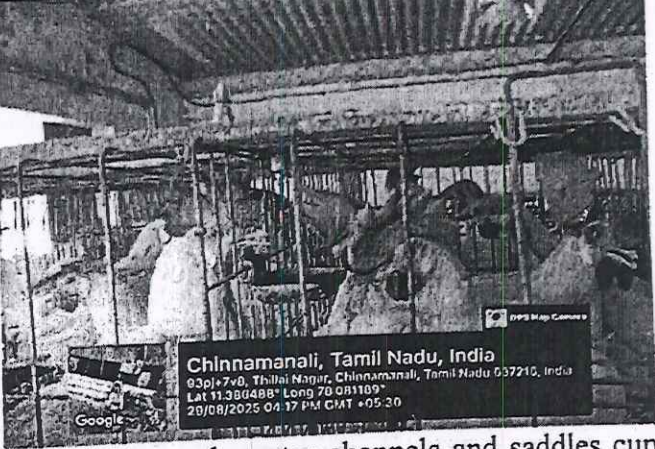
| | <p>drinking of birds, sprinkling during the summer and for cleaning sheds and equipment in between batch replacement.</p> | <p>Chinnamanali, Tamil Nadu, India<br/>93p1+7v0, Thilai Nagar, Chinnamanali, Tamil Nadu 637216, India<br/>Lat 11.380488° Long 78.081189°<br/>20/08/2025 04:17 PM GMT +05:30</p> |

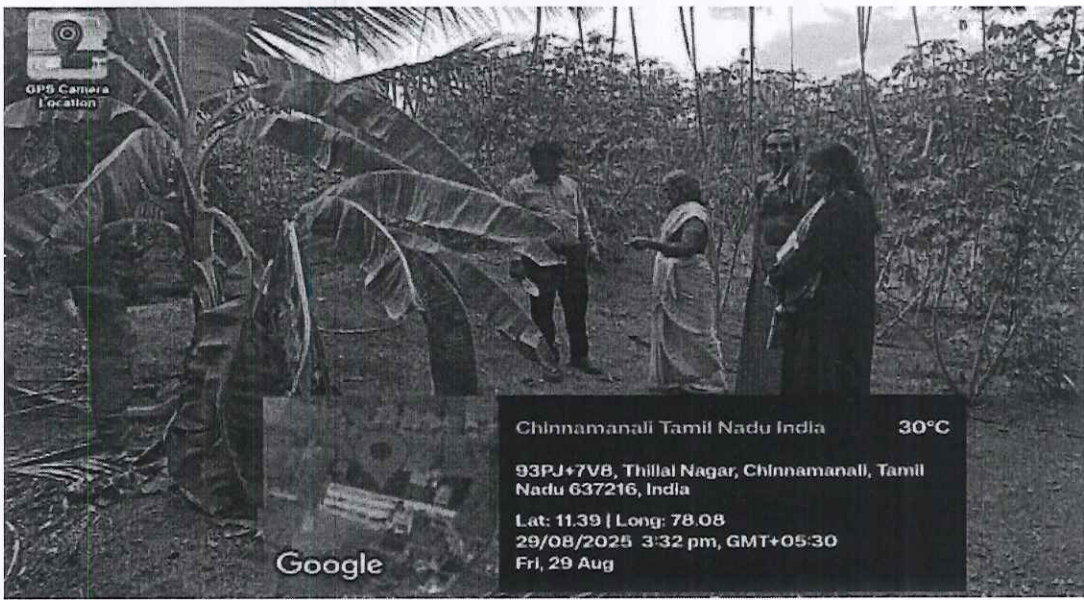
(Inspection at the agriculture land of the Petitioner )

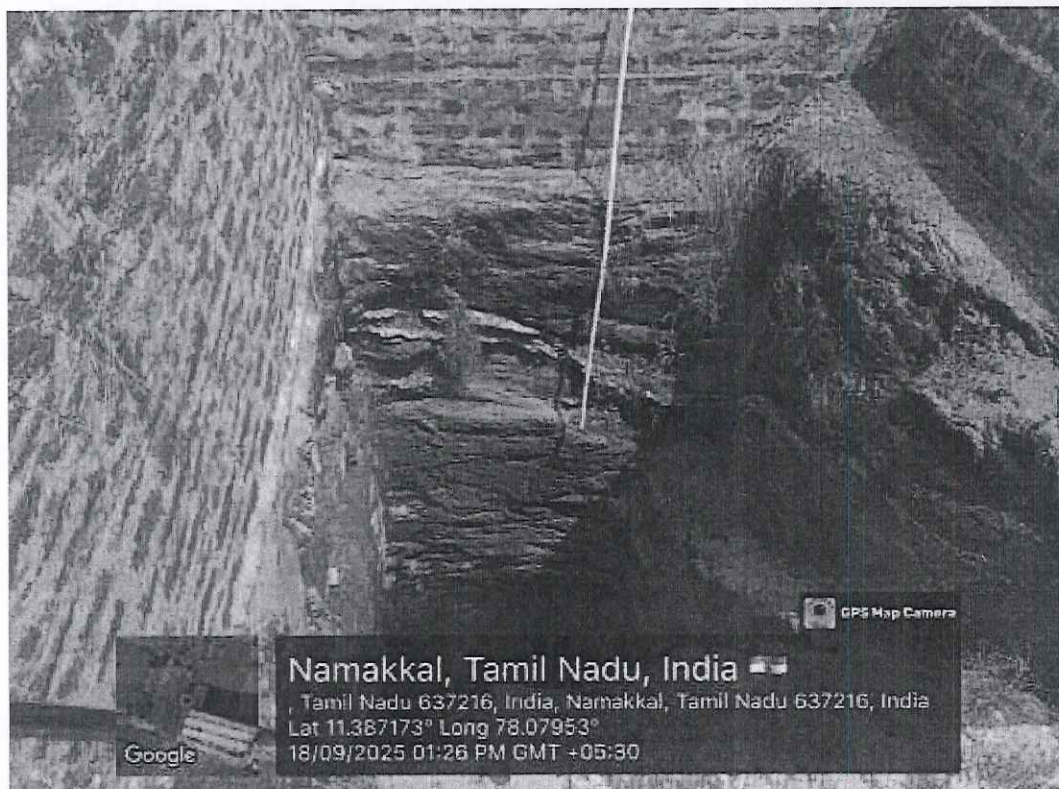
- v. Two open wells located in the petitioner land at about 2 meters distance and about 30 meters distance from the poultry farm compound wall were found in clean condition and no feathers and dust deposition noticed in the open well area (Photographs enclosed).

(Views of petitioner's Open Well located at about 2m distance from the poultry farm)
