**BEFORE THE NATIONAL GREEN TRIBUNAL
SOUTHERN ZONE BENCH, CHENNAI
ORIGINAL APPLICATION NO. 37/2023**

**REPORT ON BEHALF OF RESPONDENT NO. 2 (DEPUTY
COMMISSIONER, BENGALURU URBAN DISTRICT) IN COMPLIANCE
OF ORDER DATED 11.12.2026**

Subject: - Regarding Land bearing Sy.No.21/1, 21/2, 21/3, 23, 24, 124, 125 situated at Segeehalli Village, Bidarahalli Hobli, Bengaluru East Taluk.

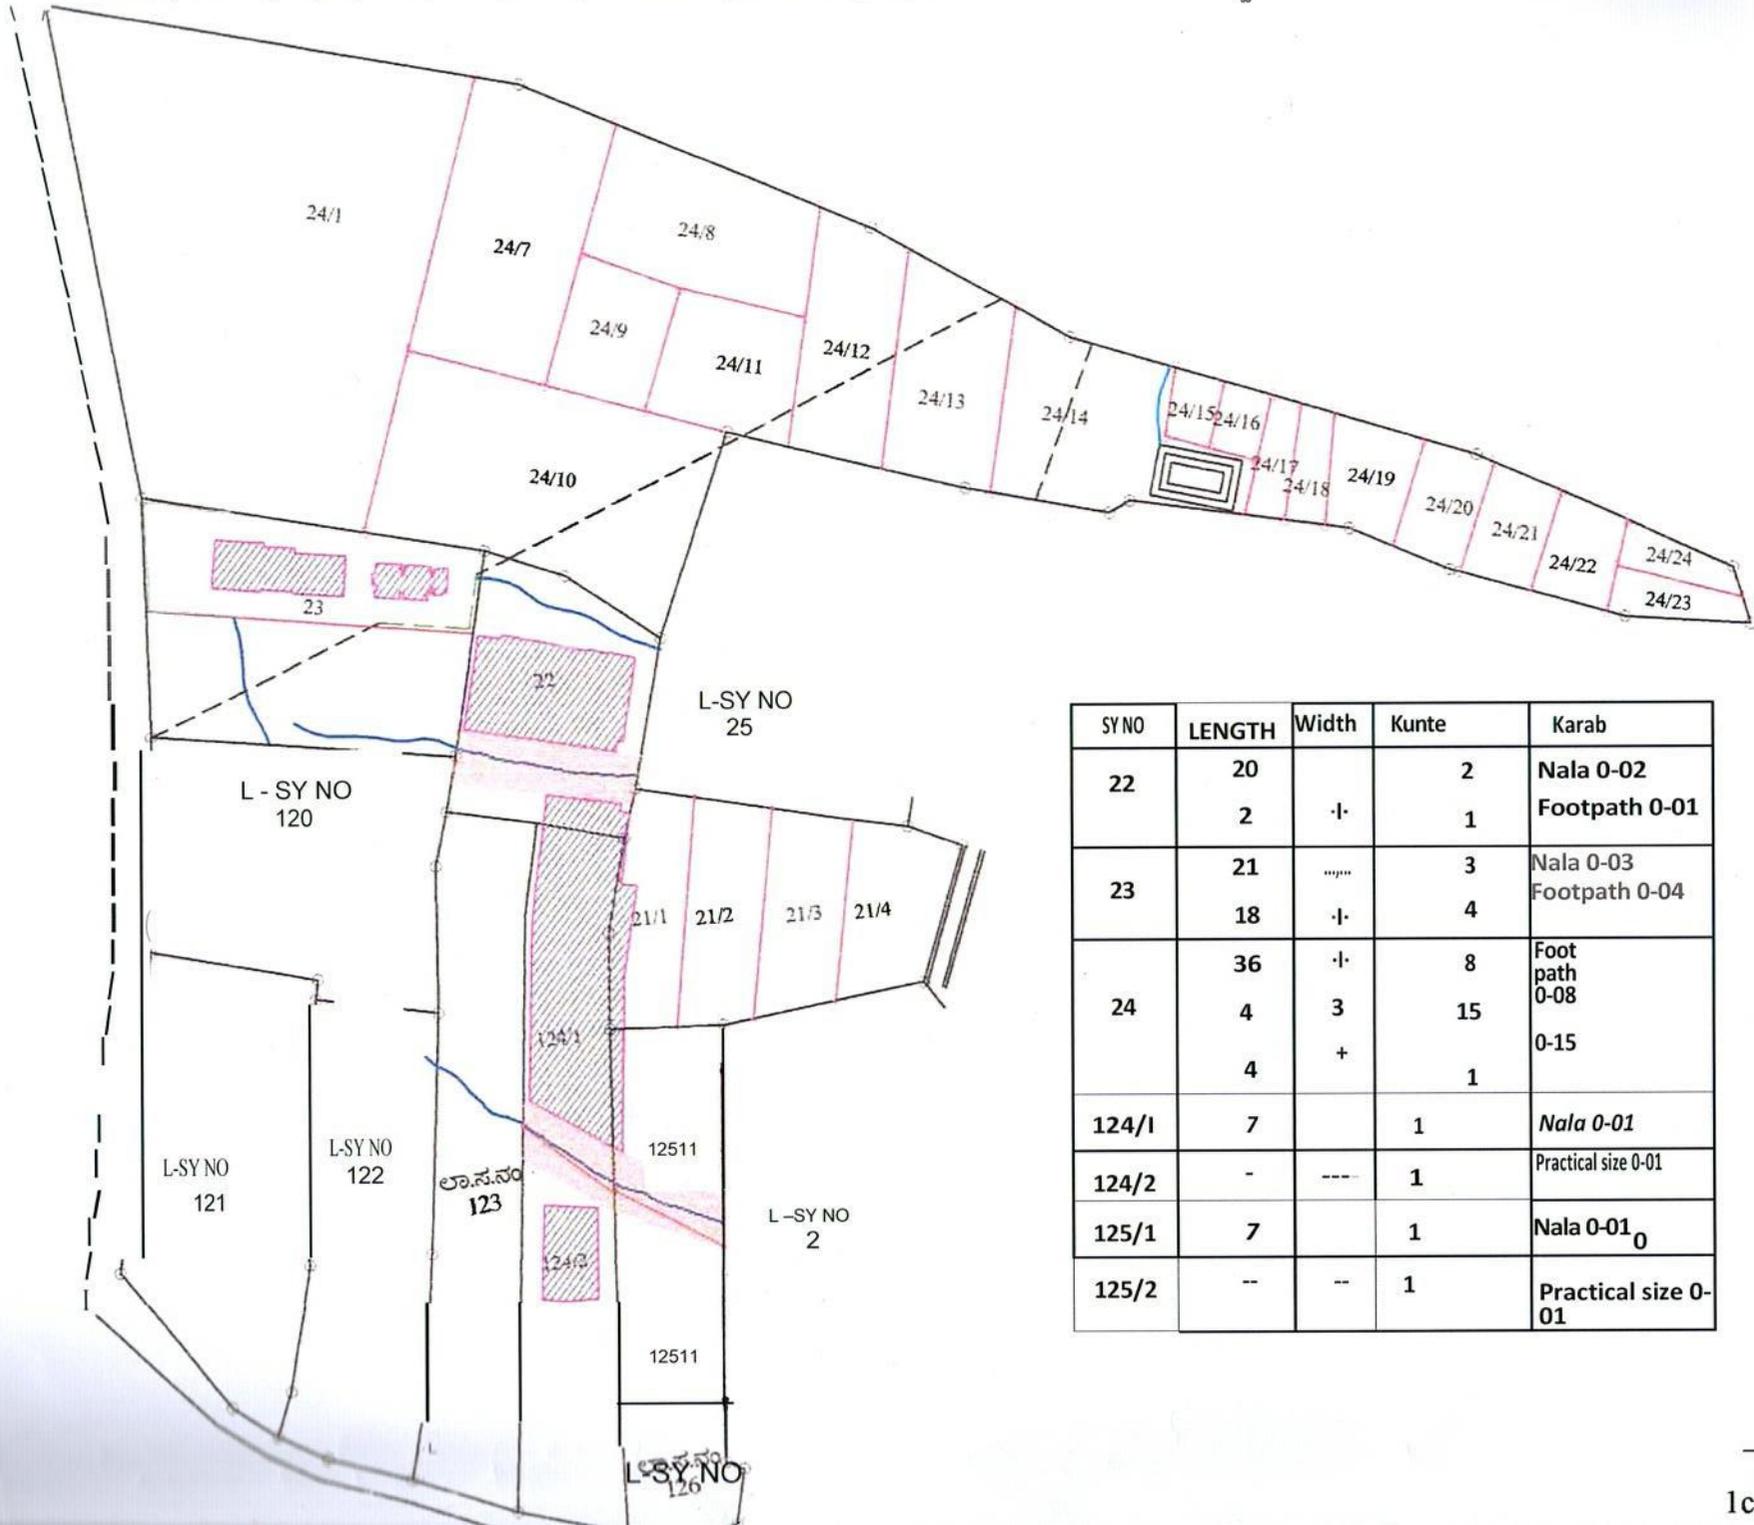
2. As per the present factual situation, the nala has lost its flow. But as per the survey records, nala existing between SY.No.24/0 and 22, SY.No.124/1 and 22. SY.No.241 and 24/2.

3. As per Survey Record the width of the nala is 1.20 mtrs. But in survey record measurement of depth of nala is not available.
4. As shown in the village map, the nala starts from Sy.No.24 and goes through Sy.No.23, 120, 22, 123, 124, 25 and joins in Sy.No.13 Kunta. Similarly, another nala starts from Sy.No.23 and goes through Sy.No.22, Sy.No.25 and joins the Nala going from Kannamangala to Kadugodi through other survey numbers. The village map is attached.

The symbol indicates that the original and hissa survey records indicate a karab of the nala, which is 1.20 meters wide.
6.

As per the current land condition marked with this colour, the length of the nala on the north side of Sy.No.22 is 100.0 meters and the length of the nala on the south side of Sy.No.22 is 100.0 meters, the length of nala in Sy.No.24/1, 24/2 is 70.0 meters. The length of nala in Sy.No.125/1, 125/2 is 70.0 meters. The area left behind is nala and its buffer zone is 100.0 meters.

Sy. No.22, Sy.No. 23 and Sy.No.124/1, 124/2, Sy.No.125/1, 125/2 marked with this color are considered as nala and its buffer zone as per the record and current land condition. its width as per the current location is 30.0 meters. But now the nala is not flowing through the place as per the current land condition

The symbol of the colour in Sy no. 24 about the nala is about 0.01 gunte as per record but the pathway passes through it as per the current land condition.

The area marked in green in Sy.No.23 on the map is the order passed by the Honorable Deputy Commissioner of Bangalore Urban District vide order No.LND(E)CR/170/16-17 dated 20-08-2018 for the diversion of the nala and foot path area.

The land marked with this color is the areas where construction is in progress as per the current land condition.
