**BEFORE THE NATIONAL GREEN TRIBUNAL,  
PRINCIPAL BENCH, NEW DELHI****OA NO. 127/2024**

**REPLY ON BEHALF OF RESPONDENT NO. 9 / ABCI  
INFRASTRUCTURE PVT. LTD.**

Sub: "Rehabilitation and Upgradation to 2-lane/2-lane with paved shoulders/4-lane configuration of Paonta Sahib-Hewna Section (Km. 0.000 to Km. 25.000) of NH-707 in the State of Himachal Pradesh under Green National Highways Corridor Project (GNHCP) with the loan assistance of World Bank on EPC Mode" – Show cause notice under Water (Prevention and Control of Pollution) Act, 1981

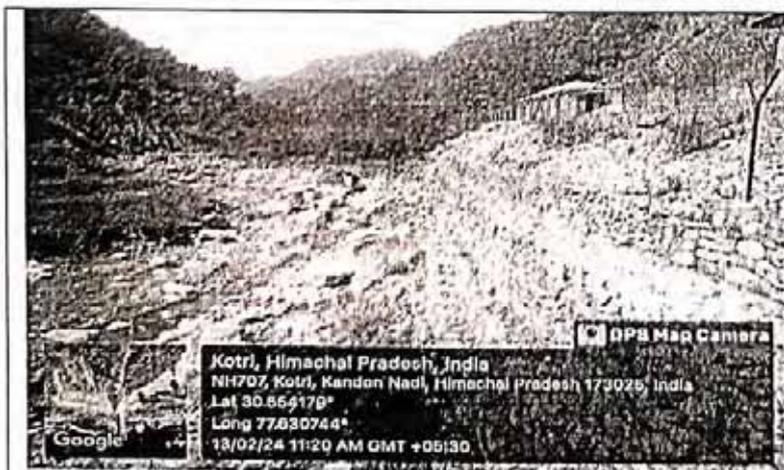
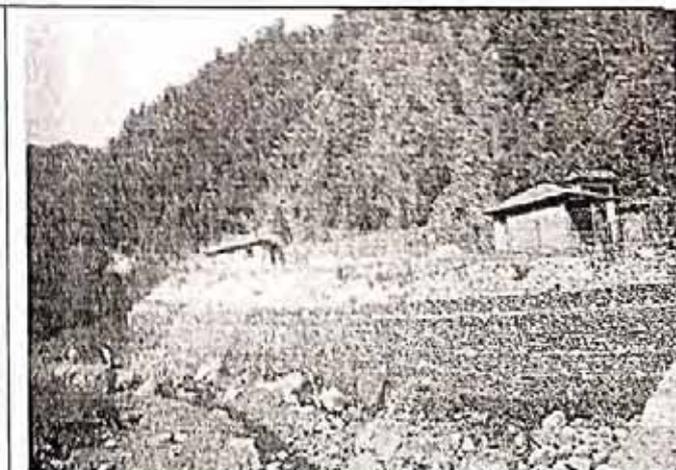
Sr. No	Road Stretch along with chainage	Observations
1	Muck Dumping site at Kando Khad near Sataun Bridge at Chainage Km 16+650	<i>The work has been completed and no further dumping is being carried out this site. It was observed that the retaining structures have been provided toward Kando Nallah to restrict the spillage of muck into nallah. However the retaining structures have been partially damaged and require immediate repair. Photographs are attached herewith.</i>
2	Muck dumping site at Poka road near GSSS Sataun.	<i>Retaining structures provided to retain the muck are not sufficient as same has been provided only on one side of the dumping site while other side of the site is without any retaining structures. Which is resulting into spillage of muck into the Tilgan khad. Photographs are attached herewith.</i>
3	Muck dumping site at at chainage Km 21+300	<i>It was observed that, no retaining structures have been provided towards the downhill side of the site. The muck dumped at this site is directly spilling into valley depression. Necessary retaining structures along with provisions of drainage are required to be provided. Photographs are attached herewith.</i>

Photograph No. 1 and Photograph No. 2 shows status of Site at Kando Khad near Saton Bridge at Chainage Km 16+650

Reference	SI No. 1, Photograph No. 1 & 2
Location	Muck Dumping site at Kando Khad near Sataun Bridge at Chainage Km 16+650
Observation	The work has been completed and no further dumping is being carried out this site. It was observed that the retaining structures have been provided toward Kando Nallah to restrict the spillage of muck into nallah. However, the retaining structures have been partially damaged and require immediate repair. Photographs are attached herewith
Compliance	Suitable protection work i.e. gabion structure was provided to retain the filled material at muck dumping site located at Ch. 16+650, however the extreme weather conditions damaged the completed works. This dumping site has already been closed and no further dumping is being carried out. Notwithstanding, in compliance of the observation made, retaining structure has been restored. please refer photographs furnished below.

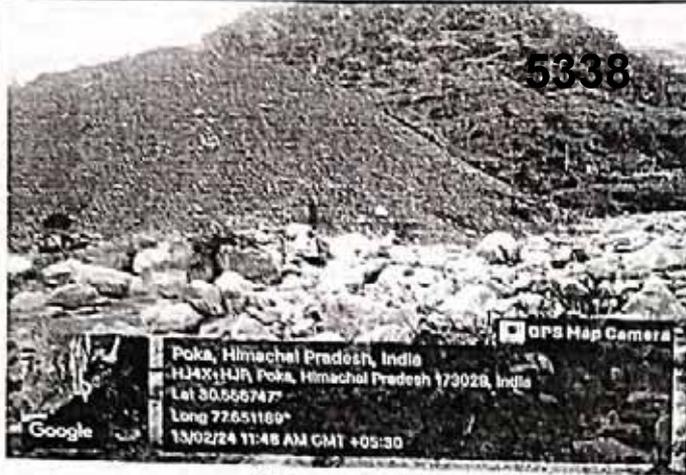
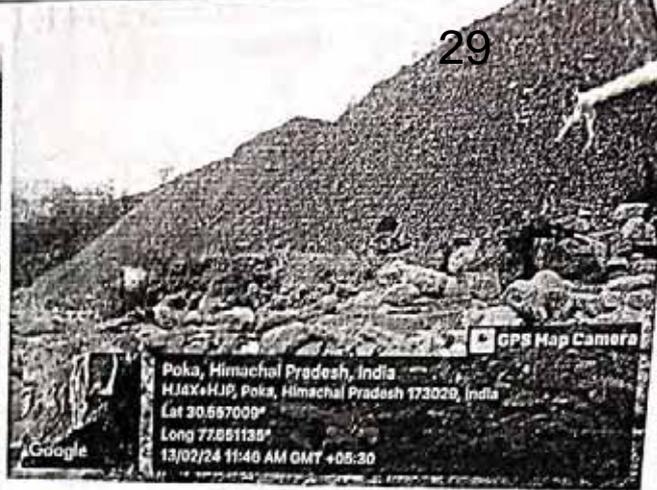
Photograph No. 3 and Photograph No. 4 shows status of Site Poka near GSSS Sataun

Reference	SI No. 2, Photograph No. 3 & 4
Location	Muck Dumping site at Poka road near GSSS Sataun
Observation	<i>Retaining structures provided to retain the muck are not sufficient as same has been provided only on one side of the dumping site while other side of the site is without any retaining structures. Which is resulting into spillage of muck into the Tilgan khad. Photographs are attached herewith.</i>
Compliance	The dumping site located at Km. 20+200 (Saton Poka road) is being used for disposal of muck. The suitable protection works i.e. Gabion structure is provided to retain the filled material on the other side is provided. The photographs are furnished below for your ready reference.

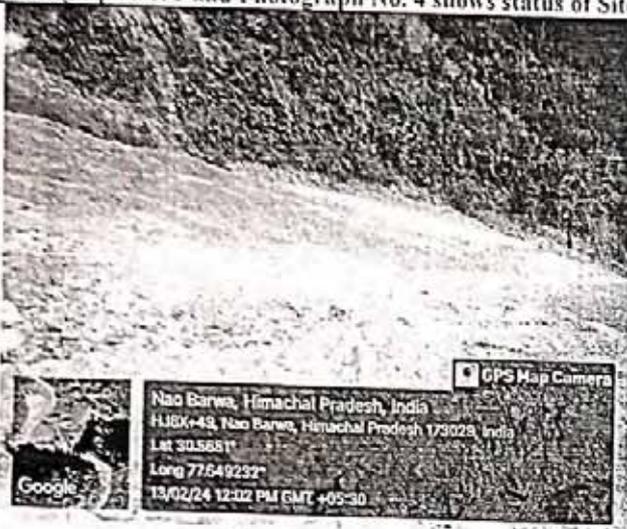
Photograph No. 5 & Photograph No. 6 shows status of Site at chainage Km 21+300

<b>Reference</b>	SI No. 3, Photograph No. 5 & 6
<b>Location</b>	Muck Dumping site at chainage Km 21+300
<b>Observation</b>	<i>It was observed that, no retaining structures have been provided towards the downhill side of the site. The muck dumped at this site is directly spilling into valley depression. Necessary retaining structures along with provisions of drainage are required to be provided. Photographs are attached herewith.</i>
<b>Compliance</b>	The Dumping site located at Km. 21+300 has already been closed and no dumping is carried out at this site. We have carried out the bench formation and provided the suitable protection works. The necessary retaining structures have been also provided towards the downhill side. We have also provided the jute mat along with seeding. We are also undertaking plantation above benching area. The photographs are enclosed herewith for your ready reference.

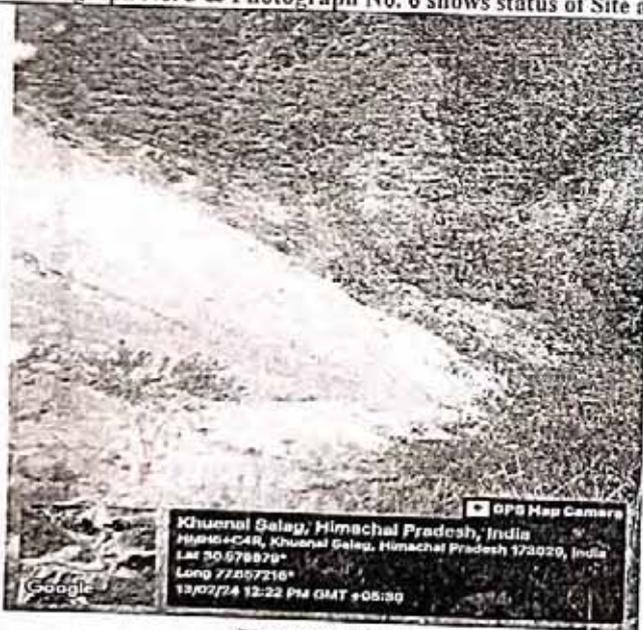
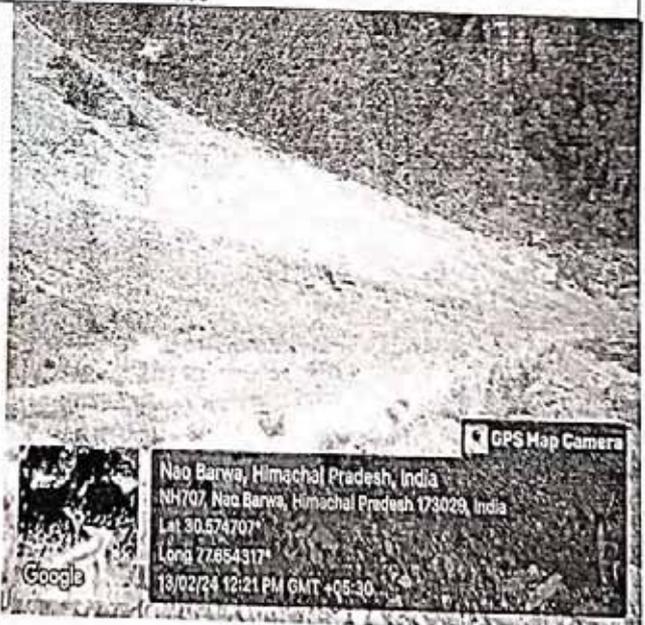
4	Muck dumping site near Hewna Temple at chainage Km 24+400	<i>The provided retaining structure were damaged in past due to flash flood in the district. The company is required to provided/repair necessary retaining structures in along the downside of hill so that, muck can be retained and spillage of same can be avoided. Photographs are attached herewith.</i>

Photograph No. 7 & Photograph No. 8 shows status of Site near Hewna Temple at chainage Km 24+400

Reference	SI No. 4, Photograph No. 7 & 8
Location	Muck dumping site near Hewna Temple at chainage 24+400
Observation	<i>The provided retaining structure were damaged in past due to flash flood in the district. The company is required to provided/repair necessary retaining structures in along the downside of hill so that, muck can be retained and spillage of same can be avoided. Photographs are attached herewith.</i>
Compliance	The dumping site located at Km 24+400 near Hewan Temple is being used for protection of temple and not for muck disposal. We have developed the front yard of the temple and provided toe wall. Photographs are enclosed herewith for your ready reference.

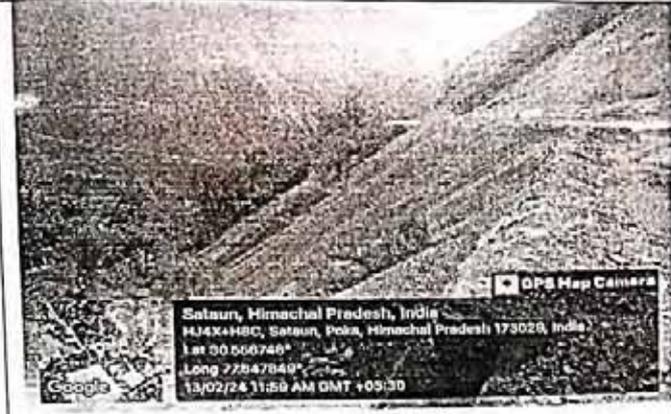
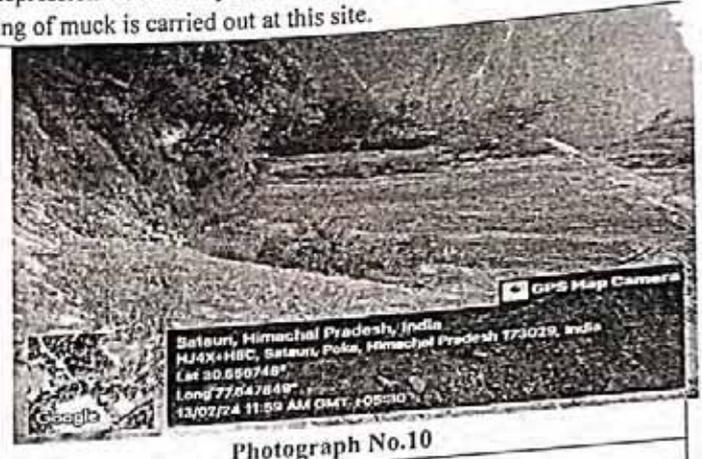
It was observed that the muck is directly disposed into the valley depression without any retaining structures. Immediate preventive measure are required to be taken and further ensure that, no dumping of muck is carried out at this site.

Photograph No. 9 & Photograph No. 10 shows status of muck dumping at Sataun after site No.4 at Sataun

Reference	Photograph No. 9 & 10
Location	Muck dumping site at chainage 18+500 (Non designated muck dumping at Saton after site no 4.)
Observation	<i>It was observed that the muck is directly disposed into the valley depression without any retaining structures. Immediate preventive measures are required to be taken and further ensure that no dumping of muck is carried out at this site.</i>
Compliance	It is clarified that the dumping site located at Km. 18+500 Saton -Renuka road is an approved dumping location by the forest department. Necessary protection work including gabion structure is also provided to retain the filled material. The photograph is furnished below for your ready reference.

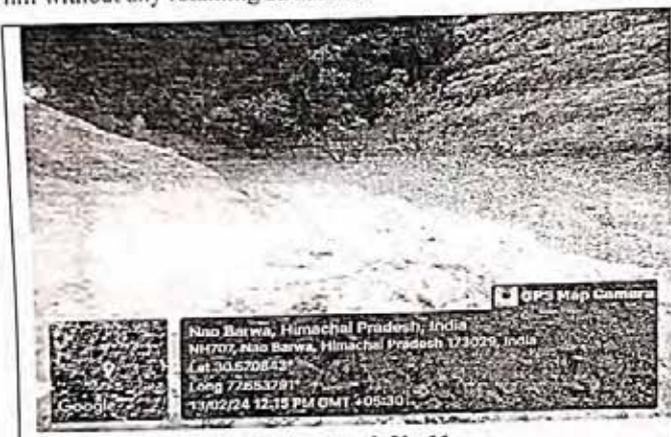
It was observed that, you have carried out dumping of muck along the hill after chainage Km 21+430. The muck is directly disposed along the hill without any retaining structures.

Photograph No. 11 & Photograph No. 12 shows status of muck dumping after chainage Km 21+430

Reference	Photograph No. 11 & 12
Location	Muck dumping site at chainage 21+430 (Non designated muck dumping after chainage Km 21+430).
Observation	<i>It was observed that, you have carried out dumping of muck along the hill after chainage Km 21+430. The muck is directly disposed along the hill without any retaining structures.</i>
Compliance	It is clarified that this dumping site is located at Km. 21+300 (same location as sl. no.-3). It is reiterated that this dumping site has already been closed and no dumping is carried out at this site. We have carried out the bench formation and provided the suitable protection works. The necessary retaining structures have been also provided towards the downhill side. We have also provided the jute mat along with seeding. We are also undertaking plantation above benching area. The photographs are enclosed herewith for your ready reference

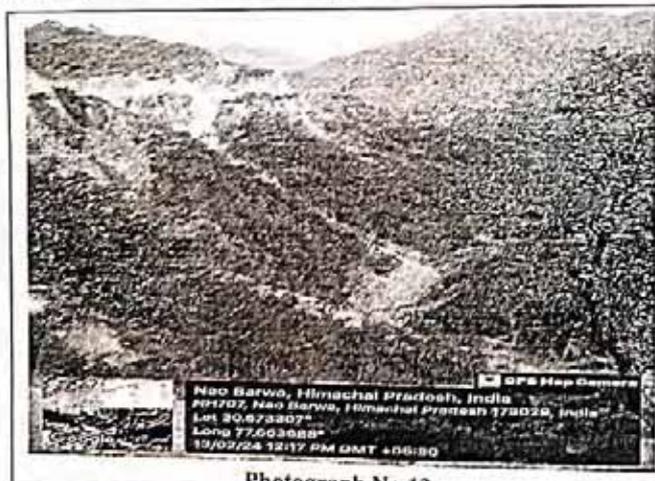
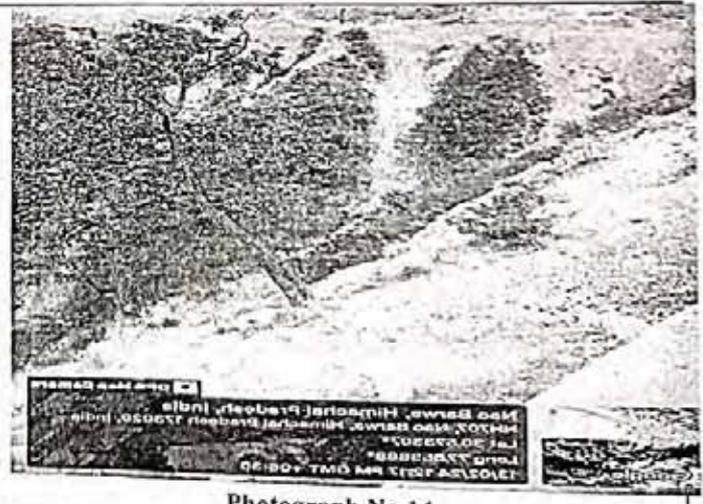
Dumping of muck along the hill after chainage Km 21+430. The muck is directly disposed along the hill without any retaining structures. Immediate preventive measure are required to be taken and to further ensure that, no dumping of muck is carried out at this site.

Photograph No. 13 & Photograph No. 14 shows status of muck dumping at chainage Km 23+200

Reference	Photograph No. 13 & 14
Location	Muck dumping site at chainage 23+200 (Non-designated muck dumping at chainage Km 21+200)
Observation	<i>Dumping of muck along the hill after chainage Km 21+430. The muck is directly disposed along the hill without any retaining structures. Immediate preventive measure is required to be taken and to further ensure that, no dumping of muck is carried out at this site.</i>
Compliance	It is clarified that The site located at Km. 23+050 to 23+150 being used for dumping of muck is an approved dumping location by the forest department. The suitable protection works including gabion structure is also being provided to retain the filled material. The work is ins progress and we are putting out best efforts to complete the same.

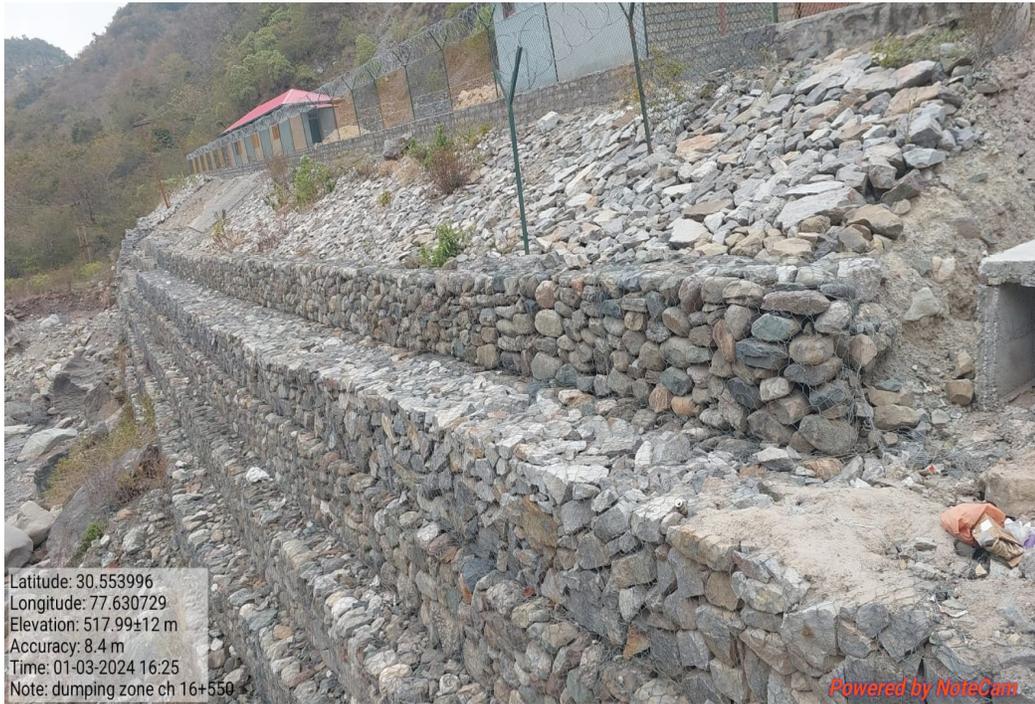
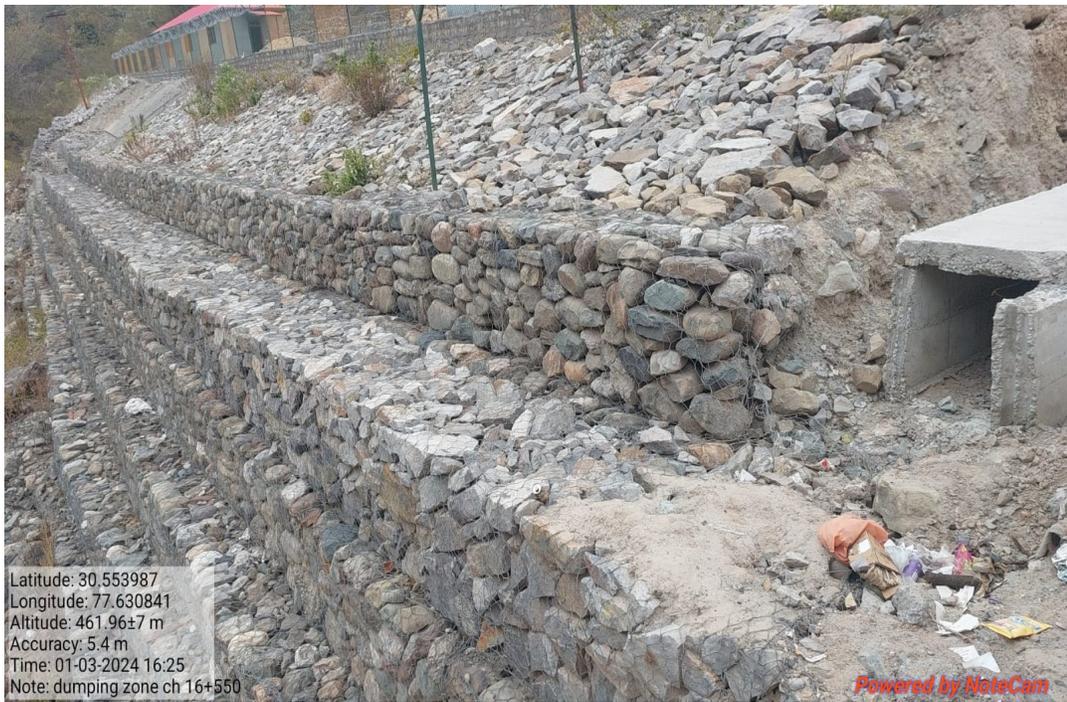
Photograph No. 1 Show status of Ch 16+650 Work In Progress

Photograph No. 2 Show status of Ch 16+650 Work In Progress

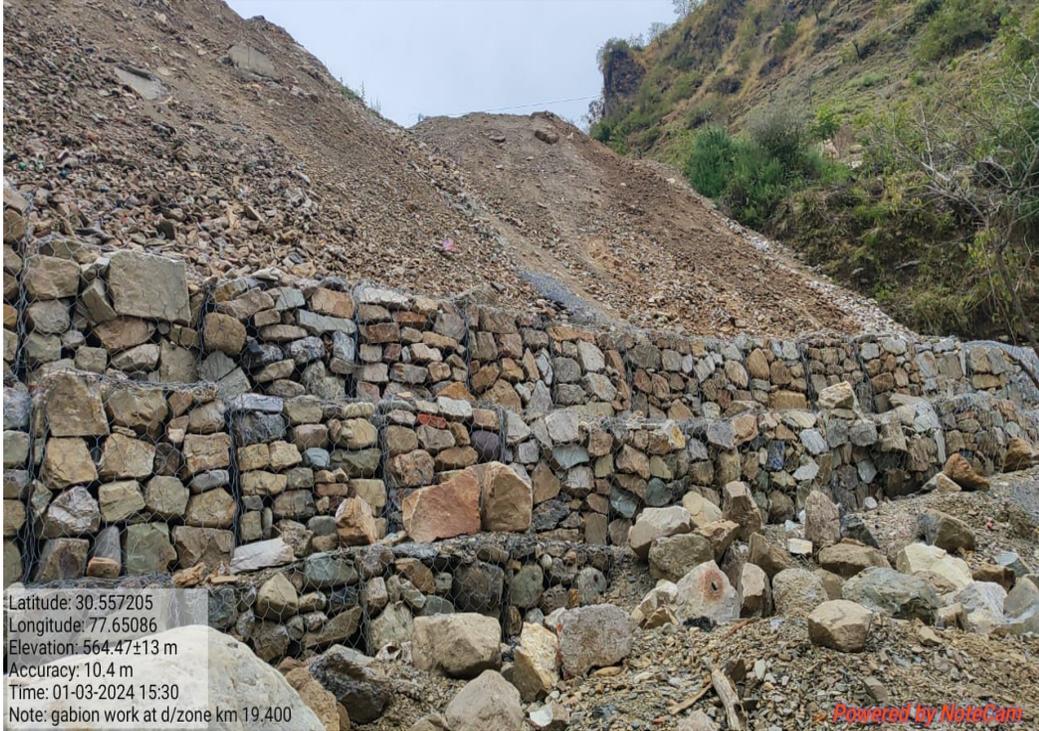
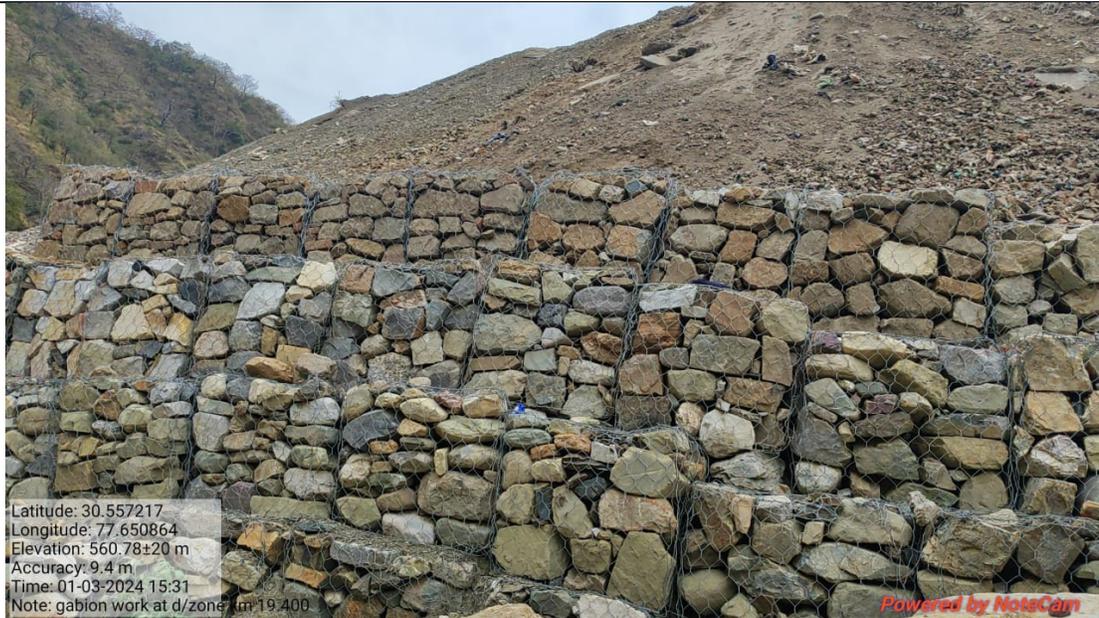
Poka Road  
Near GSSS Sataun

Photograph No. 3 Show status of Ch 19+400 Work In Progress

Photograph No. 4 Show status of Ch 19+400 Work In Progress

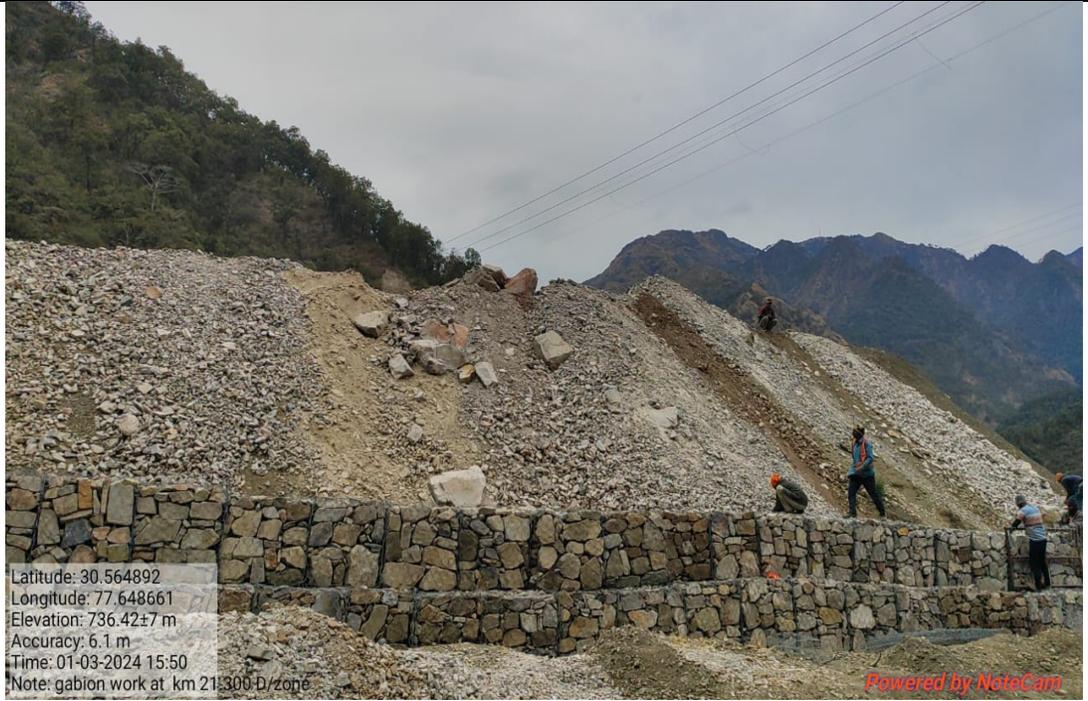
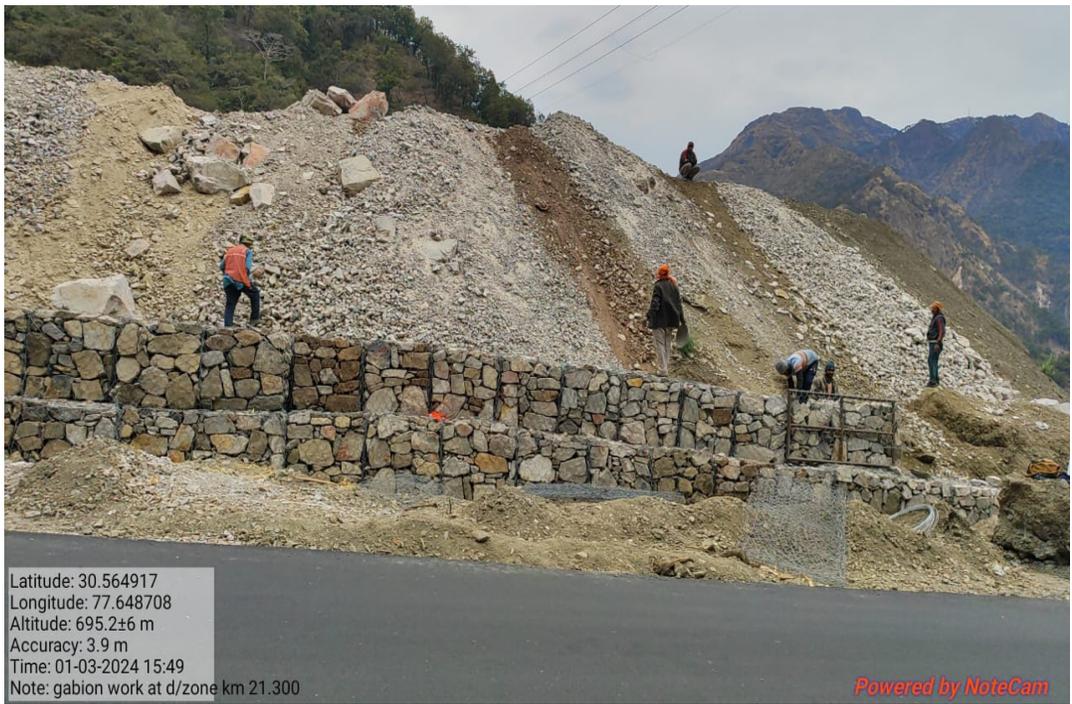
Photograph No. 5 Show status of Ch 21+300 Work In Progress

Photograph No. 6 Show status of Ch 21+300 Work In Progress

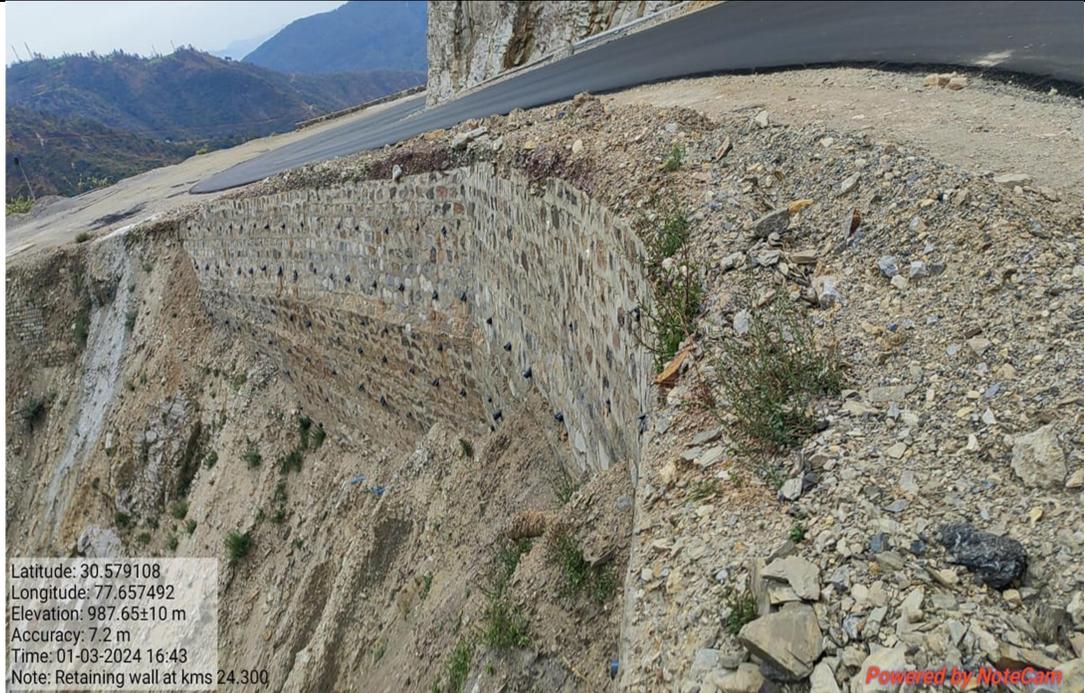
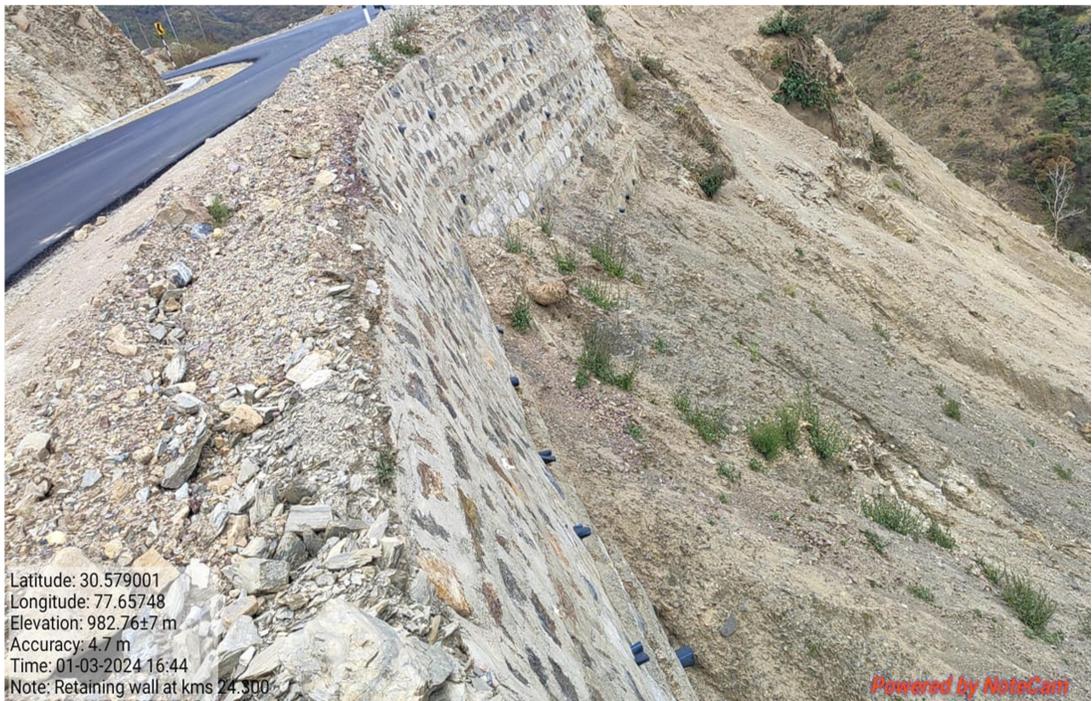
Photograph No. 07 Show Status of CH 24+400 Work Completed

Photograph No. 08 Show status of Ch 24+400 Work Completed

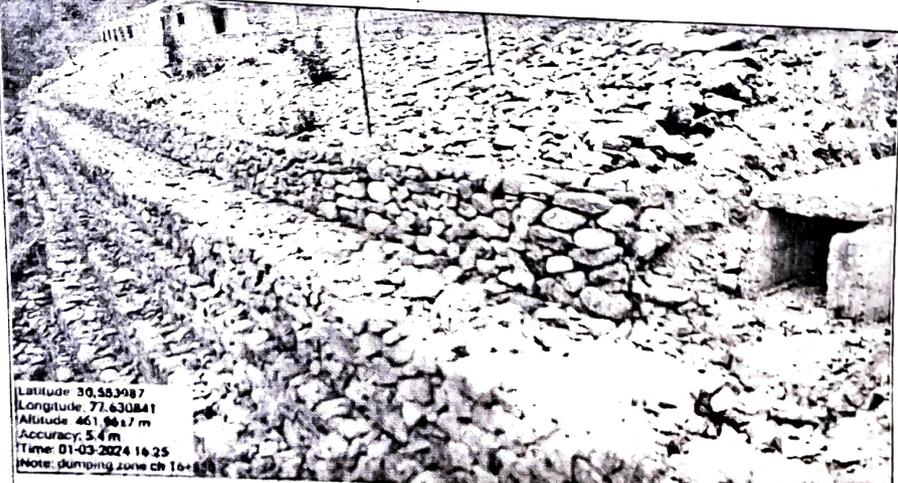
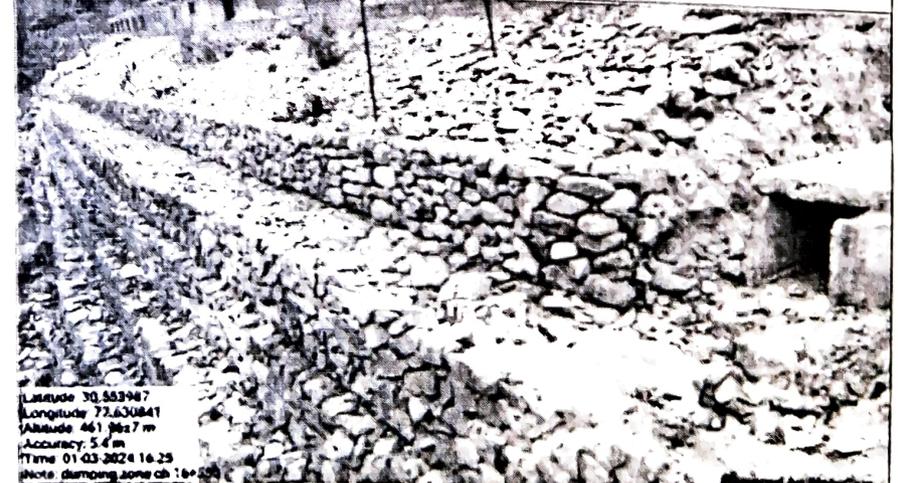
<p>Latitude: 30.553987 Longitude: 77.630841 Altitude: 461.9617 m Accuracy: 5.4 m Time: 01-03-2024 16:25 Note: dumping zone ch 16+650</p>

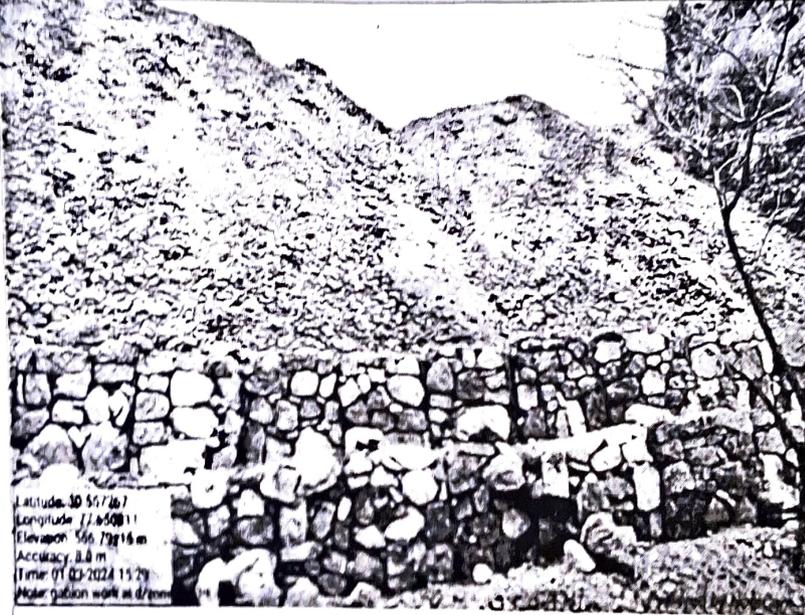
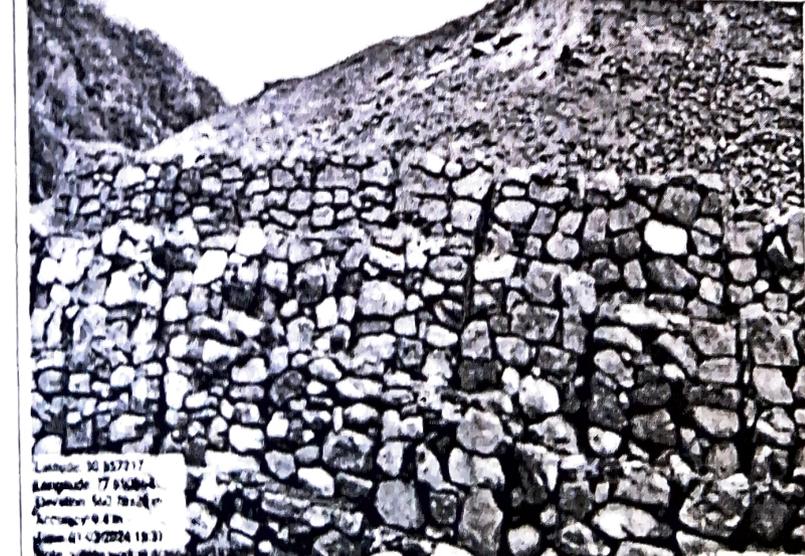
<p>Latitude: 30.517267 Longitude: 77.650811 Elevation: 566.79914 m Accuracy: 0.8 m Time: 01/03/2024 15:29 Note: gabion work at 0/2000</p>

<p>Latitude: 30.517217 Longitude: 77.650811 Elevation: 562.78201 m Accuracy: 0.8 m Time: 01/03/2024 15:31 Note: gabion work at 0/2000</p>

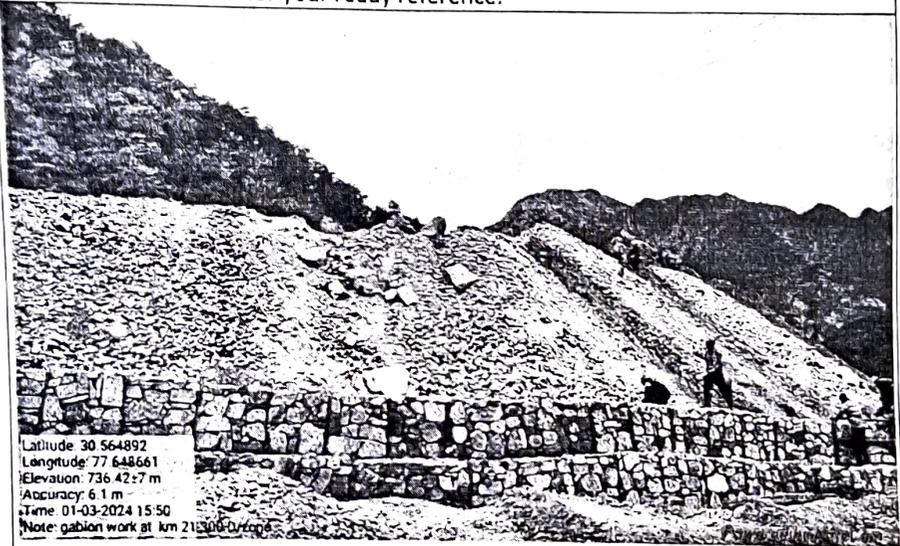
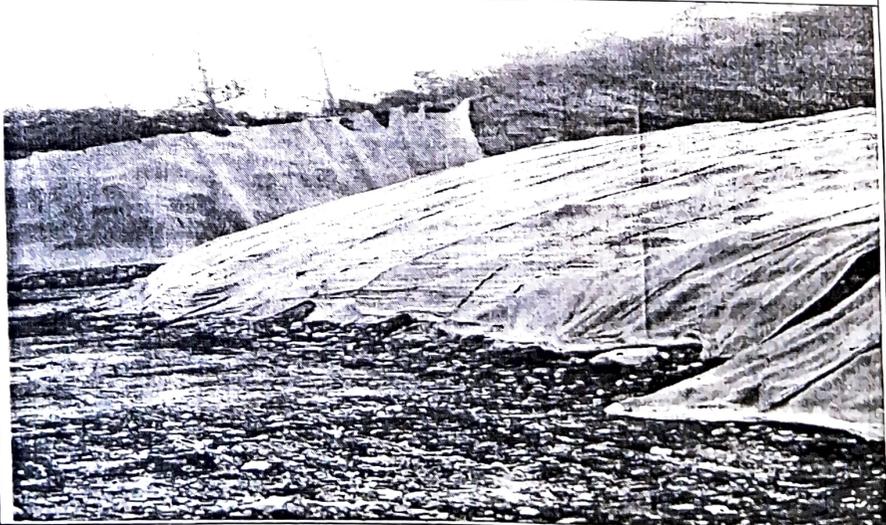
<p>Latitude 30.564892 Longitude 77.648661 Elevation 736.4277 m Accuracy 6.1 m Time 01-03-2024 15:50 Note: gabion work at km 21+300 on road</p>

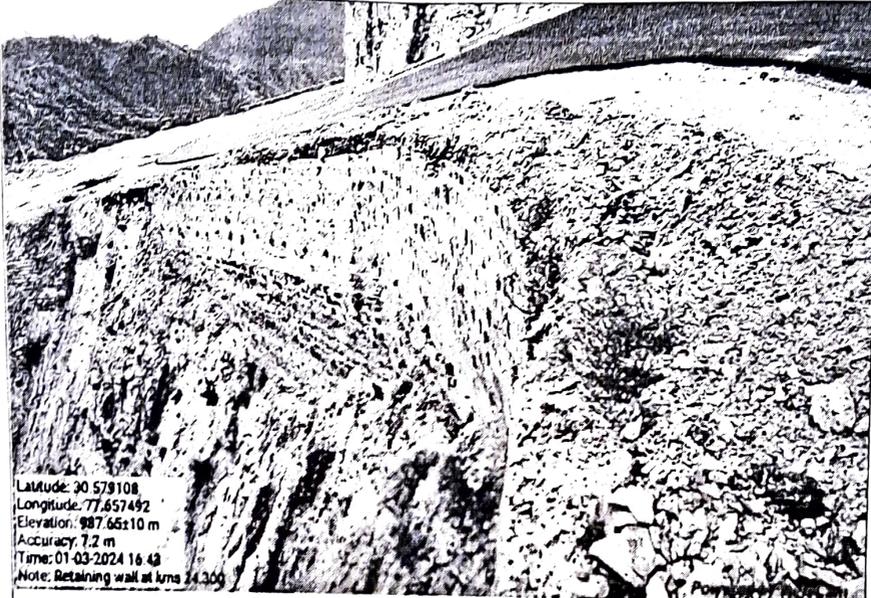
<p>Latitude: 30.579108 Longitude: 77.657492 Elevation: 987.65±10 m Accuracy: 7.2 m Time: 01-03-2024 16:43 Note: Retaining wall at kms 24.300</p>

<p>Latitude: 30.579001 Longitude: 77.65748 Elevation: 982.76±7 m Accuracy: 7.2 m Time: 01-03-2024 16:44 Note: Retaining wall at kms 24.300</p>

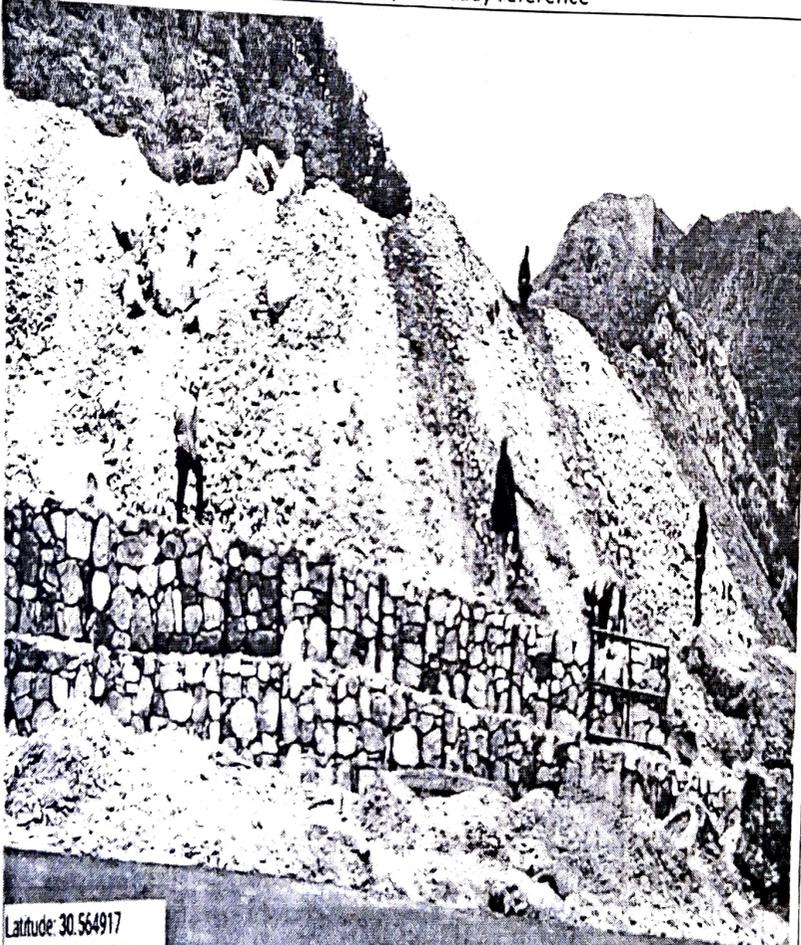
<p>Latitude: 30.564917  Longitude: 77.648708  Altitude: 695.2±6 m  Accuracy: 3.9 m  Time: 01-03-2024 15:49  Note: gabion work at d/zone km 21.300</p>

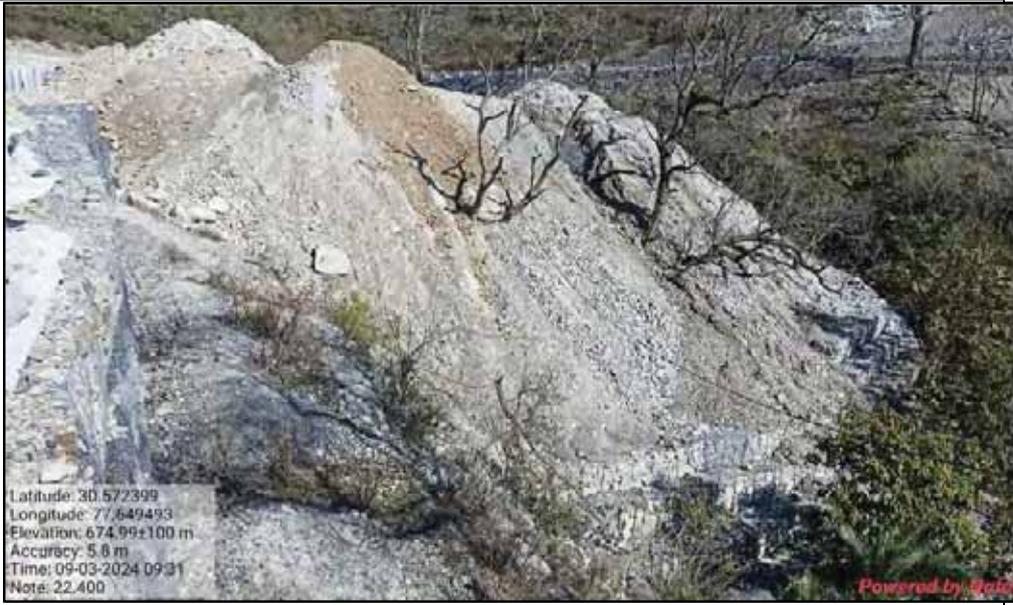
<b>Reference</b>	Sr No. 5, Photograph No. 6,7 & 8
<b>Location</b>	Muck dumping site at chainage 23+100 , 23+ 600
<b>Observation</b>	<i>Designated dumping site at chainage 23+100, 23+600 near Hewna Temple Kakwari khad and adjacent Hewna temple khakhwar in khadd are not provided with sufficient concrete wall structure and display boards.</i>
<b>Compliance</b>	<ol style="list-style-type: none"> <li>1. 23+100 : The muck disposal at these locations is being done with the permission of the concerned department. Further, this muck disposal site has already been provided with benching on top, and a gabion wall at toe. The work for the jute erosion control blanket along with the plantation is in progress at this location</li> <li>2. 23+600 : This location is eroded during monsoon season. Therefore, to protect the valley side temple muck is dumped for the protection of the Hewan temple. We have developed the front yard of the temple and provided a toe wall. The remaining work is in progress like as display board and other works.</li> </ol>
