In compliance of the Hon'ble NGT order in Execution Application No.38/2022 (In Original Application No.165/2021) dated 30.04.2024, it is most respectfully submitted here with:

- 1.1 The elevated boundary wall was constructed to support the steel fencing surrounding Laxmi Taal. The purpose of the said steel fencing was to ensure that the lake and water in it is not polluted with any waste being thrown in it as well as to avoid any kind of encroachment in the future.

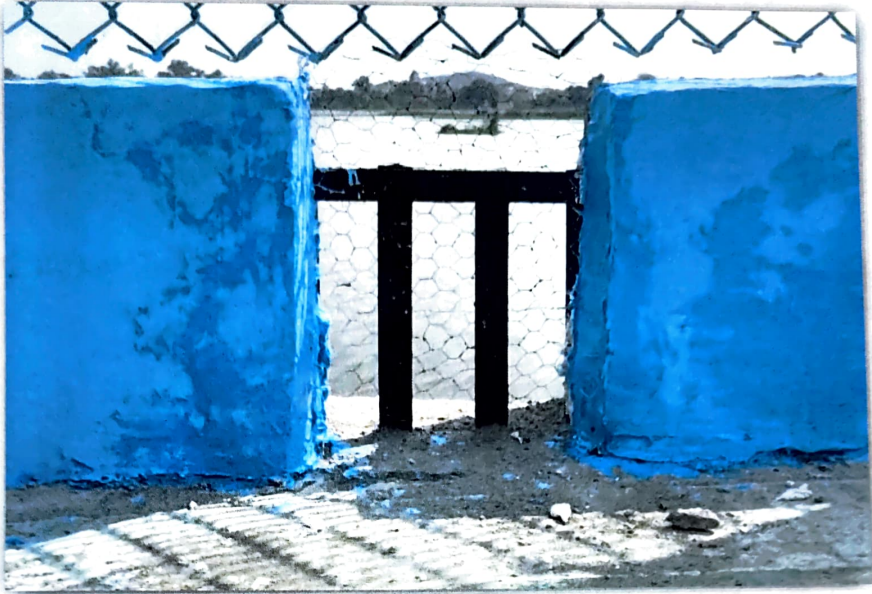
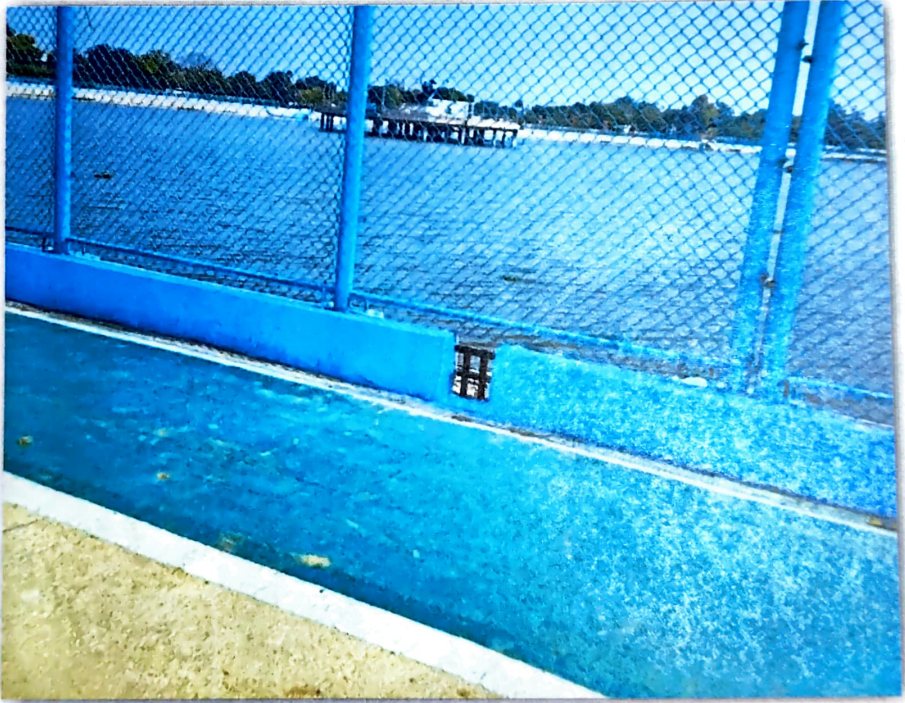
- 1.2 It is further submitted that in order to allow unhindered flow of water from the catchment area, 62 holes measuring 300mm x 230mm were made every 40 meters. As the said holes have been made every 40 meters hence the flow of water is not hindered in case of flooding. **Photographs are attached as Annex 1.**

**Figure: Showing 300mm x 230mm hole in the wall**

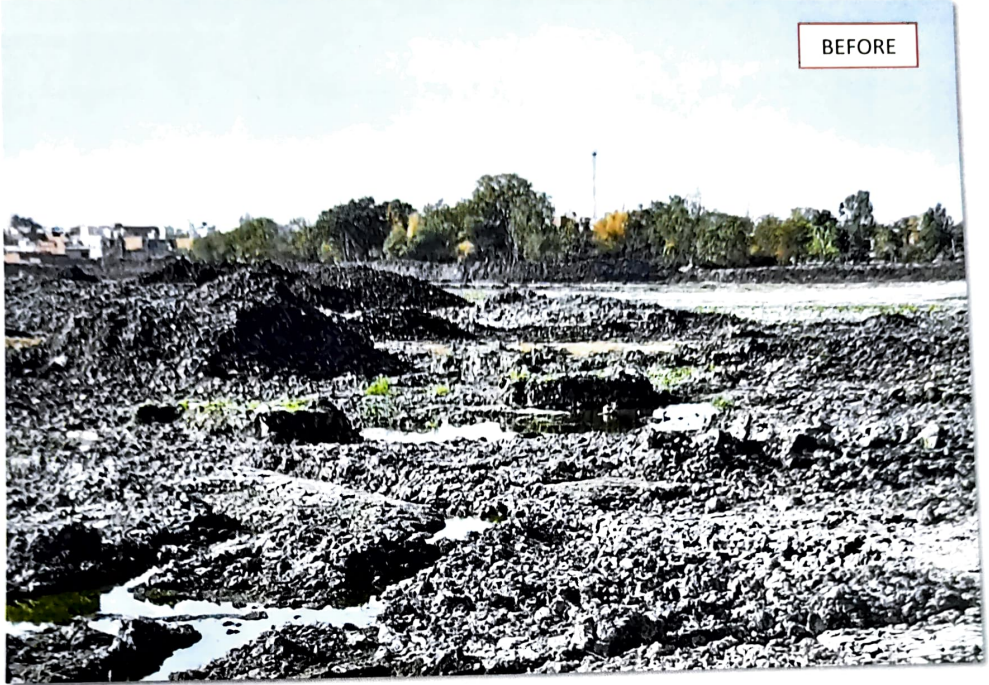
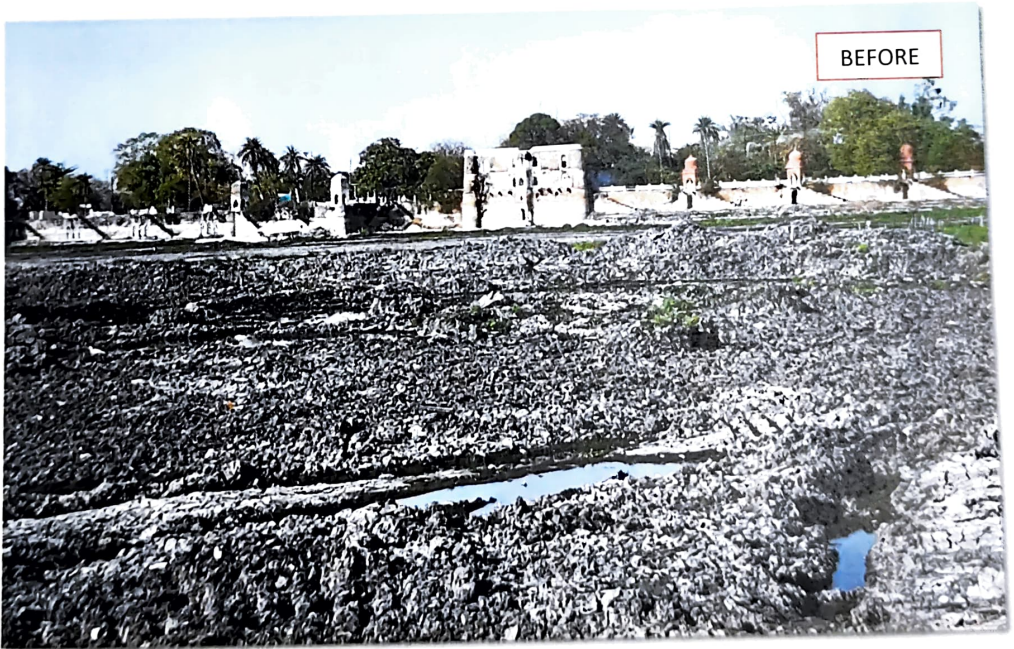
**Figure: Showing Laxmi Taal before rejuvenation**

2. It is also humbly submitted that a pathway has been made over the bund of the lake. During desiltation of the lake, excavated soil was used to create a bund around the pond. To reinforce this bund and to avoid any further siltation of the lake, a pathway was created which serves dual purpose of community participation as well as the enforcement of the bund. It is humbly submitted that the redevelopment plan of Laxmi Taal was placed before Hon'ble NGT which has been taken on record in the order in Original Application No. 165/2021 dated 25.01.2022. **Before and after photographs are enclosed as Annex 2, 3 and 4.**

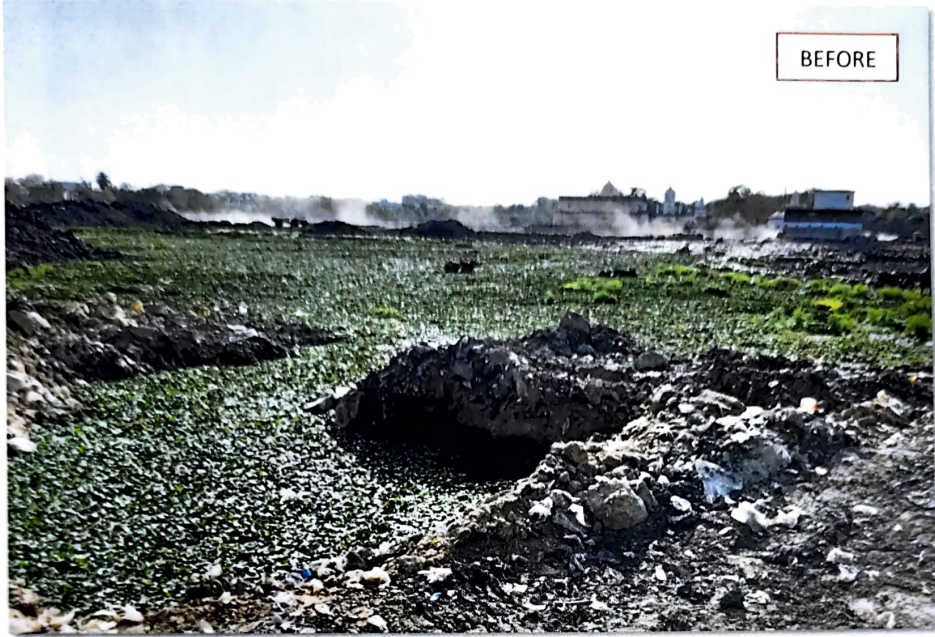
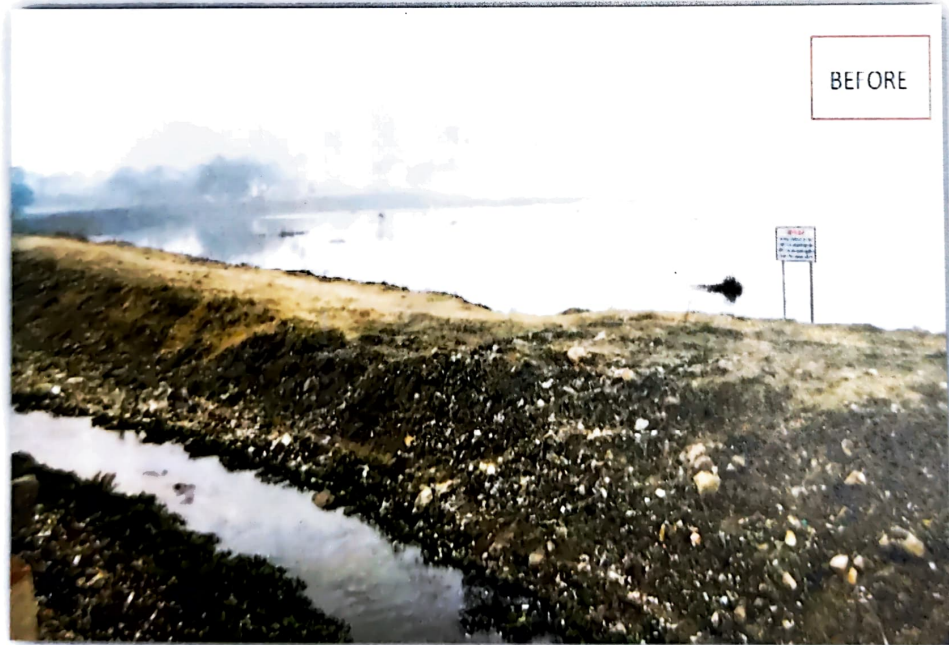
Annexure 3:

**Figure: Showing preexisting bund before rejuvenation**

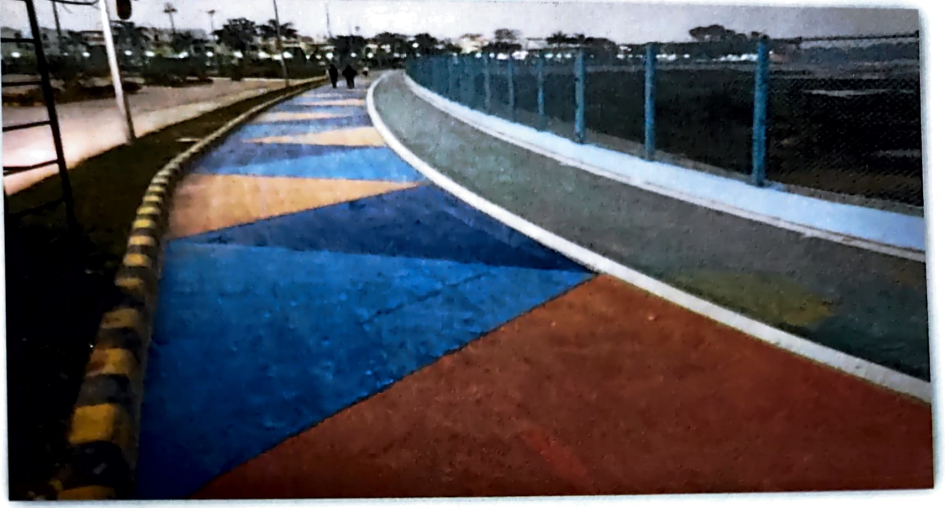
**Figure: Showing pathway constructed over preexisting bund**
