**BEFORE THE NATIONAL GREEN TRIBUNAL  
AT PRINCIPAL BENCH, NEW DELHI  
(Under Section 18 read with Section 14 and 15 of the  
National Green Tribunal Act 2010)**

**ORIGINAL APPLICATION NO: 141 OF 2022**

**REPORT CUM SUGGESTIONS**

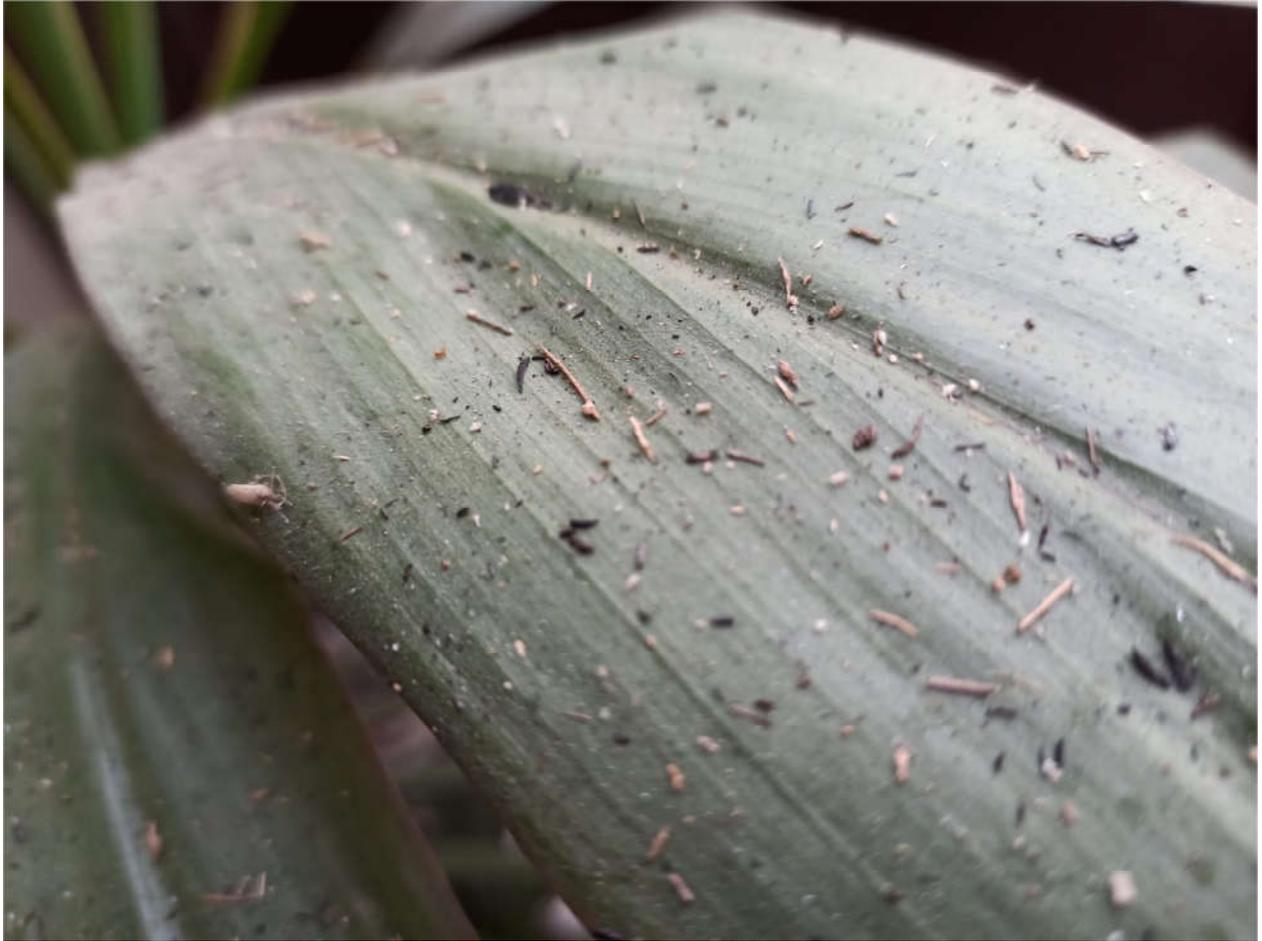
**Fly ash and small particles of Baggage on Plants**

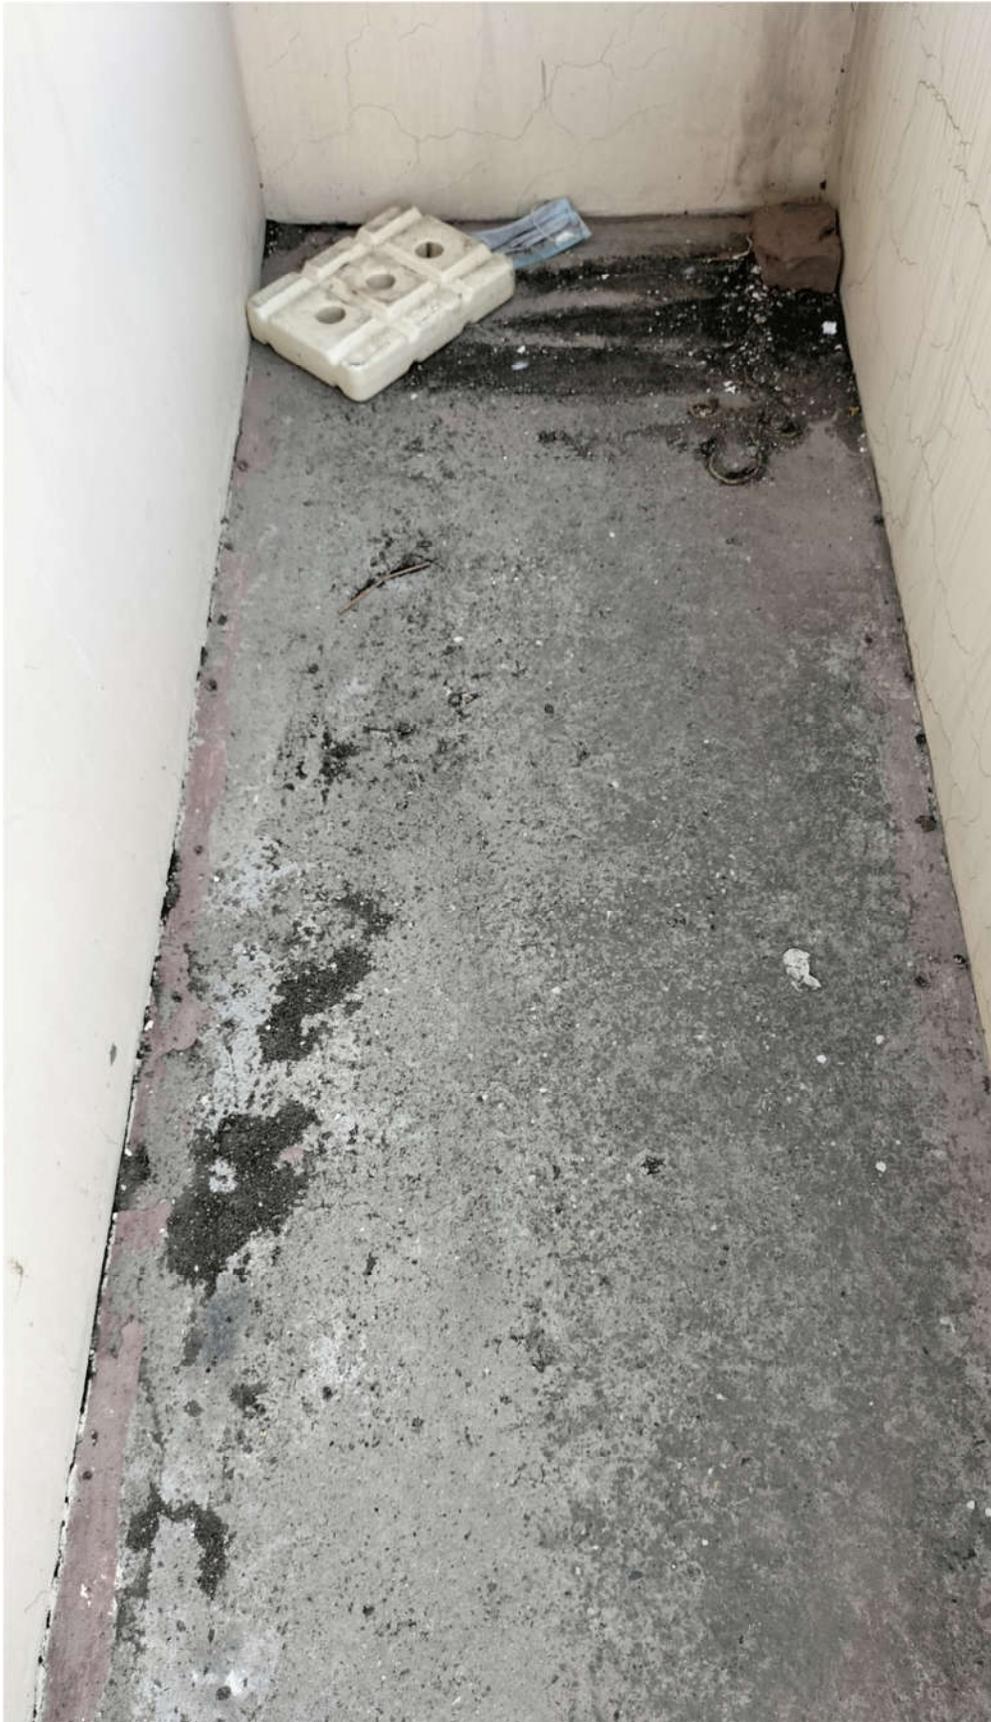
- During the visit applicant **pointed out** to the officials of the Respondent 4 & 5 the presence of micro **particles of fly-ash** within the premises as well as macro-micro particles of fly-ash in the range of 200-300 meters outside the sugar mill during random visit to a household, furthermore not only this but fly-ash can be found 1000 meters far from the Respondent No. 5 however on 31.03.2022 joint Committee didn't found any fly ash outside the industry premises.

**Rooftop corner of a resident 600 mtrs. far from sugar mill**

- Advanced and Modern Technology came into operation now-a-days namely “**ESP (Electrostatic precipitators)**” – A dry ESP electrically charges the ash particles and imparts a strong electric field in the flue gas to collect and remove them. ESP is the only mechanism which can stop fly-ash emission. It was informed by the officials of Respondent No. 5 & 6 that ESP is a very costly mechanism however Government can help in any manner

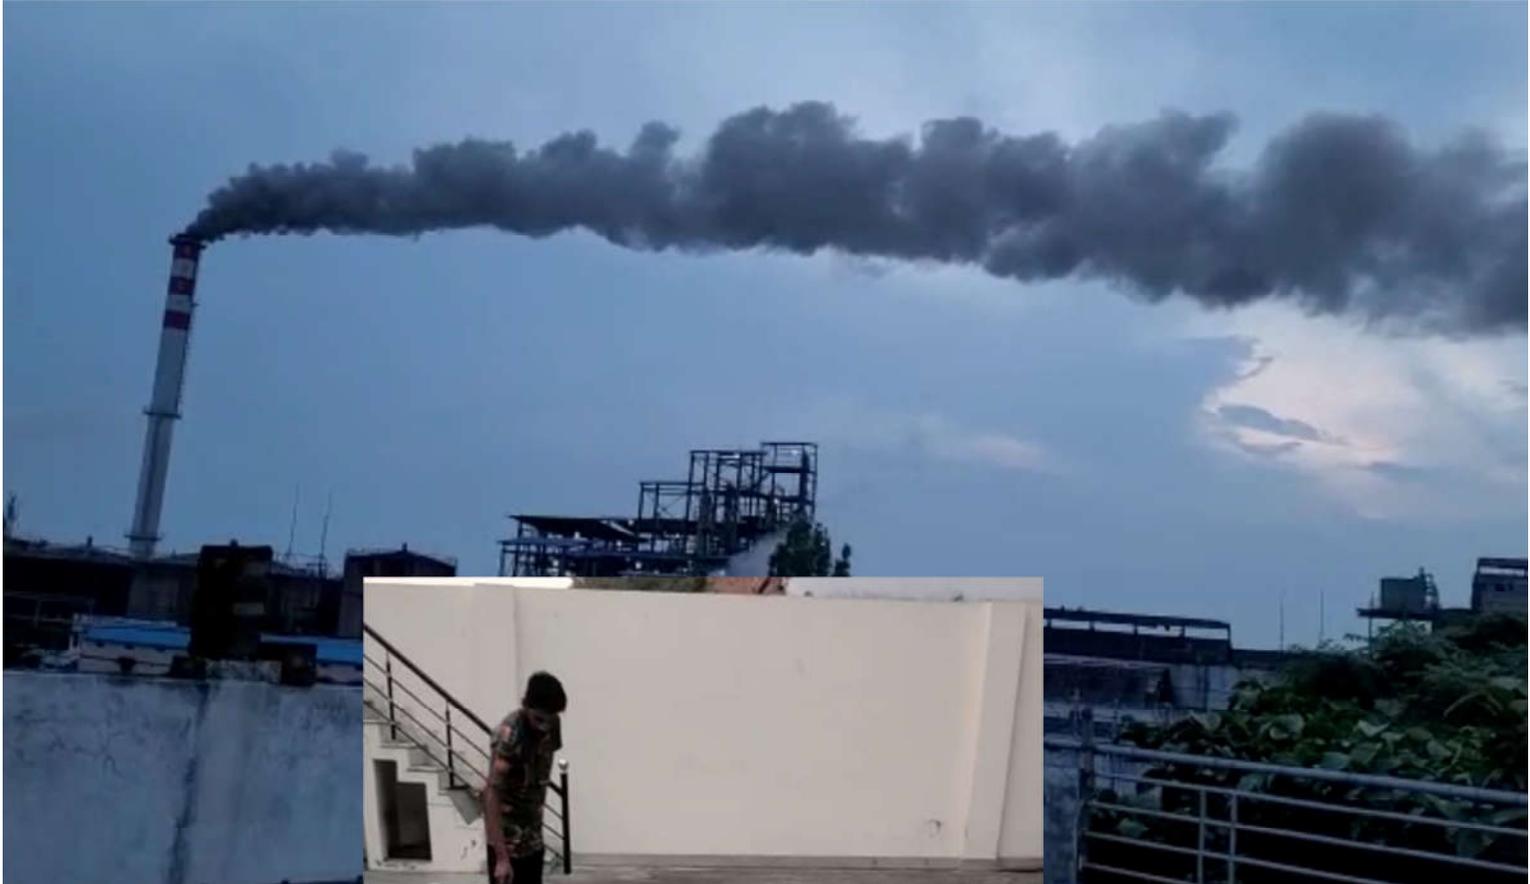
**Roof Top full with fly ash of a resident nearby**

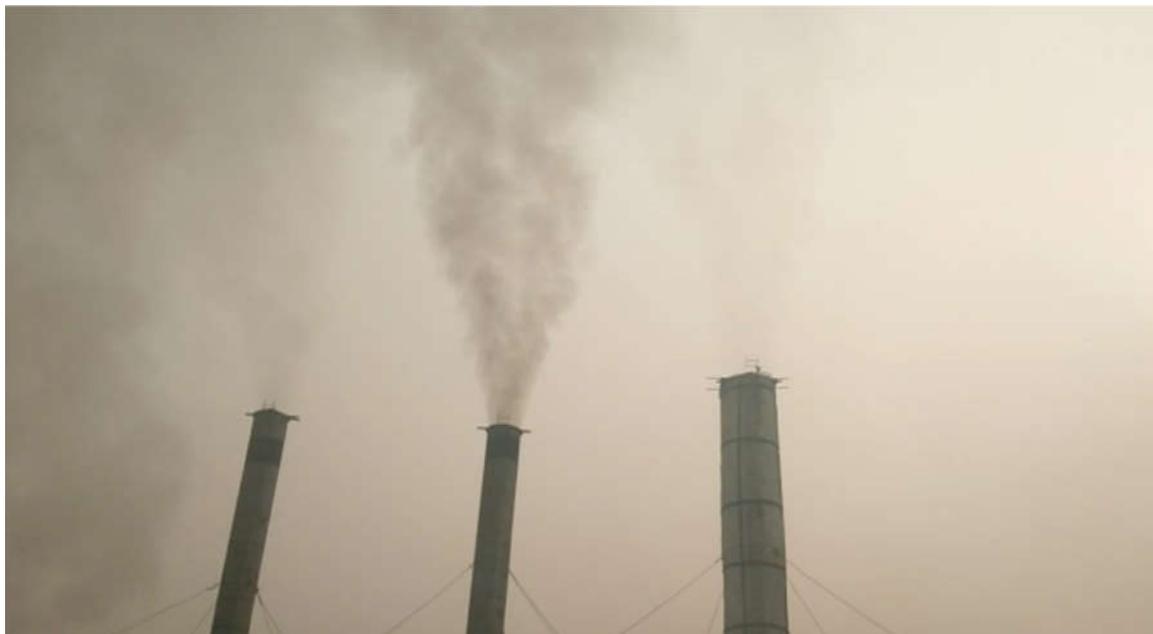
- That the first sight visited by the team was **Boiler Section** where the Chhaai/Flying Ash generally generated. Respondent No. 5 using “**Water Scrubber**” technology to stop pollutants. However, this technology is insufficient to curb emission of air pollutants i.e. Fly Ash (Chhaai) which affects health of the habitants of the Shamli City very adversely.

**Fly Ash emission from Chimney evening time**

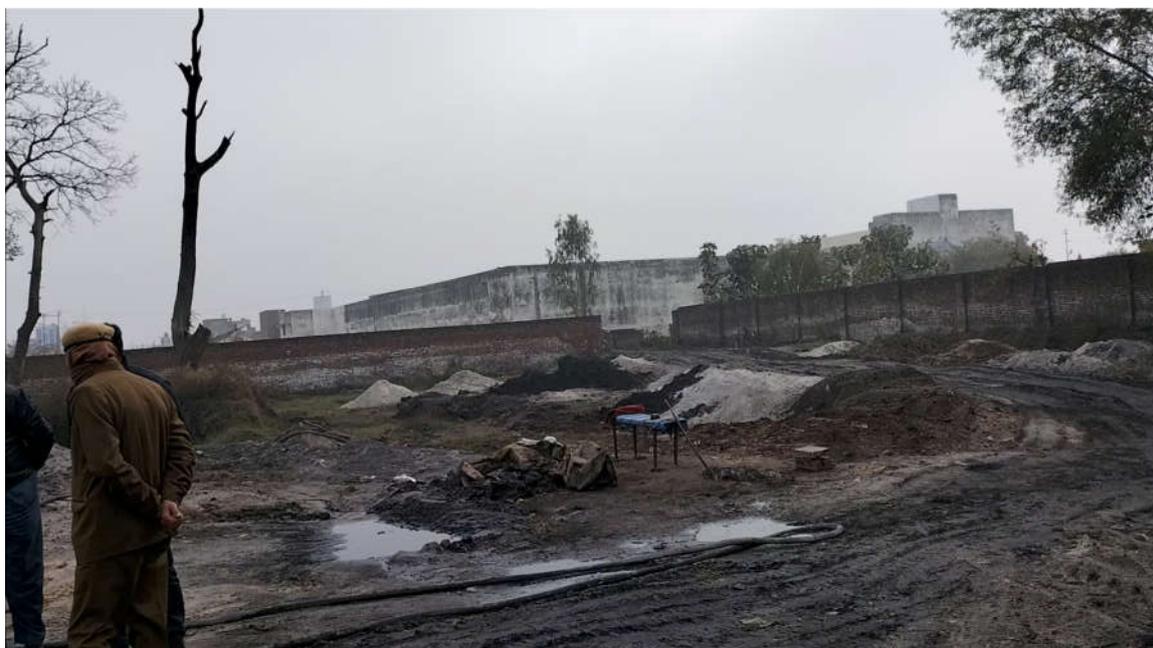
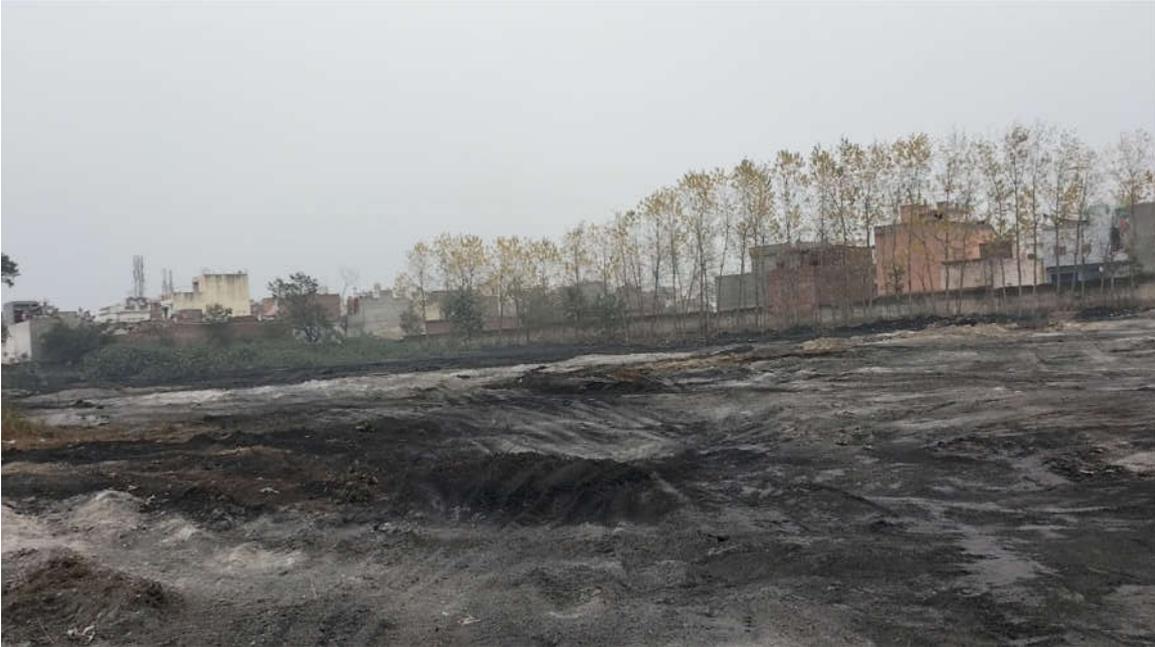
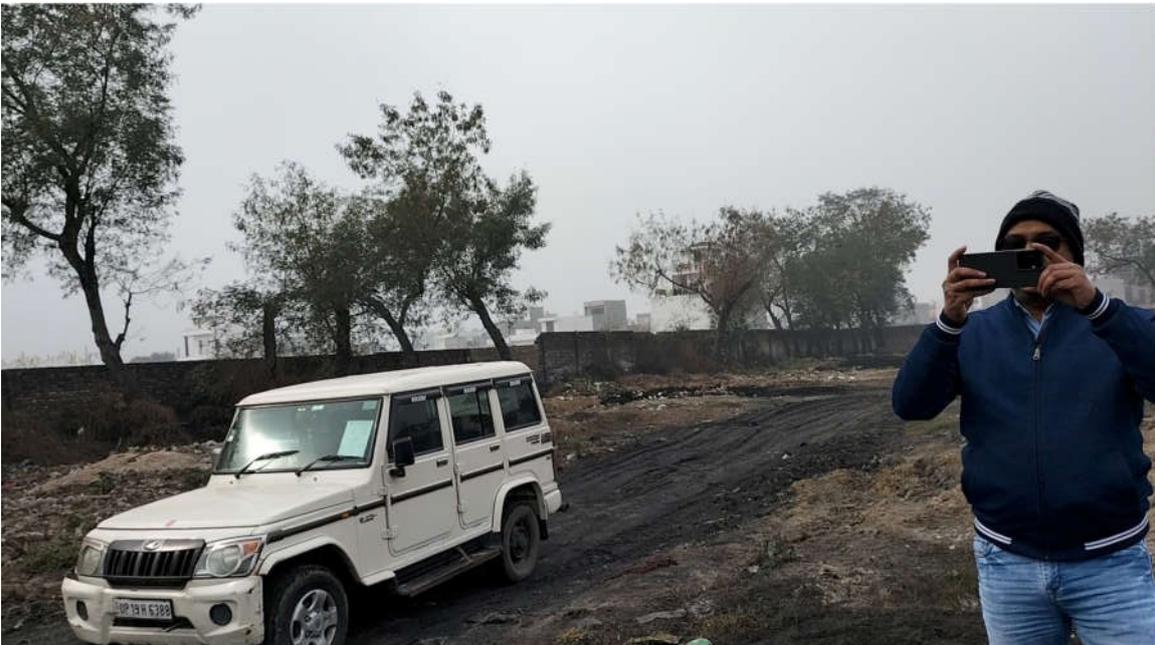
- Fly-ash landfill yard is covered with wall however **no dense plantation seen with suitable species** hence this is not sufficient to prevent or mitigate fugitive of fly-ash to go out from the yard with wind.

**Landfill Area with Plantations**

- Respondent No. 5 & 6 should use treated water for Plants, water sprinkler or pour empty pounds created by the sugar mill itself near land-fill area and other activity in proper manner.
- Respondent No. 5 & 6 should plants suitable plants near boundary walls of factory and land-fill area i.e **peepal, sisam, saptaparni and jamun etc. and other local plantations.**
- AQI (Air quality index) monitor device should also be installed in the area.

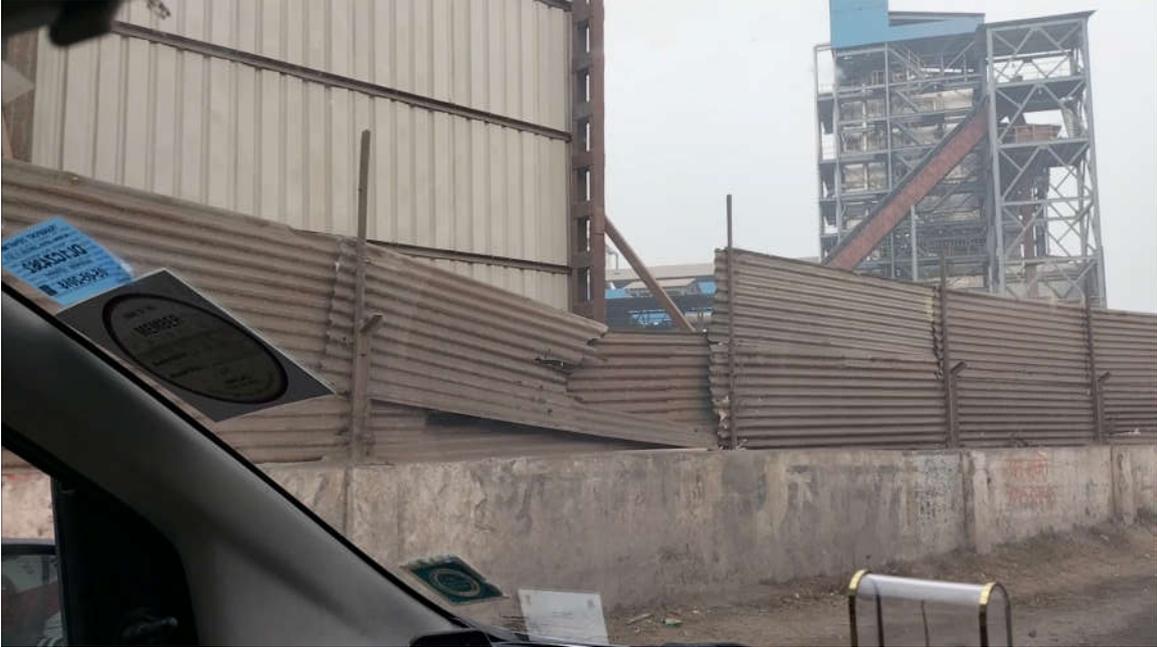
- During inspection **boundary walls** of sugar mill and distillery, which must be at least 3 meters high, as per joint committee report dated 31.03.2022. However actual position of the wall at the time of inspection was not found three meters high and as such not satisfactory at bagasse storage yard/area. Wall is made by lower part in bricks and upper part in tin sheets which are also depilated in conditions. (Annexure - Copy of the Video).

**Boundary Wall of Sugar Mill**

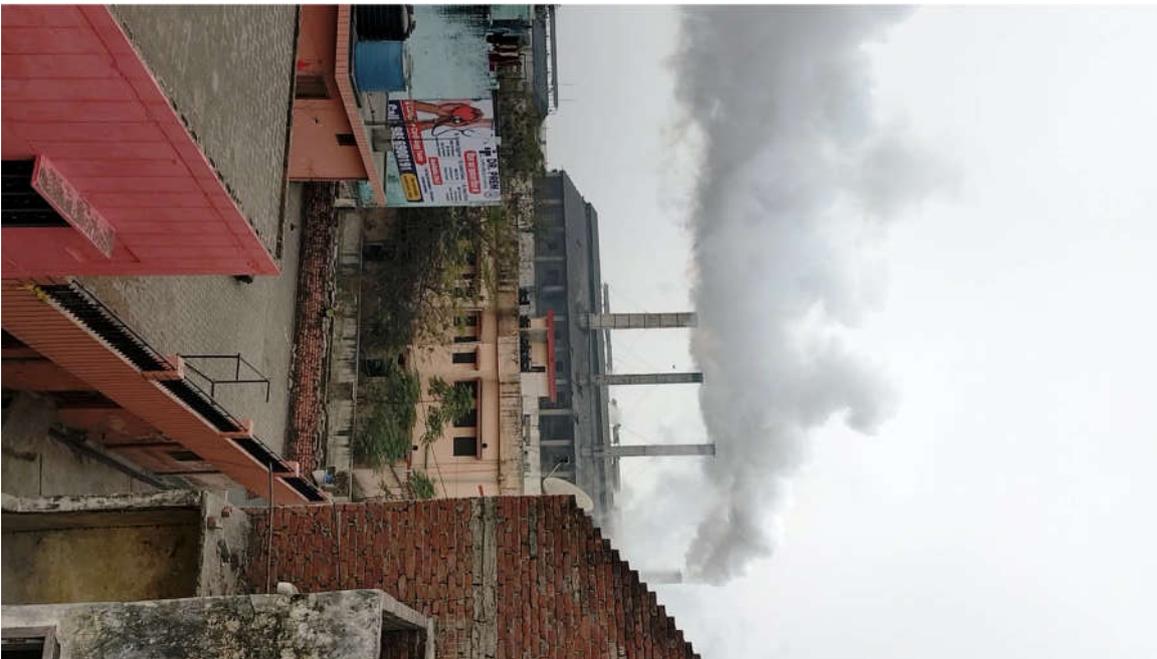
**fly ash emission day time**
