**BEFORE THE NATIONAL GREEN TRIBUNAL****PRINCIPAL BENCH, NEW DELHI**

ORIGINAL APPLICATION NO. 518 OF 2022

| <b>S. No.</b> | <b>PARTICULARS</b> | <b>PAGE NO.</b> |
|---|---|---|
| 1. | REPORT AND SUBMISSIONS ON BEHALF OF THE AMICUS CURIAE | 72-94 |
| 3. | <b>ANNEXURE A-2</b><br><br>Photographs of some of the spots/stretches in Nainital | 97-126 |

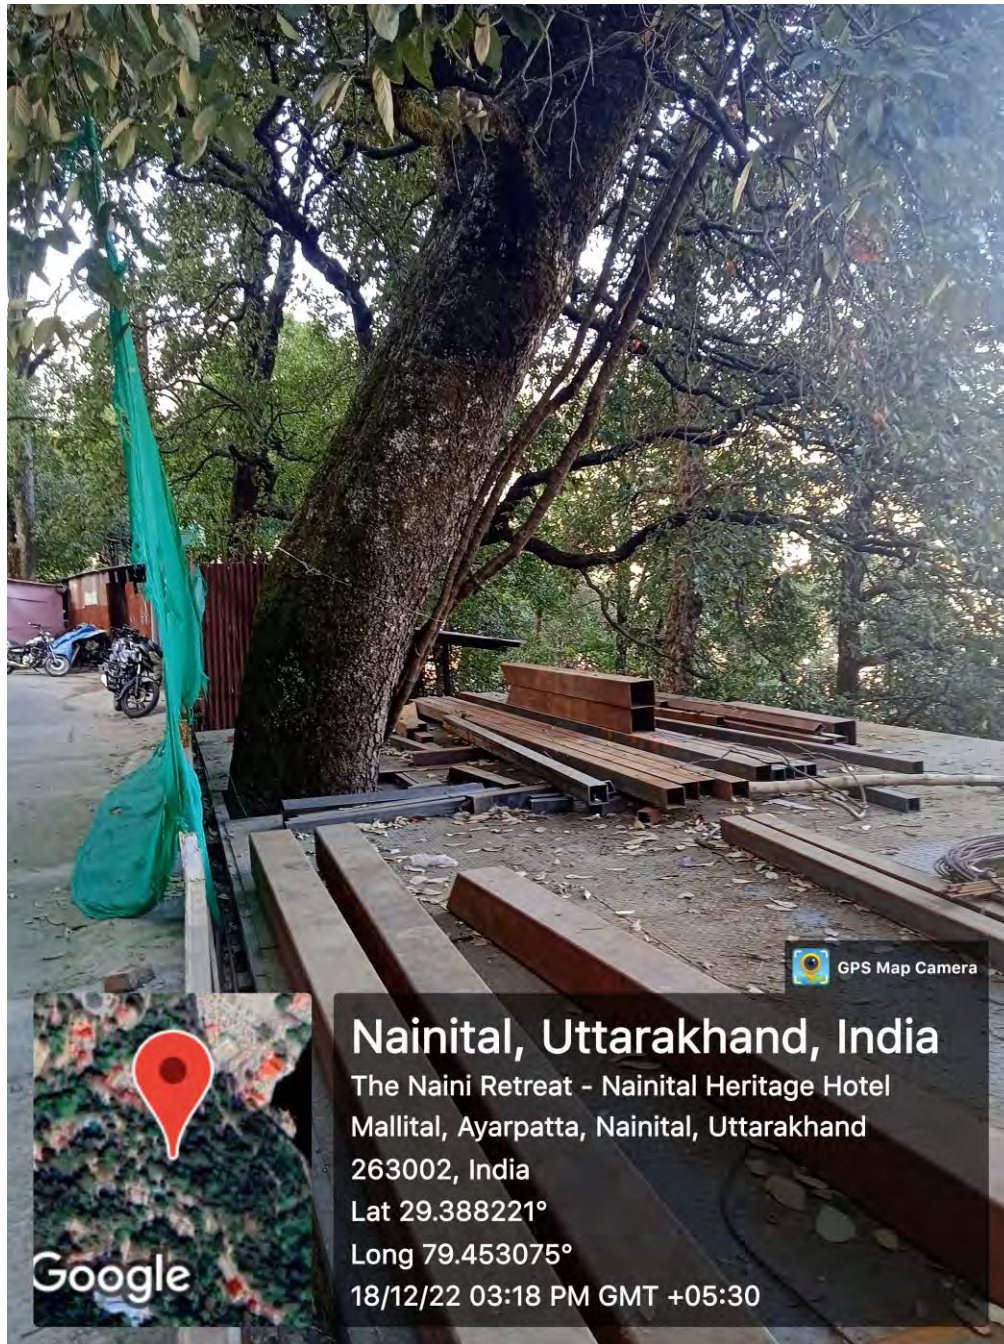
**Massive iron and steel structure on a steep slope in Ayarpatta, Nainital, purportedly built by Hotel Naini Retreat for yet another parking. The massive landslide and clearing of the vegetation could be clearly seen.**

A giant Iron structure was seen in construction on a steep slope in Ayarpatta, near Hotel Naini Retreat. The massive iron foundations of the platform was rested upon and drilled into the steep slopes, after clearing the entire vegetation on the slopes below. Massive land erosion and landslides were clearly seen on the slopes immediately below the huge iron structure, as a result of this construction and the tremendous load exerted by the platform on the steep, soft slopes below.

**RECOMMENDED MEASURES:** In light of the claims and statements made by the Applicant and other locals, a thorough inquiry is essential to reveal the details of the

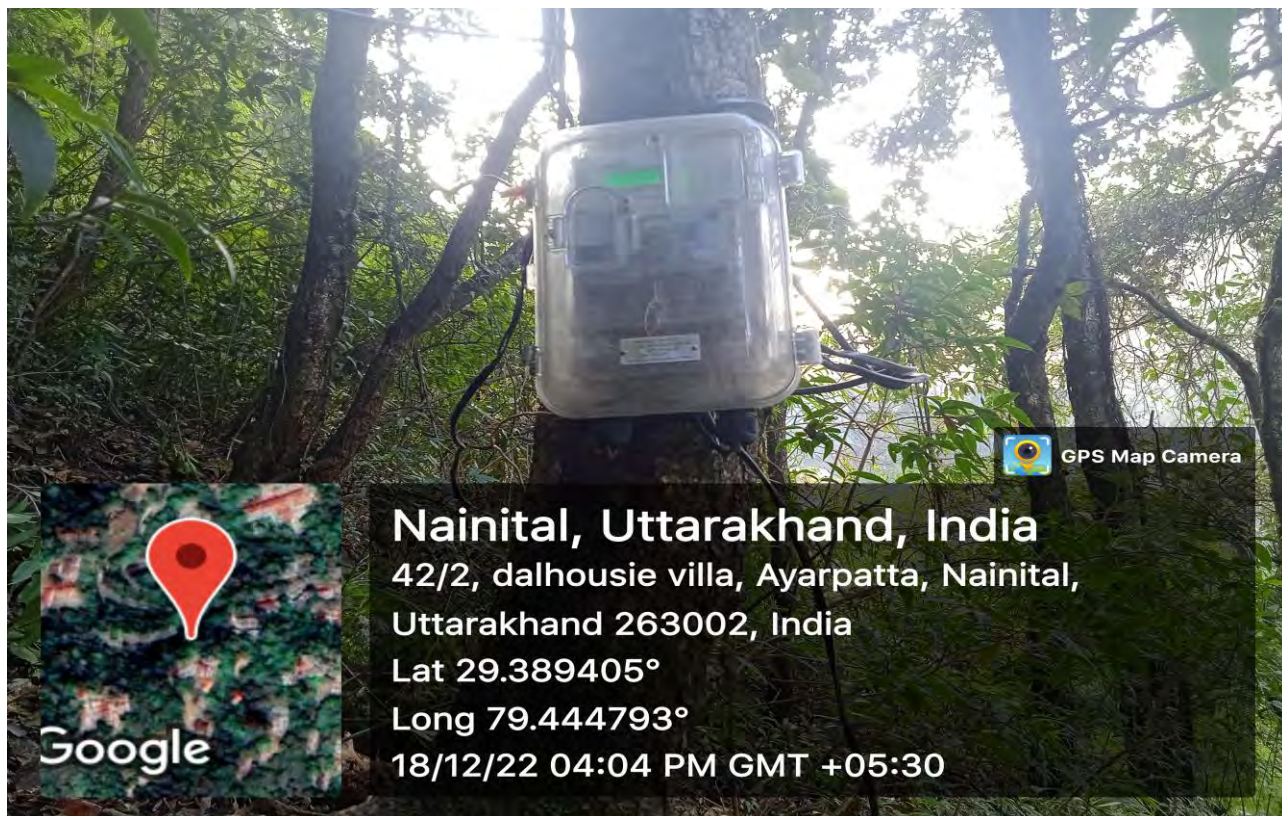
Electric meter being installed on a tree deep in a thickly vegetated area along the road, so as to operate wood cutting and other machines, to escape from the public glare.

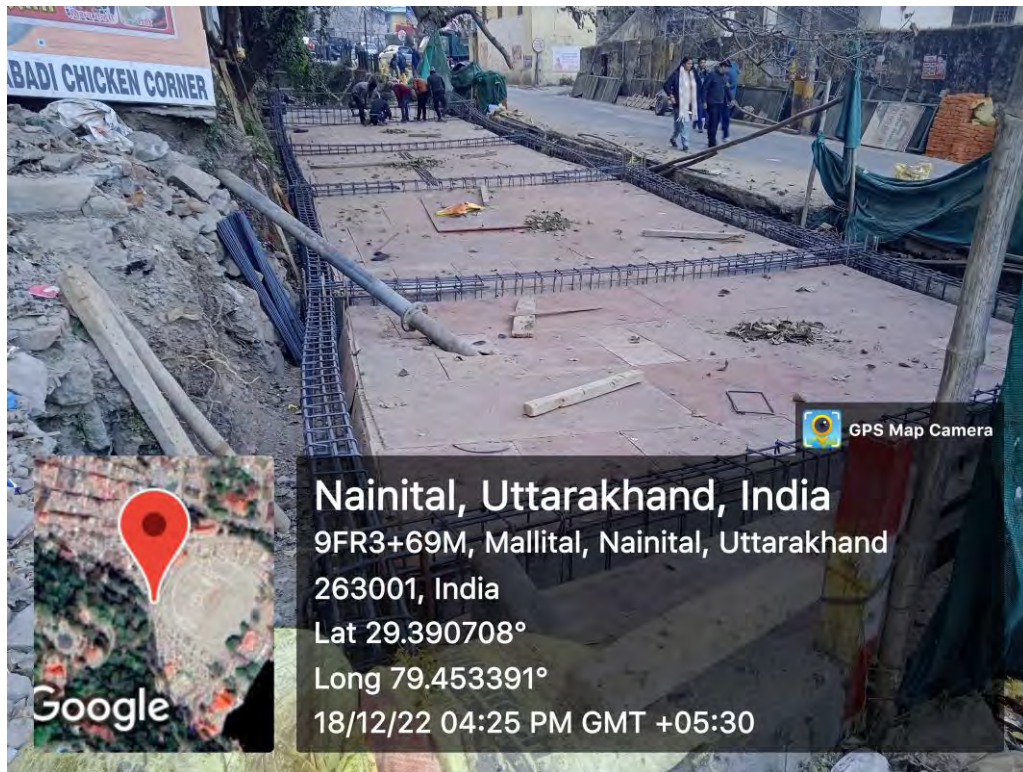
The trunk storm water drain, flowing into the Naini Lake, being concretized and covered with thick slabs, in Mallital.

**RECOMMENDED MEASURES:** The entire project details of the covering of the said storm water drain is urged to be called upon by this Hon'ble Tribunal, as to how the said construction was carried out in disregard of the observations, Orders and directions of this Hon'ble Tribunal in various cases.

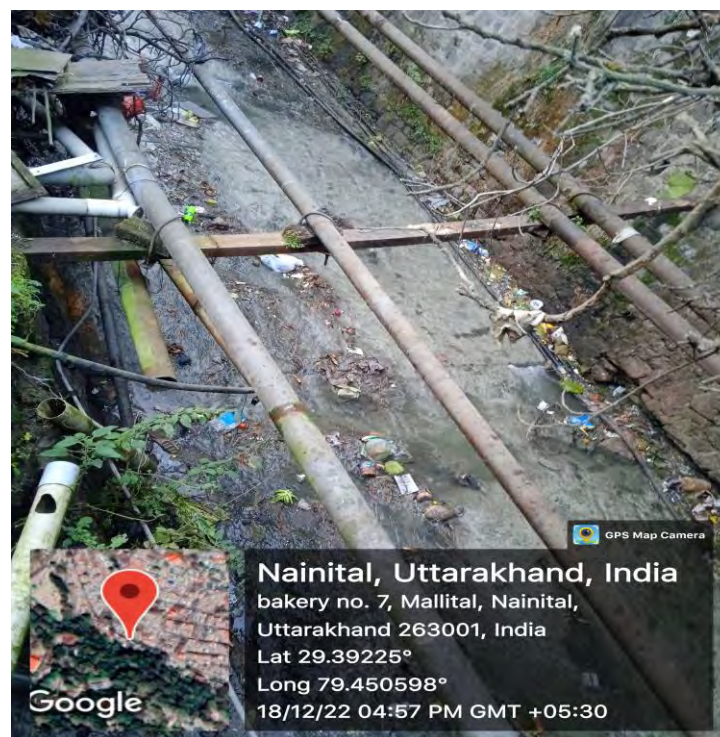
**Sewage/wastewater and solid wastes in the storm water drain flowing into the Naini Lake.  
All outlets of houses are discharging domestic sewage directly into this storm water drain.**

The storm water drain into which the sewage/wastewater was caused to be mixed, fall directly into the Naini Lake, thereby, consequently, polluting the lake. The Applicant informed that no water quality inspections are ever carried out by the Uttarakhand Jal Sansthan or by the Uttarakhand Pollution Control Board of the said drain. The Nagar Palika Parishad also assigns no significance to this main storm water drain, the contaminated water of which is discharged directly into the Naini Lake, without treatment.

**RECOMMENDED MEASURES:** Given the extent of the faecal matter and filth in the said storm water drain, thorough cleaning, thereof, is required immediately. The water quality assessment of the Naini Lake and all channels/draains flowing into it is needed to be conducted by an independent reputed testing laboratory. In view of the significance of the Naini Lake, as also the cluster of lakes around, that is, Naukuchiyatal, Saattal, Bhimtal and Khurpatal, the water quality of all such lakes is urged to be conducted, preferably on a monthly basis or at least once in every quarter, by an independent reputed testing laboratory, in addition to any testing and analysis by the Uttarakhand Jal Sasthan or the Uttarakhand Pollution Control Board, to avoid any manipulations and suppressions of the actual results. This protocol needs to be developed on an urgent basis so as to ensure prevention, control and abatement of pollution in the waters of Naini and surrounding lakes, that is, Naukuchiyatal, Saattal, Bhimtal and Khurpatal.

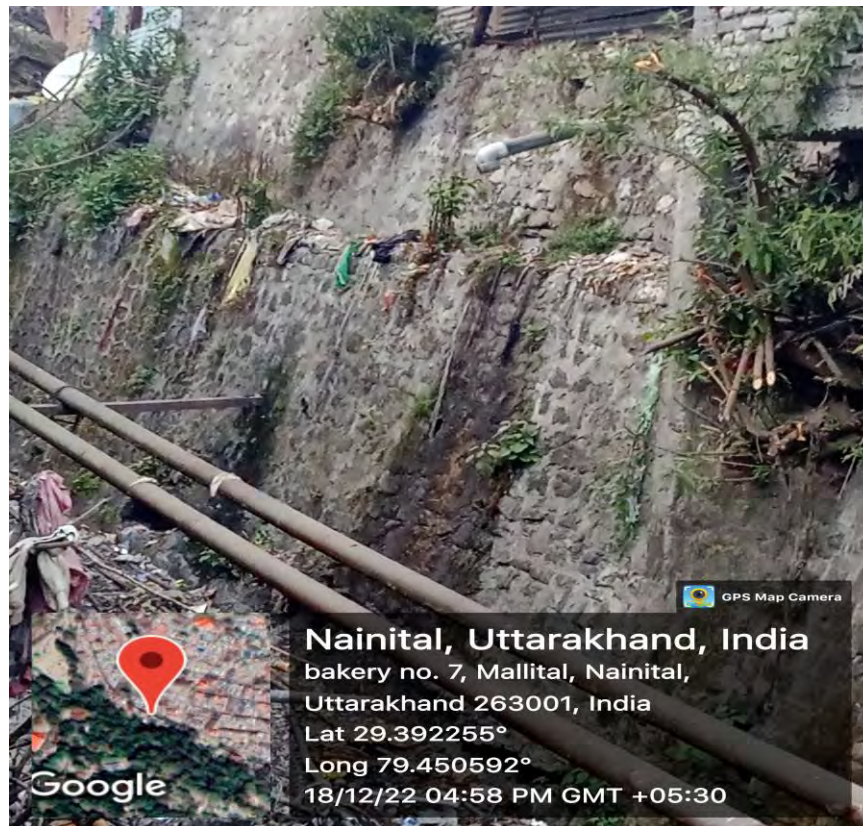
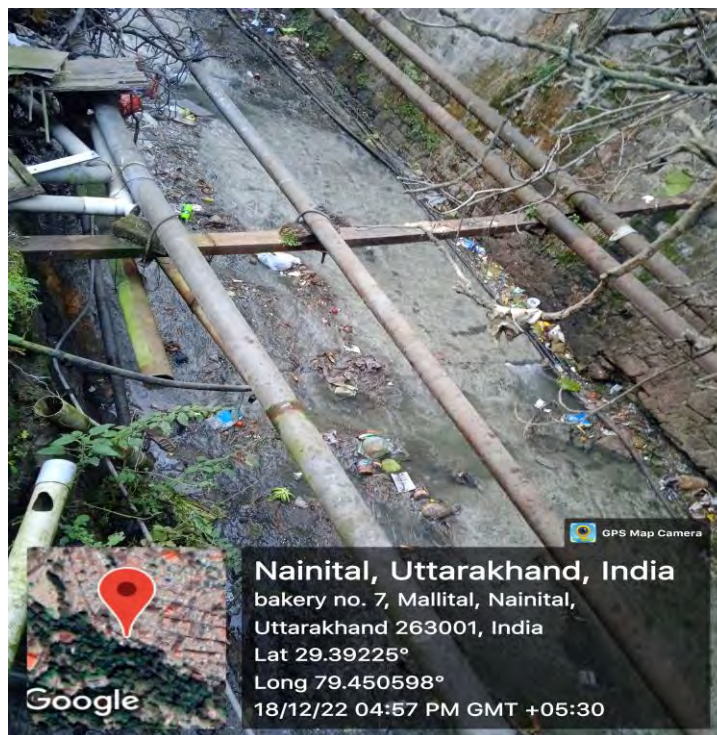
**Sewage/wastewater and solid wastes in the storm water drain flowing into the Naini Lake.  
All outlets of houses are discharging domestic sewage directly into this storm water drain.**

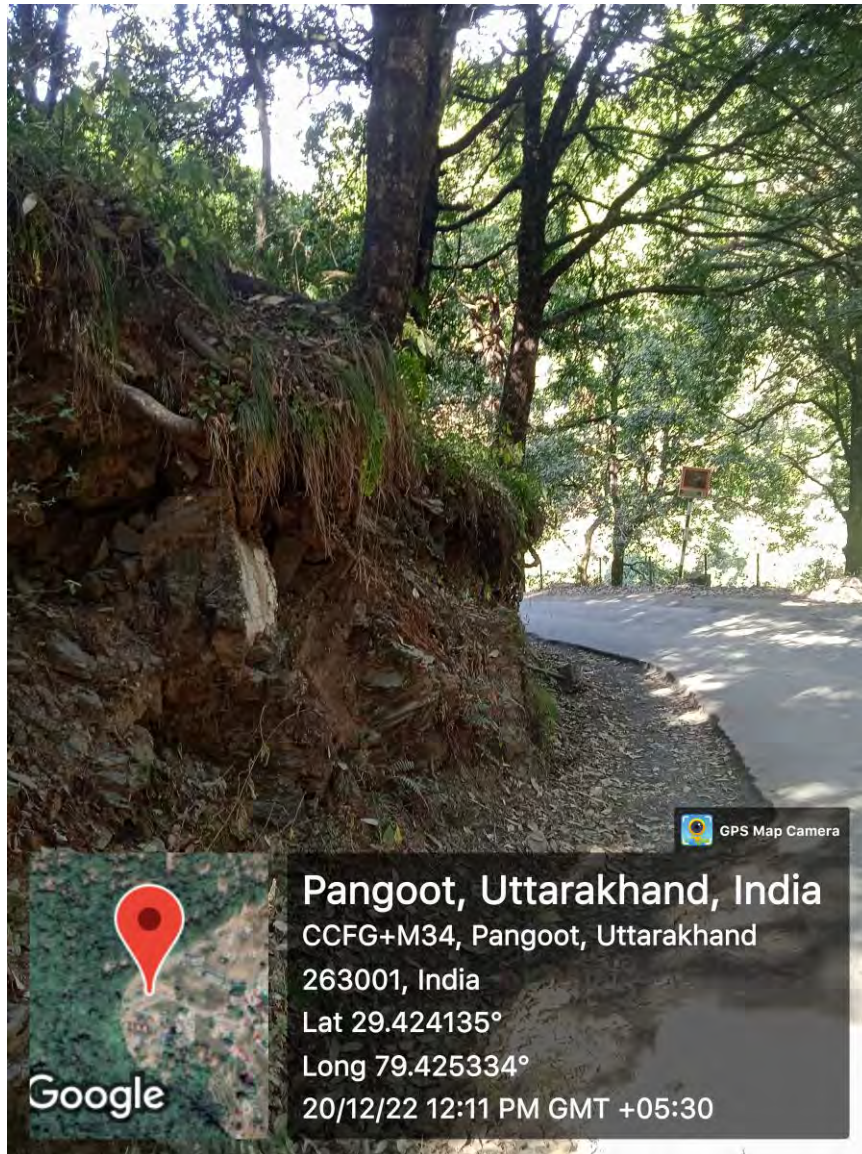
**Reckless vertical hill cutting, causing massive slope exposure and exposure of roots of trees, which become vulnerable to fall anytime. The practice is seen almost everywhere in the state.**

At least several hundred trees on the steep slopes along the roads, leading to and emerging from Pangot, were found critically damaged and were on the verge of drying up or falling down. This was due to abrupt, unscientific and reckless vertical hill cutting in the process of road-widening, leading to the exposure of the slopes and permanent slope instability, which eventually exposed the root systems of such trees, along with the other ground vegetation, consequently causing the loosening of top soil and becoming one of the primary reasons for the landslides along that particular part of the slopes.

**RECOMMENDED MEASURES:** The number of trees damaged on the steep slopes along the roads passing through Pangot ought to be determined and appropriate adequate compensatory afforestation measures be put in place, keeping in mind the species of trees damaged. Any hill cutting has to be carried out only after duly factoring in the standards of the hill slope angles, as provided in the Hill Road Manual of the Indian Roads Congress 1998.

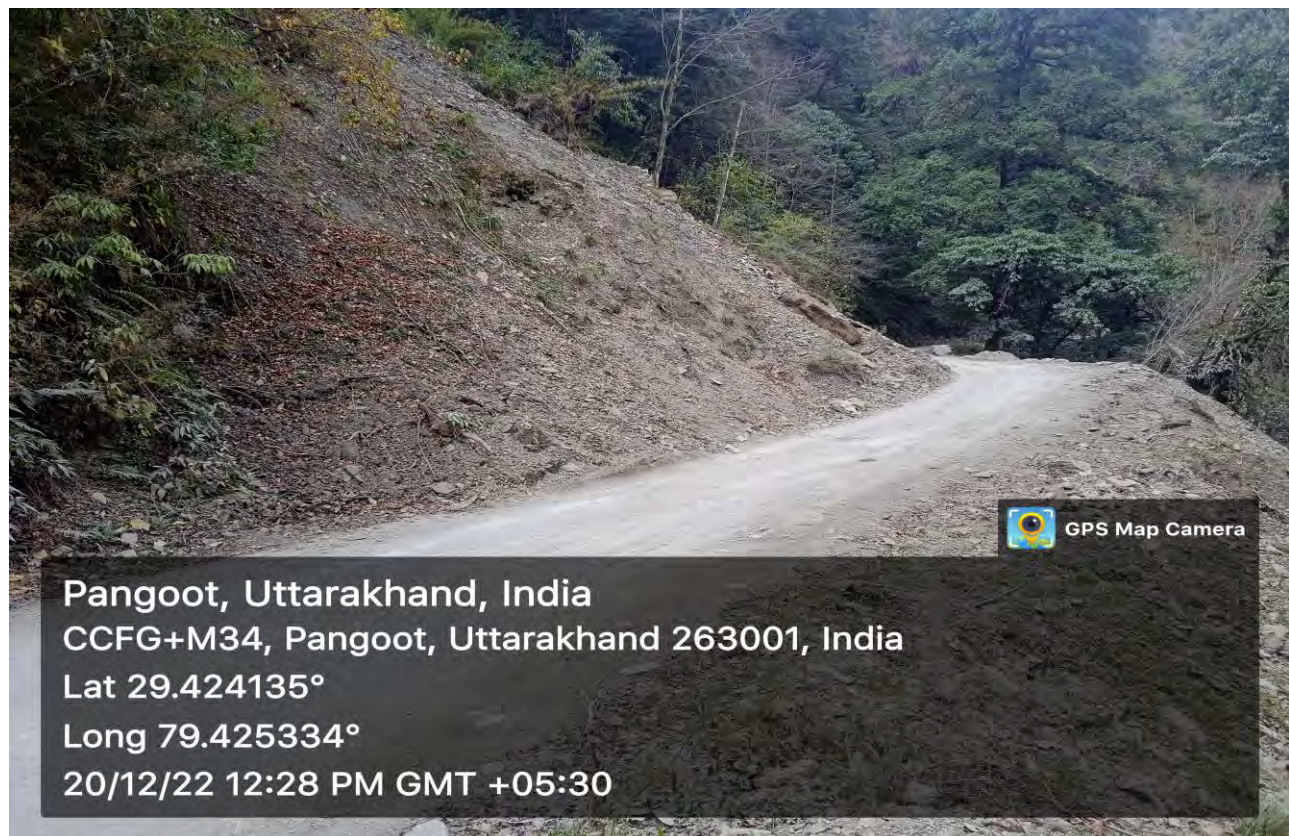
**Landslides resulting due to exposure of roots in the process of vertical hill cutting.**

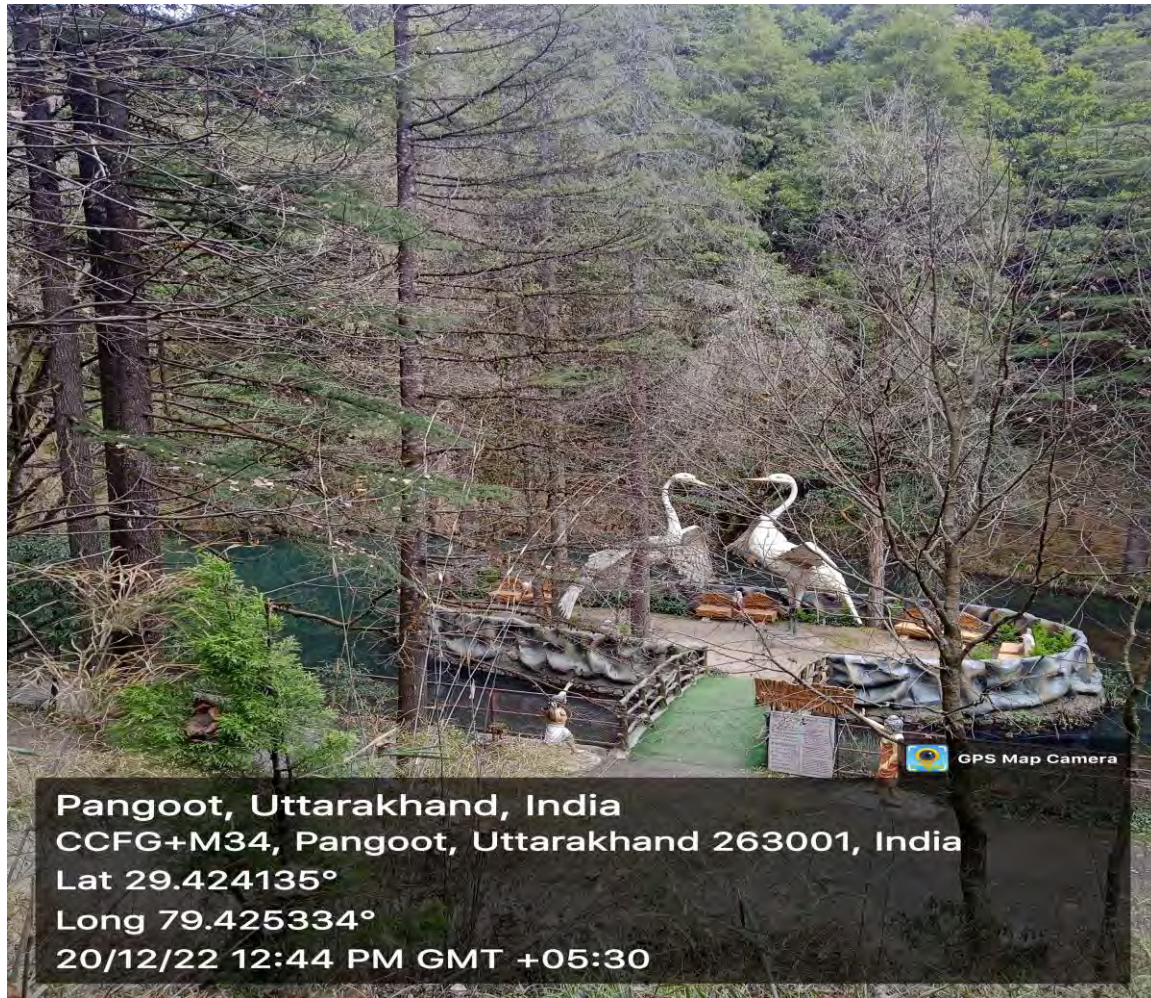
The entire patch of tree vegetation has dried up owing to constructions inside a forested area.

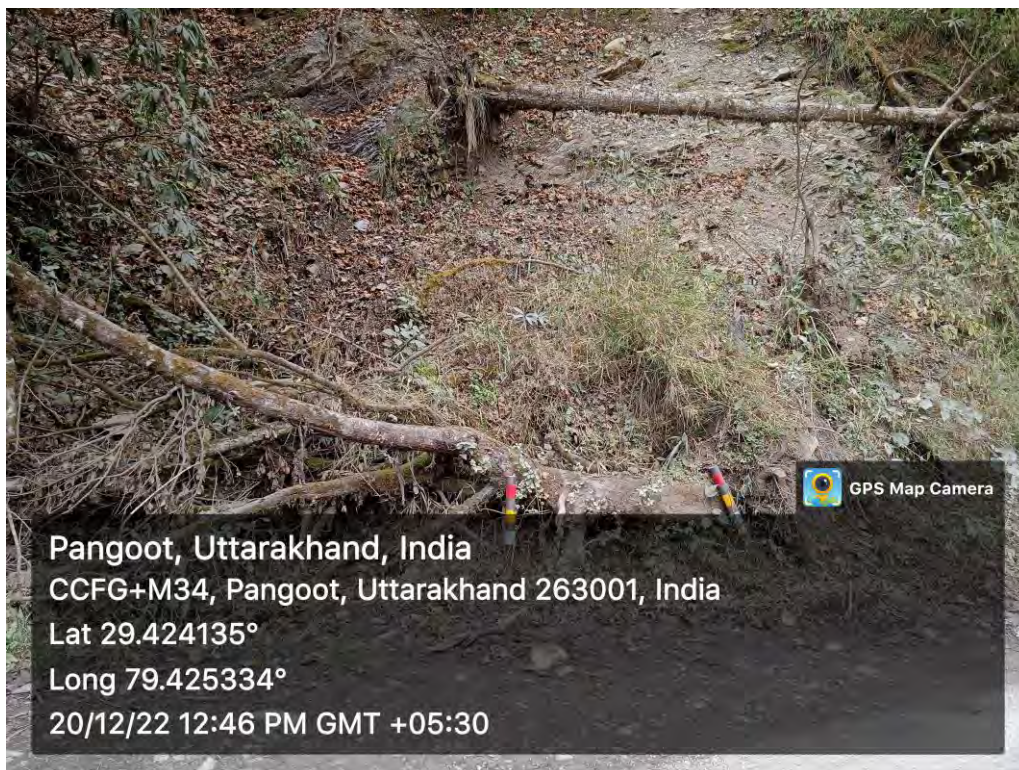
**Weakened trees fallen on the Nainital-Pangot Road.**
