ACTION TAKEN REPORT

IN OA 61/2020 (CZ)

INSPECTION REPORT

Subject: Site inspection dated 10.01.2022 in compliance of the Hon'ble NGT order dated 07.12.2021 in the matter of OA 61/2020 Major General Harpreet Singh Bedi v/s Dwarkadheesh Haveli Builders.

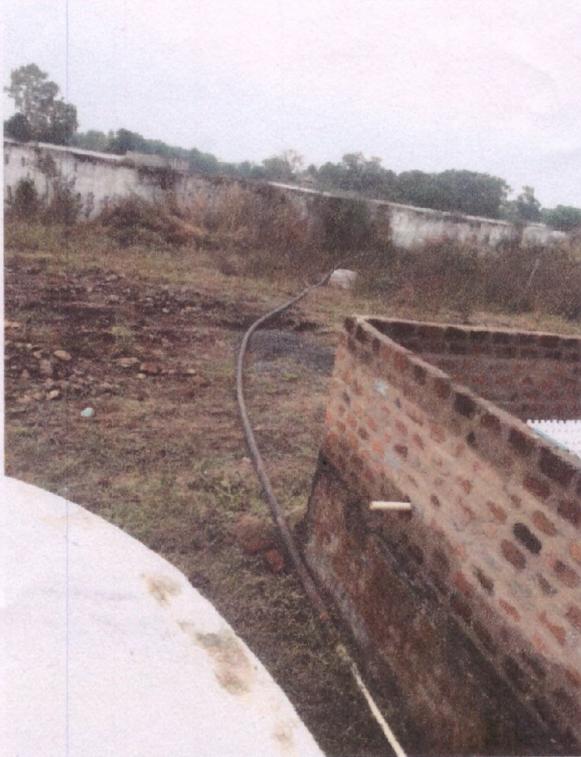
5. Transportation of treated wastewater with the help of tankers for the purpose of gardening and other uses of the society is yet to be initiated by the builder. A pipeline of 300ft. has been laid down to spread treated water in nearby open space.

Pipeline laid in open land to utilize treated wastewater

1. Dedicated tanker and dedicated pipeline should be arranged by the builder in a time-bound manner to completely utilize treated water in gardening.

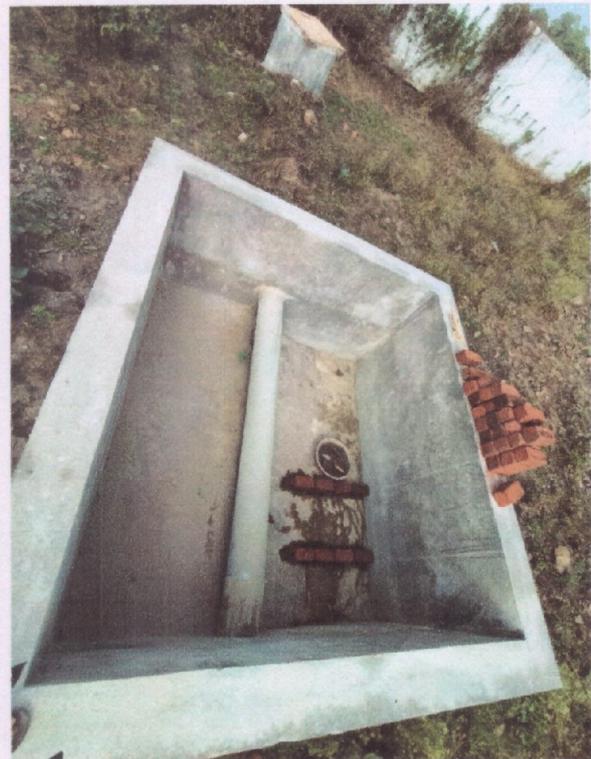
1. The STP of capacity 250 KLD was found in operation.
2. Due to rains two days back, overflow from inlet chamber of STP was found accumulated nearby as at the inlet chamber dimensions approx. 6x6 feet of the STP installation of coarse mesh screen and plumbing connections are not done by the builder.

Inlet Chamber / Dimetions appox. 6x6 feet

2. Remaining work of the inlet chamber of 6x6 ft. should be completed at the earliest to avoid any situation of overflow of sewage.
3. Disinfection system should be installed at the earliest.
4. Regular cleaning and maintenance of STP units should be done by the builder. Connection of filter press should be done at the earliest.
5. Proper gradient of nearby nallah should be maintained and it should be cleaned in regular intervals to ensure the free-flow of surface run-off.
6. Time-bound proposal is required to be submitted by the builder to resolve the shortcomings found during inspection.

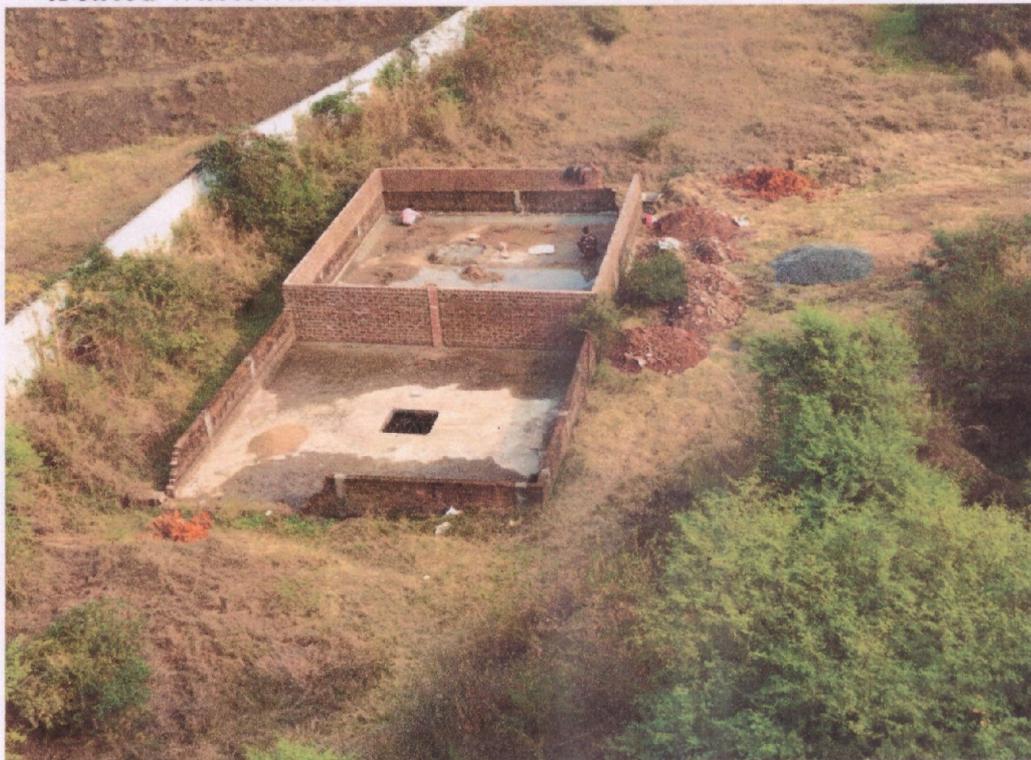
6. Nearby nallah carrying surface run-off is not clean and does not have proper gradient resulting in stagnation of water in the colony premise.
7. Sump-well for storage of potable water was found under-construction.

Construction work of Collection Sump for Potable water in progress

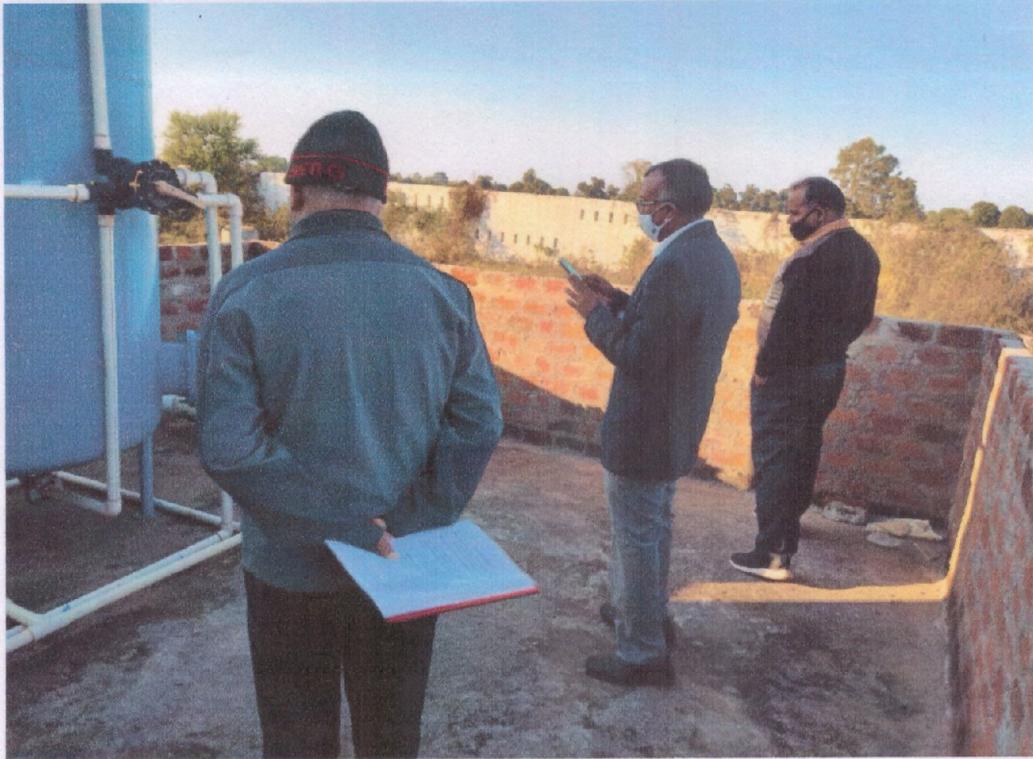
3. Disinfection of the treated wastewater with the help of Sodium Hypochlorite is being done manually.
4. Filter press unit is yet to be connected to the STP for sludge removal.

Inspection of STP units

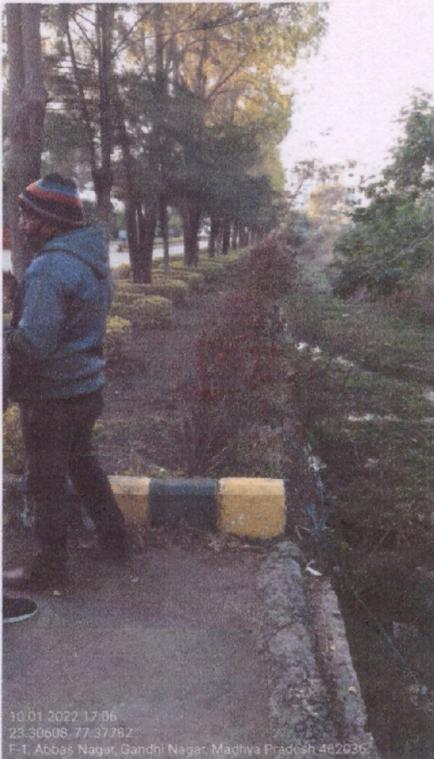
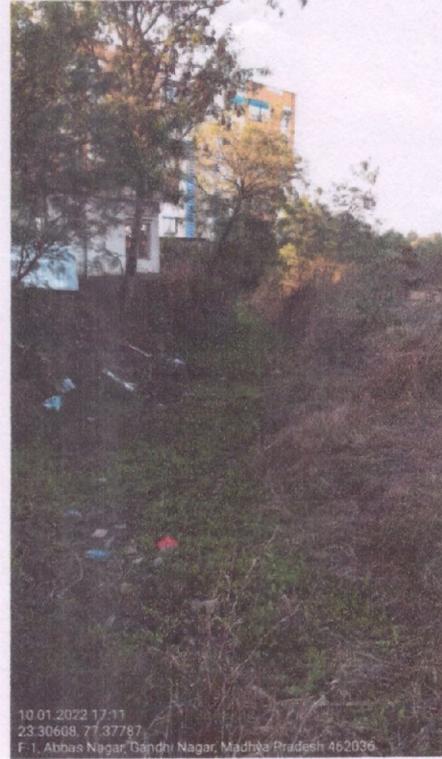
Inspection of nearby nallah requiring free-flow of surface run-off
