**BEFORE THE HON'BLE NATIONAL GREEN TRIBUNAL
EASTERN ZONE BENCH, KOLKATA
ORIGINAL APPLICATION NO. 14 OF 2026**

REPLY ON BEHALF OF THE RESPONDENT NO. 8, M/S VEDANTA LIMITED TO THE ORIGINAL APPLICATION

1. That the present Original Application has been instituted by the Applicant, alleging breach of the red mud pond/process water lake dyke on 15.09.2024 at the premises of Respondent No. 8, M/s Vedanta Limited [Alumina Refinery Unit], located at Lanjigarh, Kalahandi, Odisha, and its impact on the agricultural field and Bansadhara River. The Applicant further alleges that no environmental compensation has been imposed and collected from Respondent No. 8, M/s Vedanta Ltd.

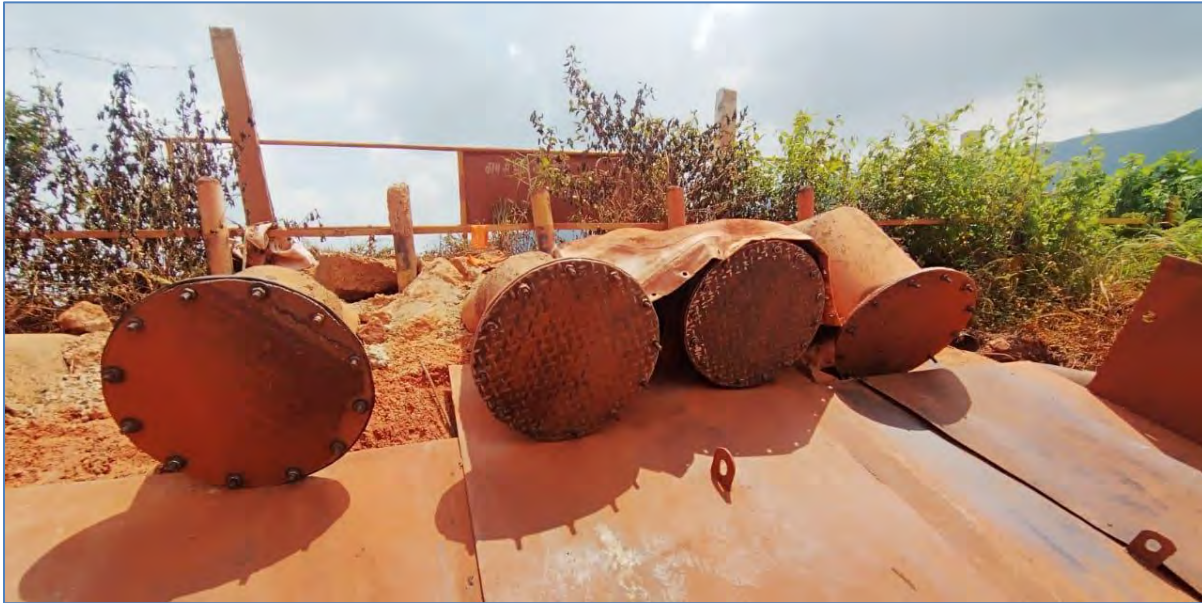
Figure-7: Isolation of intake to PWL

The photograph of isolation of PWL from BRDA is presented below in **Figure-7**.

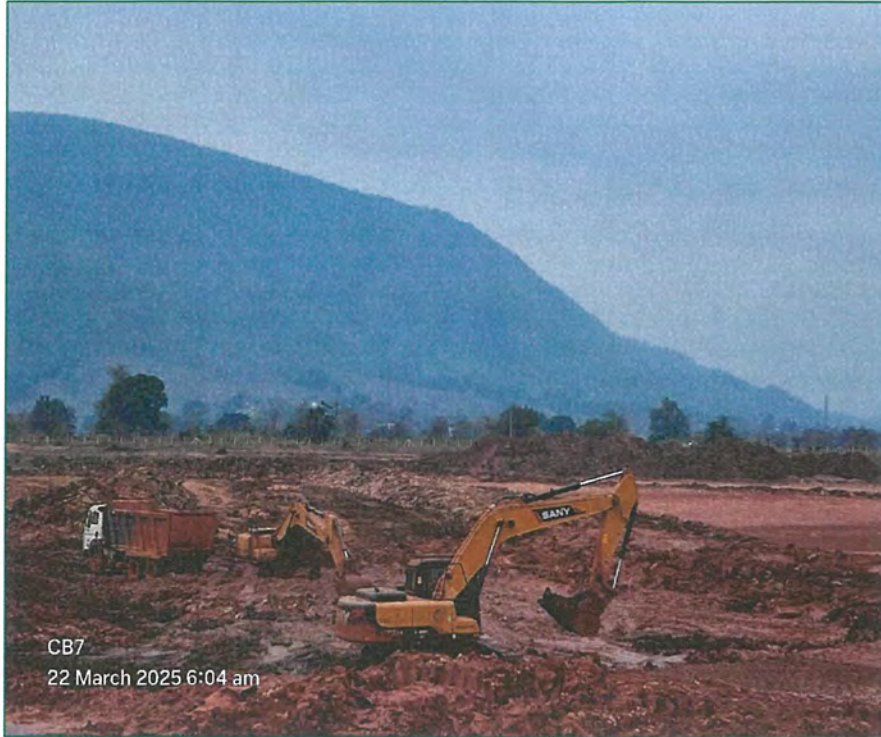
Silt Removal

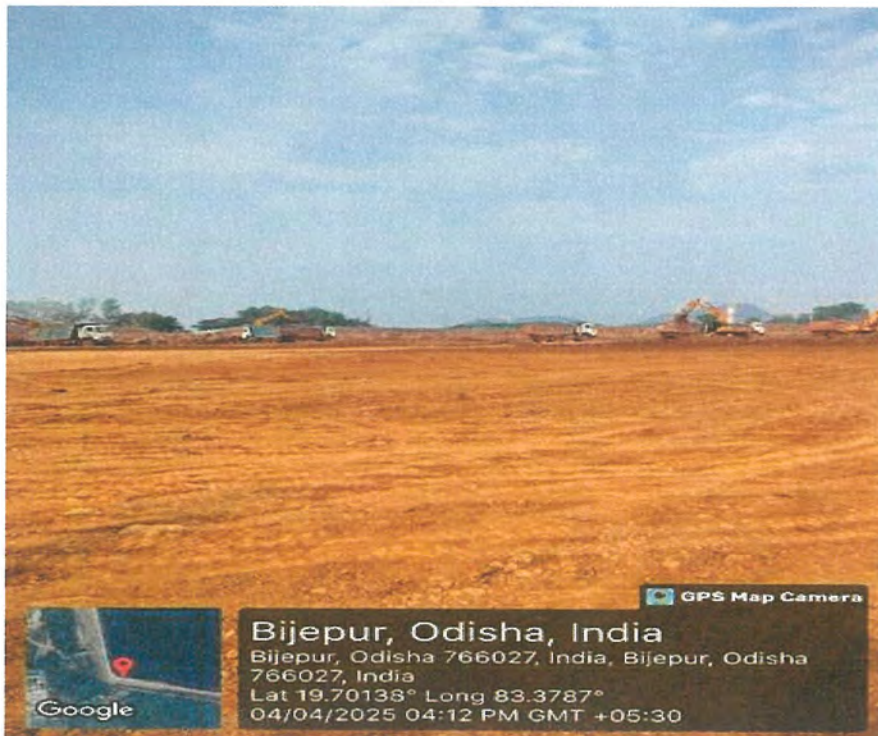
Sand bed preparation

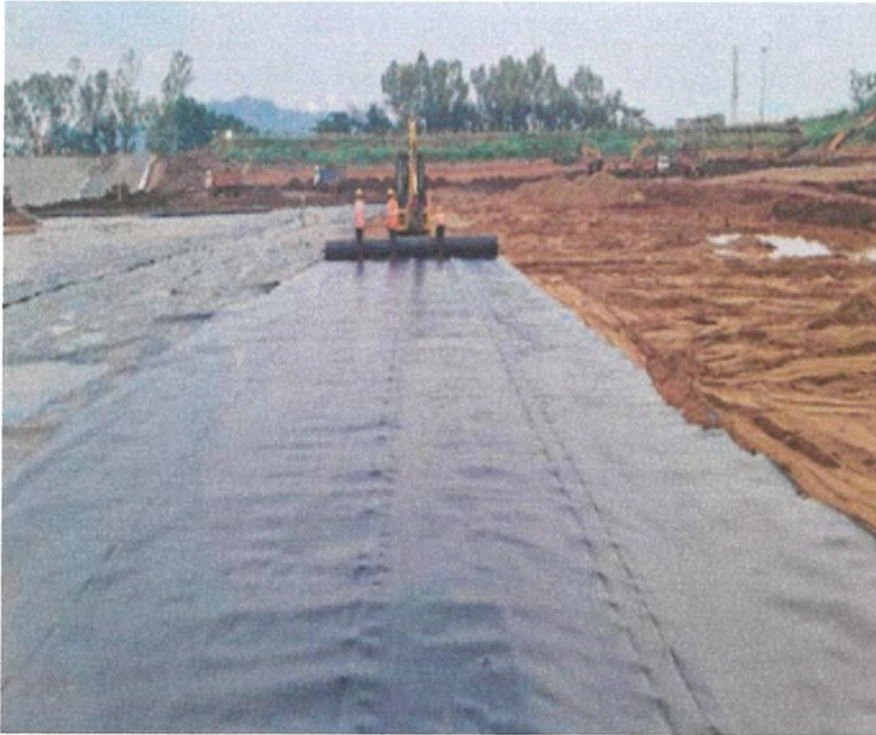
HDPE Liner Laying

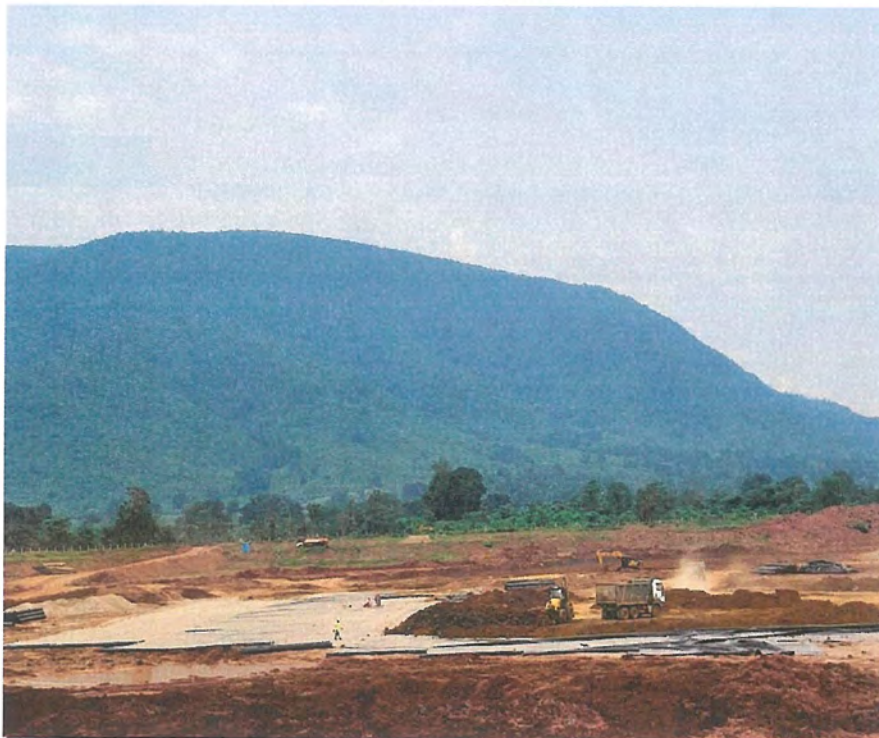
Soil overburden on HDPE liner

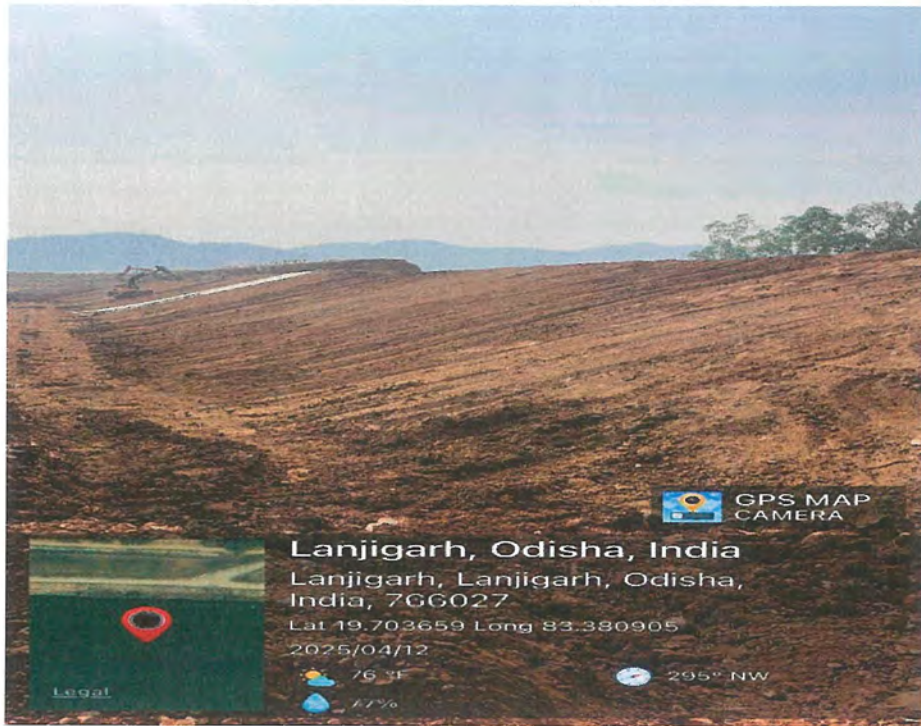
Slope Dressing & Soil Compaction

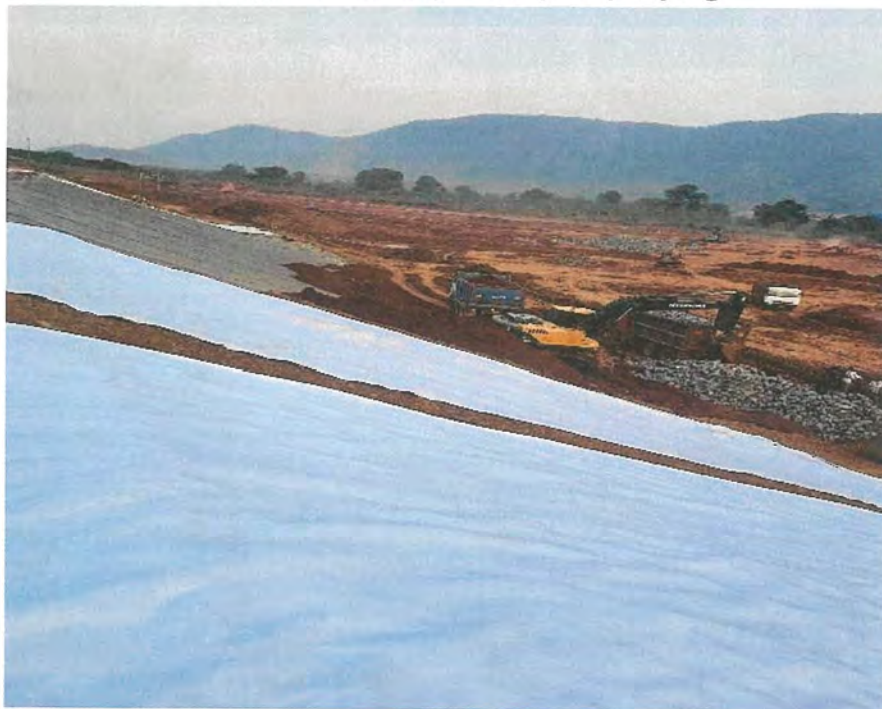
Geosynthetic Caly Liner (GCL) Laying

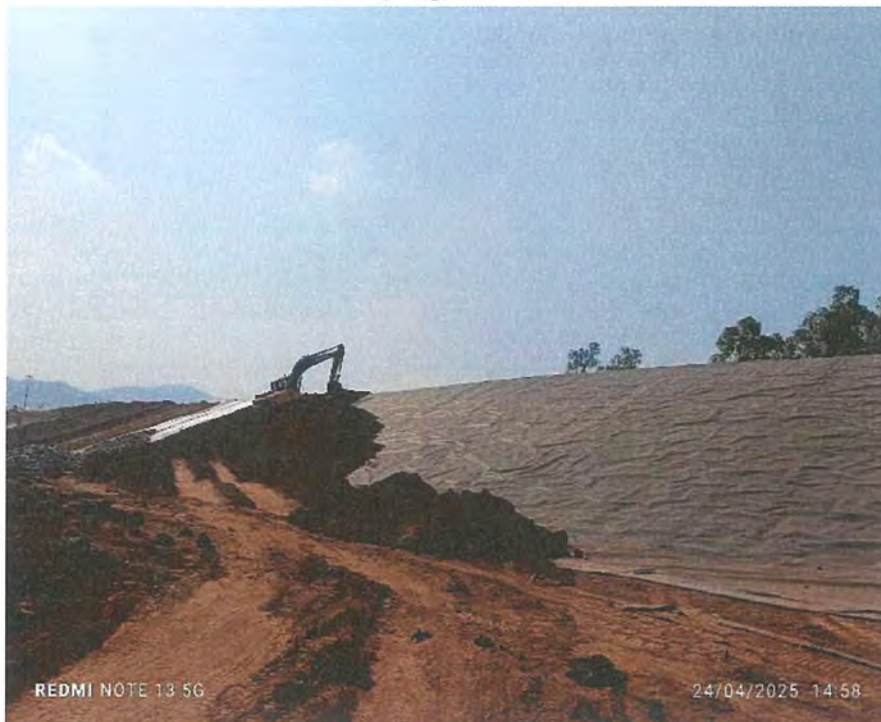
HDPE Liner Laying & Soil Over Burden

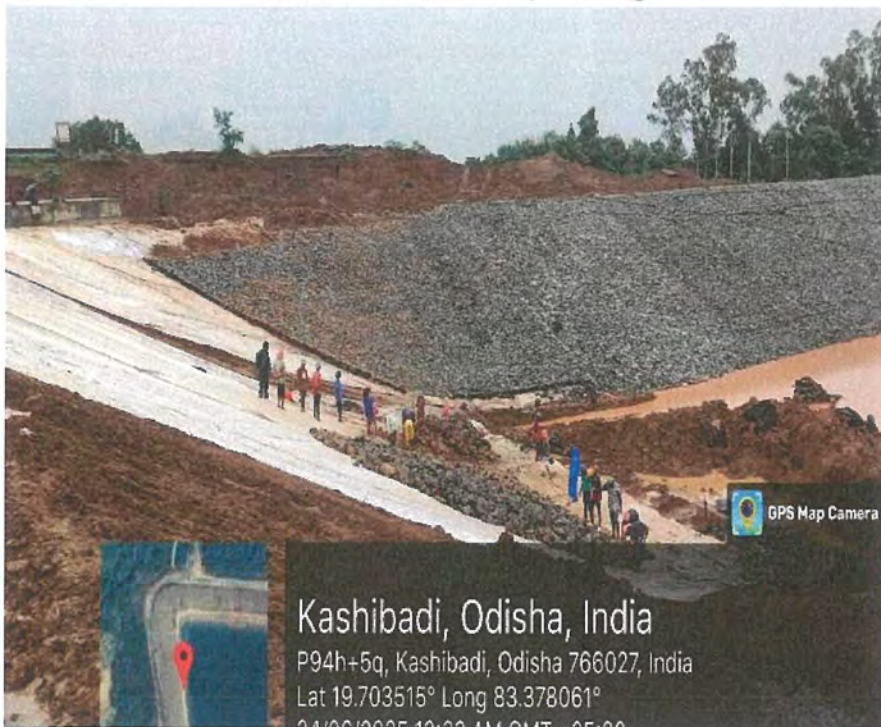
Geotextile & Stone pitching
