FINAL SURVEY REPORT (LANDSLIDE)

Ref. No.: JSLA-UII-2023-701-CAR

Final Survey Report towards insurance claim against losses due to landslide in locality of project site of **M/s. Shivalik Build Tech Pvt. Ltd. & Ministry of Road Transport and Highways** – Gumma to Fediz section (km. 94.900 to km. 103.550) of NH-707 on night of 10/11.07.2023

A/c. - M/s. Shivalik Build Tech Pvt. Ltd. & Ministry of Road Transport and Highways

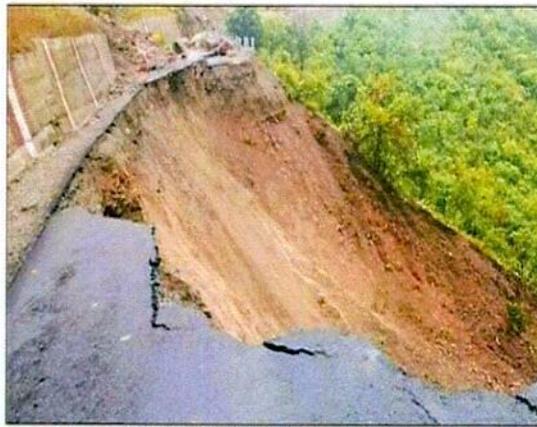
हिमाचल-उत्तराखंड सीमा के समीप फेडिज पुल में बारिश के बाद क्षतिग्रस्त एनएच 707। संभव

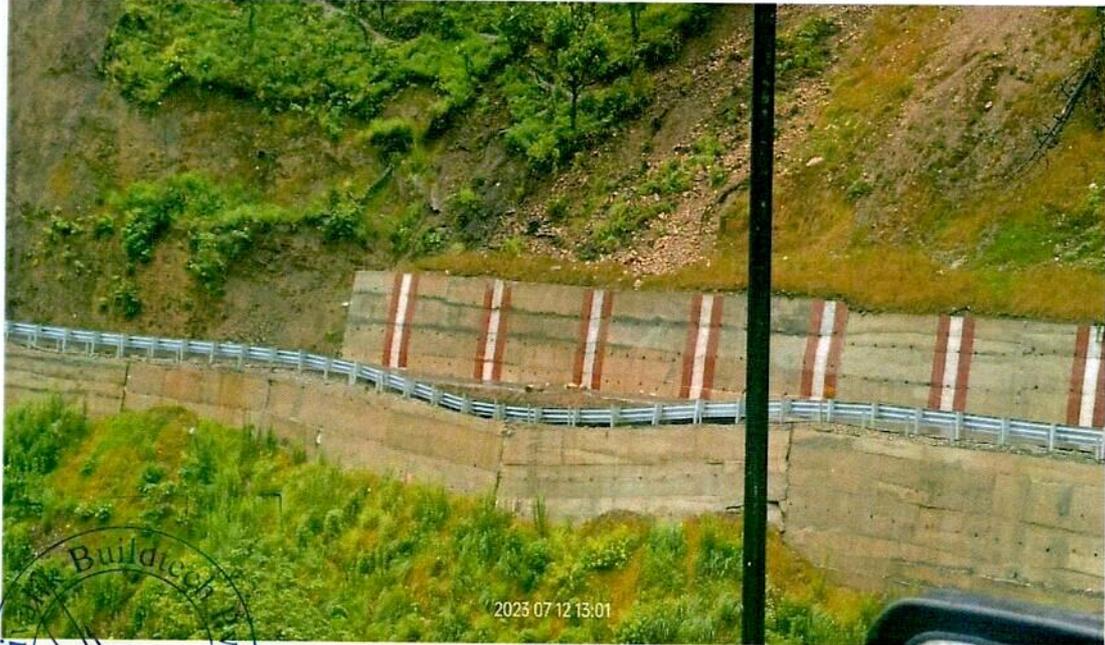
Photograph submitted by Insured depicting damages at this location after mishap is attached hereunder -

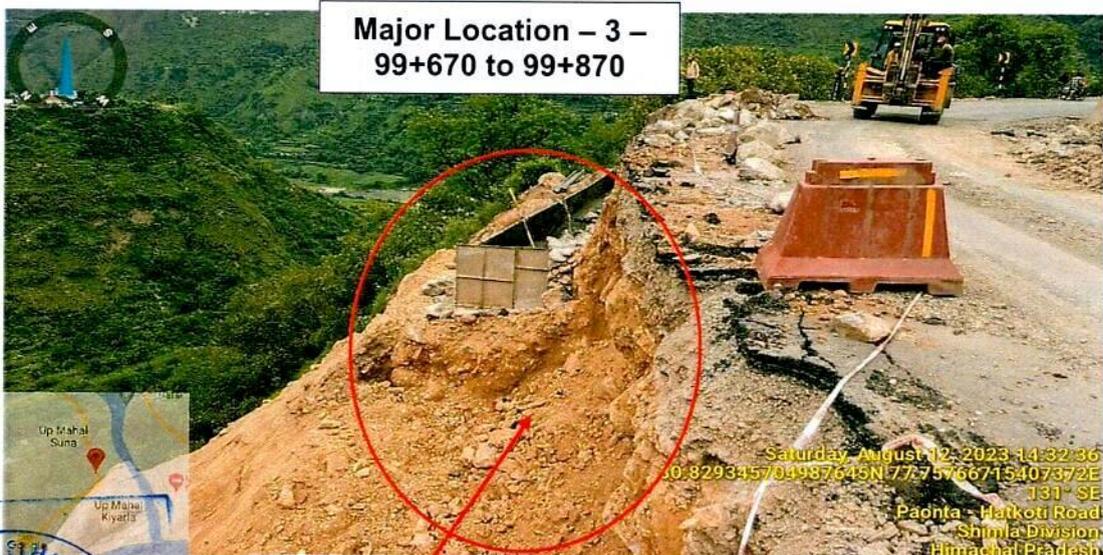
1) Major Location – 3 – 99+670 to 99+870

Retaining wall washed out

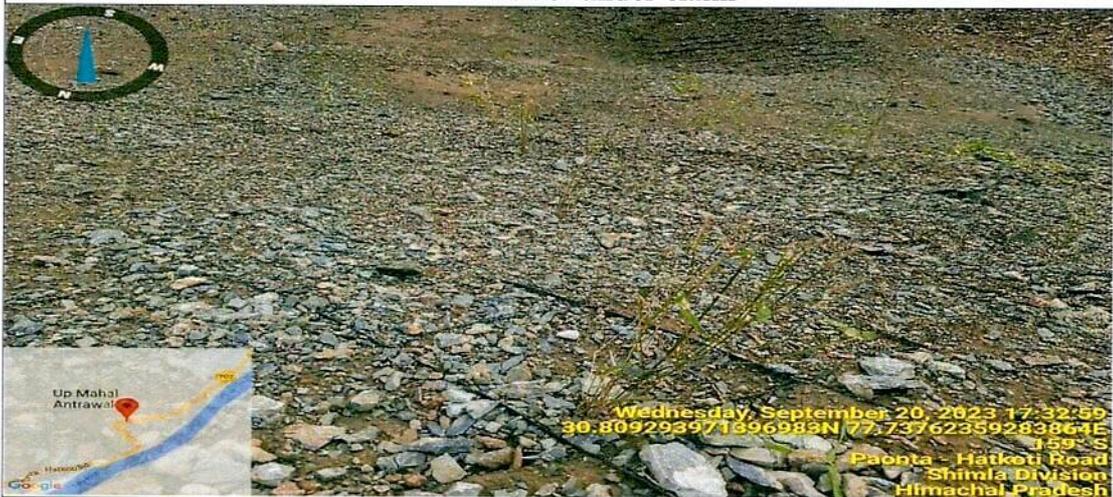
Dumping Zone - 1 - Geocell Hydrocedding plantation work is under process (This location is not under claim)
