BEFORE THE NATIONAL GREEN TRIBUNAL SOUTHERN ZONE,
CHENNAI

Application No.272 of 2024 (SZ)

Status report filed by the 2nd Respondent (as on 13.11.2025)

Condition photos of existing Major Bridge at km. 55+350

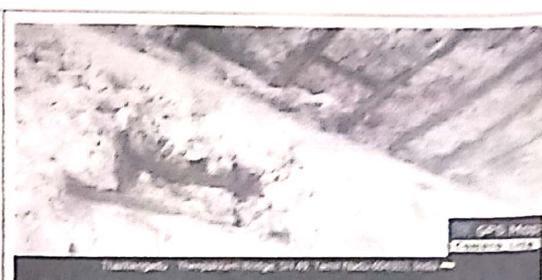
<p>Thazhargady - Therpakkam Bridge, SH 49, Tamil Nadu 604303, India</p> <p>Latitude: 12.23310323° Longitude: 79.97380679° Local: 04:32:04 PM Altitude: 0 meters GMT: 11:02:04 AM Friday, 08.10.2025 Note: ch:55+359 M.B Existing pier Cap structural concrete damaged and Reinforcement Exposed (span -33)</p>
<p>Span -33 , Deck Slab Bottom Structural Concrete Damaged and Reinforcement Exposed</p>	<p>Span -33 , Pier Cap Structural Concrete Damaged and Reinforcement Exposed</p>

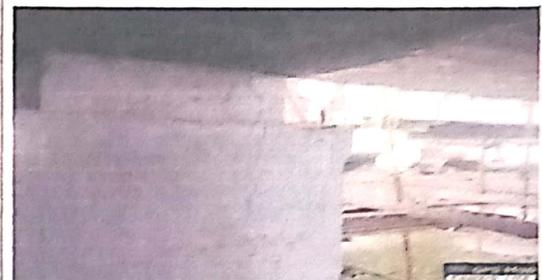
<p>Thazhargady - Therpakkam Bridge, SH 49, Tamil Nadu 604303, India</p> <p>Latitude: 12.23310403° Longitude: 79.97380684° Local: 04:32:04 PM Altitude: 0 meters GMT: 11:02:04 AM Friday, 08.10.2025 Note: ch:55+350 M.B Existing Pier Crack Observed (span -33)</p>

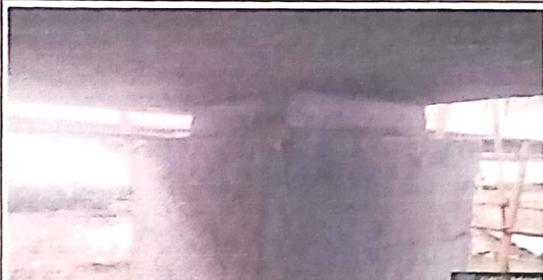
<p>Thazhargady - Therpakkam Bridge, SH 49, Tamil Nadu 604303, India</p> <p>Latitude: 12.23310266° Longitude: 79.97380674° Local: 04:32:04 PM Altitude: 0 meters GMT: 11:02:04 AM Friday, 08.10.2025 Note: ch:55+350 M.B Existing Pier Crack Observed (span -33)</p>

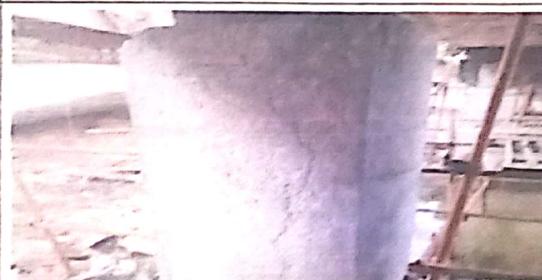
<p>Thazhargady - Therpakkam Bridge, SH 49, Tamil Nadu 604303, India</p> <p>Latitude: 12.23310247° Longitude: 79.97380674° Local: 04:32:04 PM Altitude: 0 meters GMT: 11:02:04 AM Friday, 08.10.2025 Note: ch:55+350 M.B Existing Pier Crack Observed (span -33)</p>
<p>Span - 33, Pier Crack Observed</p>	<p>Span - 33, Pier Crack Observed</p>

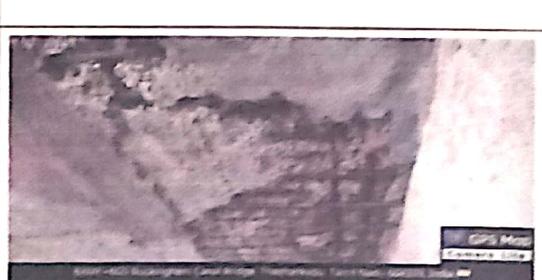
<p>SH49+353 Buckingham Canal Bridge, Thazhargady, Tamil Nadu, 604303, India</p> <p>Latitude: 12.23329250° Longitude: 79.97387704° Local: 04:39:49 PM Altitude: 0 meters GMT: 11:09:49 AM Friday, 08.10.2025 Note: ch:55+350 M.B Existing Deck Slab bottom structural concrete damaged and Reinforcement Exposed (span -34)</p>

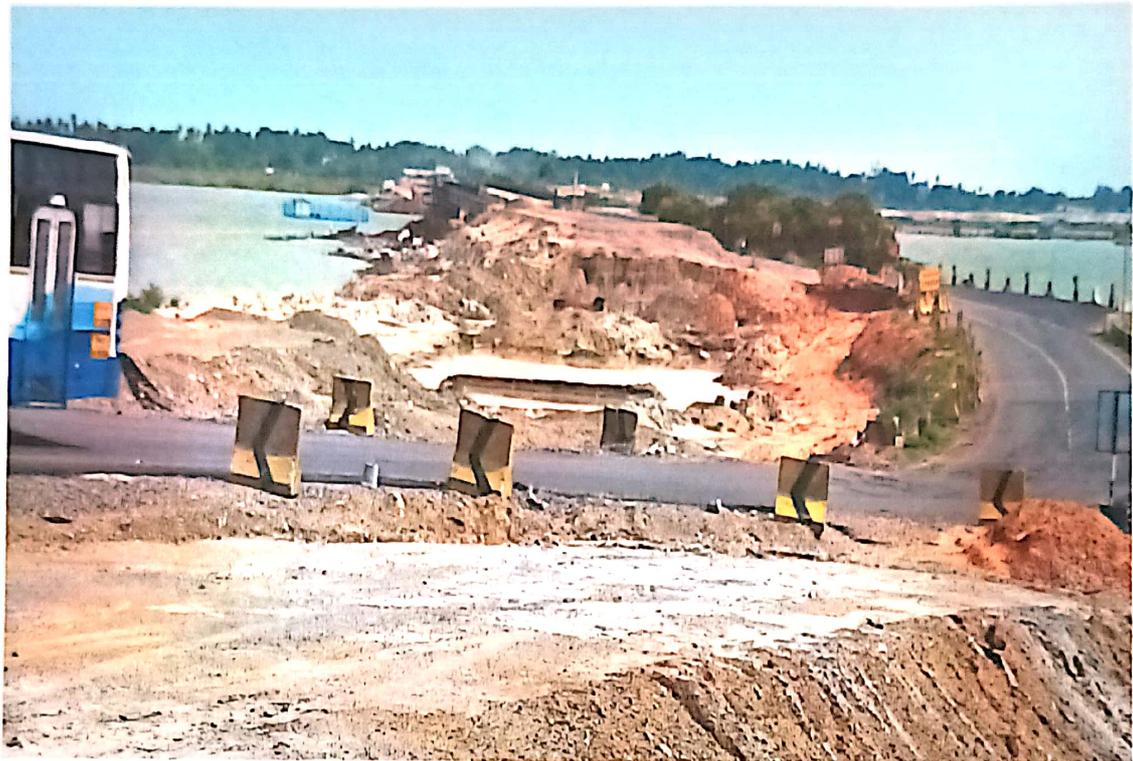
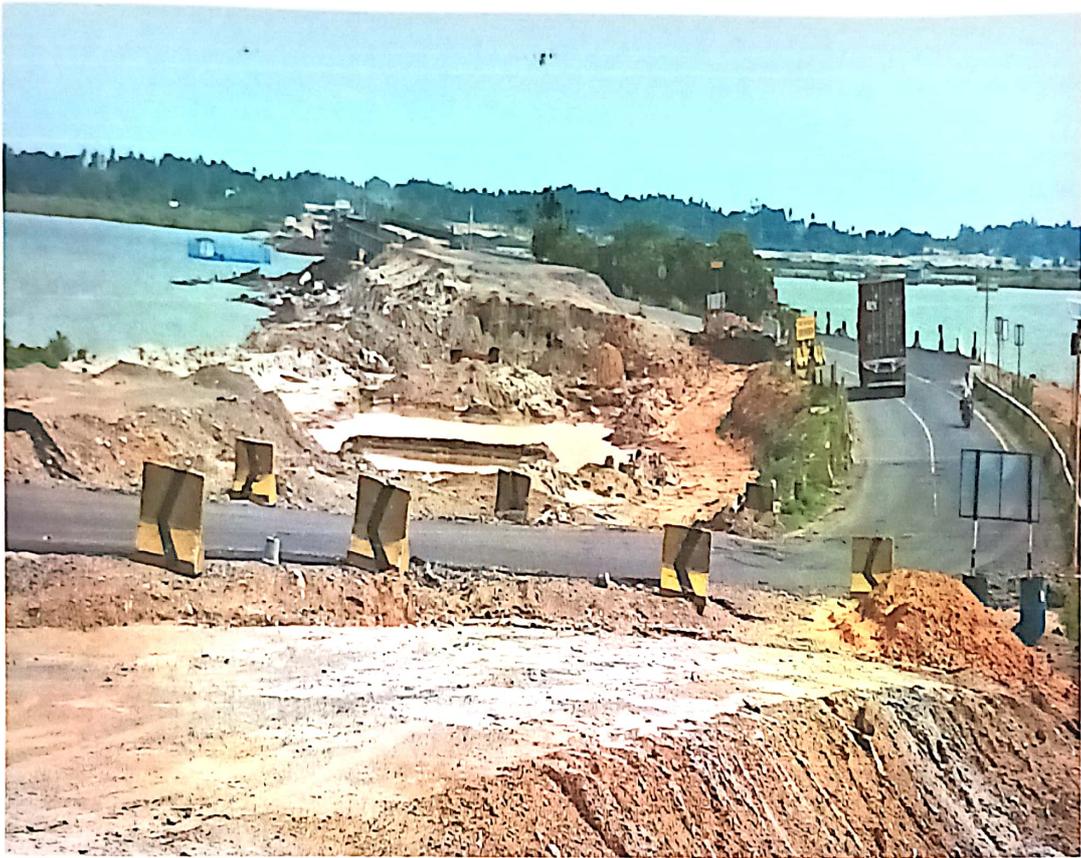
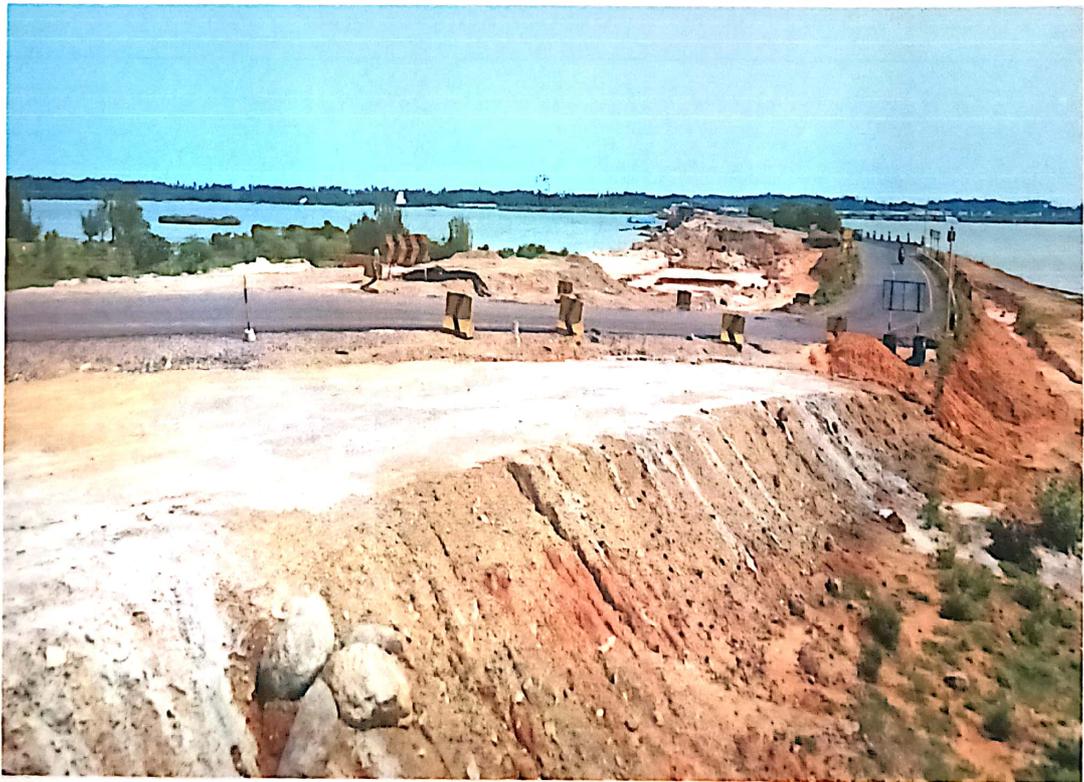
Photos showing the steep ramp diversion with high embankment filling at km. 55+800:

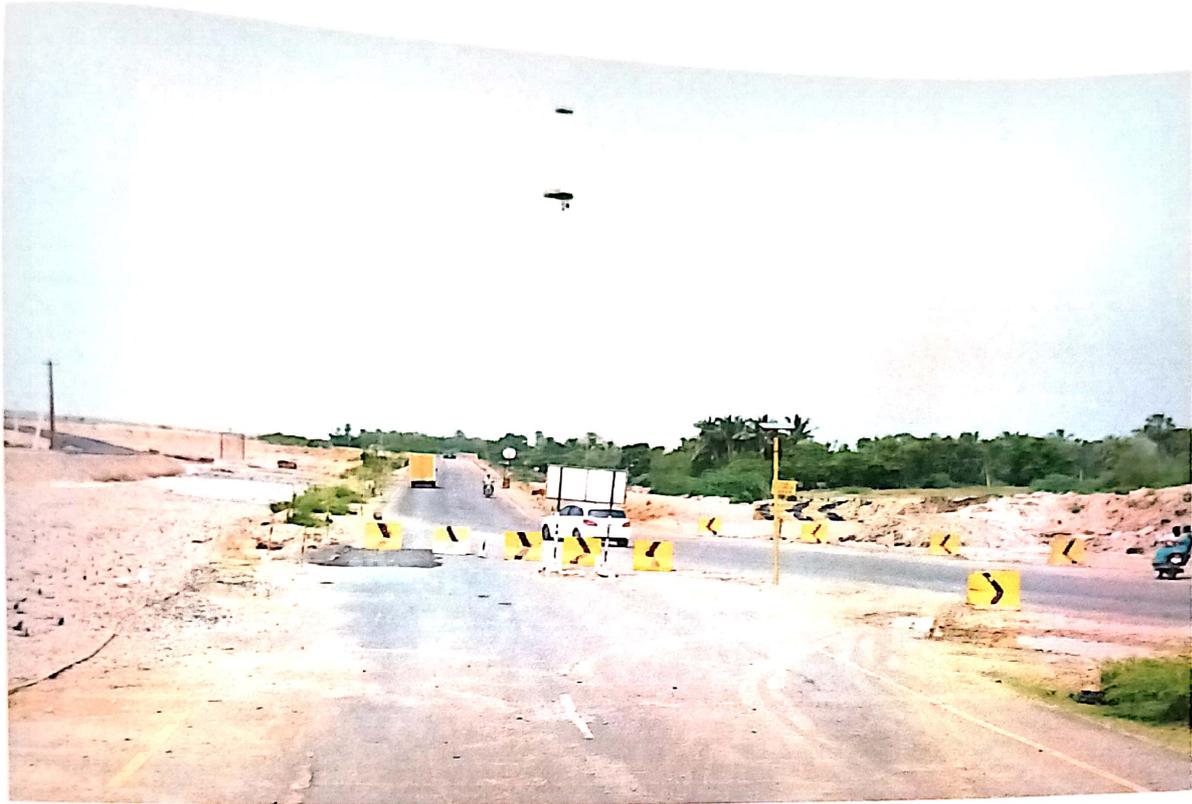
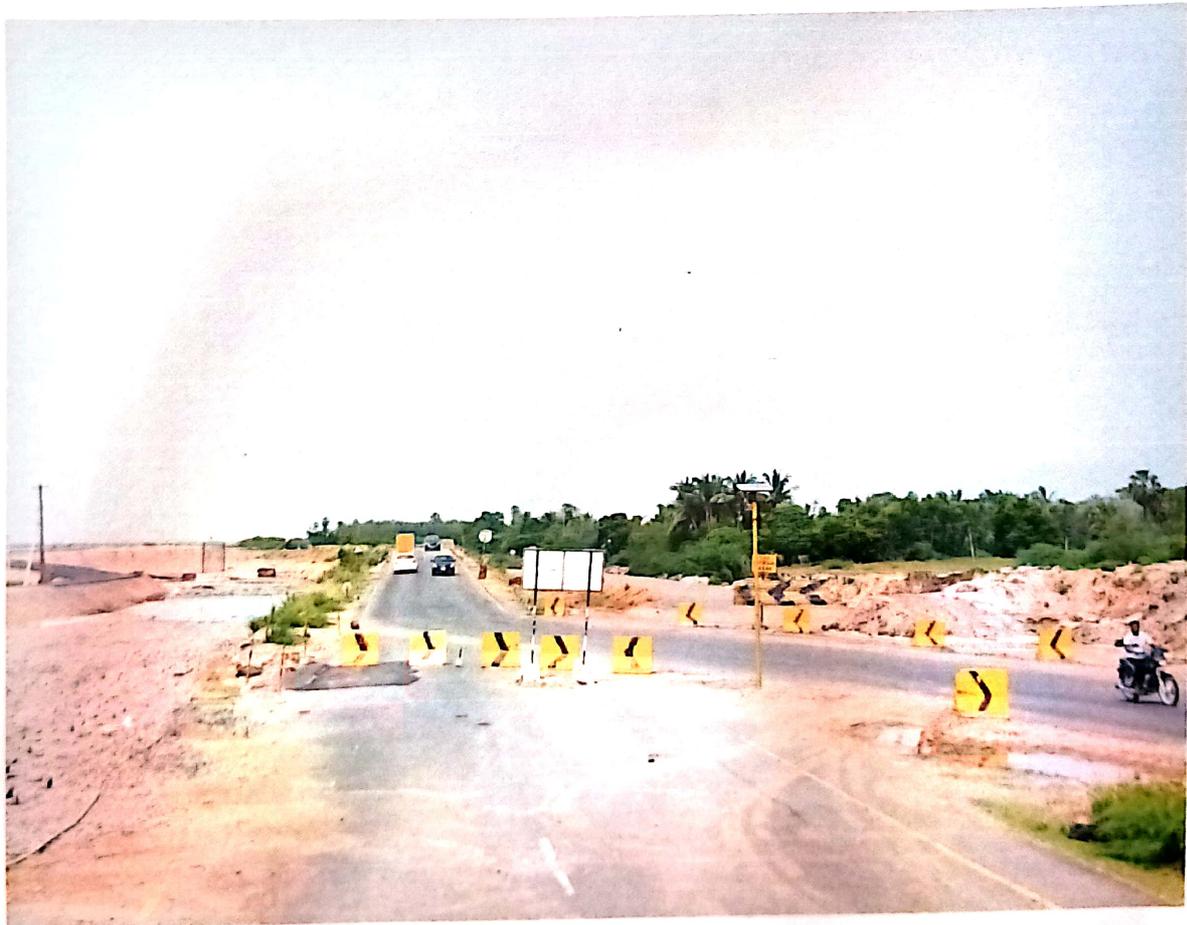
diversion at km. 56+500:

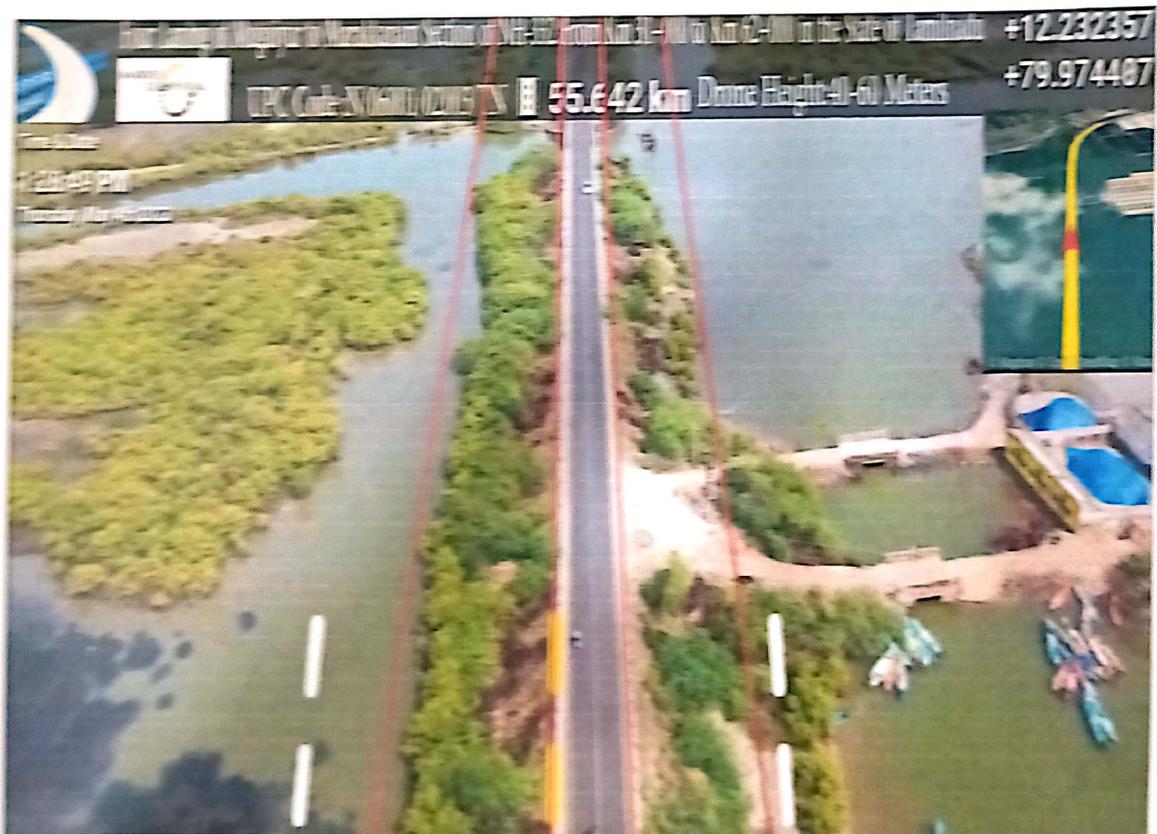
Existing Mangrove Plantation Details

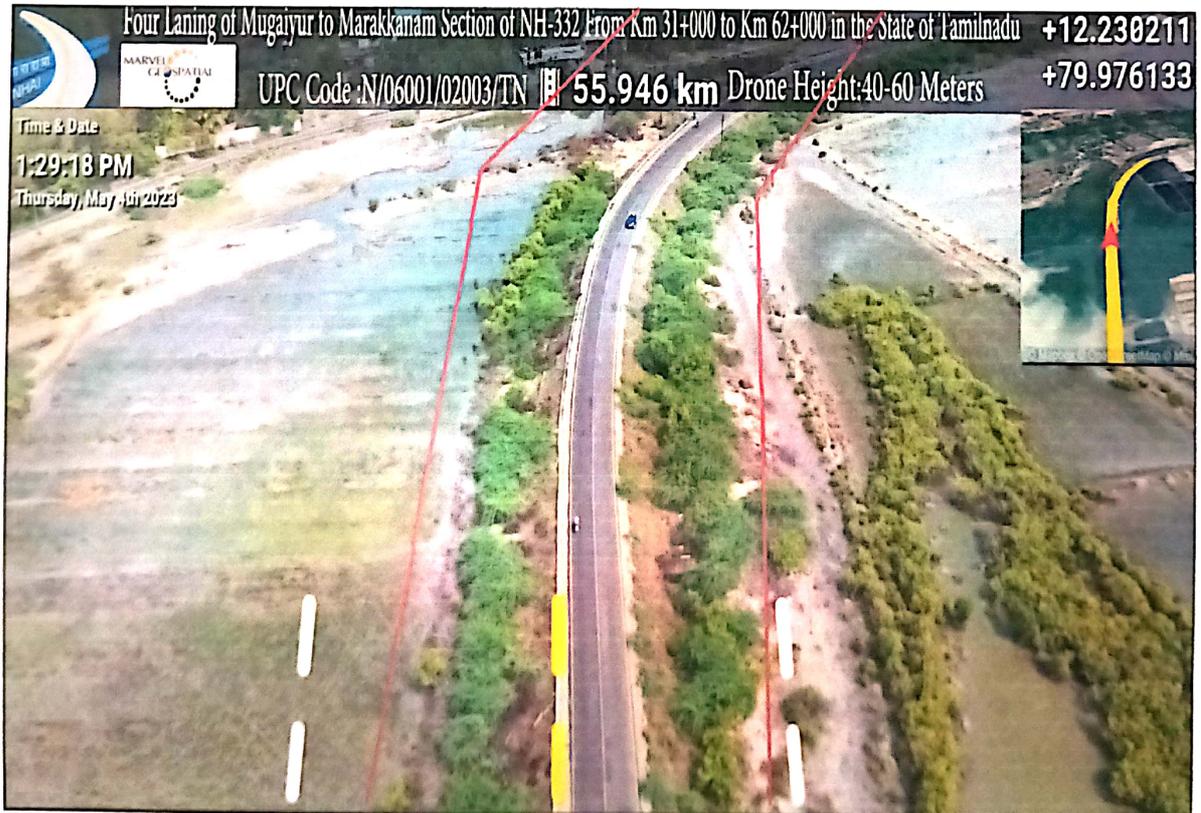
Construction of New Bridge if commenced, affected Mangrove
Plantation details area about 55,700 Sq.mtr

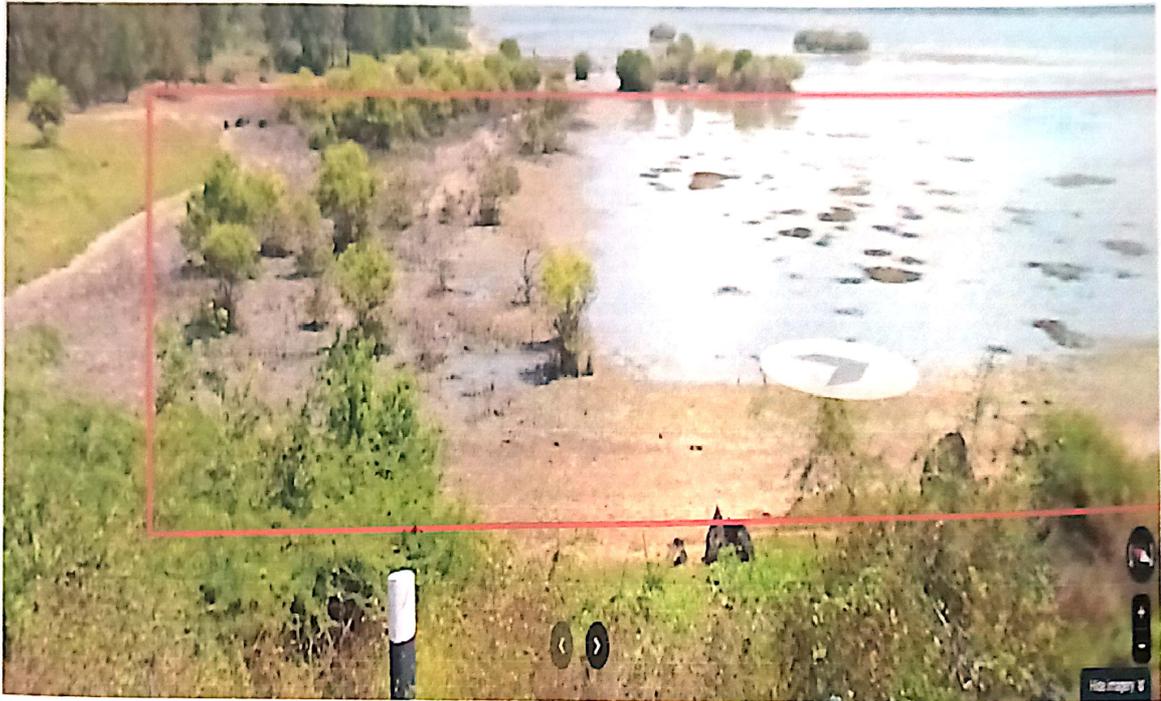
Construction of New Bridge if commenced, affected Mangrove
Plantation details area about 55,700 Sq.mtr
