Sub: Report of the joint site inspection held on 20/12/2024 from 11:15 am onwards at the property bearing survey no.16/7 of Sernabatim, Salcete, Goa.

REPORT OF THE JOINT SITE INSPECTION HELD ON 20/12/2024 FROM 11:15 AM ONWARDS AT THE PROPERTY BEARING SURVEY NO.16/7 OF SERNABATIM, SALCETE, GOA.

Site address: Survey No.16/7 of Sernabatim, Salcete, Goa

Date of inspection: 20/12/2024

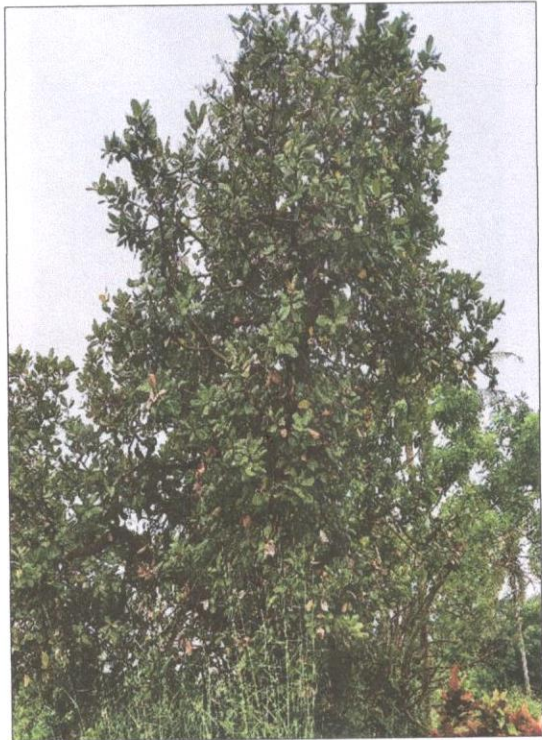
Fully grown cashew tree

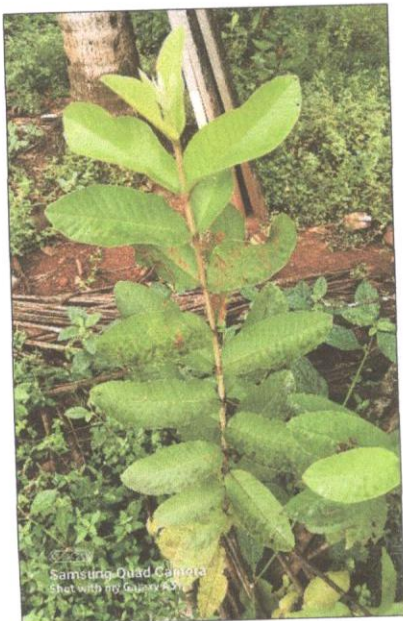
Psidium guajava
